## FORD CARS AND TRUCKS

1979-1997

### ALL FORD TRANSMISSIONS WITH ALUMINUM INPUT SHAFT RETAINER BEARING COLLAR

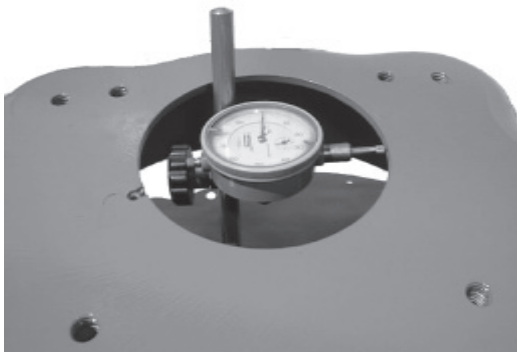
FIRST CHECK BELLHOUSING FOR BORE CONCENTRICITY. INSTALL MAGNETIC BASE TO FLYWHEEL OR PRESSURE PLATE, THEN INSTALL THE INDICATOR TO MEASURE THE BELLHOUSING BORE (SHOWN ABOVE). ROTATE THE CRANKSHAFT AND MARK DOWN THE INDICATOR READINGS (MARKING THE BELLHOUSING WORKS WELL). THE MAXIMUM OUT OF CONCENTRICITY IS .005".

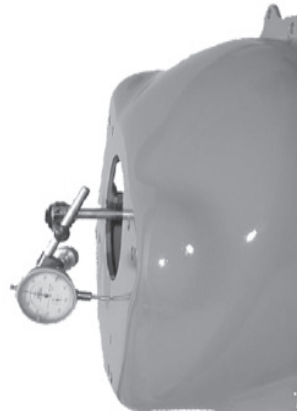
NEXT, THE BELLHOUSING FACE SHOULD BE CHECKED FOR PARALLELISM TO THE BACK OF THE BLOCK. INSTALL THE INDICATOR (AS SHOWN ABOVE). ROTATE THE CRANKSHAFT AND MARK DOWN THE READINGS (BE SURE TO PUSH THE CRANKSHAFT AGAINST THRUST BEARING FOR ACCURATE MEASUREMENT). THE MAXIMUM OUT OF PARALLELISM IS .002"

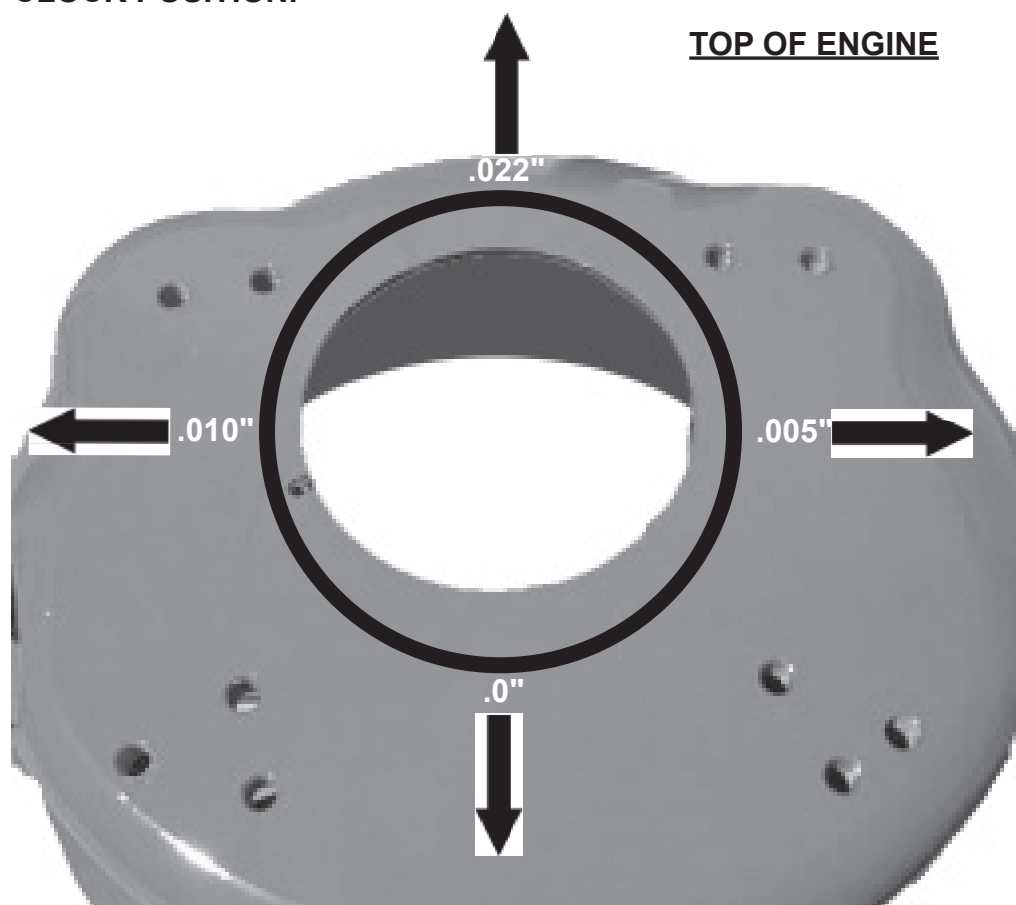
## EXAMPLE

THE BELLHOUSING WAS OFFSET TOWARD TOP OF ENGINE AND SLIGHTLY TO THE LEFT (AS VIEWED FROM BEHIND). TO ALIGN THE BELLHOUSING, INSTALL TWO .014" OFFSET DOWEL PINS WITH THE MAXIMUM OFFSET POSITIONED ROUGHLY AT THE 5 O'CLOCK POSITION.

TO CORRECT OFF-CENTER CONDITION, SELECT THE OFFSET DOWEL PIN PAIR THAT IS CLOSEST TO ONE-HALF OF THE INDICATOR READING (I.E., IF READING IS .016",  $1/2R=.008"$  USE .007" DOWELS. IF READING IS .024",  $1/2R=.012"$  USE .014 DOWELS).

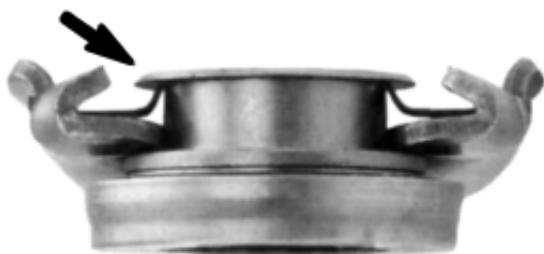
## CORRECT

**THE FORK SPRING CLIPS MUST BE INSTALLED BETWEEN  
THE THROWOUT BEARING COLLAR FLANGES. IF THE CLIPS  
ARE INSTALLED ABOVE THE TOP FLANGE AS SHOWN BELOW,  
PROPER ADJUSTMENT CANNOT BE MADE.**
