**A site investigation  
into building airtightness  
from external wall insulation**

3 house types from  
the Clients stock

December 2015 v3  
Year/Job Number: 2014 118  
Written: KP  
Checked: MR

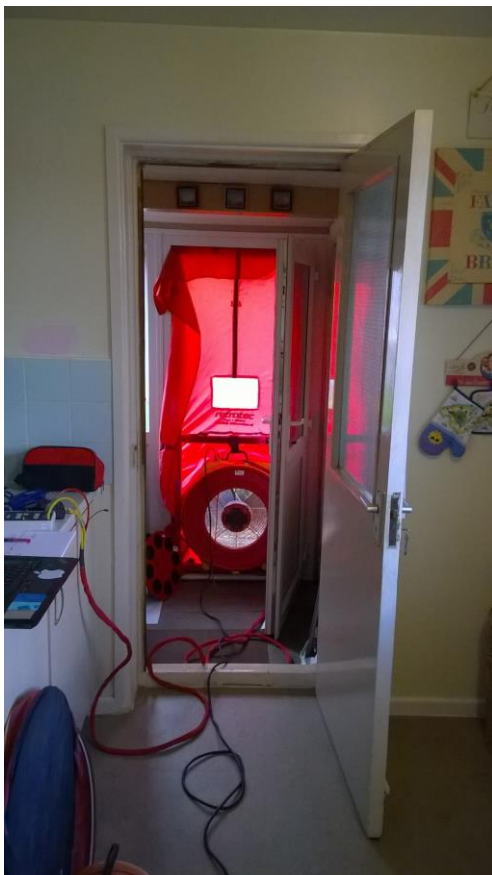
Door fan installation at House A

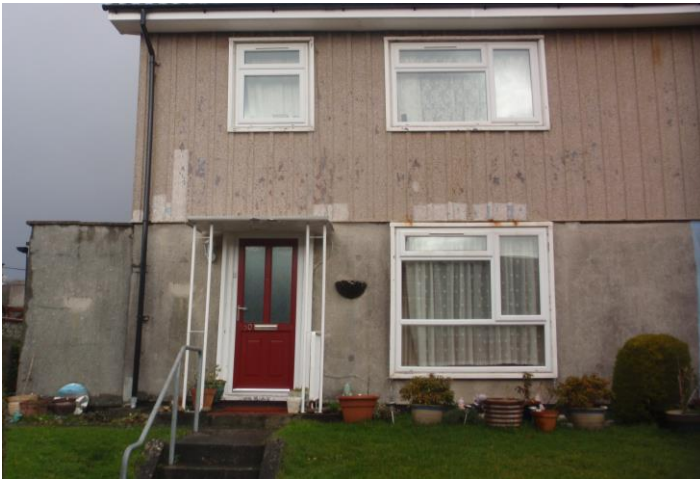
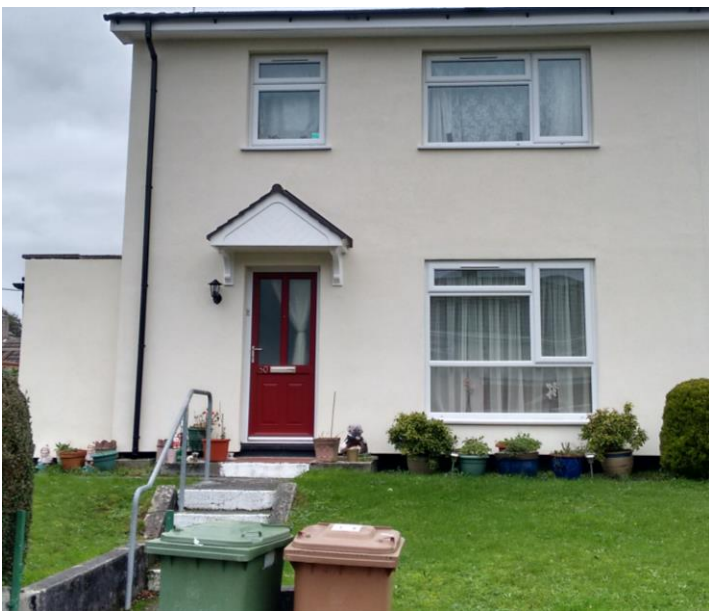
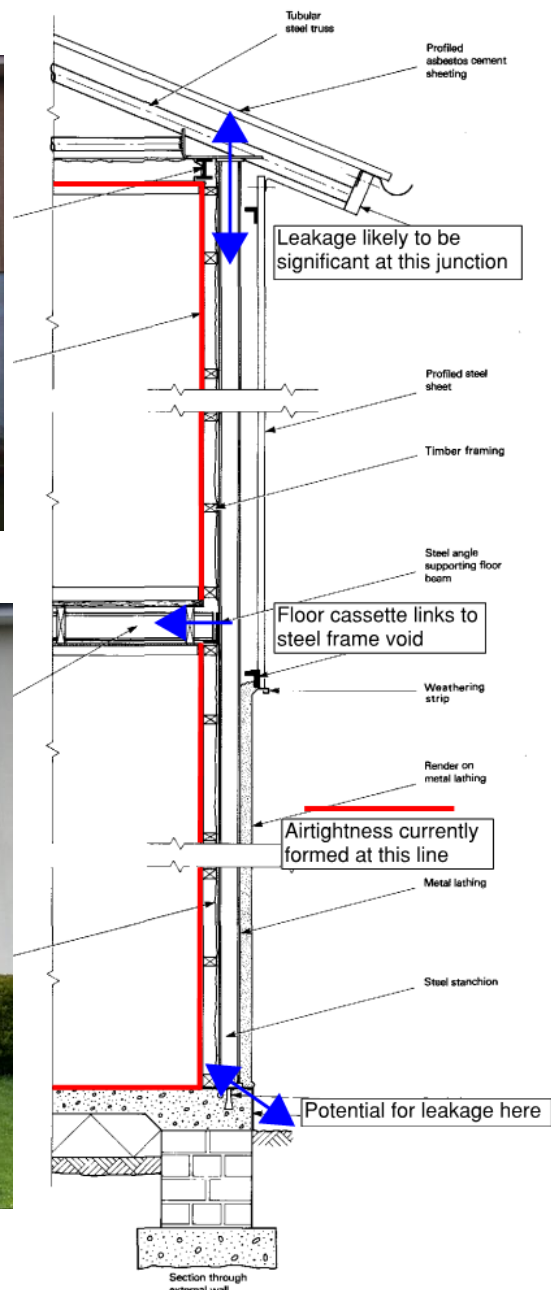
### House A

The airtight barrier in this house is currently provided by the plasterboard face to the walls and ceilings.

Air leakage is apparent at the window reveals; at the wall to ground junction; internal wall vents in bedrooms; the stair to wall junction and the wall to roof junction. Including the 'Outhouse' area in the airtightness and insulation strategy is essential, given that the residents use this space as part of their home. The before and after test results show a marginal reduction in air leakage.

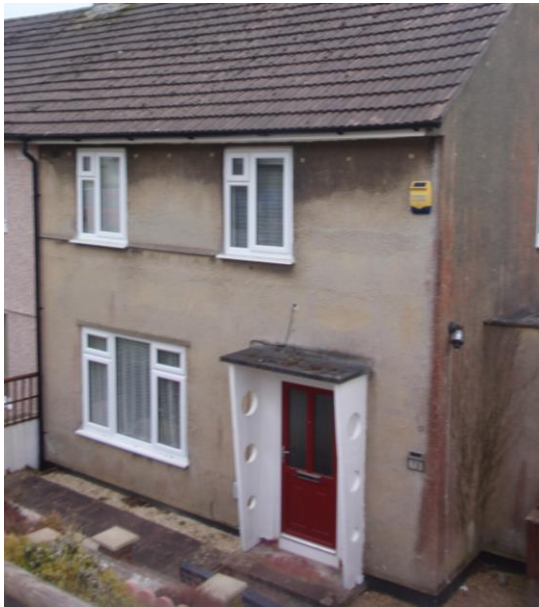
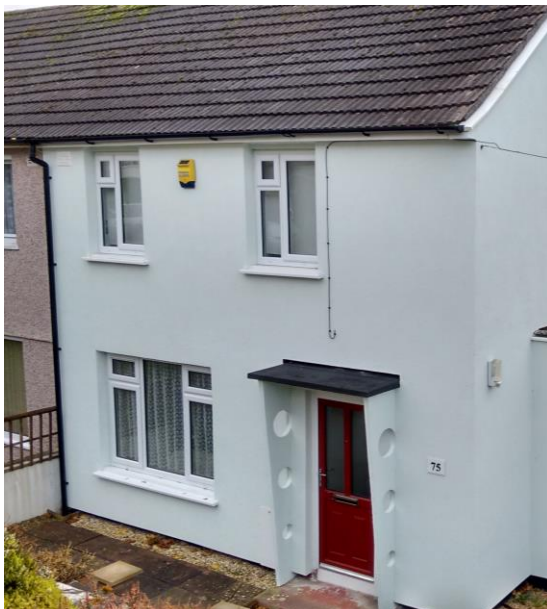
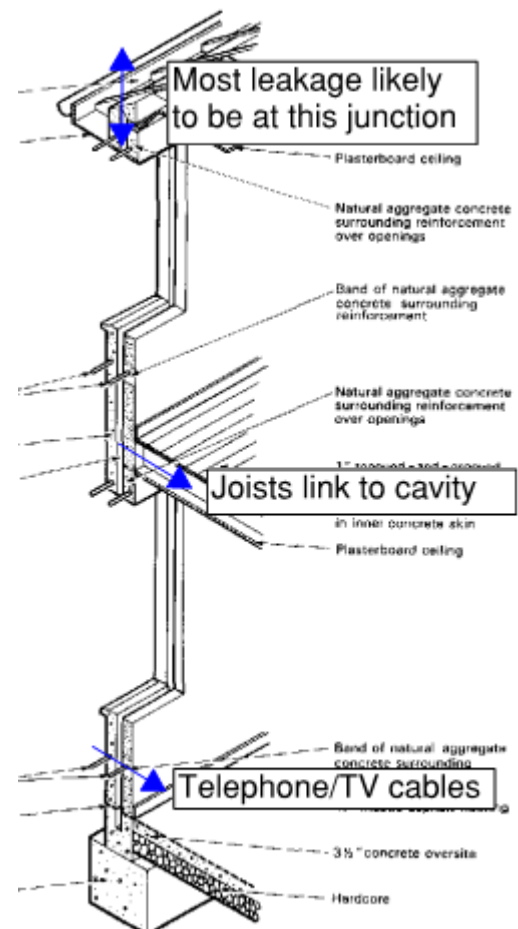
## House B

Cast concrete cavity construction is by its nature likely to be the most airtight of the 3 types tested. The most significant leaks were through services penetrations and probably the intermediate floor, likely to be caused at the point where floor joists are cast into the inner leaf of the concrete. However, given that the outhouse area forms a regularly used part of the house, airtightness in this should be addressed of the dwelling. (see photographs in Appendix for further details).

The before and after test results indicate that the air leakage has actually increased since the initial test. It is not clear why this has occurred.

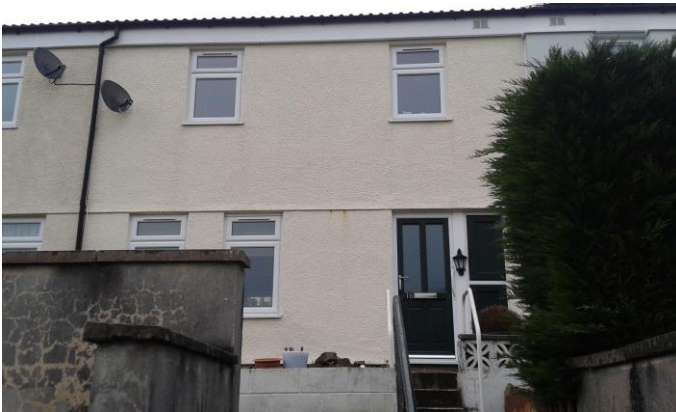
### House C

While we could undertake depressurisation tests, it was not possible to pressurise the house to 50Pa with our fan. We abandoned the test at this point as one of the residents was unwell with chest problems, and even with heating on the fan test was cooling the house to an uncomfortable level. While earlier No-fines houses were wet plastered internally, these later ones have an internal lining which appears to be consist of plasterboard on battens. Therefore there is essentially a cavity behind the concrete. Significant leakage through the intermediate floor shows that this cavity is not well sealed from the outside. Without further examination it is not possible to say definitively where these leaks originate from.

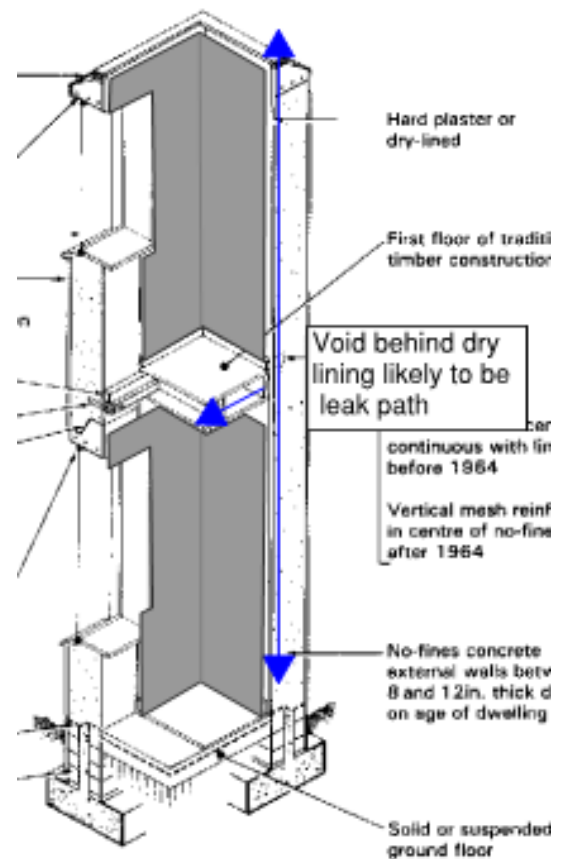
Given the airflow felt through a socket on an internal wall it is possible that the wall to roof junctions play an important role. The very high air leakage in this house would certainly limit the effectiveness of any external insulation unless the detailing of the insulation is carefully considered at the window reveals, at the wall to ground junction and the wall to roof junction. However BRE guidance (Williams 1991) suggests that there is an intentional drainage slot at the base of the No-fines wall which needs to be maintained, so the strategy does need some thought.

The before and after test results show a marginal reduction in air leakage.

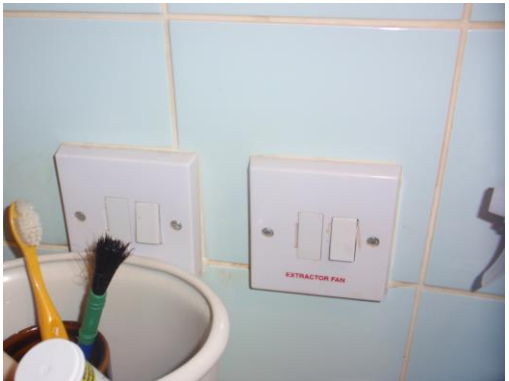
| <b>Sockets/switches</b><br>Leakage was noted from all the sockets and switches in the house | |

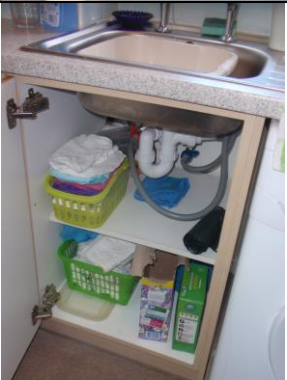
| <b>Plumbing behind kitchen sink</b><br>A draught could be felt coming from the kitchen sink cupboard. This is likely to be from the plumbing penetrations | |

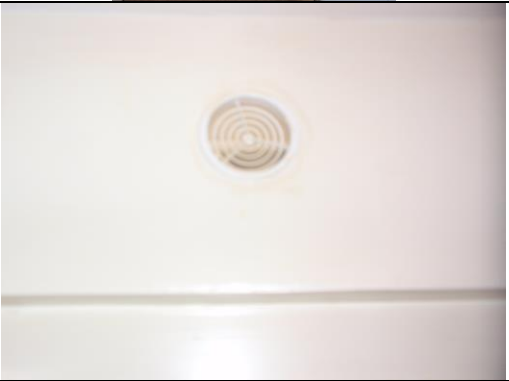
| <b>Gas pipe vent in kitchen</b><br>This gas pipe venting was installed during the refit of the kitchen | |

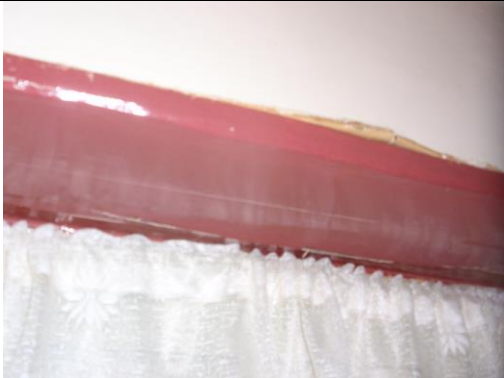
| <b>Window reveal in lounge</b><br>Air appeared to be coming in through the | |

| <p>damaged reveal, which may be due to corrosion in the steelwork.</p> | |

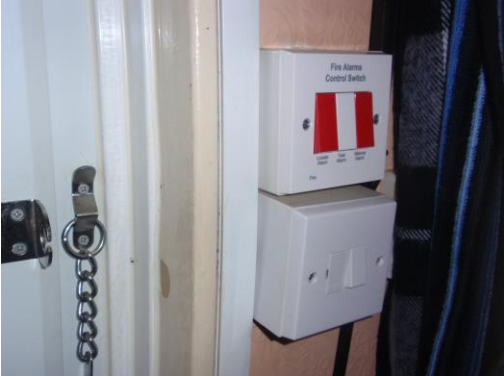
| <p><b>Switches and trunking by front door</b><br/>Despite being surface mounted, air could be felt both from in and around the switches and the trunking</p> | |

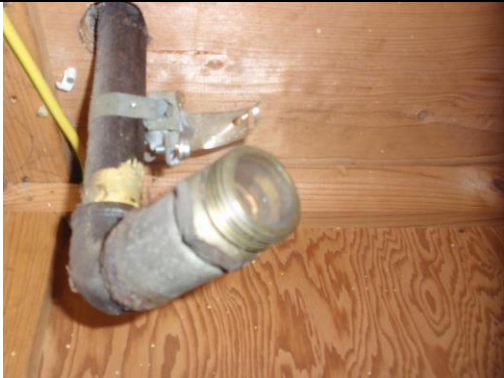
| <p><b>Disused gas pipework</b><br/>The disconnected pipe appears to run to the outside of the building, where it must also be disconnected, and does not appear to be capped off</p> | |

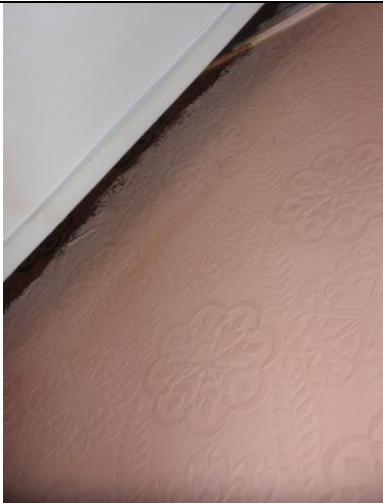
| <p><b>Behind stairs</b></p> <p>The plasterboard appears to stop somewhere behind the steel stair construction, allowing significant airflow at this point. Access very difficult.</p> | |

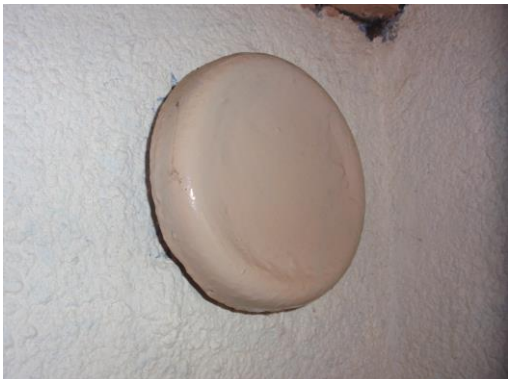
| <p><b>Wall vents</b></p> <p>2 vents within the main wall of the house which are open to the outhouse area but do not appear to connect to the interior</p> | |

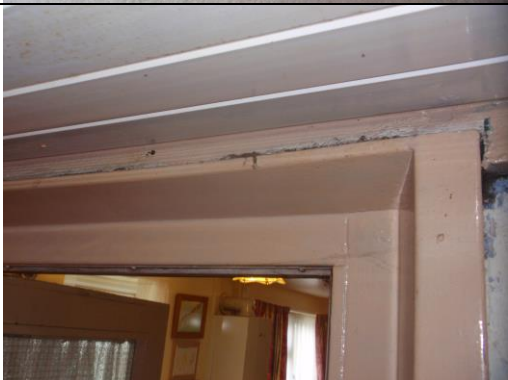
| <p><b>Doorframe</b></p> <p>Around the top of the steel doorframe within the outhouse area</p> | |

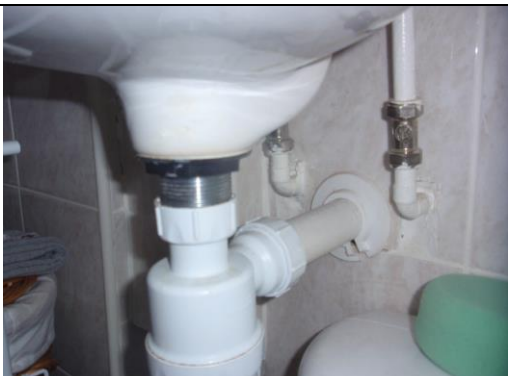
| <p><b>Bath panel/plumbing</b></p> <p>Leakage was noted at the plumbing penetrations and from behind the bath panel</p> | |

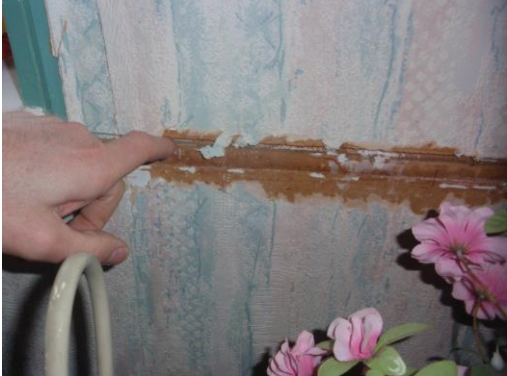
| <p><b>Plasterboard damage</b><br/>A gap in the plasterboard leaked significantly</p> | |

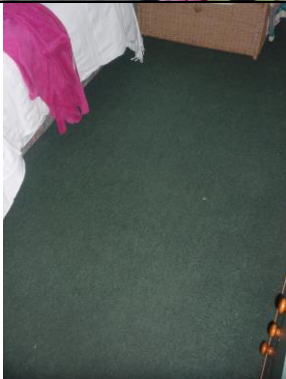
| <p><b>Intermediate floor</b><br/>Lightweight carpet upstairs lifted during the depressurisation test, showing a significant leakage path through the wall construction into the floor cassette</p> | |

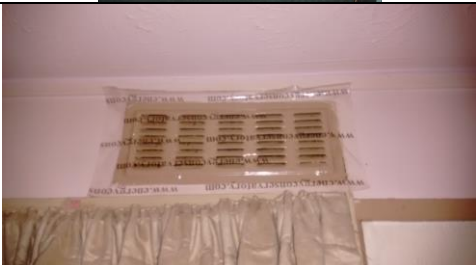
| <p><b>Wall Vents</b><br/>Uncontrolled vents in bedrooms into the wall cavity. There is significant air flow through these. They were temporarily sealed during the tests.</p> | |

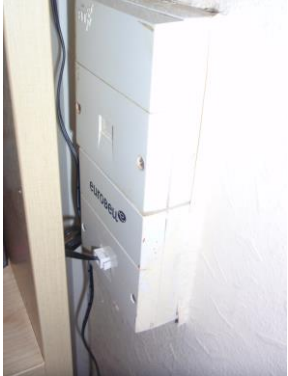
| <p><b>Phone point</b><br/>The telephone sockets were leaky, suggesting poor sealing of the telephone cable entry</p> | |

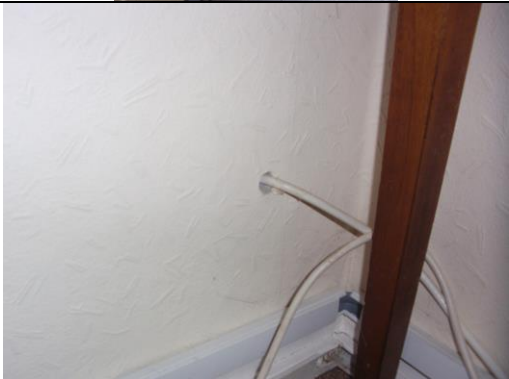
| <p><b>Cable</b><br/>This cable was very poorly sealed. Control over 3<sup>rd</sup> party works is important in avoiding unwanted leakage</p> | |

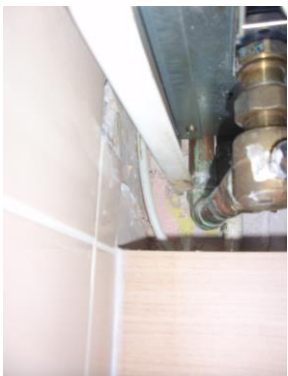
| <p><b>By boiler</b><br/>This is likely to be from the gas pipe penetration or from another services penetration hidden behind the built-in kitchen units</p> | |

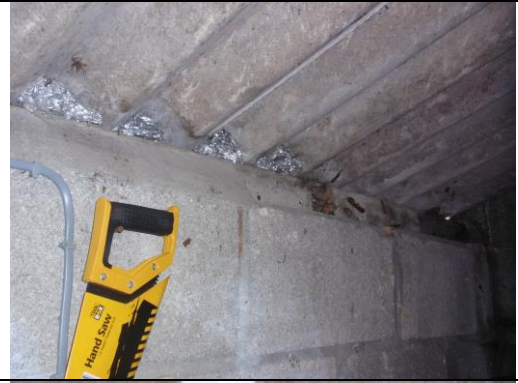
#### Roof to wall junction

This junction is not sealed, with gaps between the corrugated asbestos roofing and the rendered blockwork wall

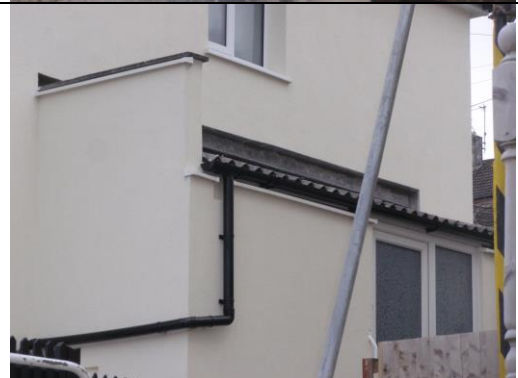
#### An insulated house nearby

The asbestos roofing has been left in situ, and there is a cold bridge where the roofing meets the main house wall. The corrugated roofing junction with the outhouse wall does not appear to have been made airtight, and the insulation stops short of the roof both at the top (main house) and bottom (outhouse)

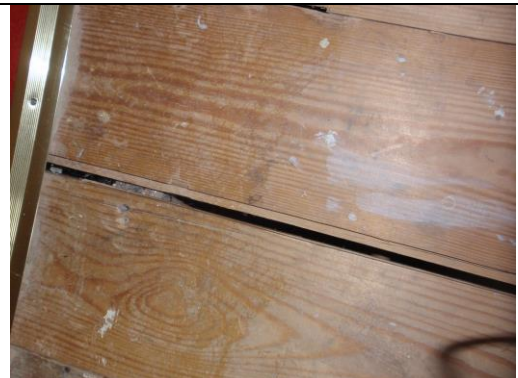
#### Intermediate floor

Where floor coverings were absent a small amount of leakage could be felt through the gaps between floorboards

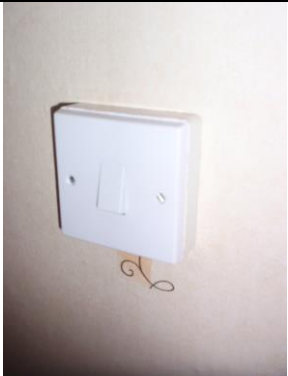
| <p><b>Switch (on internal wall) and ceiling roses</b><br/>The switch was leaky, suggesting that the internal stud wall is open to the loft space<br/>Additionally, leakage was noted at ceiling roses, which is to be expected</p> | |

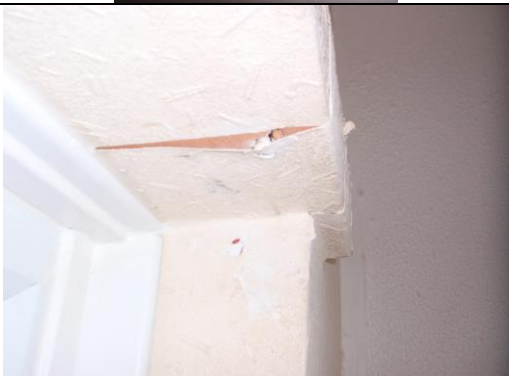
| <p><b>Lintel</b><br/>A leak was noted where the lintel surface decoration was damaged, which may suggest that the lintel itself is damaged somehow, or that the internal plaster has come loose and the hole behind communicates with the cavity</p> | |

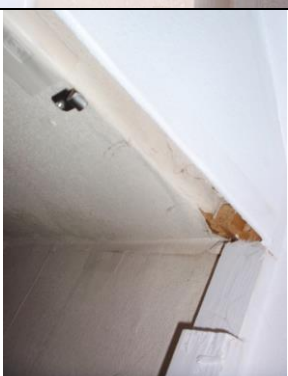
| <p><b>Built in cupboard</b><br/>The corner of this built in cupboard in the front bedroom was leaky</p> | |

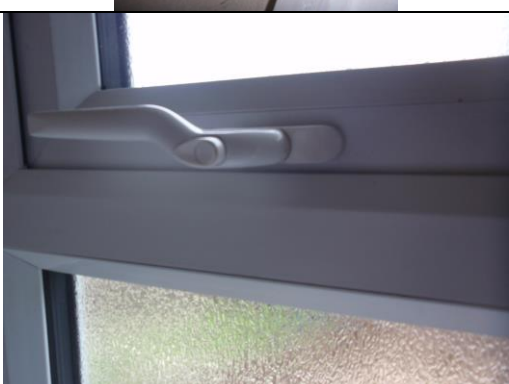
| <p><b>Windows</b><br/>Some of the windows had slight leaks where either the opening sashes did not seal fully or glazing unit beading was not sealing fully</p> | |

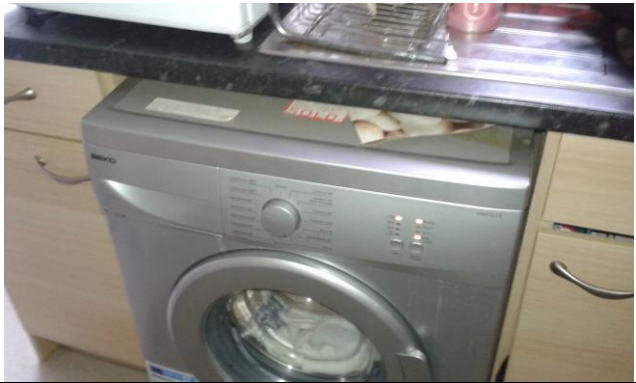
| <b>Behind built in kitchen units</b><br>Significant airflow could be felt through all the kitchen cupboards and drawers both on the external and party wall, as well as from around the washing machine. Air could also be felt behind the cooker (on the party wall) | |

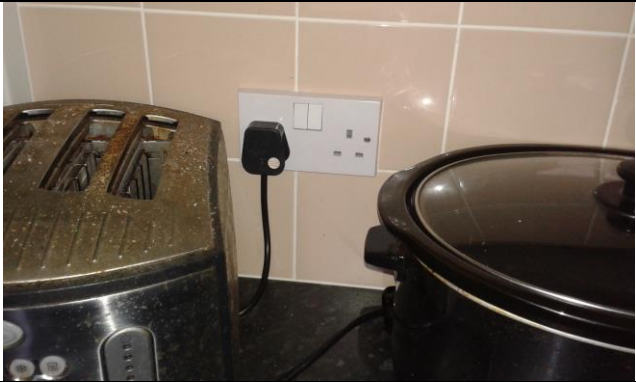
| <b>Kitchen Sockets</b><br>All sockets were leaky, including one on an internal wall | |

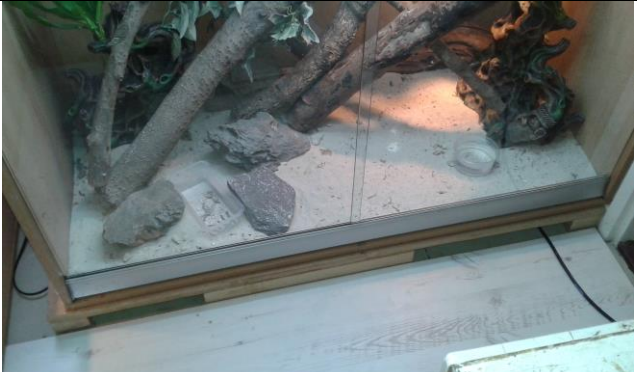
| <p><b>Under vivarium in dining room</b><br/>Air could be felt coming from under the vivarium. This may have been from a socket on the external wall or from the wall to floor junction</p> | |

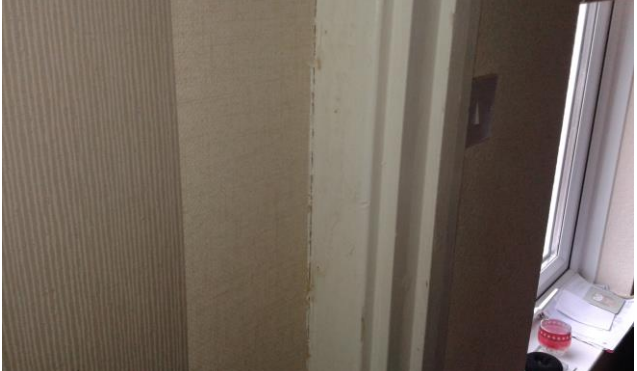
| <p><b>Internal to external wall junction</b><br/>The junction of the internal wall and external wall was leaky</p> | |

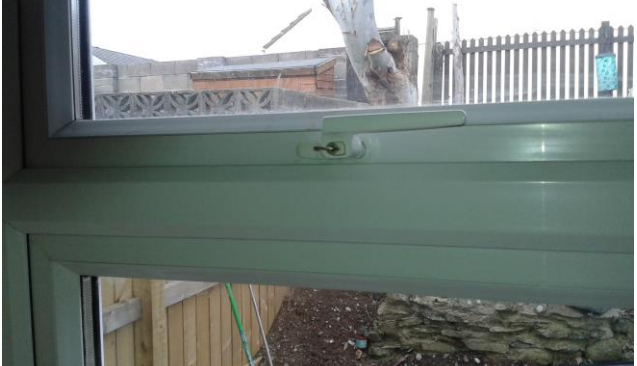
| <p><b>Window in dining room</b><br/>This was quite leaky. Other ground floor windows appeared to be ok</p> | |

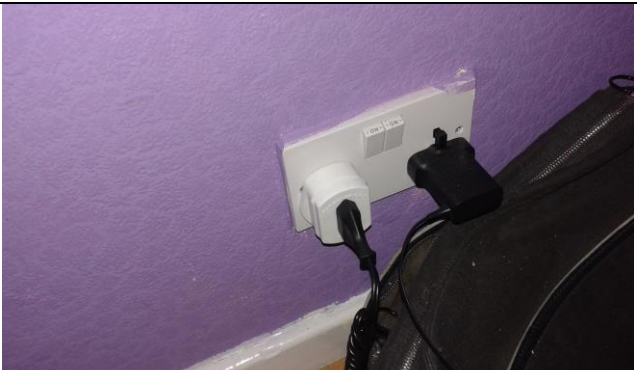
| <p><b>Sockets</b><br/>First floor sockets were leaky, indicating that the void behind the dry lining is providing a path for airflow</p> | |

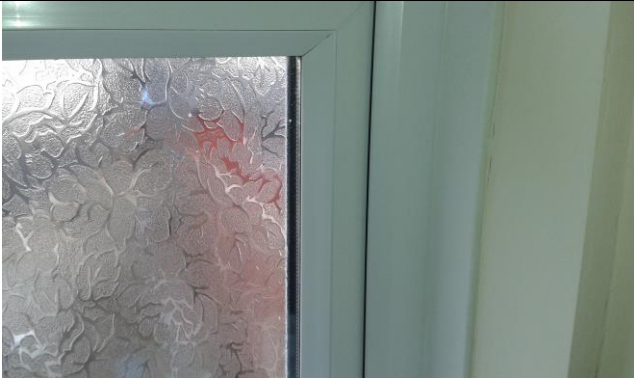
| <p><b>Windows</b></p> <p>Some windows were leaky, particularly the one in the wet room. This room was reported to be particularly draughty by the tenants</p> | |

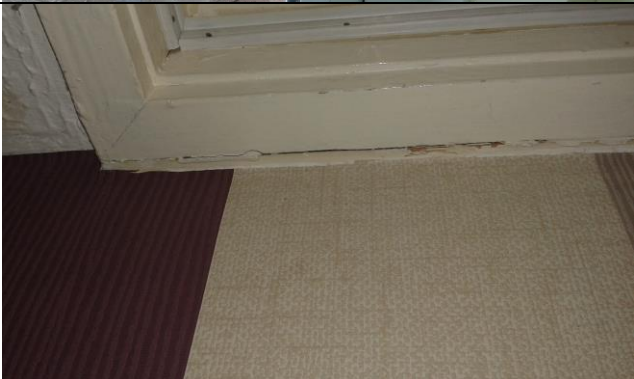
| <p><b>Loft hatch frame</b></p> <p>The loft hatch was well sealed, but where the frame meets the ceiling there was a leak. There were also leaks at cracks in the plasterboard ceiling</p> | |

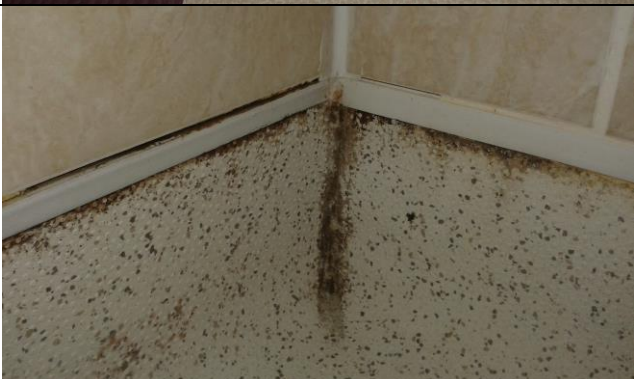
| <p><b>Boxing in wet room</b></p> <p>Leaks could be felt at the junction between the wall finish and wet room floor. This room was reported to be particularly draughty by the tenants</p> | |

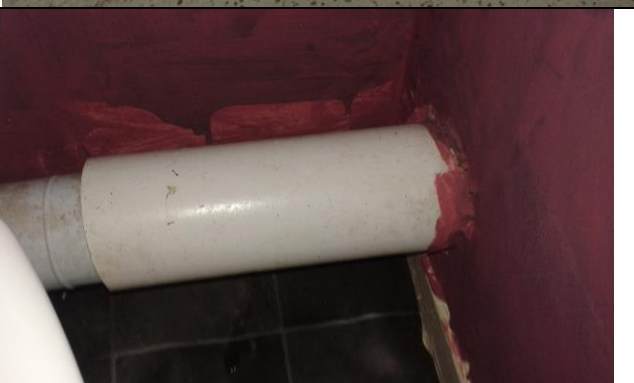
| <p><b>Soil pipe</b></p> <p>Air leakage was noted at the soil pipe. This runs into the adjacent room (ie the soil pipe runs parallel to the external wall)</p> | |

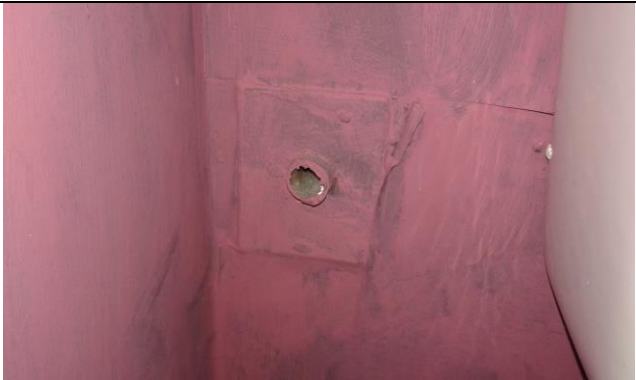
| <p><b>Old overflow</b><br/>Although this was filled with foam externally, leakage was felt through the old disconnected toilet overflow</p> | |

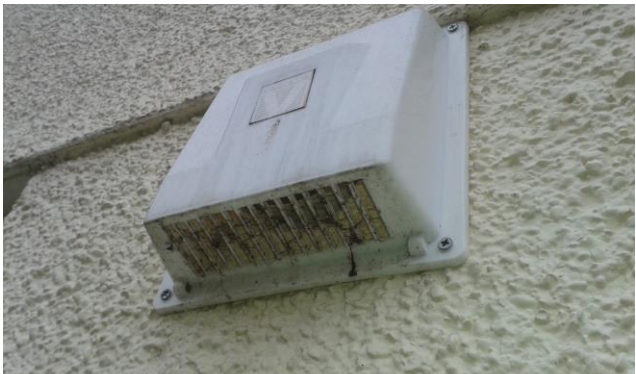
| <p><b>Kitchen extract cowl</b><br/>There are no flaps to this cowl to reduce airflow when the fan is not running</p> | |

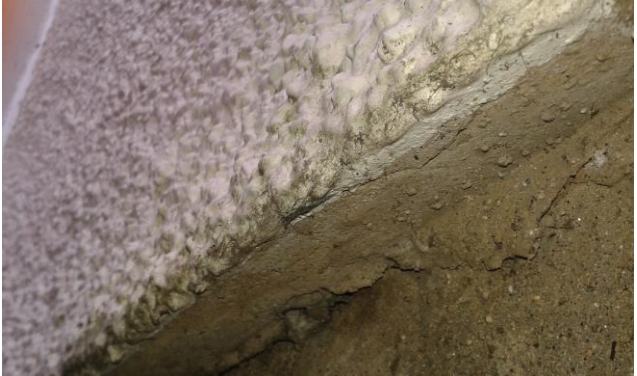
| <p><b>Render stop line</b></p> <p>At the back of the render stop line the no-fines concrete could be felt exposed in places, providing a potential leak path due to voids within the no-fines material. However, according to the BRE there is supposed to be drainage at this location</p> | |

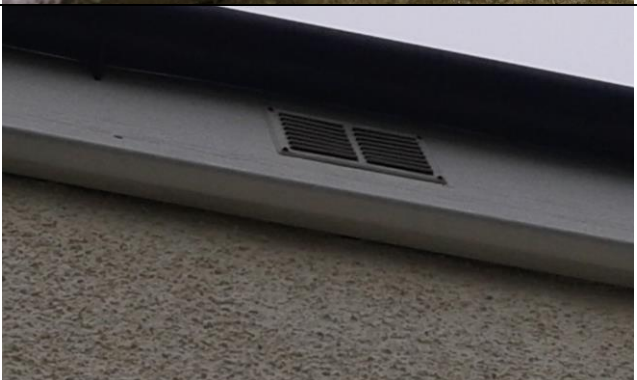
| <p><b>Eaves vents</b></p> <p>Eaves ventilation appears to have been fitted. It is likely that this ventilation connects with the void behind the dry lining</p> | |
