Accurate Home Inspection

Property Inspection Report

Property address: **1212 Sample Ave
Coloma, MI 49038**

Inspection date: **Sunday, April 10, 2016**

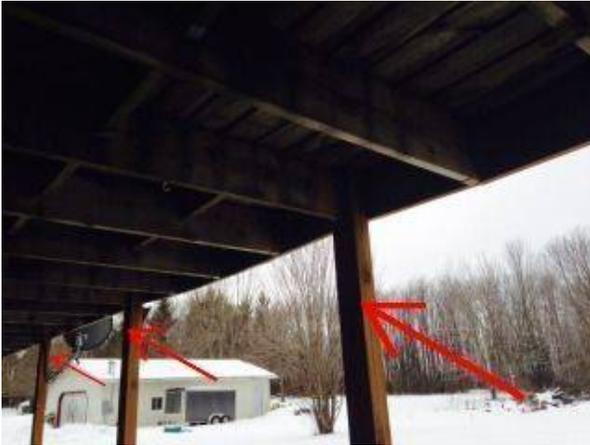
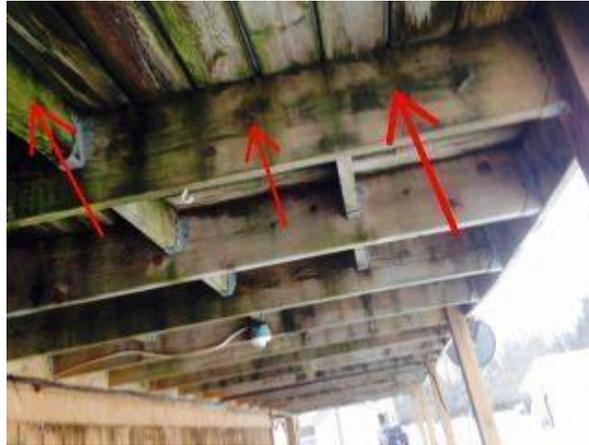
Fungal rot was found in support posts, joists, beams and/or bracing at one or more structures covering decks, patios and/or

porches. Recommend that a qualified person repair as necessary. All rotten wood should be replaced.

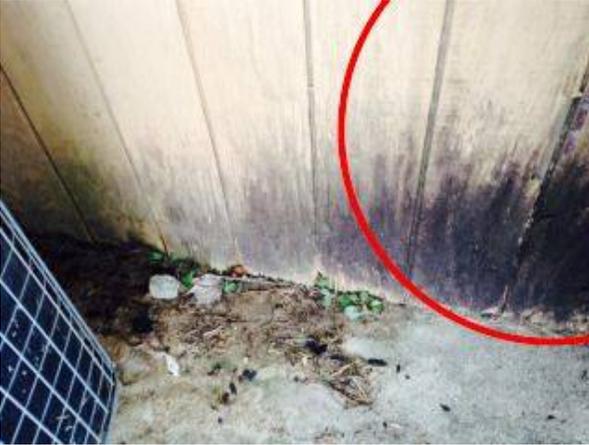
Photo 21-1

This property was clad with composition wood-fiber siding. Various manufacturers (e.g. Louisiana Pacific, Weyerhaeuser and Masonite) have produced this type of siding, which is made from oriented strand board (OSB) or "hardboard." It is prone to deteriorate and/or fail prematurely due to moisture penetration, especially when the paint coating is substandard or has not been maintained. Failure is typically visible in the form of swelling, cracking, buckling, wafer pops, delamination and fungal growth.

Some areas of siding on this structure showed symptoms described above and need replacement and/or maintenance. Some manufacturers (e.g. Louisiana Pacific) recommend a repair process for this siding where affected areas are sealed with Permanizer Plus, a flexible primer made by Pittsburgh Paint, followed by two coats of 100% acrylic latex paint. This sealant must be applied to the bottom edges using a brush. The face of the siding can be sprayed. The Permanizer Plus sealer isn't required for edges that aren't swollen, cracked or deteriorated, but the acrylic latex should still be brushed on these edges.

Recommend that a qualified contractor evaluate and replace siding as necessary, and/or seal and repaint as necessary. Repairs should be made per the siding and/or sealant manufacturer's installation instructions, and per standard building practices.

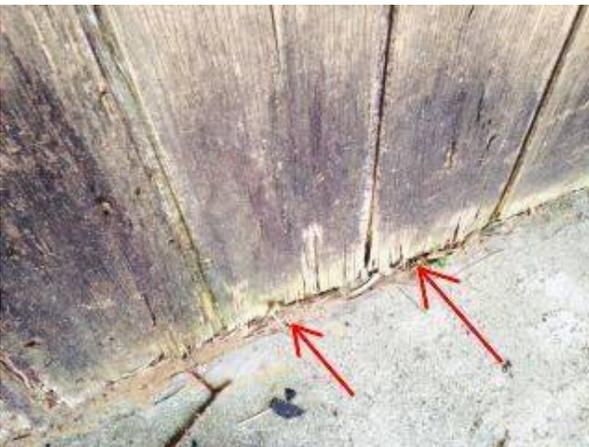
Photo 23-1

Soil was in contact with or less than 6 inches from siding, trim or structural wood. This is a conducive condition for wood-destroying organisms. Recommend grading or removing soil as necessary to maintain a 6-inch clearance. If not possible, then recommend replacing untreated wood with pressure-treated wood. Installation of borate-based products such as Impel rods can also reduce the likelihood of rot or infestation if soil cannot be removed. Note that damage from fungal rot and/or insects may be found when soil is removed, and repairs may be necessary.

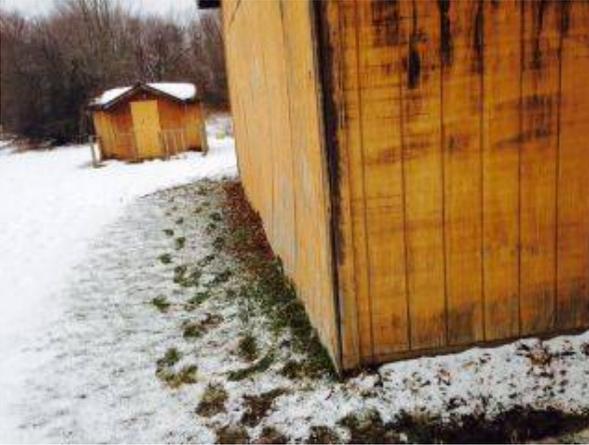
Photo 24-1

Soil was in contact with or less than 6 inches from siding or trim. Regardless of what material is used for siding, it should not be in contact with the soil. If made of wood, siding or trim will eventually rot. For other materials, ground or surface water can infiltrate siding or trim and cause damage to the wall structure. Wood-destroying insects are likely to infest and damage the wall structure. This is a conducive condition for wood-destroying organisms. Recommend grading or removing soil as necessary to maintain a 6-inch clearance. Note that damage from fungal rot and/or insects may be found when soil is removed, and repairs may be necessary.

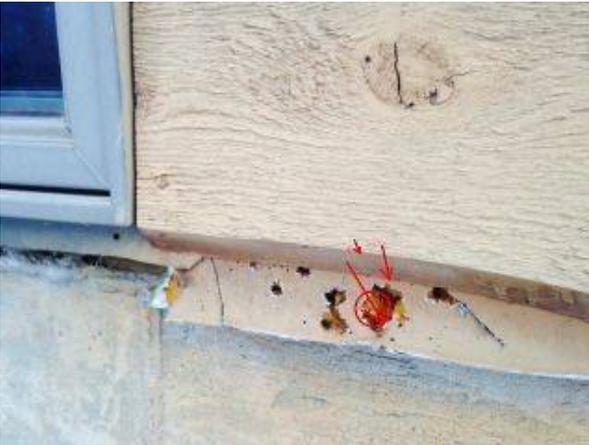
Photo 25-1

One or more holes or gaps were found in siding or trim. Vermin, insects or water may enter the structure. Recommend that a qualified person repair as necessary.

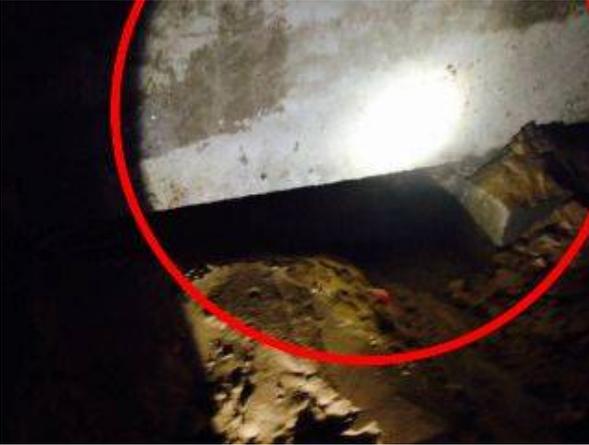
Photo 27-1

One or more holes or gaps were found in the foundation. Vermin may enter the building substructure as a result. Recommend that a qualified person repair as necessary.

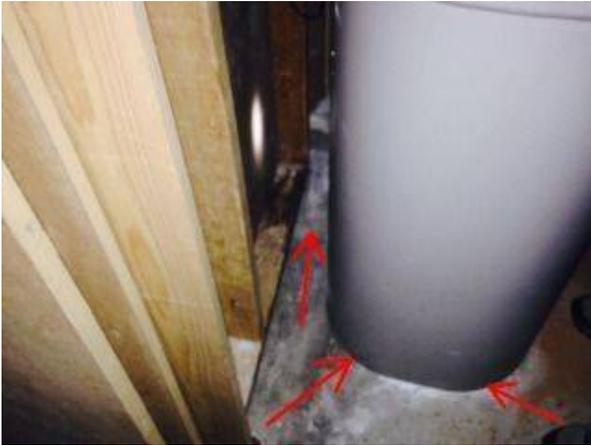
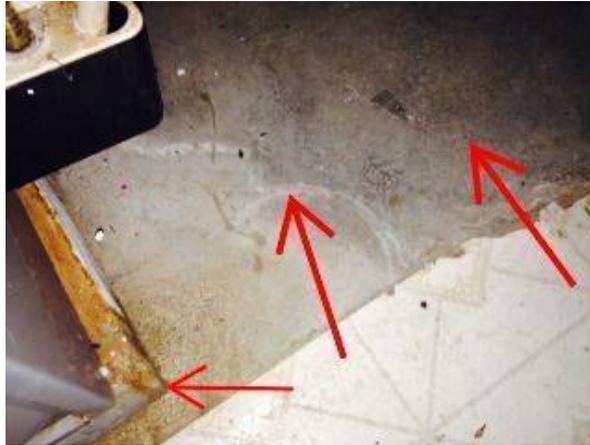
Evidence of prior water intrusion or accumulation was found in one or more sections of the crawl space. For example, sediment stains on the vapor barrier or foundation, and/or efflorescence on the foundation. Accumulated water is a conducive condition for wood-destroying organisms and should not be present in the crawl space. Recommend that the client review any disclosure statements available and ask the property owner about past accumulation of water in the crawl space. The crawl space should be

monitored in the future for accumulated water, especially after heavy and/or prolonged periods of rain. If water is found to accumulate, then recommend that a qualified contractor who specializes in drainage issues evaluate and repair as necessary. Typical repairs for preventing water from accumulating in crawl spaces include:

- Repairing, installing or improving rain run-off systems (gutters, downspouts and extensions or drain lines)
- Improving perimeter grading
- Repairing, installing or improving underground footing and/or curtain drains

Ideally, water should not enter crawl spaces, but if water must be controlled after it enters the crawl space, then typical repairs include installing trenches, gravity drains and/or sump pump(s) in the crawl space.

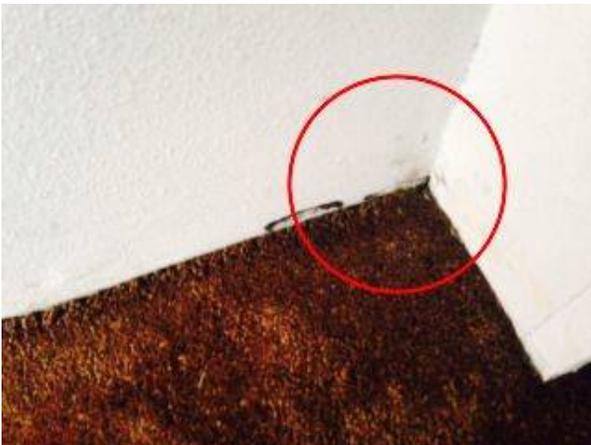
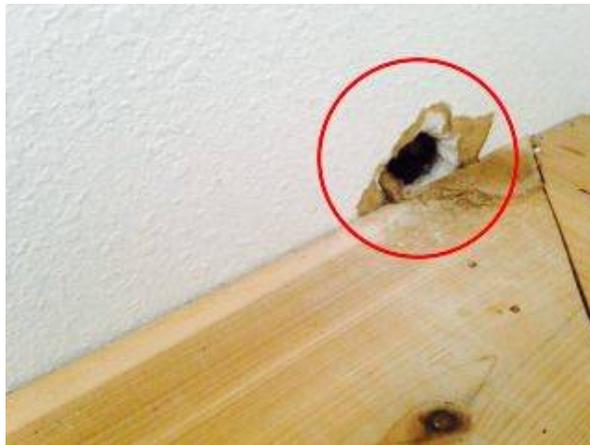
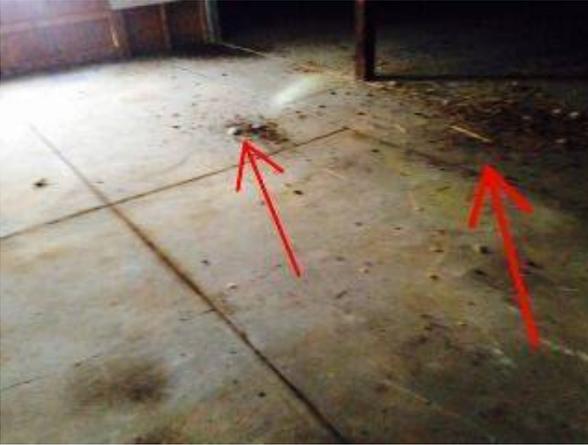
Evidence of rodent infestation was found in the form of in the . Consult with the property owner about this. A qualified person should make repairs to seal openings in the structure, set traps, and clean rodent waste as necessary. Recommend following guidelines in these Center for Disease Control articles:

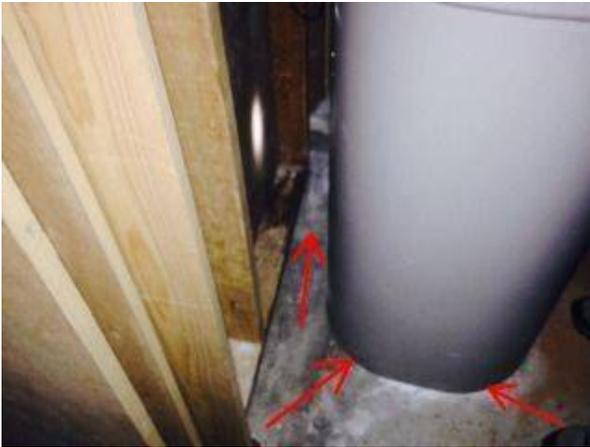
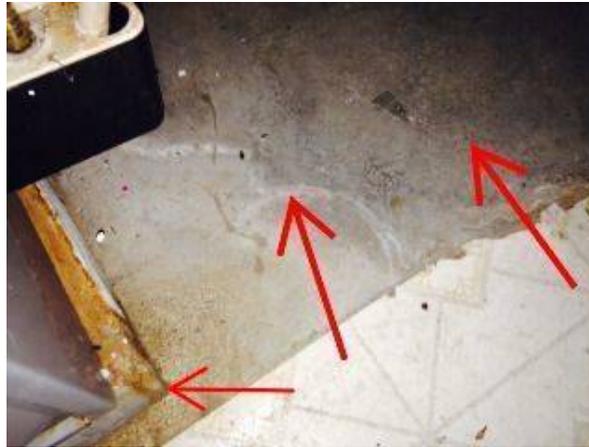
Evidence of prior water intrusion was found in one or more sections of the basement. For example, water stains or rust at support post bases, efflorescence on the foundation, etc. Accumulated water is a conducive condition for wood-destroying organisms and should not be present in the basement. Recommend reviewing any disclosure statements available and ask the property owner about past accumulation of water in the basement. The basement should be monitored in the future for accumulated water, especially after heavy and/or prolonged periods of rain. If water is found to accumulate, then recommend that a qualified contractor who specializes in drainage issues evaluate and repair as necessary. Typical repairs for preventing water from accumulating in basements include:

- Repairing, installing or improving rain run-off systems (gutters, downspouts and extensions or drain lines)
- Improving perimeter grading
- Repairing, installing or improving underground footing and/or curtain drains

Ideally, water should not enter basements, but if water must be controlled after it enters the basement, then typical repairs include installing a sump pump.

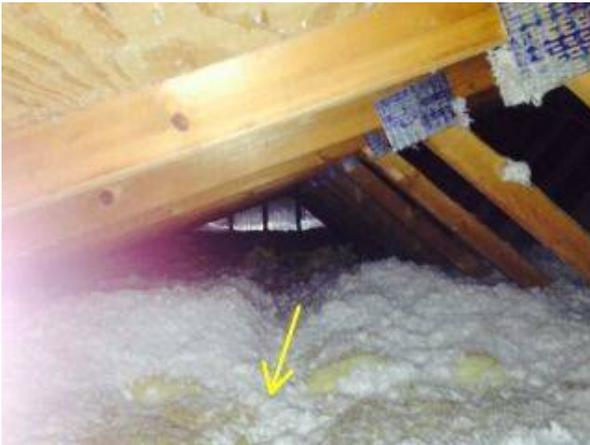
Photo 42-1

Roof sheathing (plywood or oriented strand board) was sagging in some areas and no panel edge clips ("H clips") were installed. These should be installed when truss or rafter spacing is 24 inches o.c. or more and with 3/8-inch sheathing. These clips help support the edges of the sheathing, and sagging can result if they're not installed. This may also void the warranty on some brands of shingles. Recommend that a qualified contractor evaluate and repair per standard building practices.

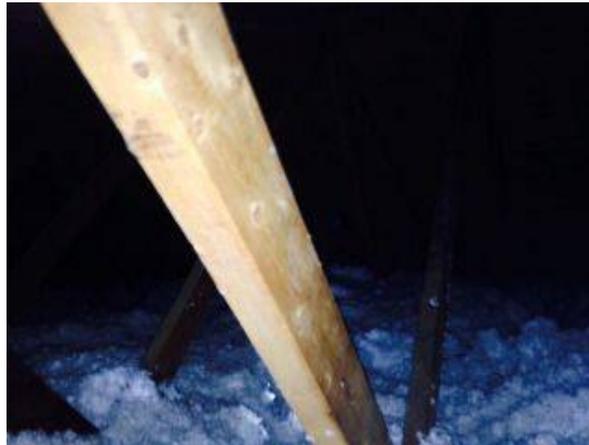
Photo 42-2

Insulation is uneven along attic.

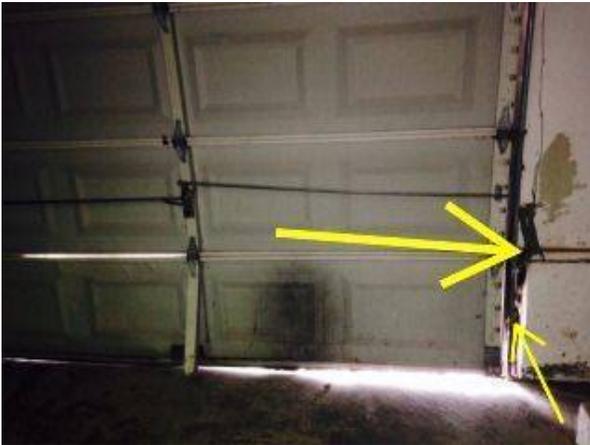
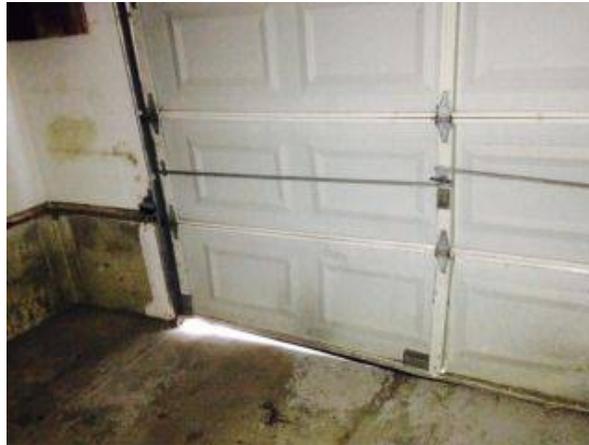
One or more garage vehicle doors were damaged or deteriorated. Recommend that a qualified contractor door(s) as necessary.

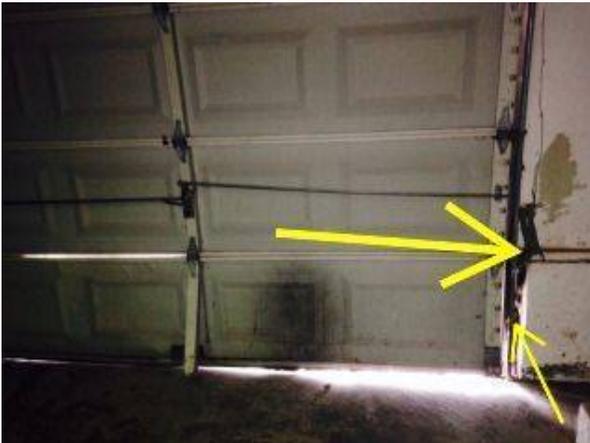
Photo 46-1

One or more garage vehicle doors were difficult or unable to open or close. Vehicle doors should open and close smoothly and easily. A qualified person should evaluate and repair as necessary. This may require lubrication or repair to hardware such as rollers or brackets.

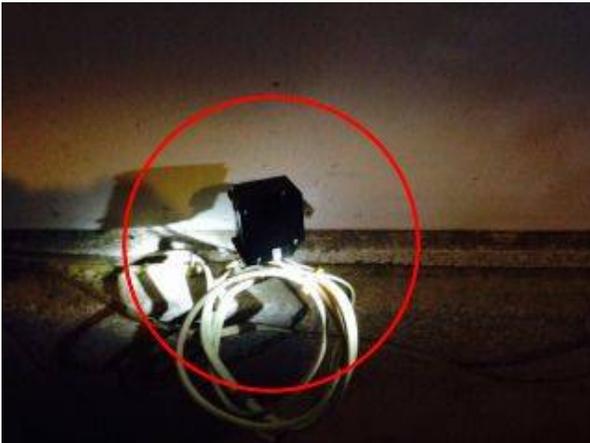
Photo 51-1

One or more circuit breakers in panel(s) # were broken or damaged. This is a potential shock or fire hazard. Recommend that a qualified electrician replace circuit breakers and make repairs as necessary.

Breaker loose in garage

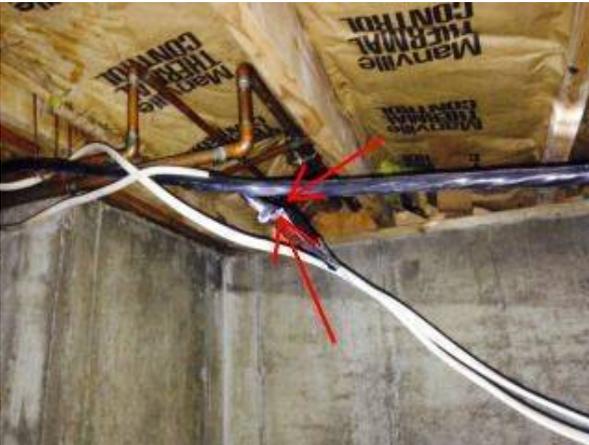
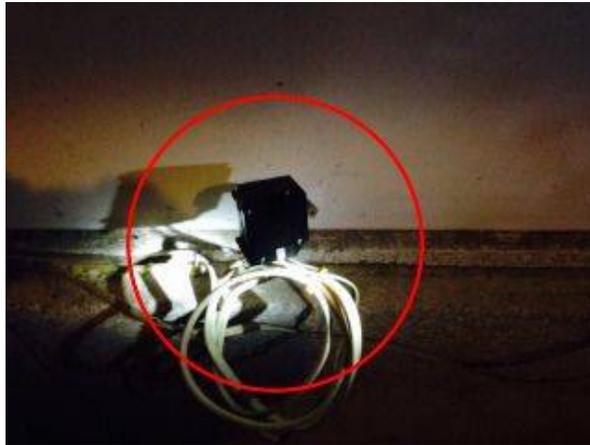
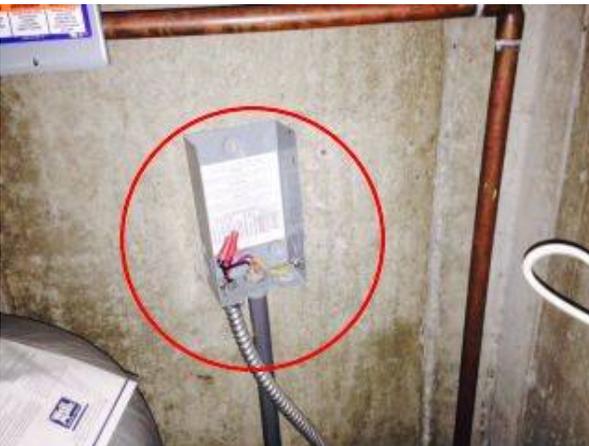
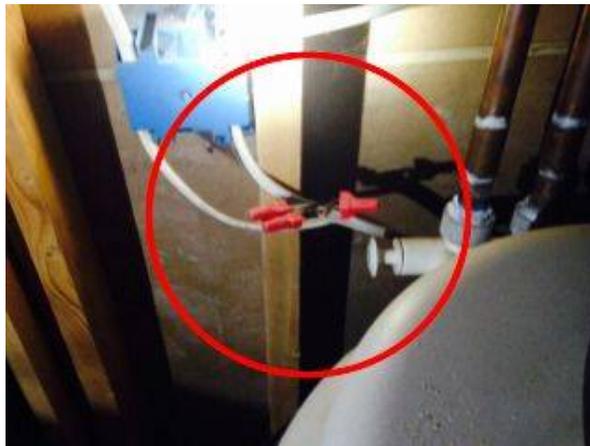
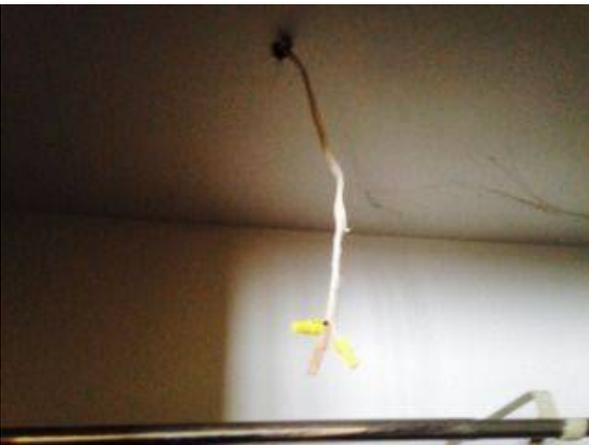
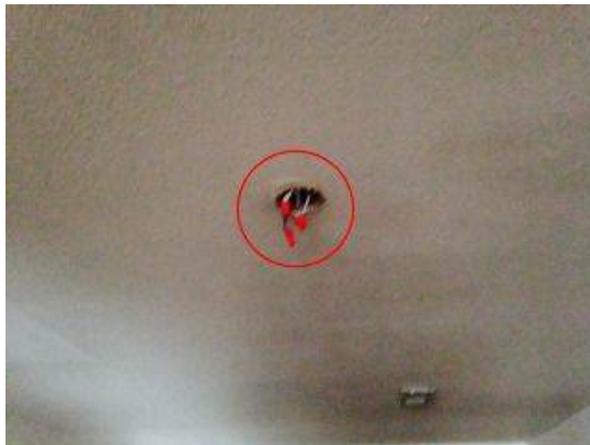
Non-metallic sheathed wiring was loose, unsupported, or inadequately supported at one or more locations. Such wiring should be trimmed to length if necessary and attached to runners or to solid backing with fasteners at intervals of 4 1/2 feet or less. Fasteners should be installed within 12 inches of all enclosures. Recommend that a qualified electrician repair per standard building practices.

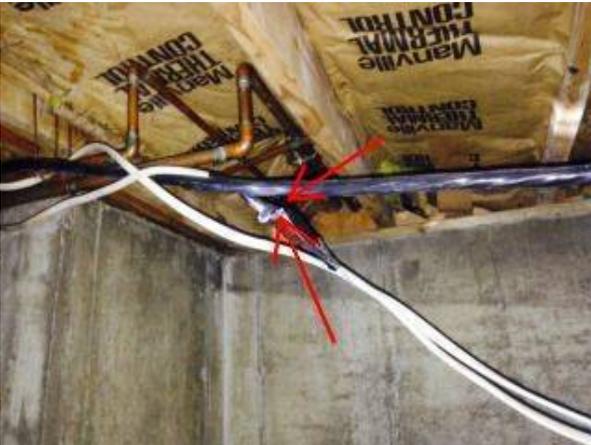
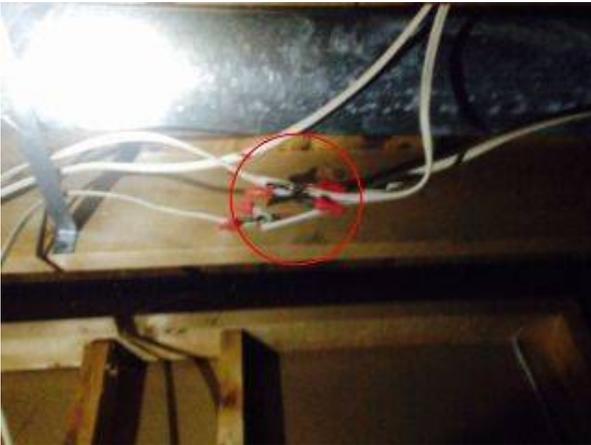
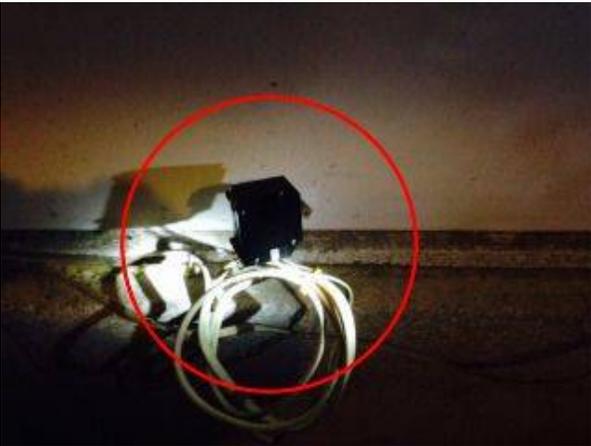
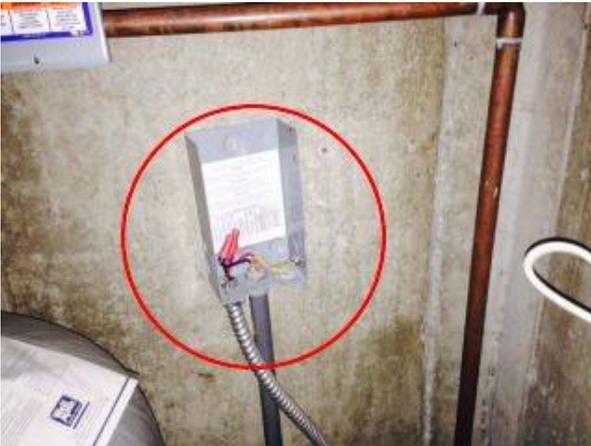
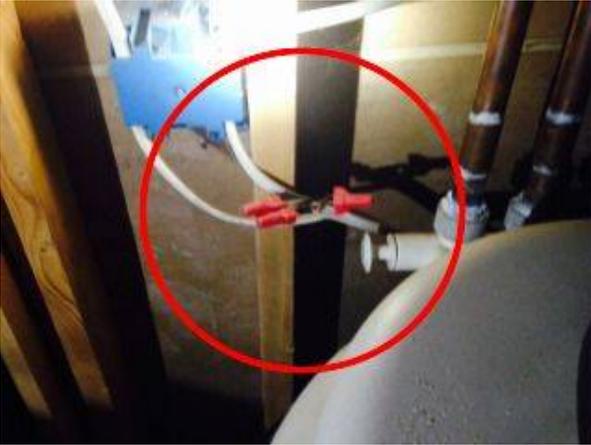
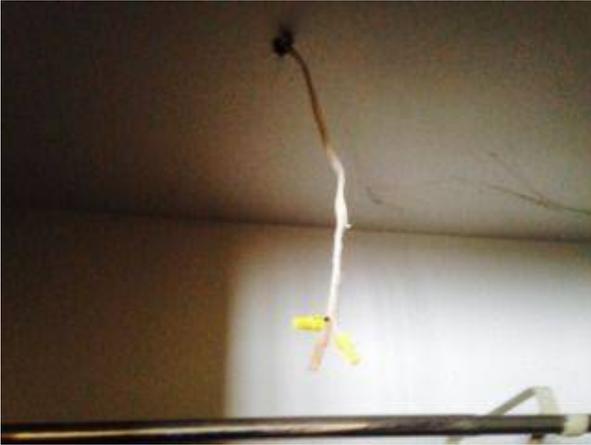
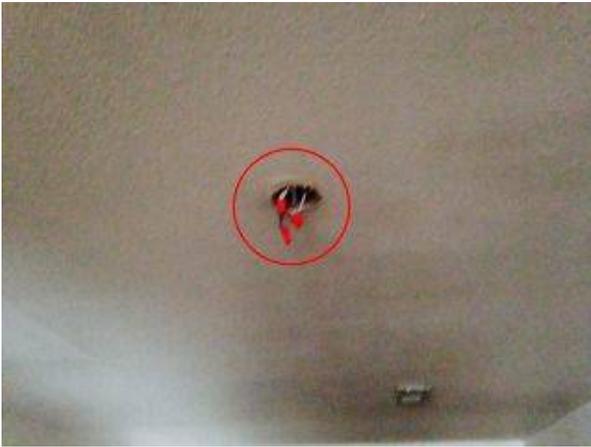
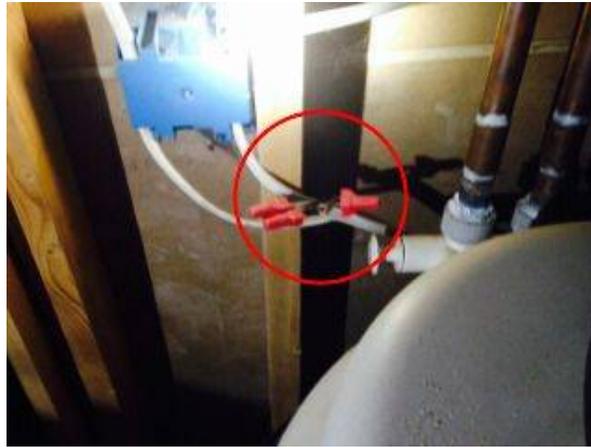
Wire splices were exposed and were not contained in a covered junction box. This is a potential shock or fire hazard. Recommend that a qualified electrician repair per standard building practices. For example, by installing permanently mounted junction boxes with cover plates where needed to contain wiring splices.
Cost estimate: \$ 100

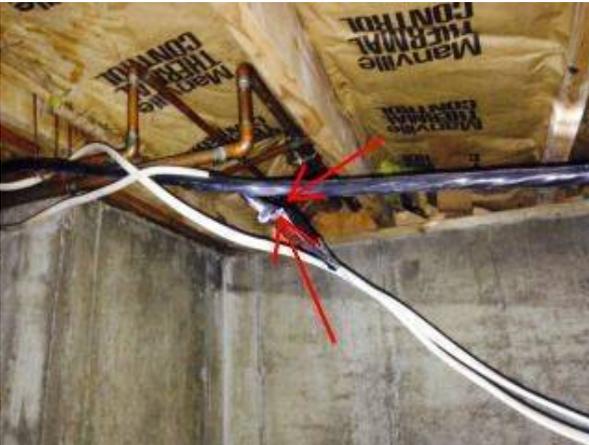
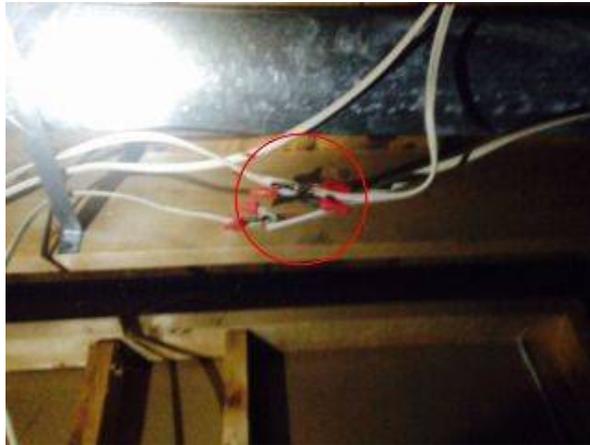
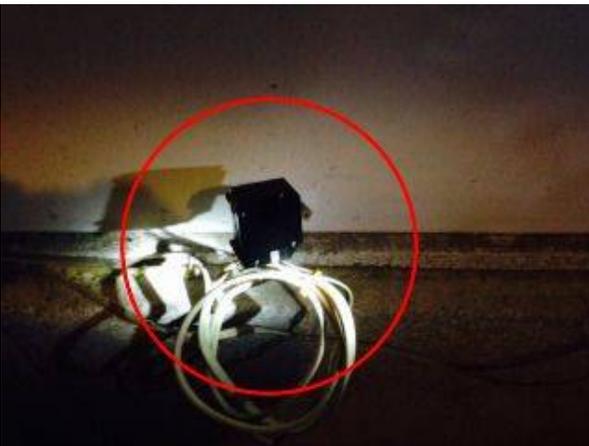
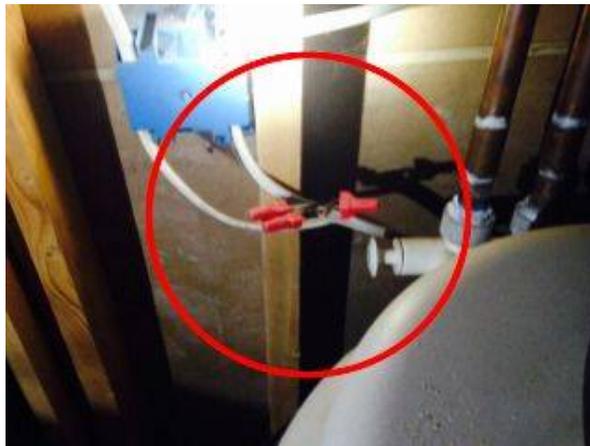
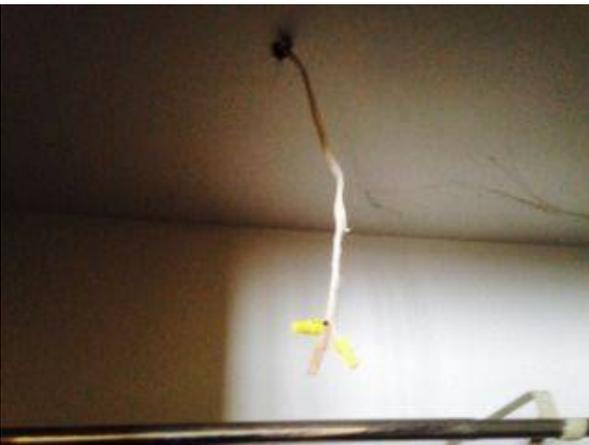
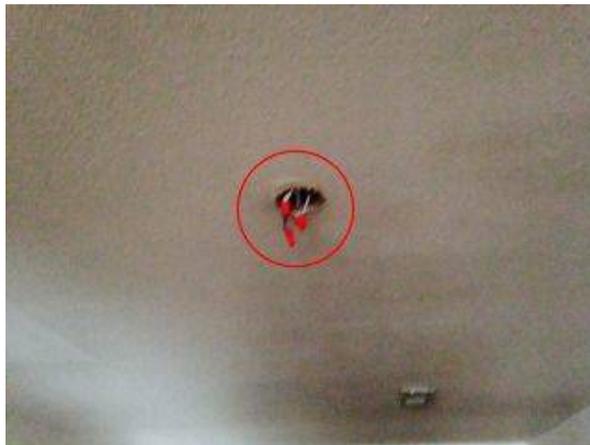
Need to be placed in a covered junction box.

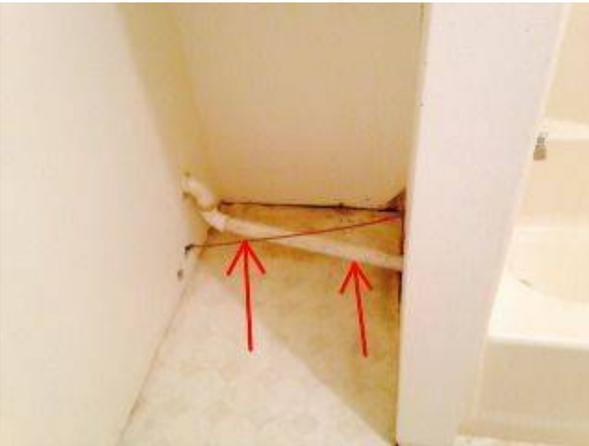
Photo 67-1

One or more drain pipes had a substandard slope. Clogging or leaks can occur as a result. Drain and waste pipes should be sloped 1/4 inch per foot of length if less than 3 inches in diameter, or 1/8 inch per foot of length for larger diameters. Recommend that a qualified plumber repair per standard building practices.

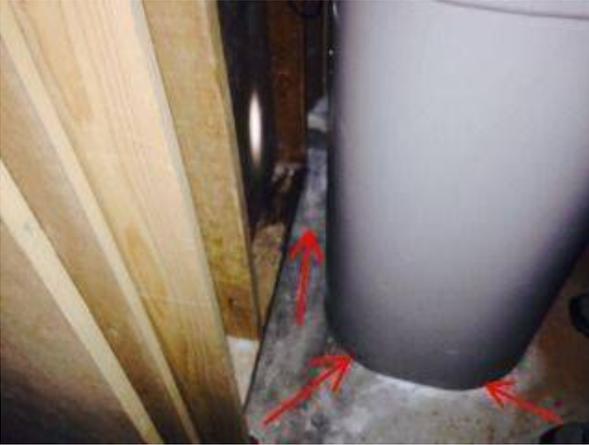
Photo 74-1

Water stains were found below or near the water heater. This may be a sign that the water heater is failing, or be a sign of a past leak. Consult with the property owner about this and review any disclosure statements. Depending on what information is available about the stains, a qualified plumber should evaluate and make repairs or replace the water heater as necessary.
