Good Living Homes LLC
Home Inspections

1921 River Birch Dr., Shawnee, OK 74804
Inspection prepared for: Vicki Jager
Date of Inspection: 7/27/2015 Time: 8am
Weather: Sunny

Inspector: John Crouch
License #70001257
Newalla, OK 74857
Phone: 4054815032
Email: john@goodlivinghomes.com
goodlivinghomes.com

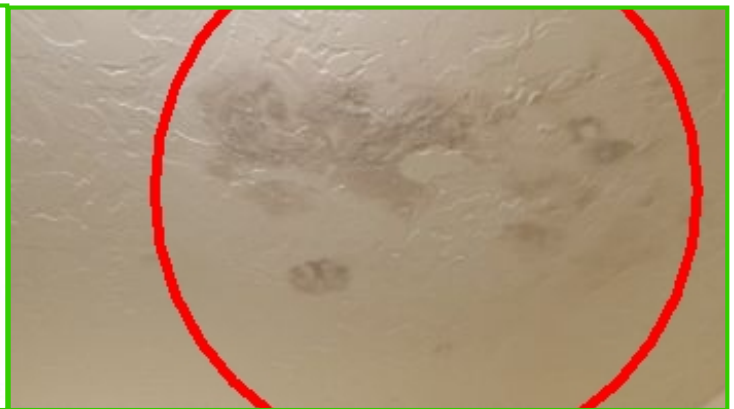
Observations:
 • The closet is in serviceable condition.
 • There is evidence of a small leak (see roof section) on the ceiling. After the leak is repaired on the roof, this should go away. However, the current spot on the ceiling should be properly treated with mold treatment. (Not bleach)

Some active mold growth

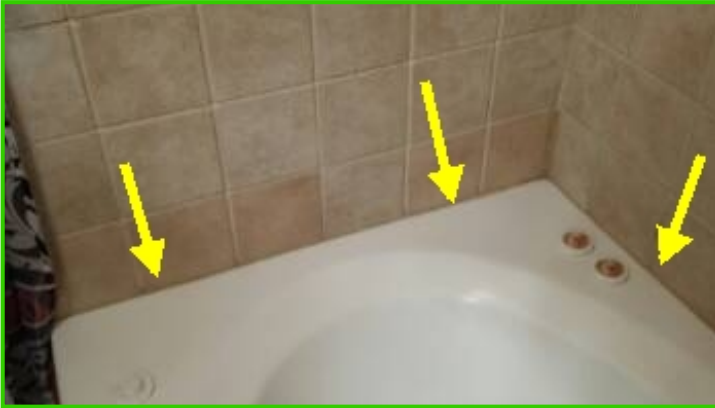
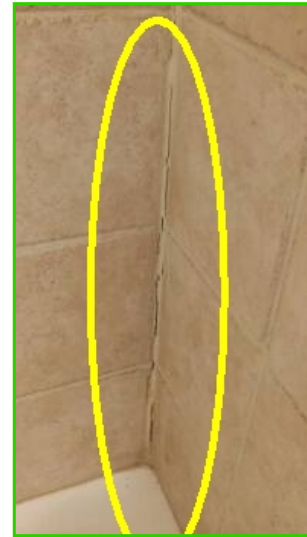
- Ceramic tile noted.
- Caulking needed around perimeter in master.

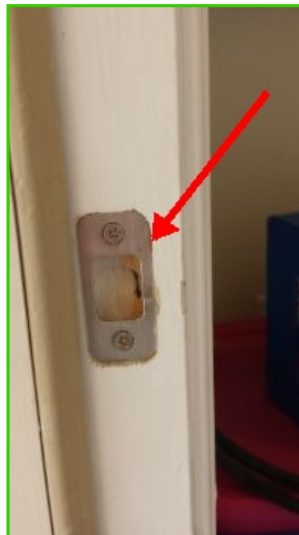
- The door knob does not operate properly at the garage entry door. Recommend repair or replacement.

Deadbolt does not engage all of the way. Hole needs to be drilled out. Estimated cost is \$25

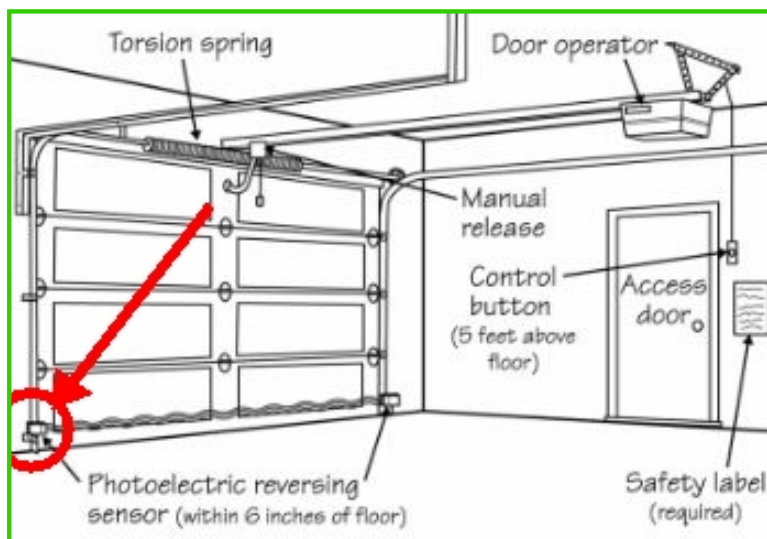
Observations:
 • Chain drive opener noted.
 • Photo safety reverse feature works but the eyes on the sensors get tripped due to the bright sun in the morning. Might want to call a garage door repairman out to see if there is an option to remedy this. Estimated cost is \$50

This is the sensor that is being effected by the sun.

Garage door sensor repair \$50

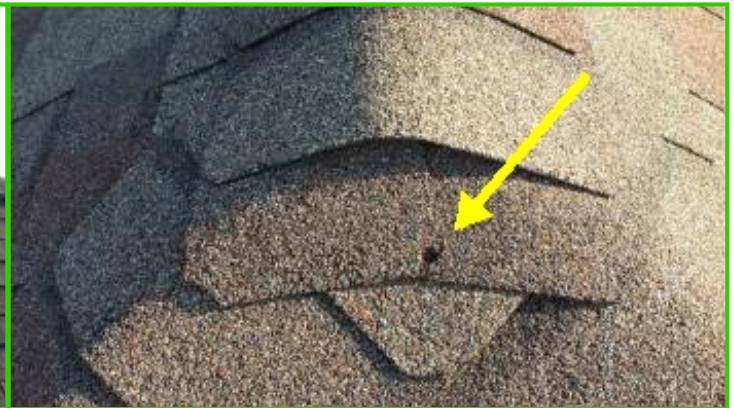
Nail hole

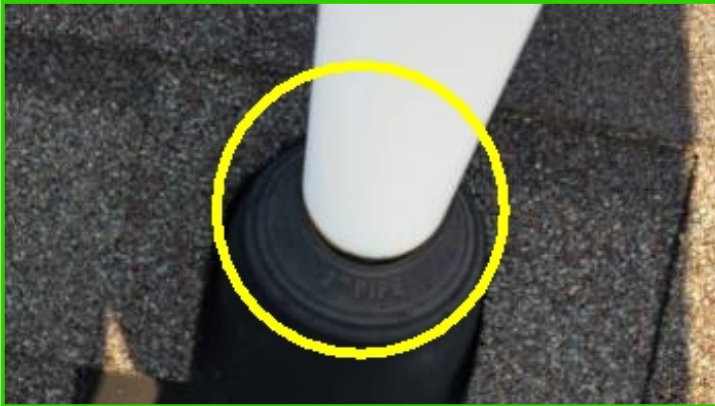
Replace seal or cover with sleeve. Obvious gap on rubber.

- Recommend re-sealing all through the roof vents and projections as a part of routine maintenance.

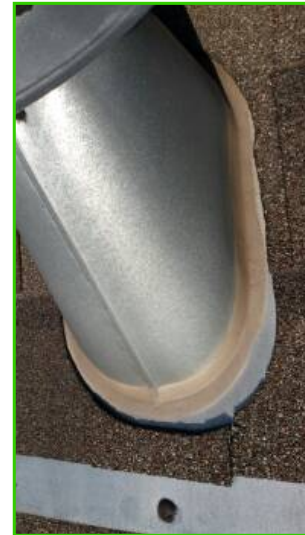
Sealant is in good shape.

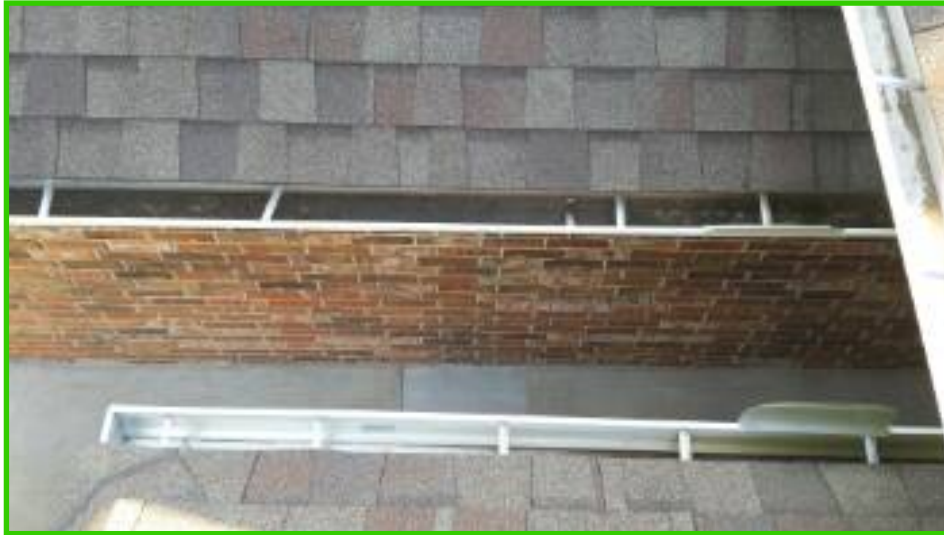
- No major system safety or function concerns noted at time of inspection.
- The home had no roof drainage system to channel roof drainage away from the foundation on east, west, and south sides. Recommended installation of a roof drainage system to help protect the home foundation at least on the east side due to the downward slope of the terrain towards the house.

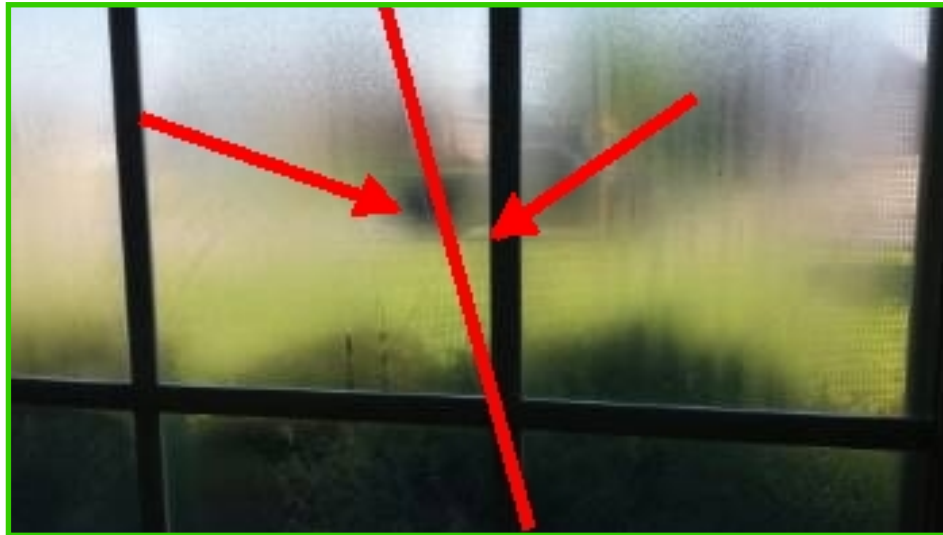
Observations:
 • Components appeared in satisfactory condition at time of inspection.
 • Window glass cracked in guest bedroom on north side.

Window is cracked and needs to be replaced. Estimated cost is \$200

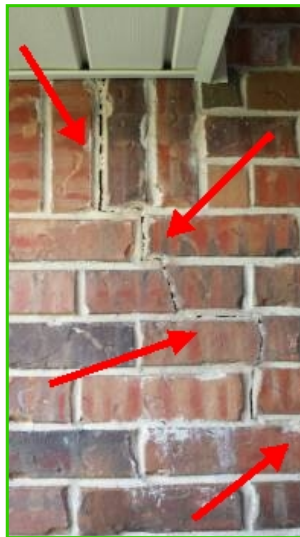
- Common cracks noted.
- Evidence of repairs observed, unable to determine the effectiveness of these repairs.
- Expansive cracks and settling observed, suggest sealing cracks as necessary. Location is at entry door.

- Recommend review for repair or replacement as necessary. Contact the foundation jack company to come out and give a professional opinion on the slab.

Contact foundation repair company

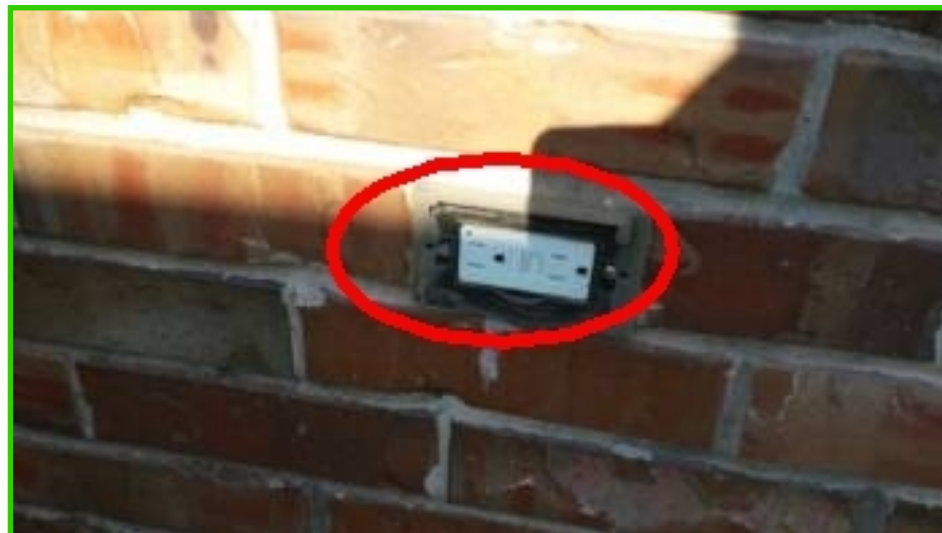
Observations:
 • **Missing cover.**

Estimated cost for repair is \$25
