Sum, Sum Pro & Krypton Pro - Seatpost Saddle Top Clamp Replacement Program

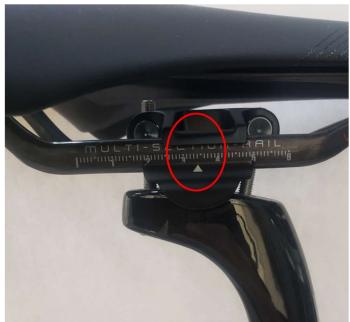
Assembled seatpost top clamp needing replacement (without white arrow)

If, following inspection, you can confirm that your bike is equipped with a seatpost saddle top clamp that requires to be replaced, please contact your Argon 18 authorized retailer. A replacement package (SKU201116) will be sent to them rapidly. In the meantime, we recommend you refrain riding the affected bicycle.

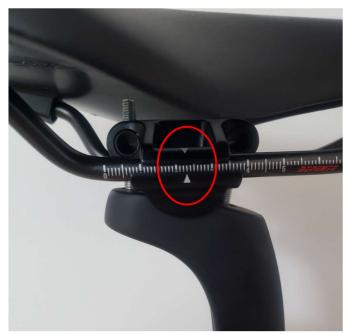
New seatpost saddle top clamp assembled (with white arrow)

1. Please note that there is **no spring needed** with the new seatpost saddle top clamp configuration. Therefore, it must be removed and discarded when replacing the seatpost saddle top clamp.
