# **Running Change Notice E-119 Tri+ Disc**

# **Forks**

# **Stem Cap**

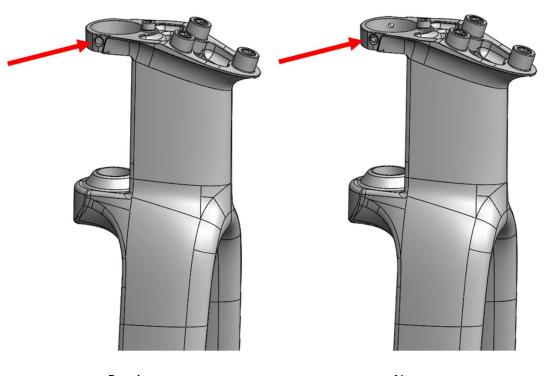
Previous New

The fork stem was modified to change the assembly method of the stem cap. Previously, rubber plugs protruding from the stem cap sat within recesses on the fork that held the stem cap in position. For the new configuration, threaded holes were added to the fork that allow for the stem cap to be assembled with M3\*6mm flat head screws.

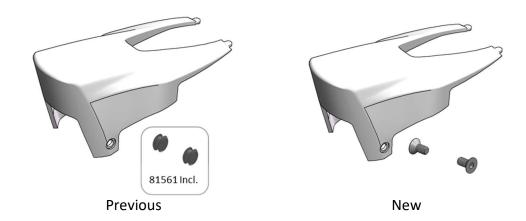
The stem cap PN81560 was modified to include two M3\*6mm flat head screws. Also, the rubber plugs (PN81561) were removed from the stem cap kit and will only be available as a separate part (pair).

Figures below show the previous and new configurations of PN81560.

Refer to Section 14.7 of the Assembly Guide for the installation of the stem cap on the bike, available here:
