**Operations Committee Report**  
**Ron Leonard, Committee Chairman**  
[ronl@bigelkmeadows.org](mailto:ronl@bigelkmeadows.org)

**Date: 19, August 2021**

# ENGINEER'S INSPECTION REPORT

DAM NAME: MEADOW LAKE T: 040N R: 0720W S: 35 COUNTY: LARIMER DATE OF INSPECTION: 7/26/2021  
DAM ID: 040229 YRComp: 1957 DAM HEIGHT(FT): 16.9 SPILLWAY WIDTH(FT): 60.0 PREVIOUS INSPECTION: 1/2/2014  
CLASS: Low hazard DAM LENGTH(FT): 271.0 SPILLWAY CAPACITY(CFS): 7499.0 NORMAL STORAGE (AF): 32.0  
DIV: 1 WD: 4 CRESTWIDTH(FT): 30.0 FREEBOARD (FT): 9.3 SURFACE AREA(AC): 7.0  
EAP: Not Required CRESTELEV(FT): 7499.2 DRAINAGE AREA (AC.): 12600.0 OUTLET INSPECTED:

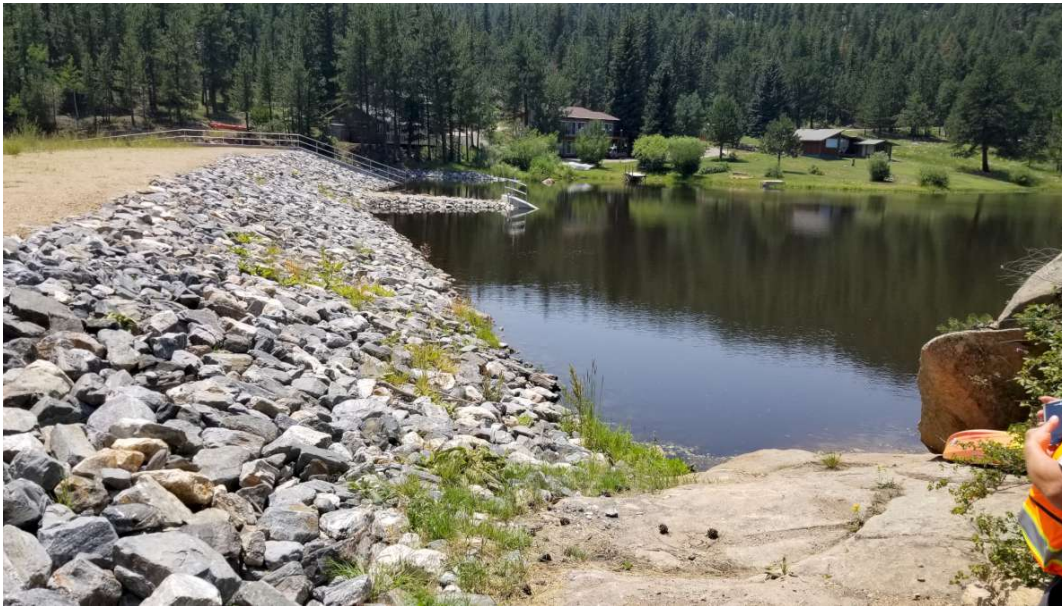
**Description:****Upstream slope is 3:1 and protected by riprap.****Observation:****First filling of the reservoir occurred in the spring of 2020. Upstream slope remains in like new condition, no signs of disturbance to the riprap.**CONDITIONS OBSERVED:  Good  Acceptable  Poor

Typical photo taken along the upstream slope from the north end of dam looking south.

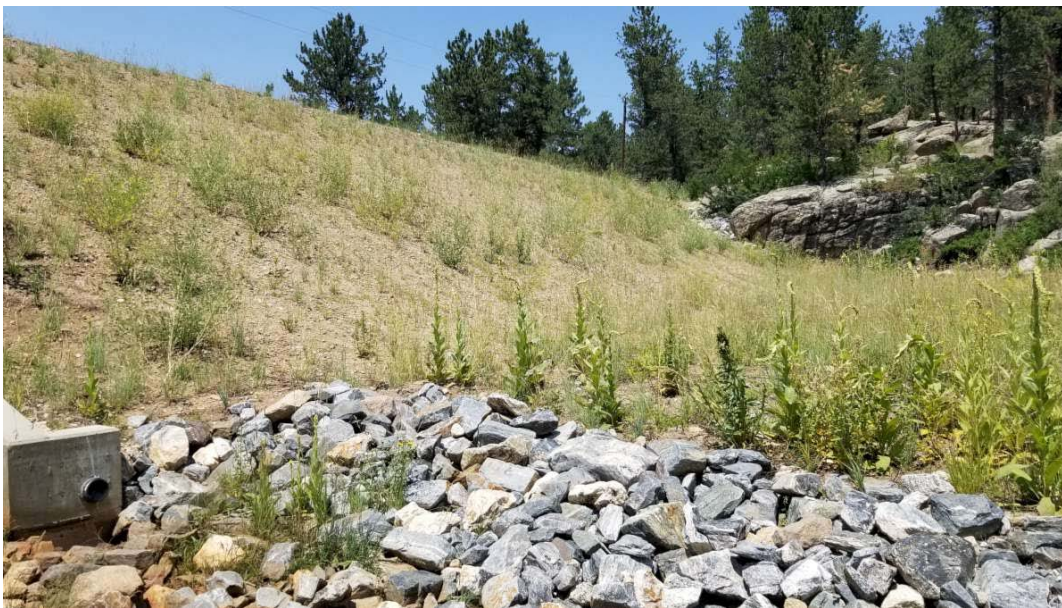
**Description:****The downstream slope of the embankment has a typical slope of 2:1.****Description:****The slope is protected with a growth of native vegetation and is uniform along the length. Growth of vegetation is sparse. (22) Minor erosion rills (gullies) are forming on the slope due to runoff down the slope.****Action:****- The HOA should consider another round of seeding or hydro seeding to get grass to grow which will in time prevent further erosion. Getting dryland vegetation to grow on new embankments is difficult and often needs a 2nd round of seeding.**  
**- Check the crest in the location of the rills to make sure drainage from the crest is not concentrating in these locations.**CONDITIONS OBSERVED:  Good  Acceptable  Poor

Photo along the downstream slope. Note sparse vegetation growth.

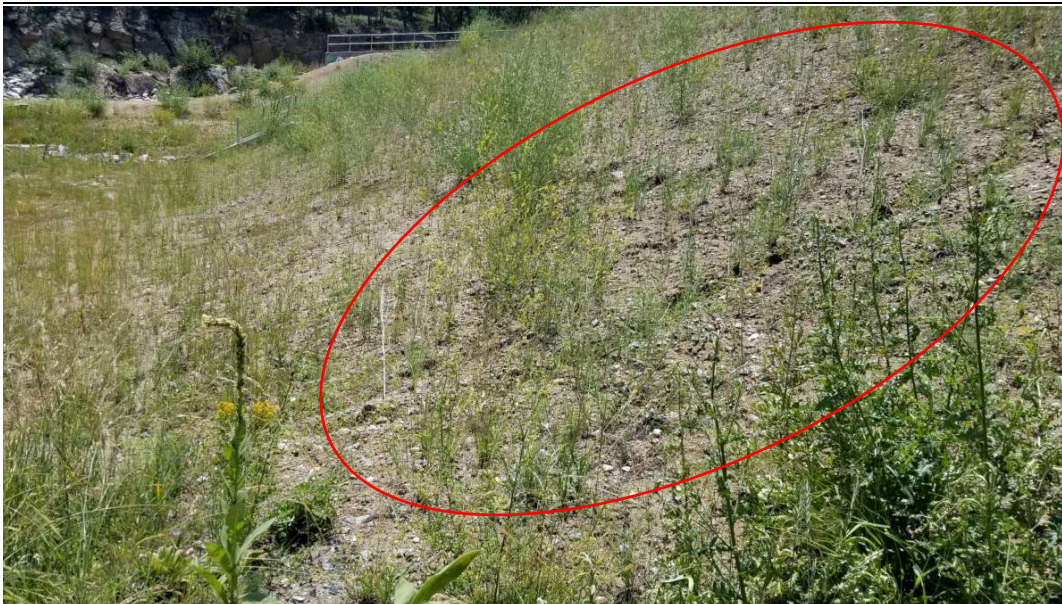
Photo of the erosion rills that are forming on the slope north of the outlet.

- LUBRICATE AND OPERATE OUTLET GATES THROUGH FULL CYCLE  
**7/26/2021 - This should be done annually as part of the valve O&M.**  
 OTHER  
**7/26/2021 - Repair erosion along he north spillway training wall/riprap transition.**  
 OTHER  
**7/26/2021 - Re-seed downstream slope to protect the embankment and repair erosion scarps as needed.**

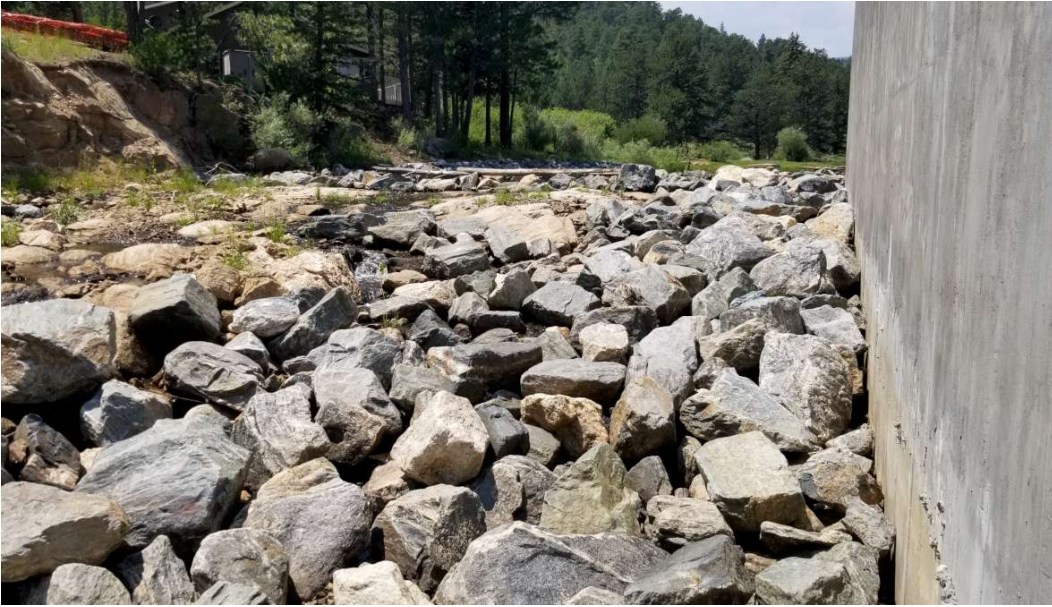
Main channel appears in good condition after two seasons of spring runoff passing through it.

Typical photo of the emergency spillway crest and downstream channel.

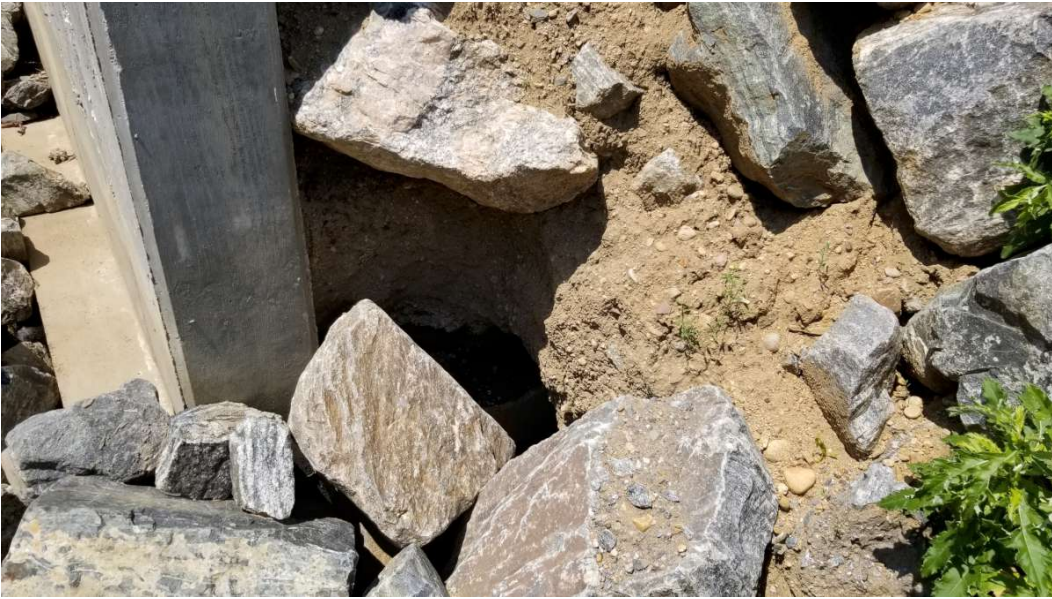
(59) Erosion is occurring along the north training wall where it ties into the spillway channel (see photo). Appears to be caused by an eddy occurring at this transition between the concrete wall and riprap channel. The bank of the channel at this location is very steep and hard to get riprap to stay on the slope. Might need grouted riprap or a short concrete retaining wall.

Photo showing the erosion occurring at the transition between the north training wall and riprap channel.

Address the erosion on the left wing wall before next runoff season or it will continue to erode the downstream berm.

**Repair of the erosion occurring at the end of the north spillway training wall should be addressed this fall. This will not need approval but I am happy to answer questions if you have any.**

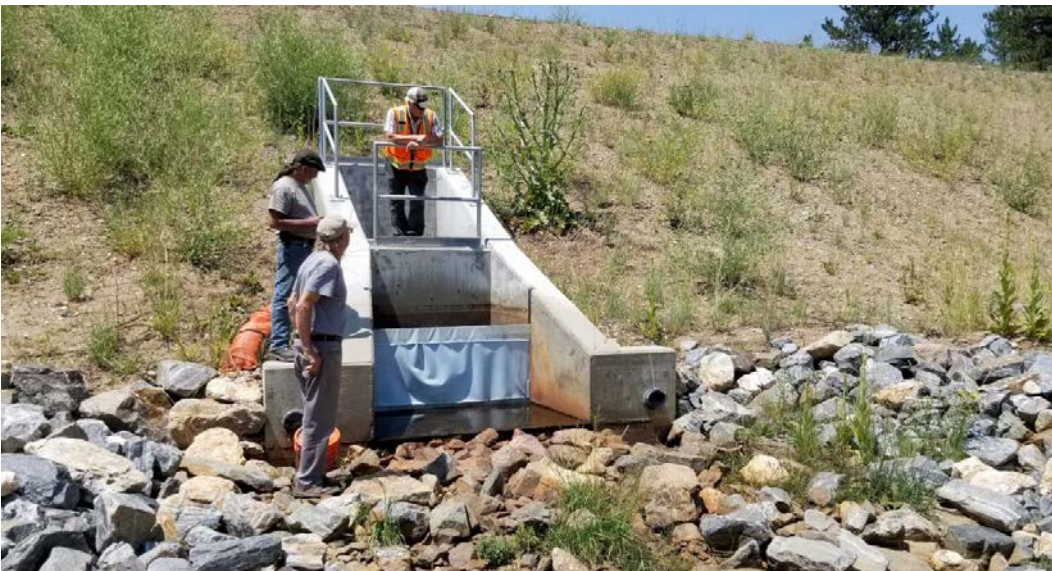
(38) The rodent screens are very fine mesh and are becoming clogged by algae growth.

Photo of the outfall structure. Note screens on the toe drains should be replaced with larger mesh size.

A larger mesh size of 1/2 to 1-inch will keep rodents out and not tend of build up algae.
