LEVEL 1 - ASSESSMENT

Property Address: **3577 E 129th St**
 Permanent Parcel Number: **137-11-001**
 Source: **Forfeiture**
 Neighborhood: **Mt. Pleasant**
 Ward: **04**

Reviewer's Name: **William Beard**

Date of Site Visit: **April 16, 2021**

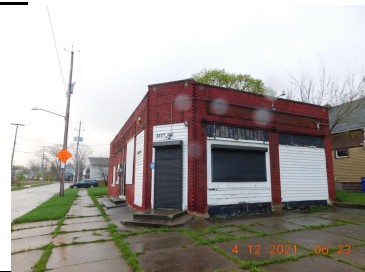
photo

Summary: The Structure is in rough shape. The area is Depressed and the interior needs lots of work. The mechanicals are shot the HVAC is old the cost to renovate would be extreme but, this property may be candidate for renovation. (Brick Siding) (No Tag Meter is Present)
