Subject: **COC COMMUNICATION Nr 8**

Document No: **3.10**

From: The Clerk of the Course

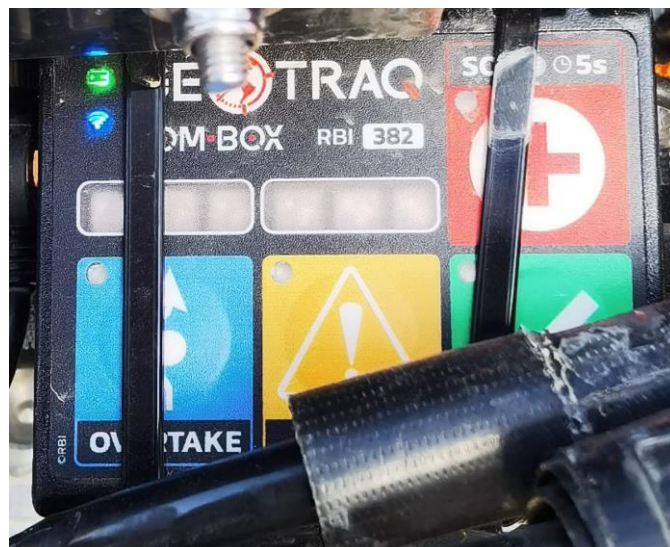
Moreover, we identified some competitors from all classes from bike to car that they have wrapped the whole enclosure of the ComBox with numerous zip ties that caused the operating buttons to be pressed permanently, so even that there is a time out in the firmware, the devices were sending nonstop signals, blocking the system and overloading the network. (see the picture to see that bad installation).

In order to avoid what happened yesterday, it's mandatory to install the device according to Instruction Manual provided.

Please, read the manual and watch the video to understand how the 4 buttons of the ComBox shall be operated we realize that buttons for overtaking and danger were pressed randomly but the common case was when a danger signal was received the competitors answered by pressing the blue button that started an overtake procedure, what is incorrect.
