Demo Test Report for Furuto's Anti-Corrosion Materials in Oil Refinery (June 28, 2012 ~ June 27, 2014) 2nd Anniversary result Test Result : EXCELLENT (No any corrosion was found)

Object of Demo Test: (Above ground) facilities of Oil Refinery in coastal region)

Demo Test for Furuto's Anti-Corrosion Materials in Oil Refinery (120628 ~ 140627_2nd Anniversary)

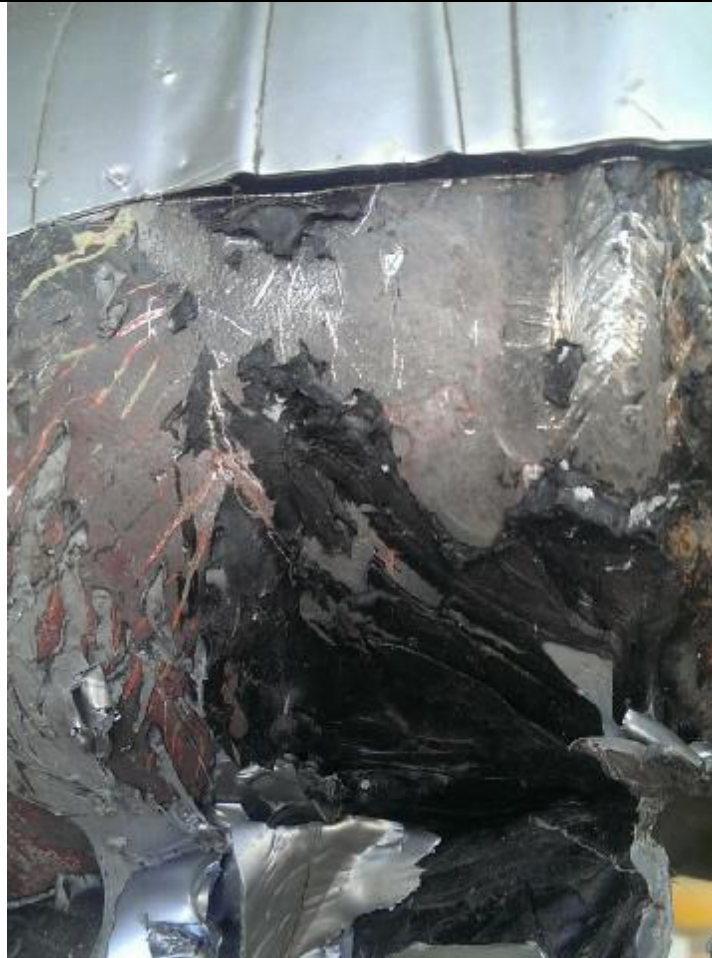
1 year Demo Test Result: June 28, 2013_Peel-off to check (= No any corrosion) = EXCELLENT Water & Air Immersion Resistance, and UV Resistance.

One year no any corrosion (both Weld End and Pipe's surface is still showing Metallic Luster, which same as the original status). Remark: the Brown color was the primer of paint which is the Surface Preparation of pipe did not good enough)

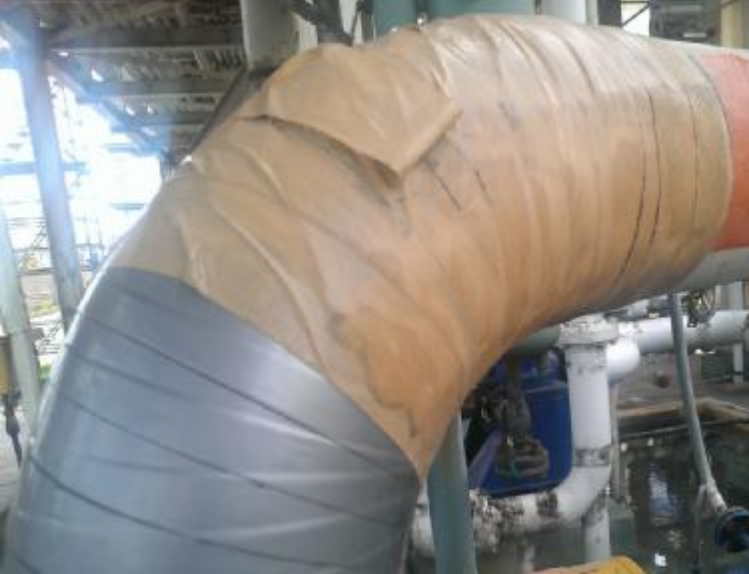
Appearance: 2 years later (June 27, 2014) – before checking

Remark: The surface's Anti-Corrosion Materials did not recovery by Furuto's SOP during one year (2013) checked. (it's just only use a packaging tape for temporary repaired, which couldn't Anti-UV, Water Tight & Air Tight).
 Tip: [Enlarge the PDF file to see the photo in details.](#)

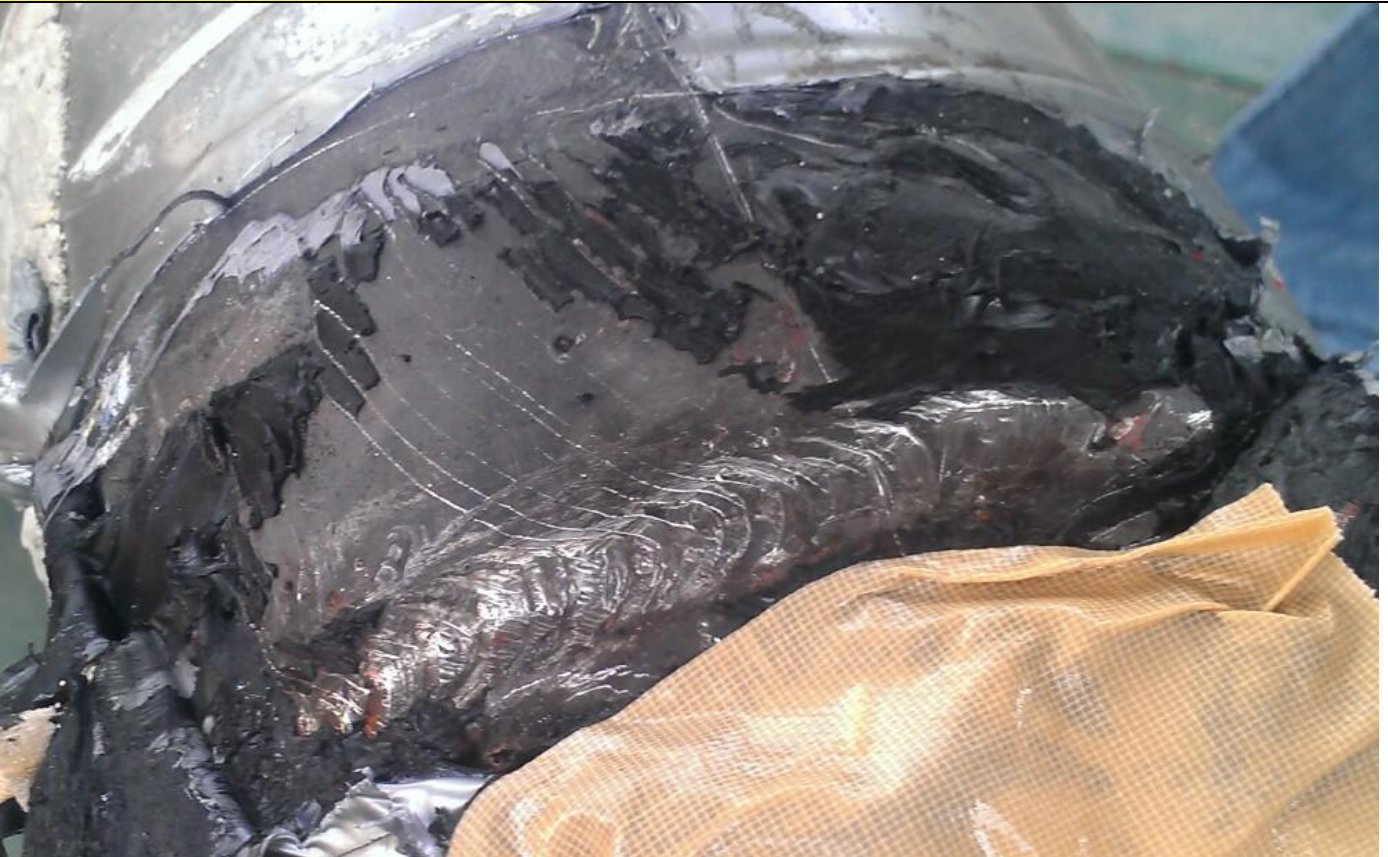
2 year Demo Test Result: June 27, 2014_Peel-off to check (= No any corrosion) = EXCELLENT Water & Air Immersion Resistance, and UV Resistance.

Two year no any corrosion (both Weld End and Pipe's surface is still showing Metallic Luster, which same as the original status).

Remark: the Brown color was the primer of paint which is the Surface Preparation of pipe did not good enough)

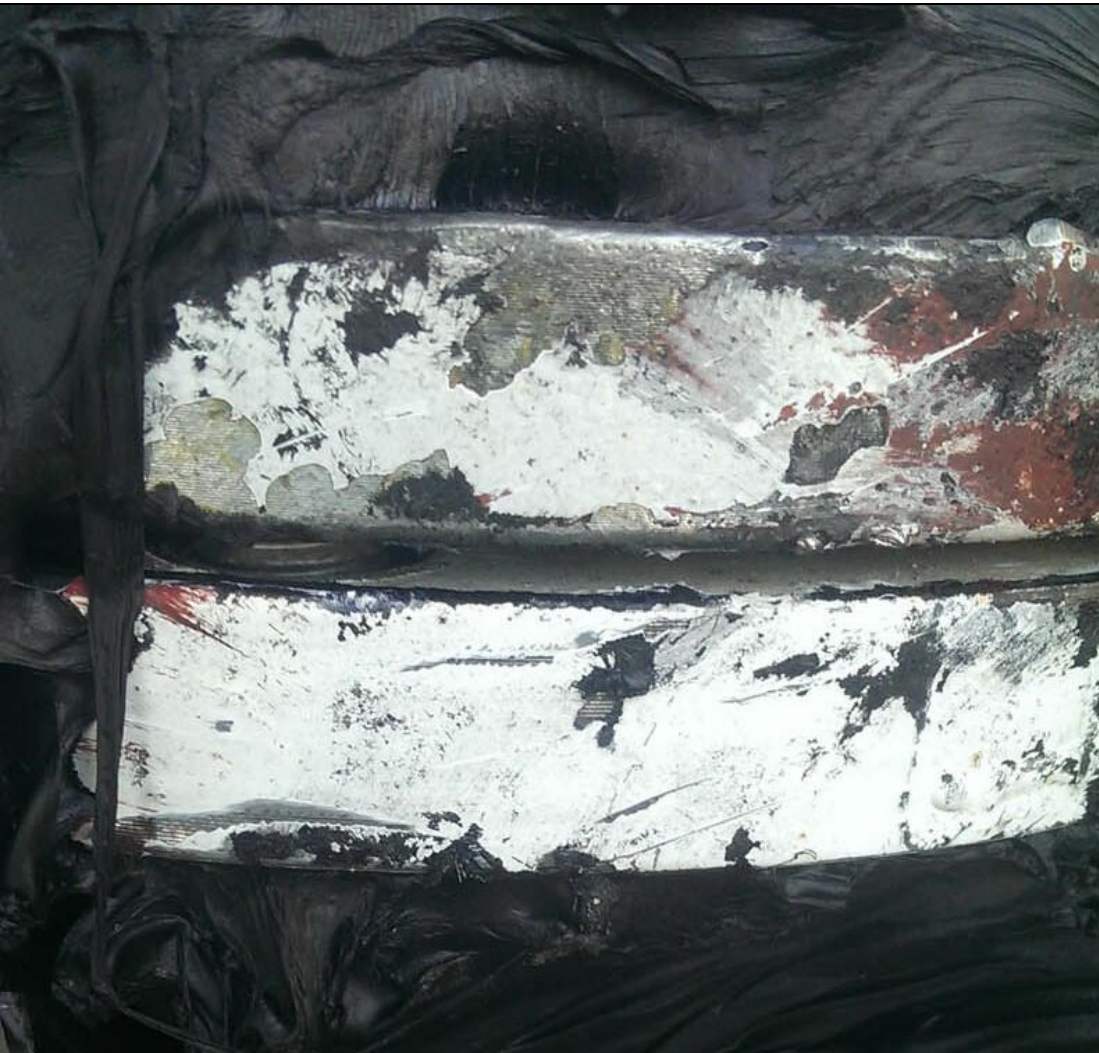
1 year Demo Test Result: June 28, 2013_Peel-off to check (= No any corrosion) = EXCELLENT Water & Air Immersion Resistance, and UV Resistance.

One year no any corrosion (the Flange's surface and Gap is still showing Metallic Luster, which same as the original status). Remark: the Brown color was the primer of paint which is the Surface Preparation of pipe did not good enough)

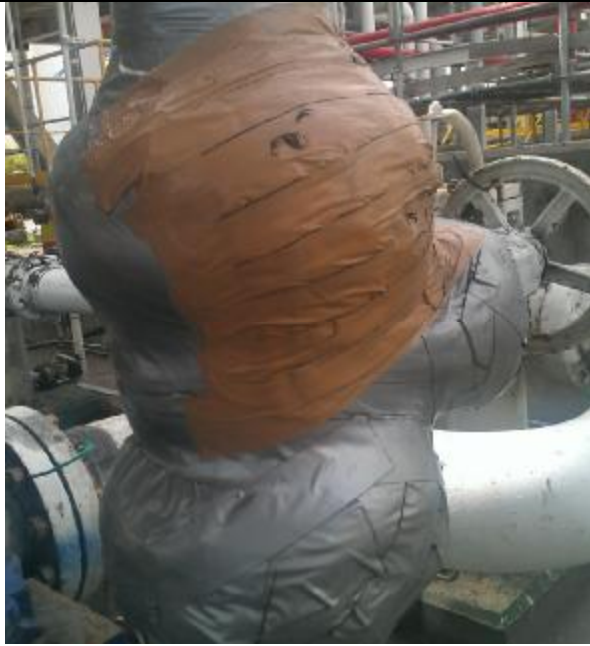
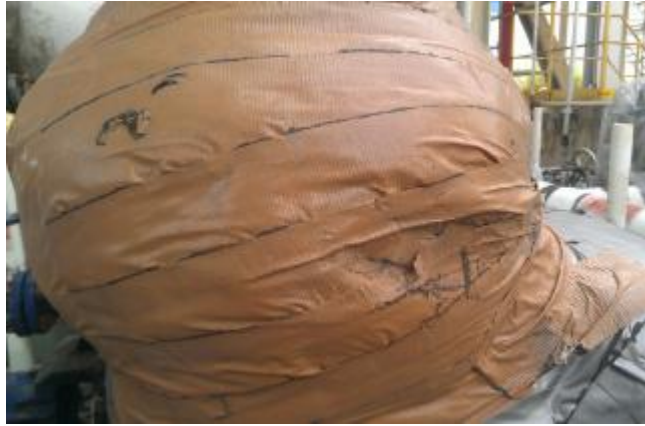
Appearance: 2 years later (June 27, 2014) – before checking

Remark: The surface's Anti-Corrosion Materials did not recovery by Furuto's SOP during one year (2013) checked. (it's just only use a packaging tape for temporary repaired, which couldn't Anti-UV, Water Tight & Air Tight).

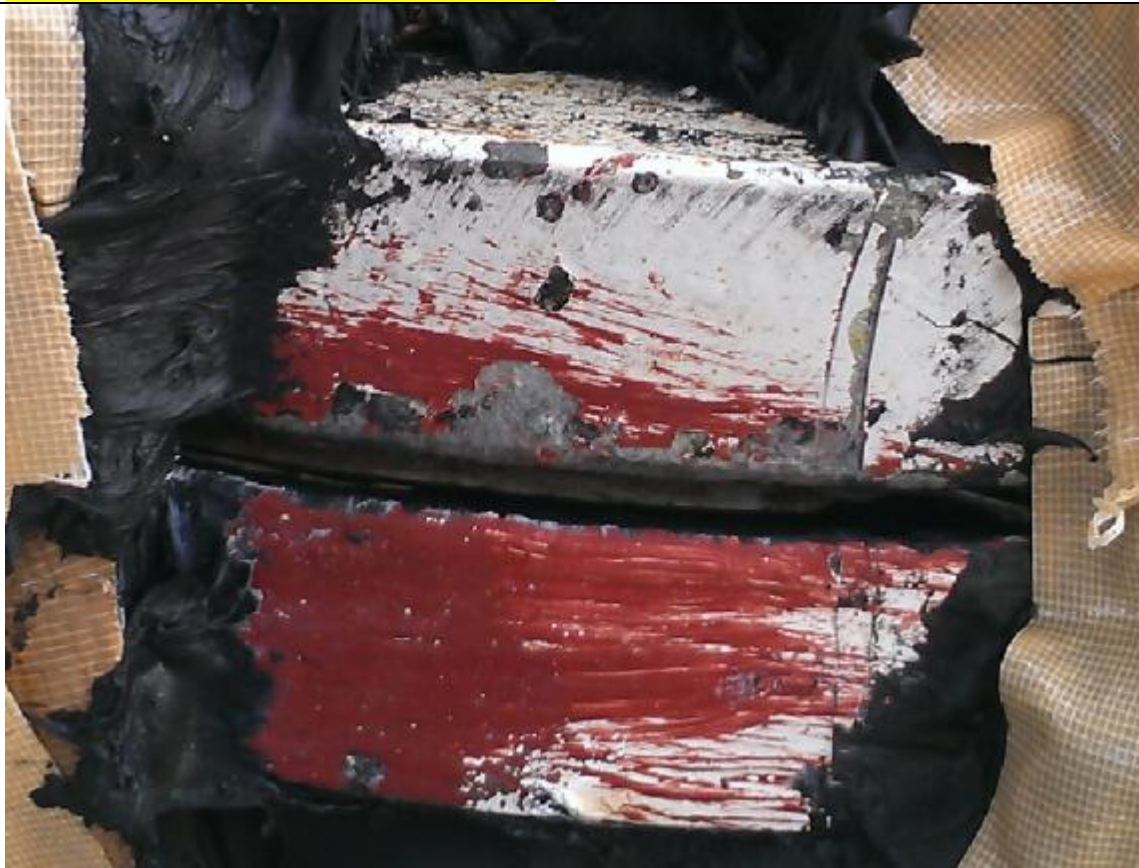
2 year Demo Test Result: June 27, 2014_Peel-off to check (= No any corrosion) = EXCELLENT Water & Air Immersion Resistance, and UV Resistance.

One year no any corrosion (the Flange's surface and Gap are still showing Metallic Luster, which same as the original status). Remark: the Brown color was the primer of paint which is the Surface Preparation of pipe did not good enough) [Tip: Enlarge the PDF file to see the photo in details.](#)

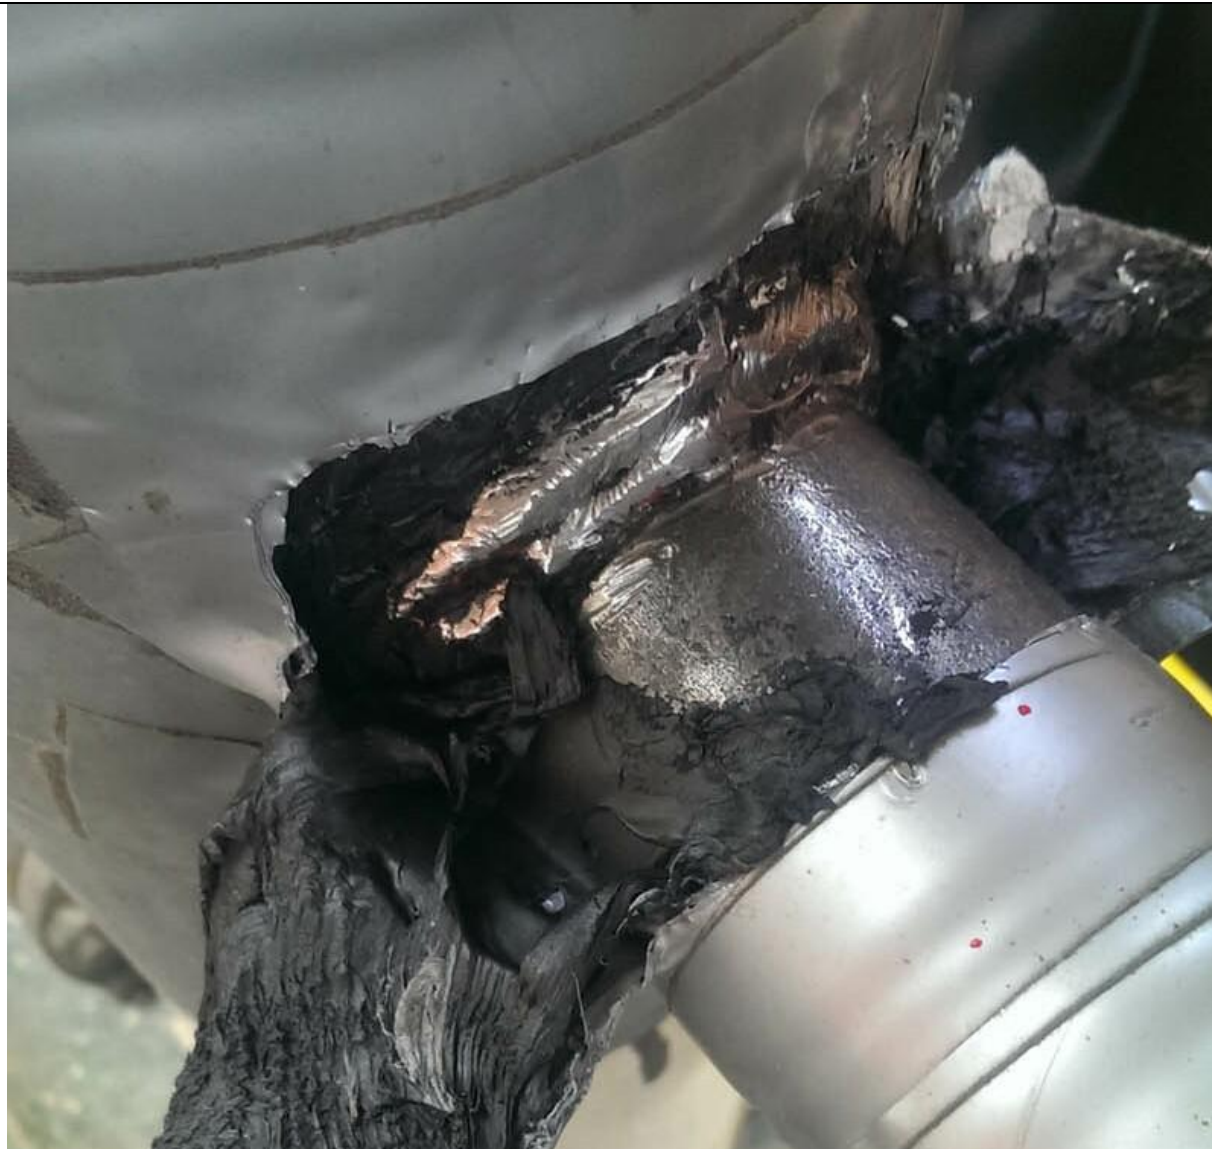
1 year Demo Test Result: June 28, 2013_Peel-off to check (= No any corrosion) = EXCELLENT Water & Air Immersion Resistance, and UV Resistance.

One year no any corrosion (both Weld End and Pipe's surface is still showing Metallic Luster, which same as the original status). Remark: the Brown color was the primer of paint which is the Surface Preparation of pipe did not good enough) [Tip: Enlarge the PDF file to see the photo in details.](#)

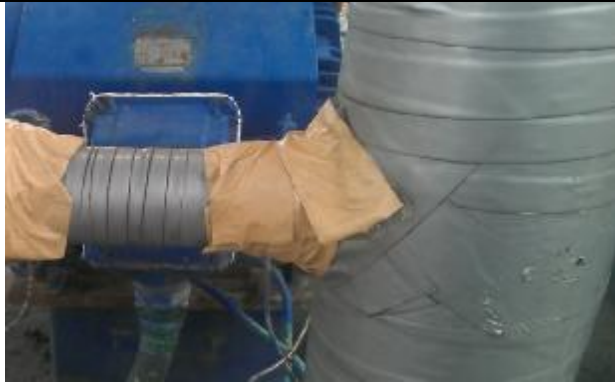
Appearance: 2 years later (June 27, 2014) – before checking

Remark: The surface's Anti-Corrosion Materials did not recovery by Furuto's SOP during one year (2013) checked. (it's just only use a packaging tape for temporary repaired, which couldn't Anti-UV, Water Tight & Air Tight)

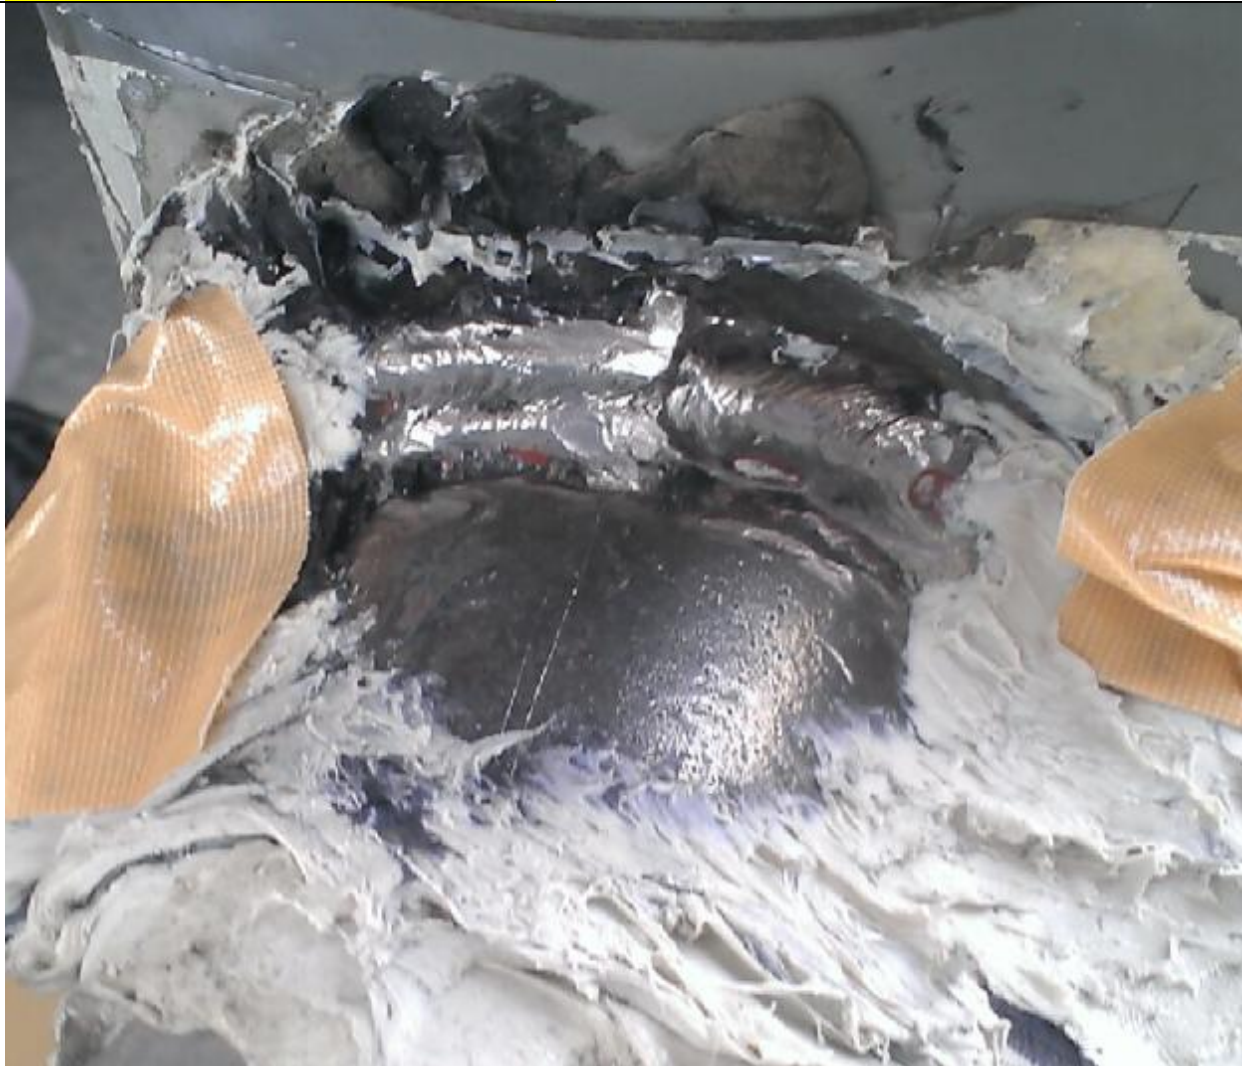
2 year Demo Test Result: June 27, 2014_Peel-off to check (= No any corrosion) = EXCELLENT Water & Air Immersion Resistance, and UV Resistance.

Two year no any corrosion (both Weld End and Pipe's surface is still showing Metallic Luster, which same as the original status). [Tip: Enlarge the PDF file to see the photo in details](#)

Remark: the Brown color was the primer of paint which is the Surface Preparation of pipe did not good enough the Light Gray color was the repaired material which wrapped at one year test dated on Jun.28,2013)

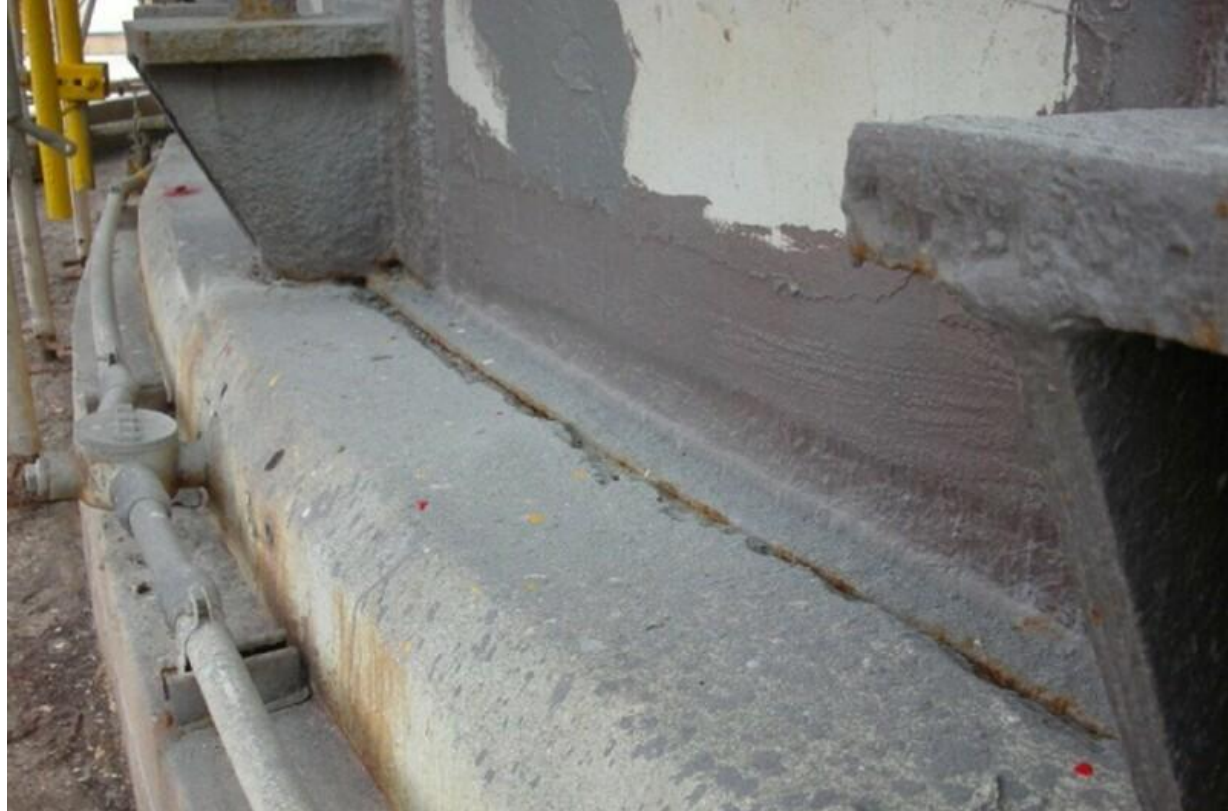
Appearance: in the Beginning (June 28, 2012, before reinforcement)

Remark: This object's surface didn't made any of Surface Preparation before demo test (= had rust),
This demo test is focusing the IMMERSION RESISTANCE (Water Tight & Air Tight) for the reinforcement
between Tank bottom edge's corrosion and Concrete base, with hope it's without deterioration in future.

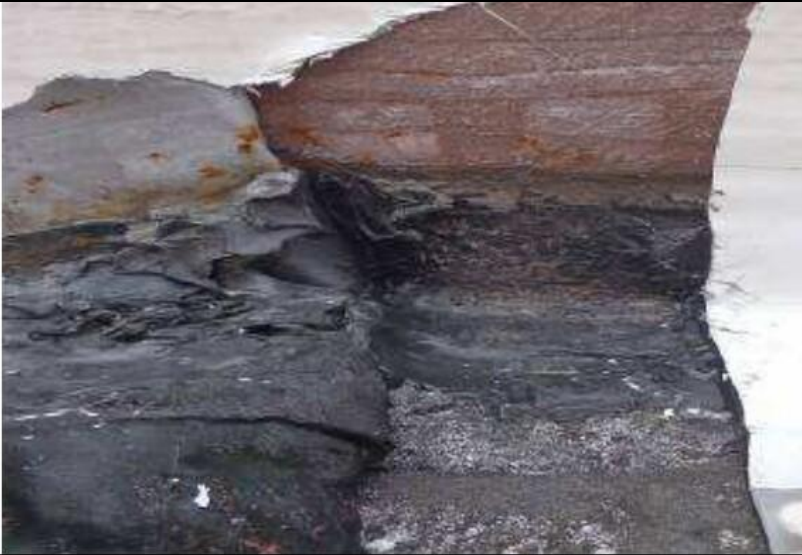
1 year Demo Test Result: Sep 14, 2013_Peel-off to check (= No Deterioration) – for R Angle = 50mm
(= No any corrosion) = EXCELLENT Water & Air Immersion Resistance, and UV Resistance.

102 年 09/14 Tank 與水泥直角拆除

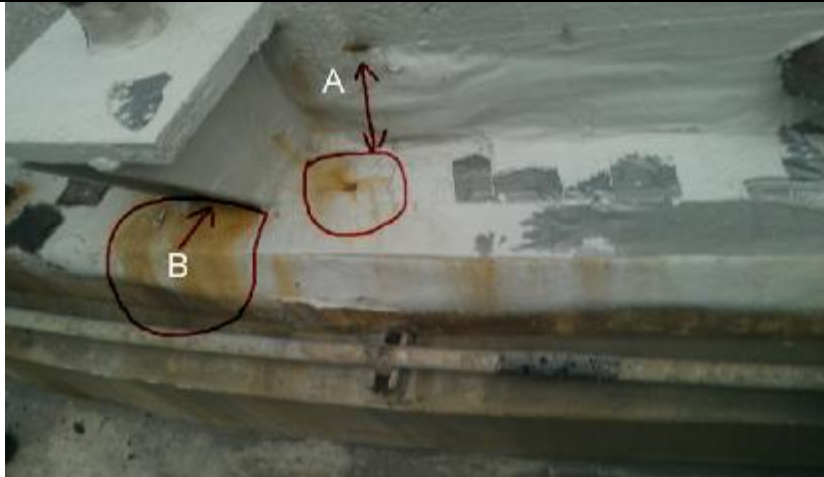
Appearance: 2 years later (June 27, 2014) – before checking (for right hand area)

- (1) A (defect point): it's been peel-off the tape for checked one year before, but did not recovery the Tape as Furuto's SOP, caused the inside steel surface was rust and found the rust water marks in outside.
- (2) B (steel base of big nut) inside did not used Furuto's Anti-Corrosion materials= it's been found the serious problem of rust water marks in outside.

(NOTE: the right hand area = no rust water marks found)

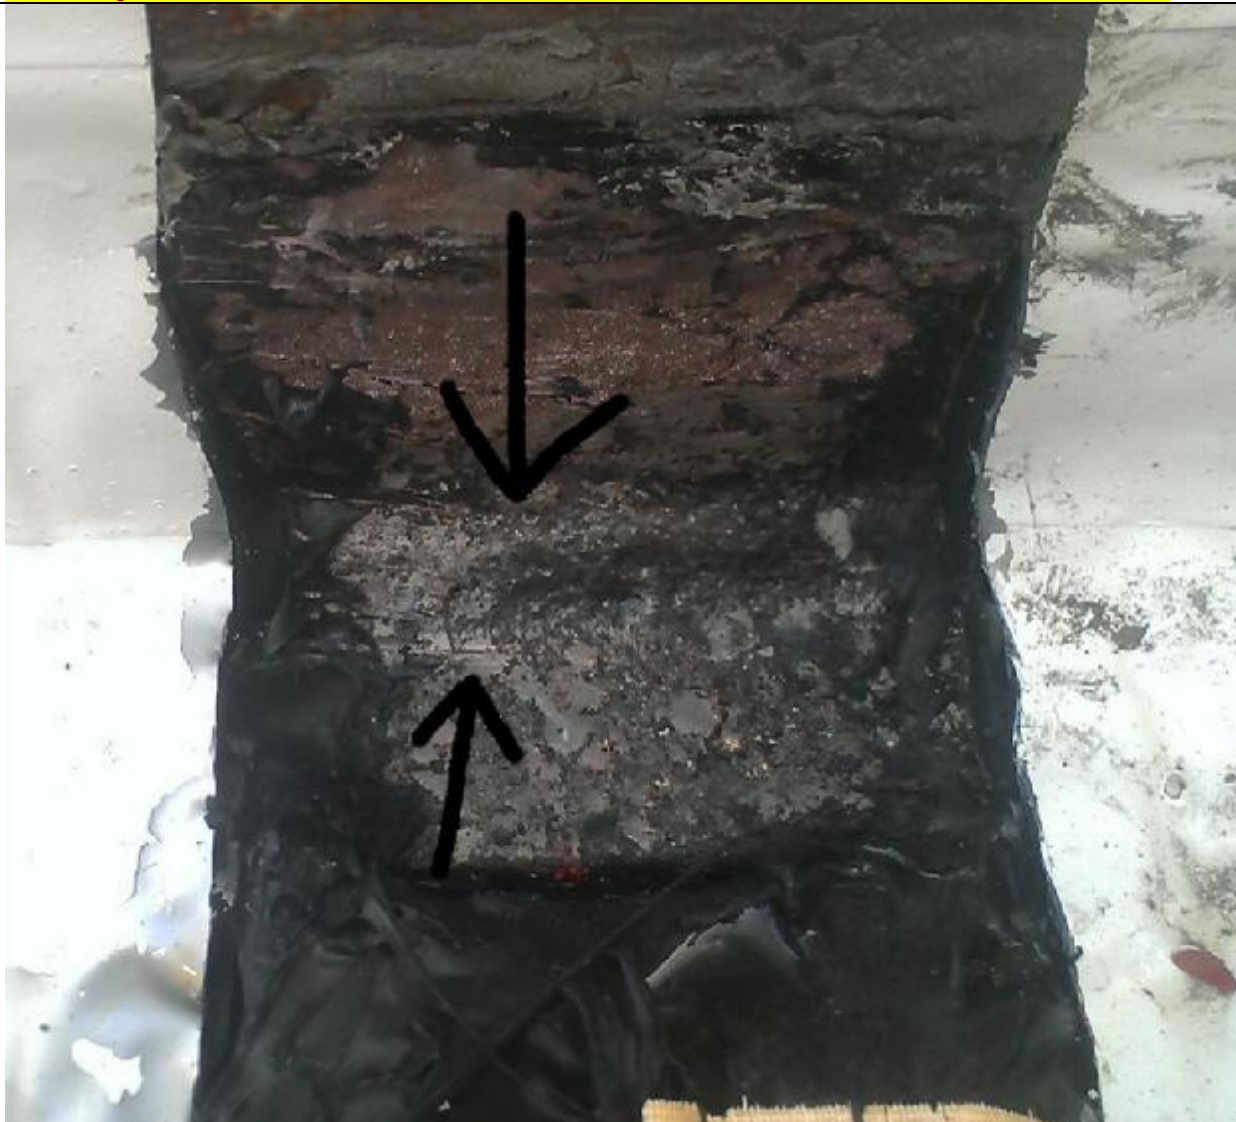
2 year Demo Test Result: June 27, 2014_Peel-off to check (= No any deterioration for corrosion)

(= No any corrosion) = EXCELLENT Water & Air Immersion Resistance, and UV Resistance.

Two year no any corrosion (both Tank bottom edge and Concrete base, No any deterioration for the corrosion, which same as the original status = Excellent Water Tight & Air Tight by the reinforcement) = EXCELLENT IMMERSION RESISTANCE.

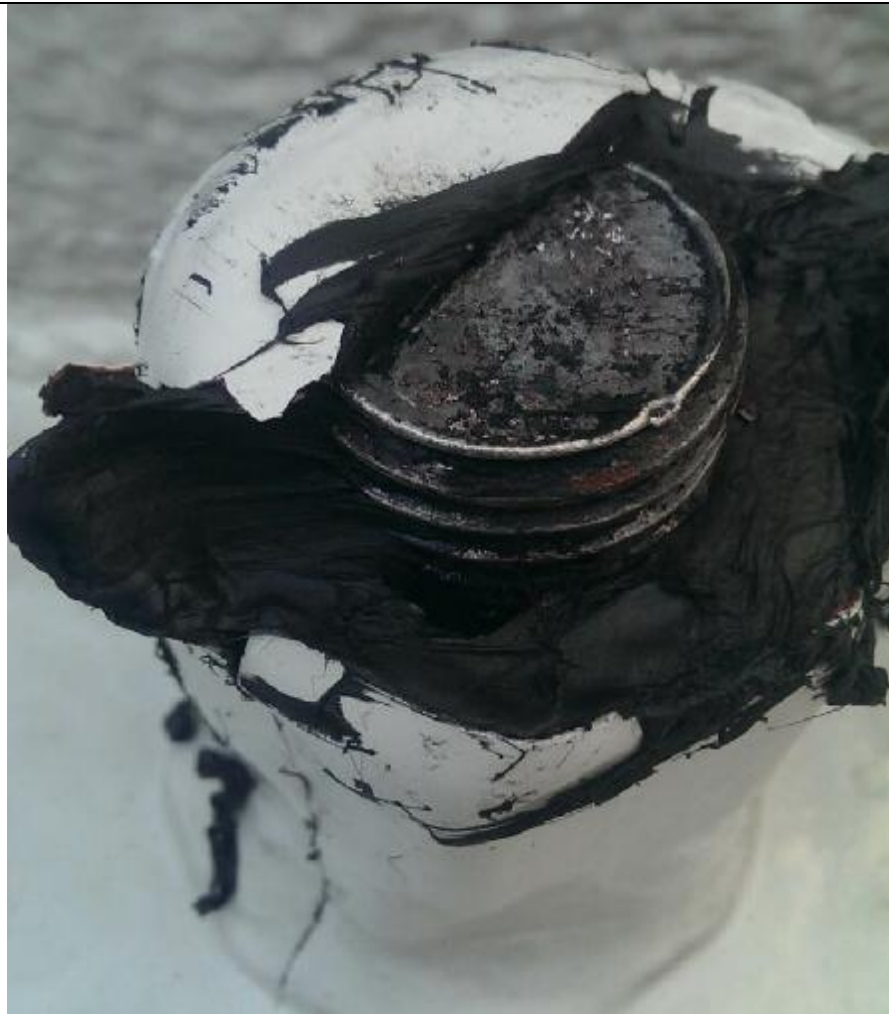
1 year Demo Test Result: June 28, 2013_Peel-off to check (= No any corrosion) = EXCELLENT Water & Air Immersion Resistance, and UV Resistance.

One year no any corrosion (top of Bolt surface is still showing Metallic Luster, which same as the original status).

Remark: the Brown color was the primer of paint which is the Surface Preparation of steel did not good enough

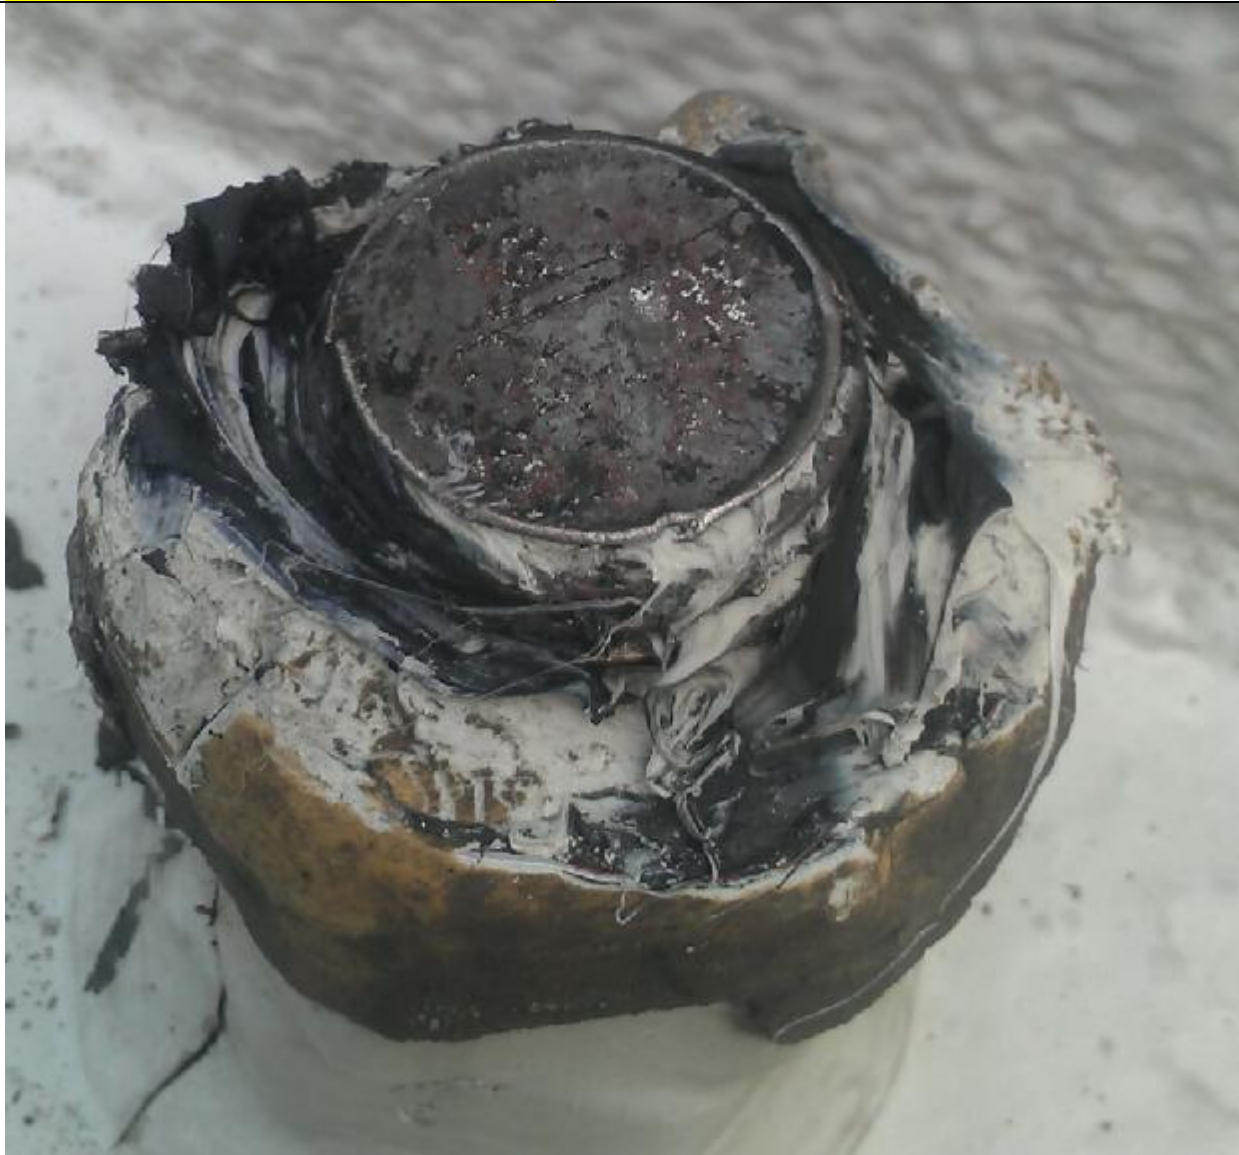
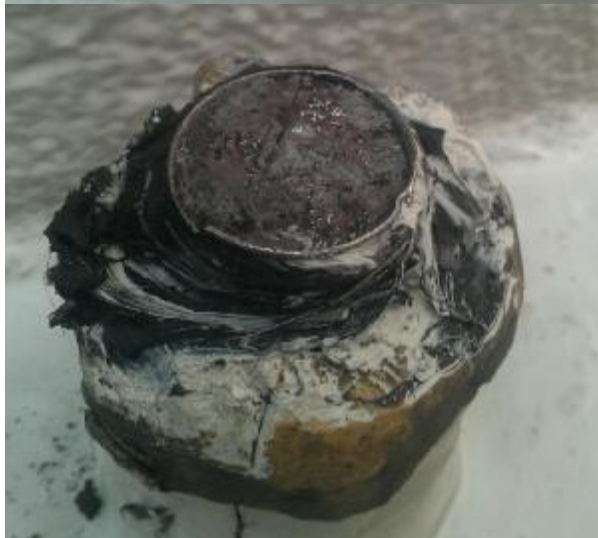
2 year Demo Test Result: June 27, 2014_Peel-off to check (= No any corrosion) = EXCELLENT Water & Air Immersion Resistance, and UV Resistance.

Two year no any corrosion (top of Bolt surface is still showing Metallic Luster, which same as the original status). Remark: the Brown color was the primer of paint which is the Surface Preparation of steel did not good enough; the Light Gray color was the repaired material which wrapped at one year test dated on Jun.28,2013)

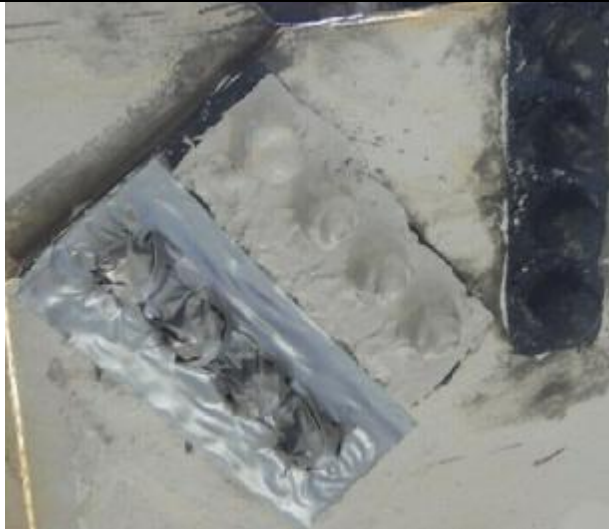
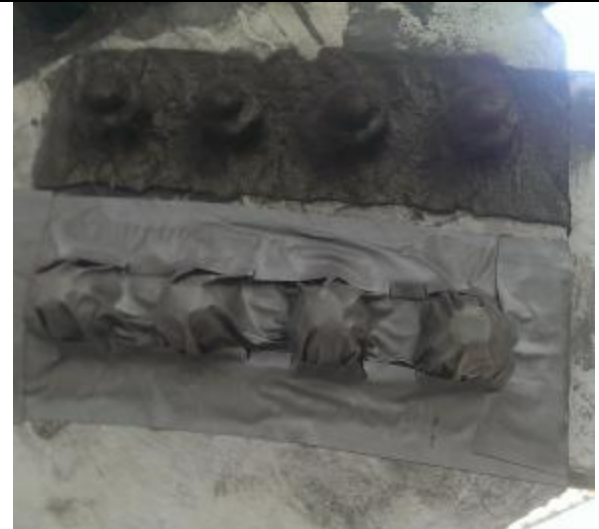
Appearance: One year later (Jun. 28, 2013)

Remark: **Correct Demo: upside** sample (white and black) appearance good and easy to be apply.
Incorrect Demo: downside (= Wrong method, different with Furuto's SOP), it's no need the #F3 Surface Protection Tape (Sliver color), because the appearance was no good and not easy to be apply.

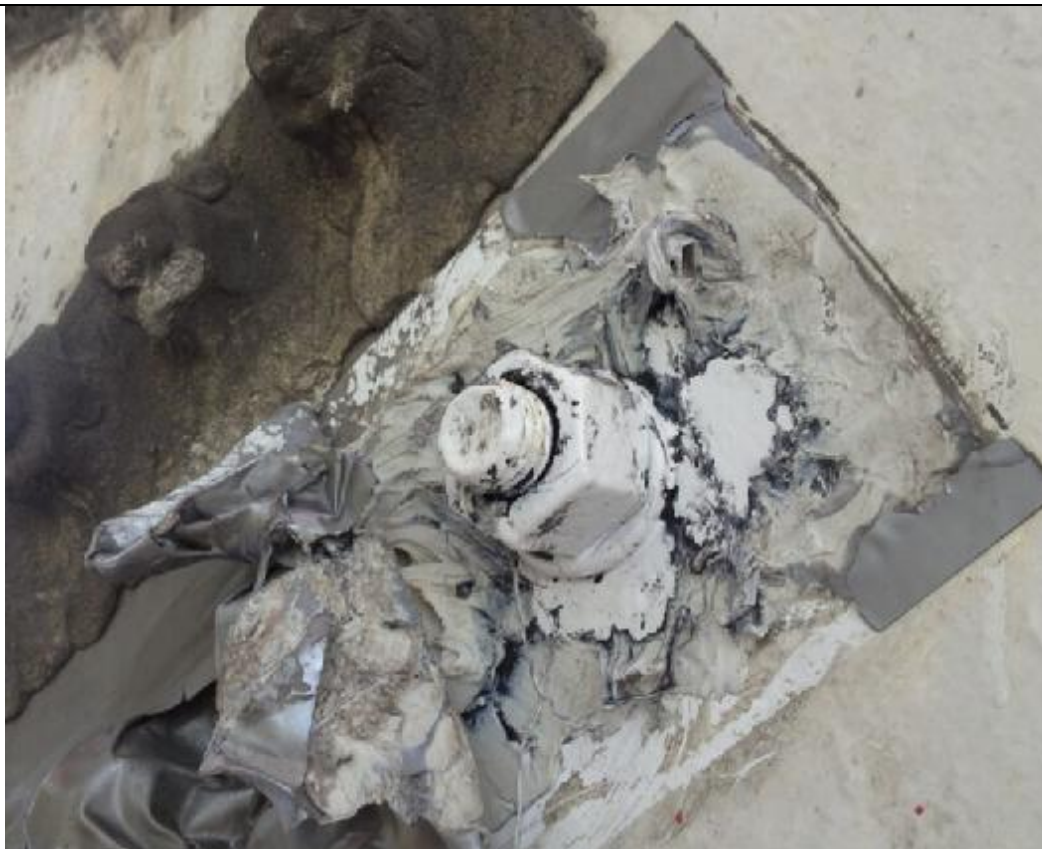
1 year Demo Test Result: June 28, 2013_Peel-off to check (= No any corrosion) = **EXCELLENT Water & Air Immersion Resistance, and UV Resistance.**

One year no any corrosion

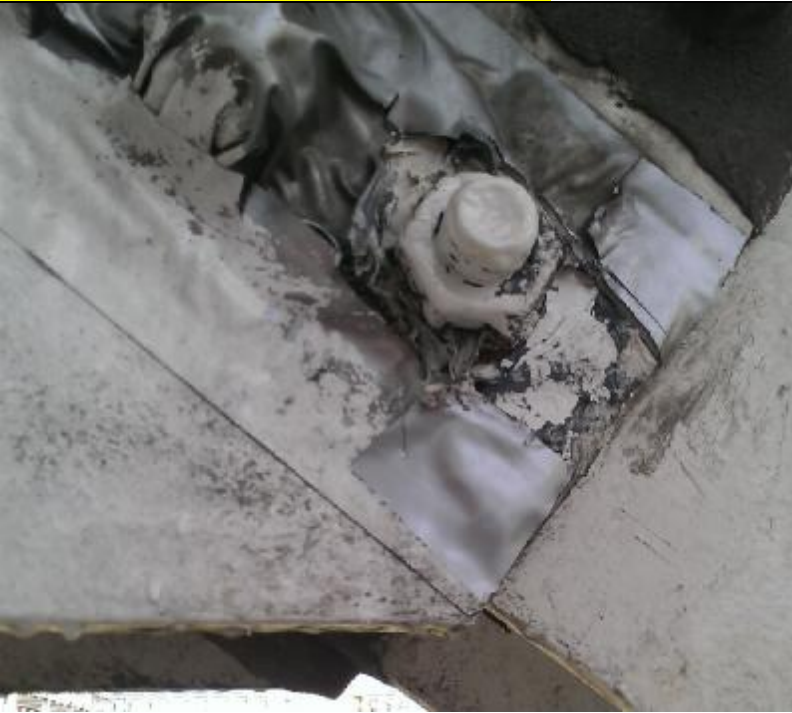
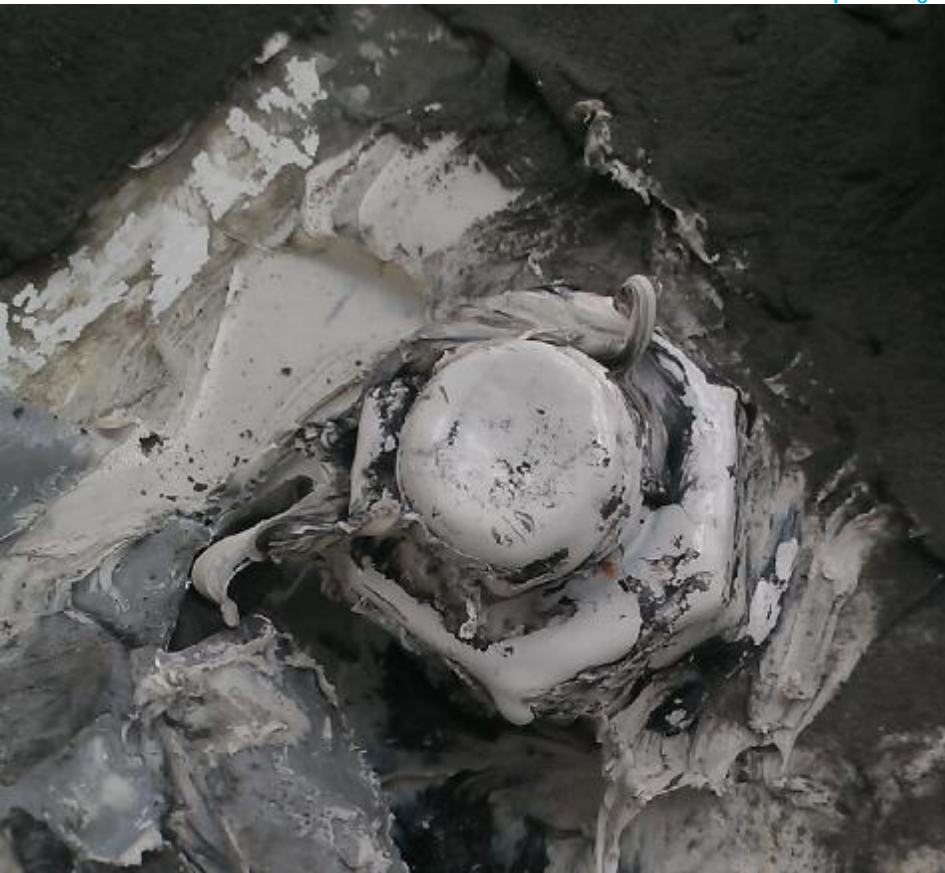
2 year Demo Test Result: June 27, 2014_Peel-off to check (= No any corrosion) = EXCELLENT Water & Air Immersion Resistance, and UV Resistance.
