FACILITY CONDITION ASSESSMENT

Bernardo Elementary School
1122 Mountain Heights Drive
Escondido, California 92025

164076.23R000-002.017

August 17, 2023

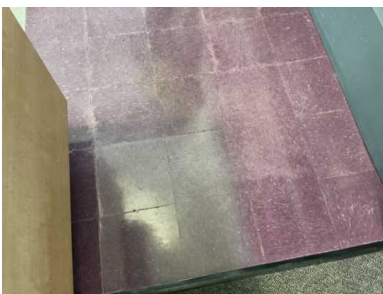
Flooring in Poor condition.

Vinyl Tile (VCT)
Building Admin Bernardo Elementary School
Throughout building

Edges are warping - AssetCALC ID: 6875736

Uniformat Code: C2030
Recommendation: **Replace in 2023**
