FACILITY CONDITION ASSESSMENT

Conway Elementary School
1325 Conway Drive
Escondido, California 92025

July 6, 2025

August 18, 2023

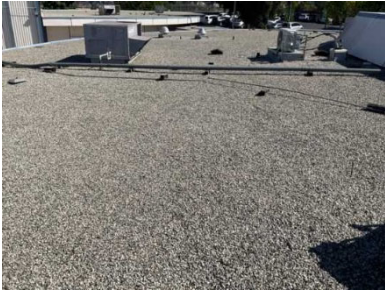
Built-Up
Admin/Library Building Conway Elementary
School Roof

Roofing in Poor condition.

Roof leaks reported throughout - AssetCALC ID: 6933743

Uniformat Code: B3010
Recommendation: **Replace in 2024**

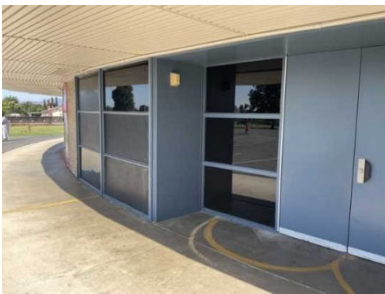
Wood, up to 15 SF
MPR/Kitchen Conway Elementary School
Building Exterior

Window in Poor condition.

Windows show deterioration - AssetCALC ID: 6933835

Uniformat Code: B2020
Recommendation: **Replace in 2024**

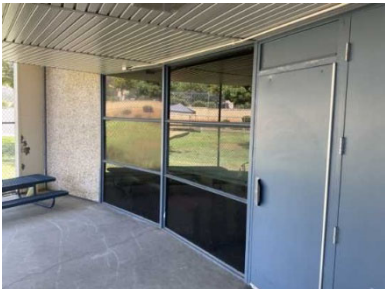
Wood, up to 15 SF
Kindergarten Conway Elementary School
Building Exterior

Window in Poor condition.

Windows show deterioration - AssetCALC ID: 6933764

Uniformat Code: B2020
Recommendation: **Replace in 2024**

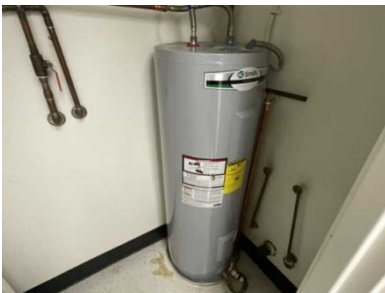
Electric, Commercial (12 kW)
MPR/Kitchen Conway Elementary School
Utility closet

Water Heater in Poor condition.

Unit is functioning but is past its EUL - AssetCALC ID: 6933812

Uniformat Code: D2010
Recommendation: **Replace in 2024**

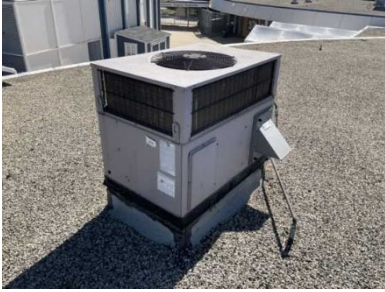
RTU, Pad or Roof-Mounted
MPR/Kitchen Conway Elementary School Roof

**Packaged Unit in Poor condition.**

HVAC equipment has aged and reported to struggle throughout campus - AssetCALC ID: 6933798

Uniformat Code: D3050
Recommendation: **Replace in 2024**

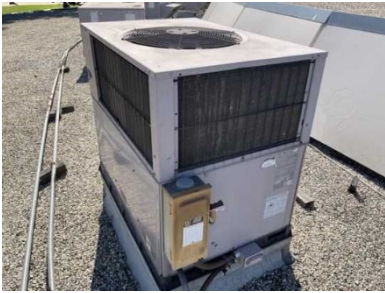
RTU, Pad or Roof-Mounted
Admin/Library Building Conway Elementary
School Roof

**Packaged Unit in Poor condition.**

Uniformat Code: D3050
Recommendation: **Replace in 2024**
