FACILITY CONDITION ASSESSMENT

Farr Avenue Elementary School
933 Farr Avenue
Escondido, California 92025

164076.23R000-006.017

September 17, 2023

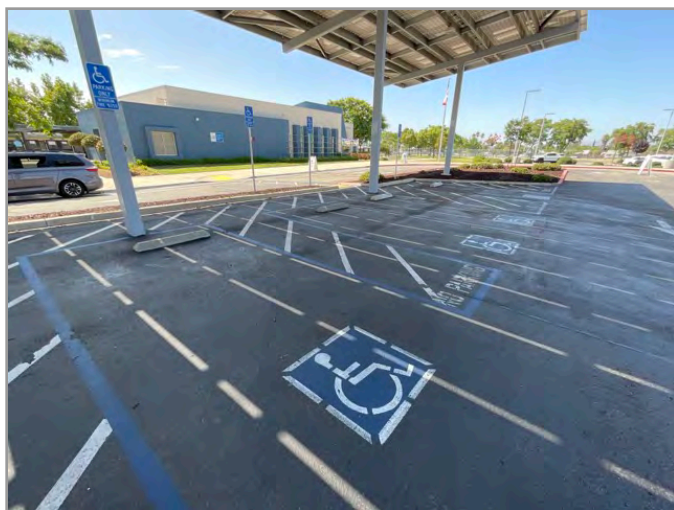
OVERVIEW OF ACCESSIBLE PARKING AREA

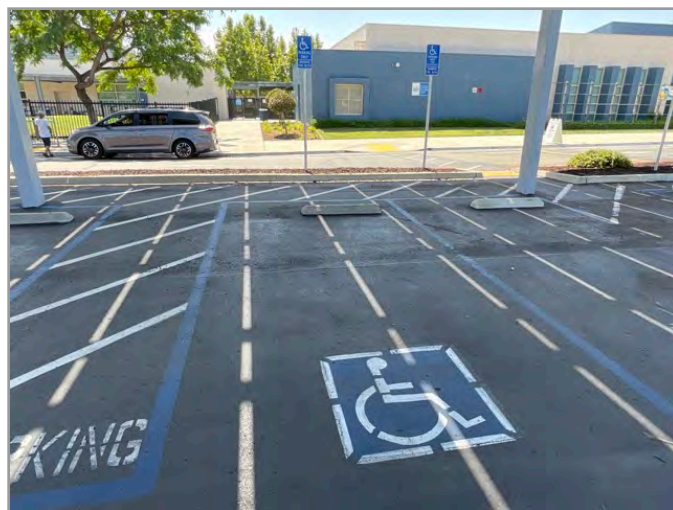
CLOSE-UP OF STALL

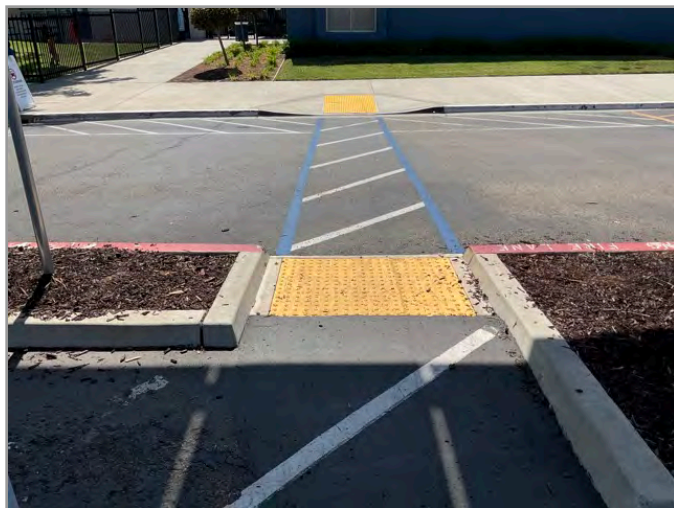
ACCESSIBLE PATH

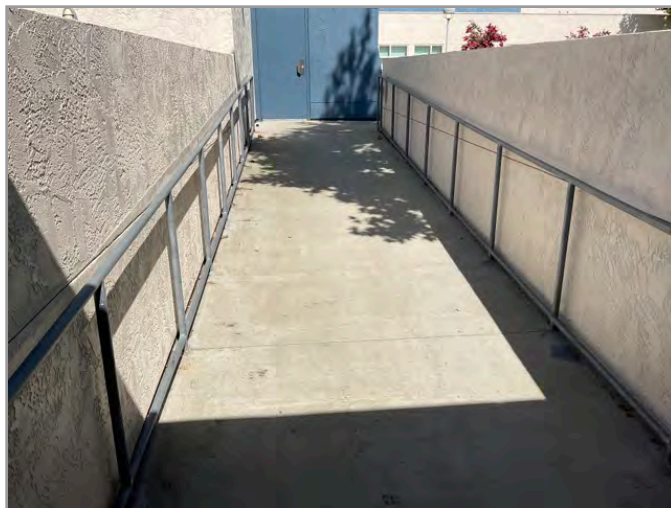
ACCESSIBLE RAMP

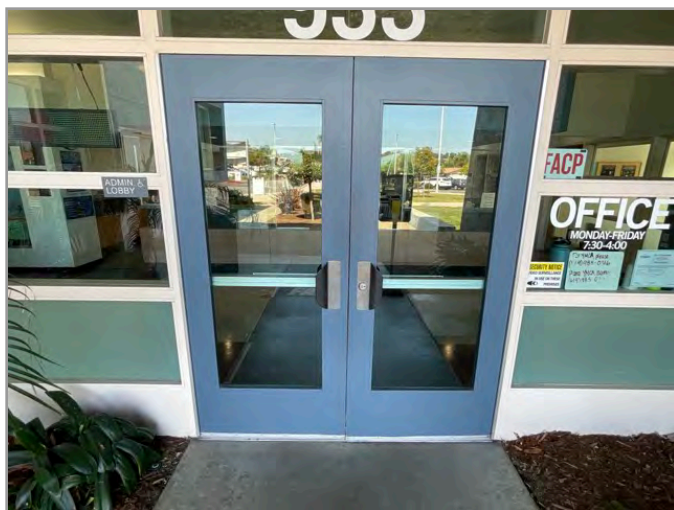
ACCESSIBLE ENTRANCE

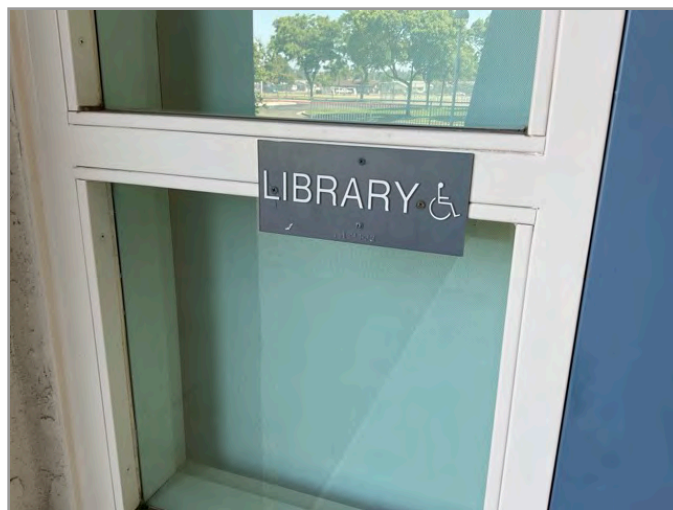
SIGNAGE

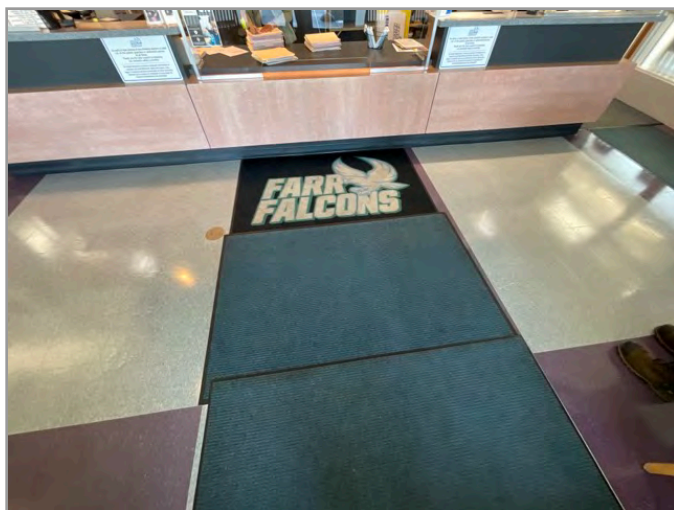
ACCESSIBLE INTERIOR PATH

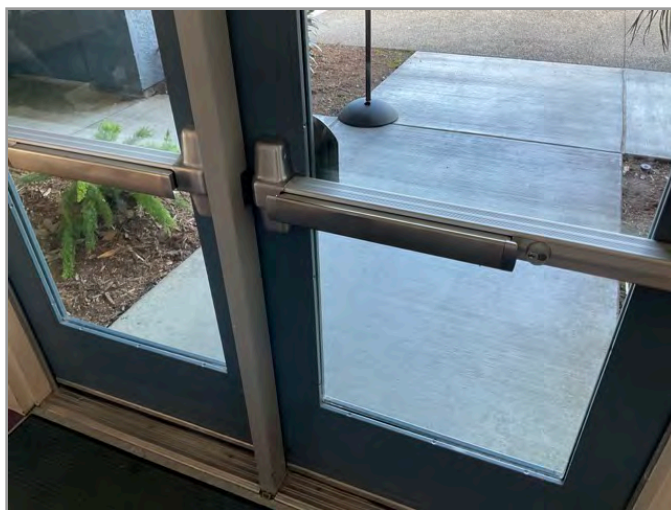
DOOR HARDWARE

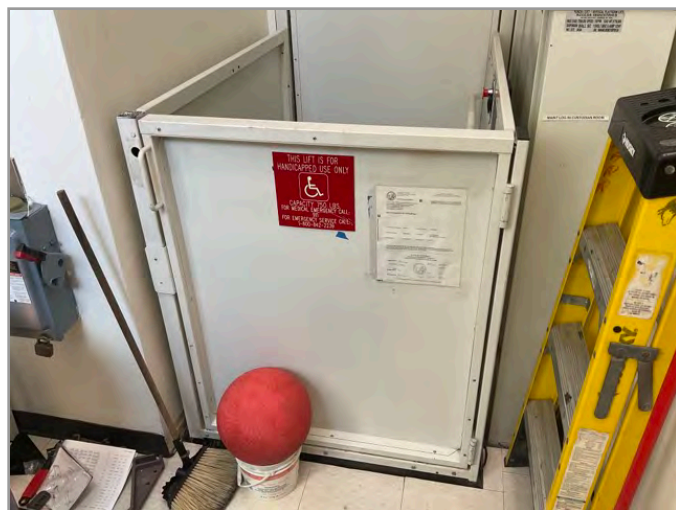
WHEELCHAIR LIFT

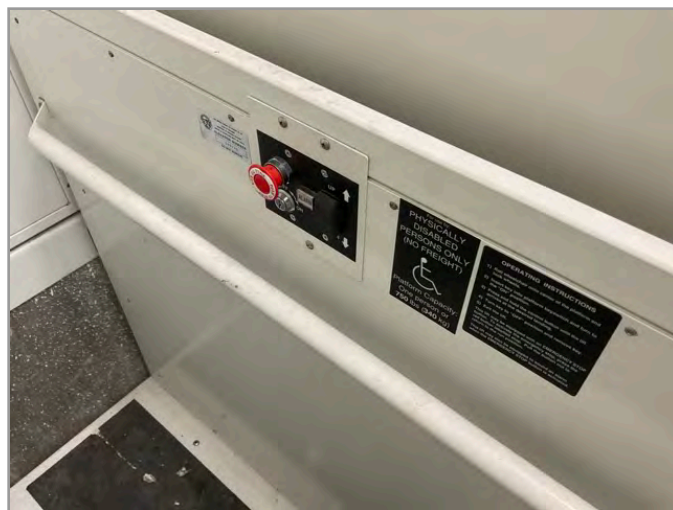
WHEELCHAIR LIFT CONTROLS

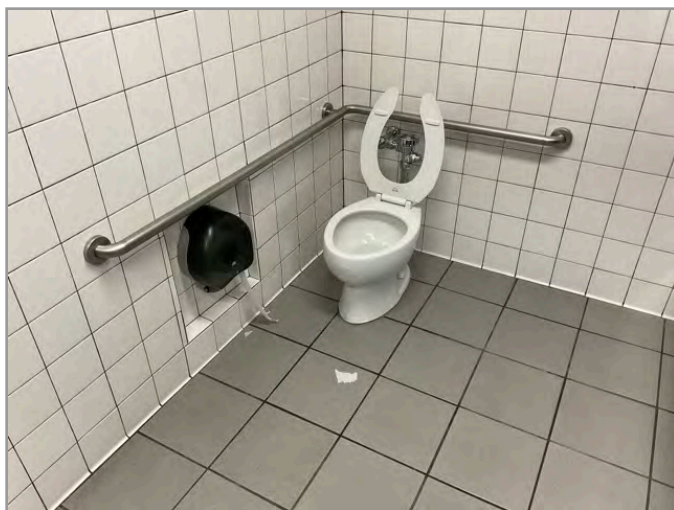
TOILET STALL OVERVIEW

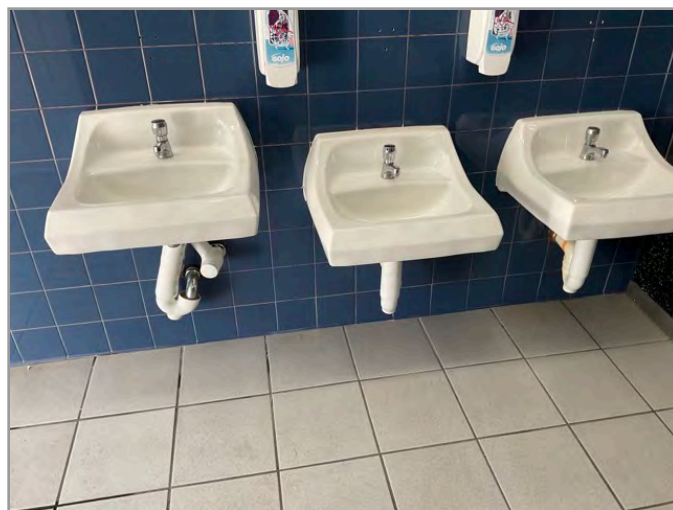
SINK, FAUCET HANDLES AND ACCESSORIES

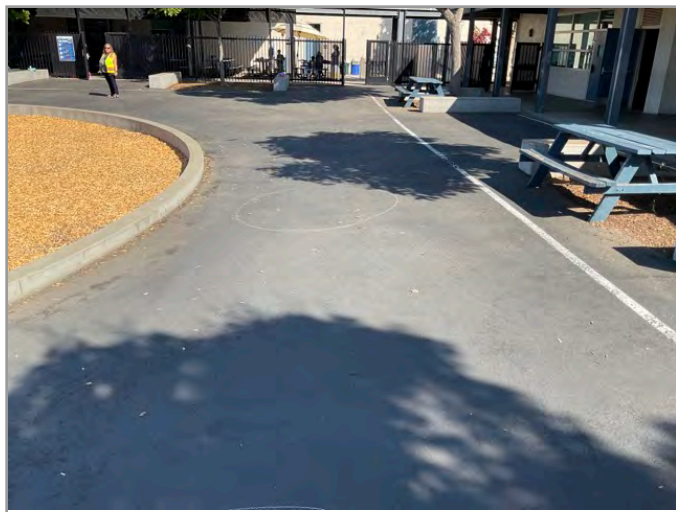
ACCESSIBLE ROUTE TO PLAYGROUND

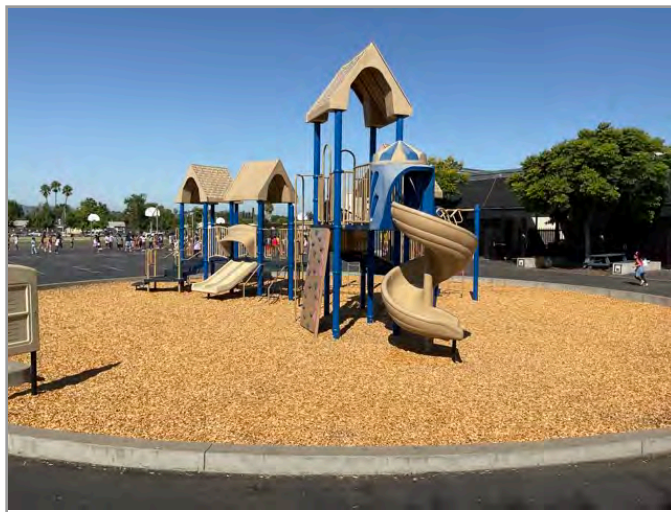
OVERVIEW OF PLAYGROUND
