FACILITY CONDITION ASSESSMENT

Felicita Elementary School
737 West 13th Avenue
Escondido, California 92025

164076.23R000-007.017

September 18, 2023

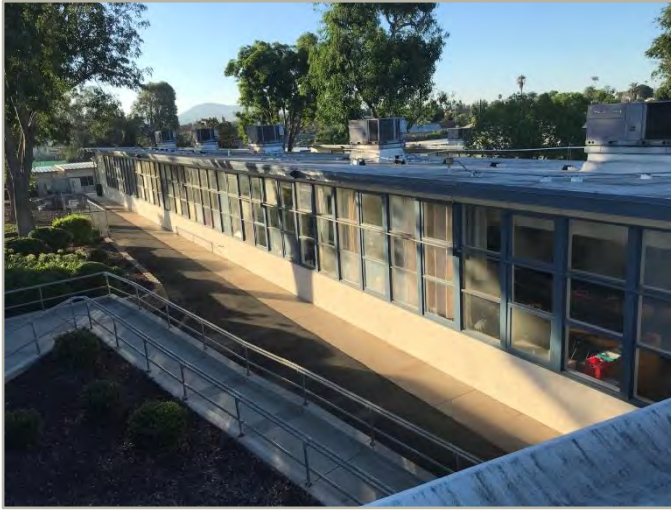
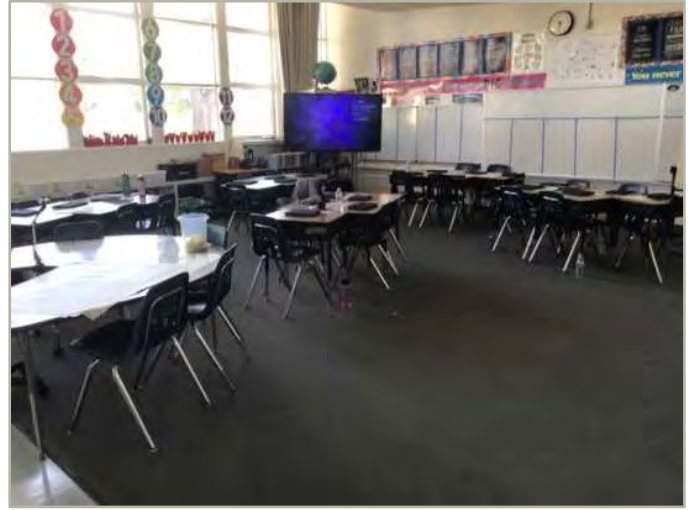
3. Building B

Fire Suppression	Fire extinguishers only	Fair
Electrical	Source & Distribution: Main panel with copper wiring Interior Lighting: Linear fluorescent Emergency Power: None	Fair
Fire Alarm	Alarm system with smoke detectors, alarms, strobes, pull stations, and exit signs	Fair
Equipment/Special	None	--
Accessibility	Presently it does not appear an accessibility study is needed for this building. See Appendix D.	
Key Issues and Findings	Packaged units have exceeded their useful life

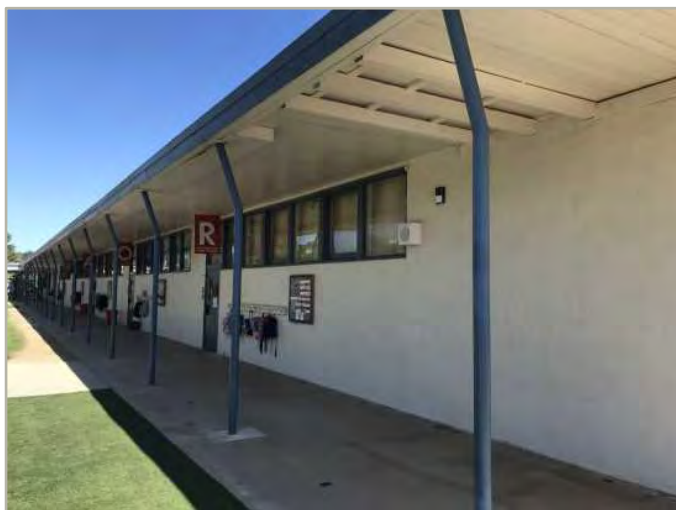
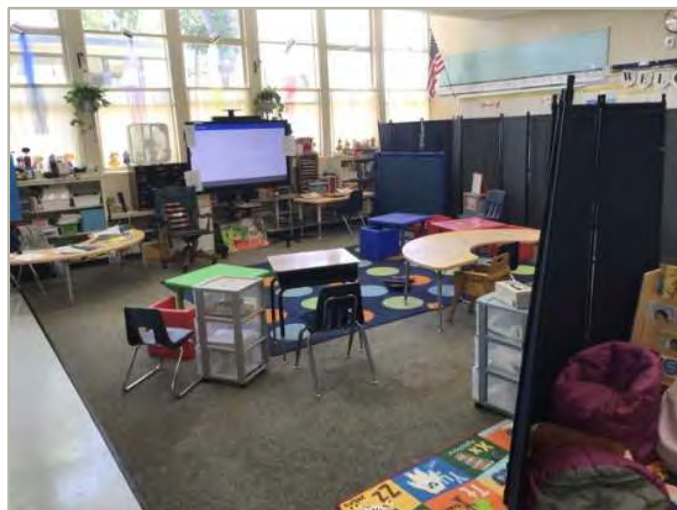
4. Building C

Electrical	Source & Distribution: Main panel with copper wiring Interior Lighting: Linear fluorescent Emergency Power: None	Fair
Fire Alarm	Alarm system with smoke detectors, alarms, strobes, pull stations, and exit signs	Fair
Equipment/Special	None	--
Accessibility	Presently it does not appear an accessibility study is needed for this building. See Appendix D.	
Key Issues and Findings	Packaged units have exceeded their useful life

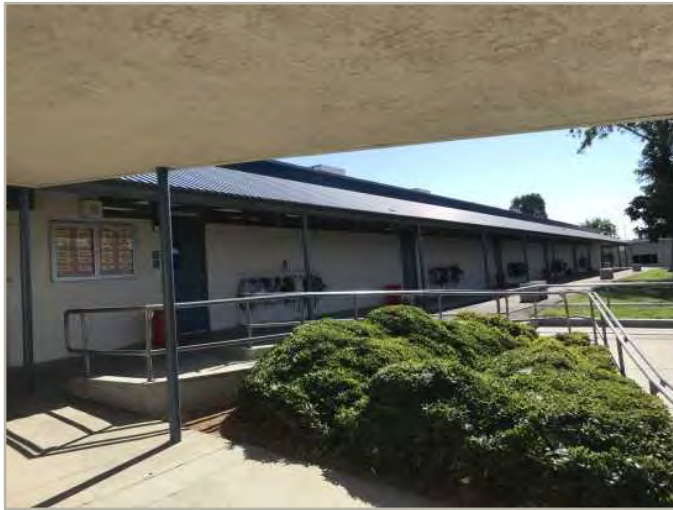
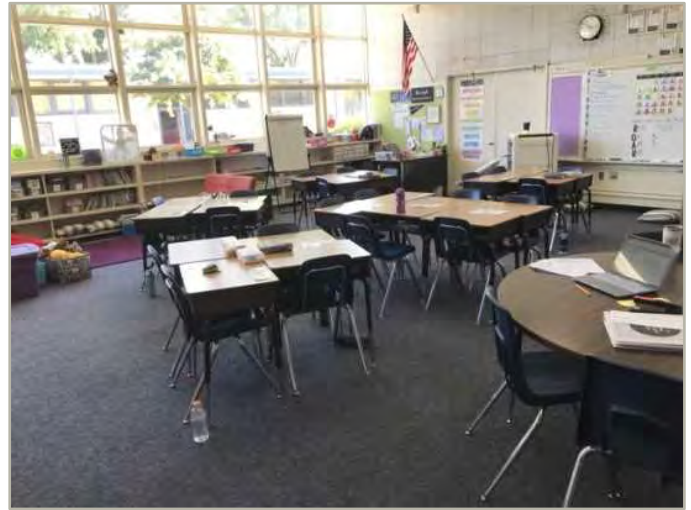
5. Building D

Electrical	Source & Distribution: Main panel with copper wiring Interior Lighting: Linear fluorescent Emergency Power: None	Fair
Fire Alarm	Alarm system with smoke detectors, alarms, strobes, pull stations, and exit signs	Fair
Equipment/Special	None	--
Accessibility	Presently it does not appear an accessibility study is needed for this building. See Appendix D.	
Key Issues and Findings	Packaged units have exceeded their useful life

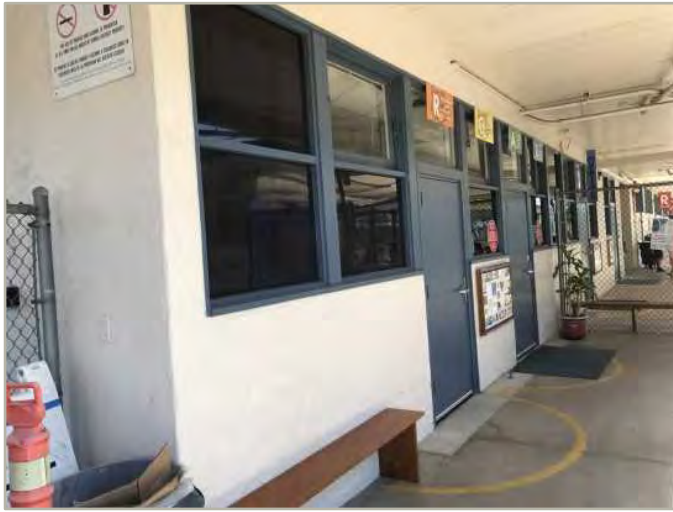
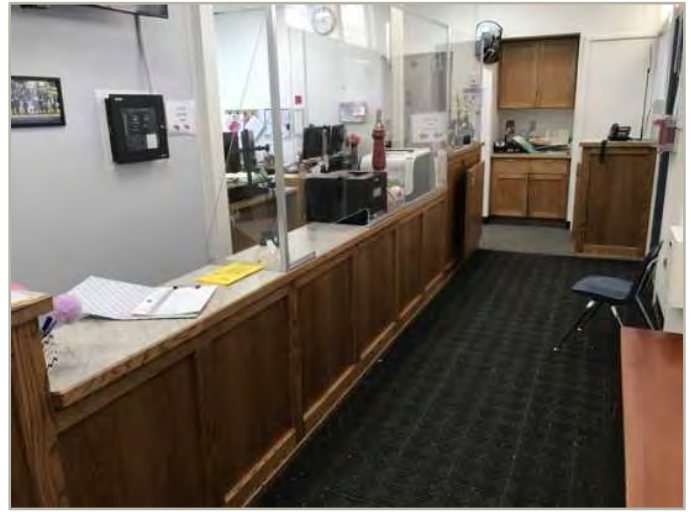
6. Building E

Electrical	Source & Distribution: Main panel with copper wiring Interior Lighting: Linear fluorescent Emergency Power: None	Fair
Fire Alarm	Alarm panel with smoke detectors, alarms, strobes, pull stations, and exit signs	Fair
Equipment/Special	None	--
Accessibility	Presently it does not appear an accessibility study is needed for this building. See Appendix D.	
Key Issues and Findings	Packaged units have exceeded their useful life

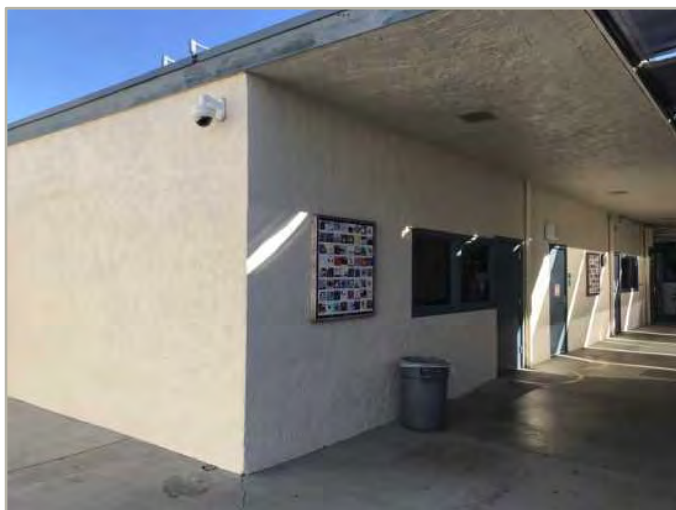
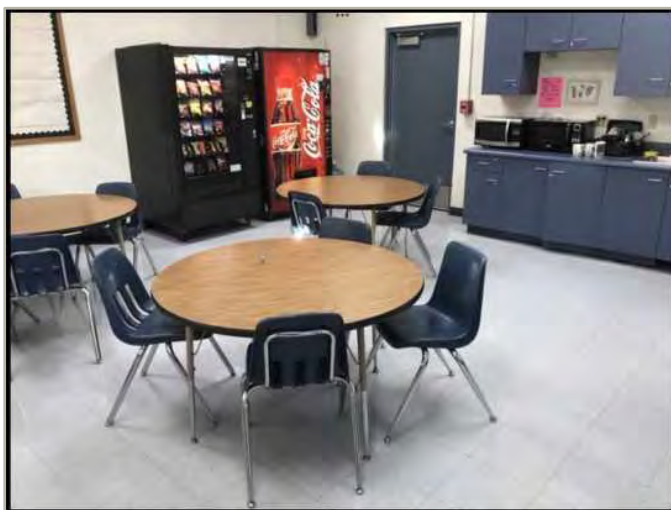
7. Building F

Building F: Systems Summary		
Electrical	Source & Distribution: Main panel with copper wiring Interior Lighting: Linear fluorescent Emergency Power: None	Fair
Fire Alarm	Alarm panel with smoke detectors, alarms, strobes, pull stations, and exit signs	Fair
Equipment/Special	None	--
Accessibility	Presently it does not appear an accessibility study is needed for this building. See Appendix D.	
Key Issues and Findings	Packaged units have exceeded their useful life

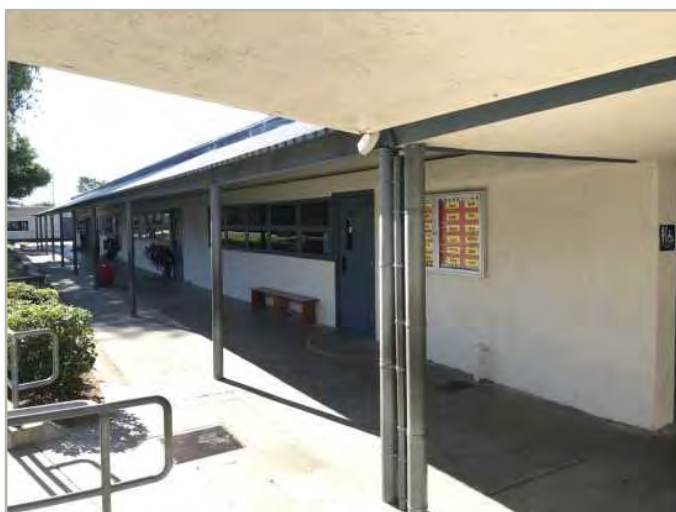
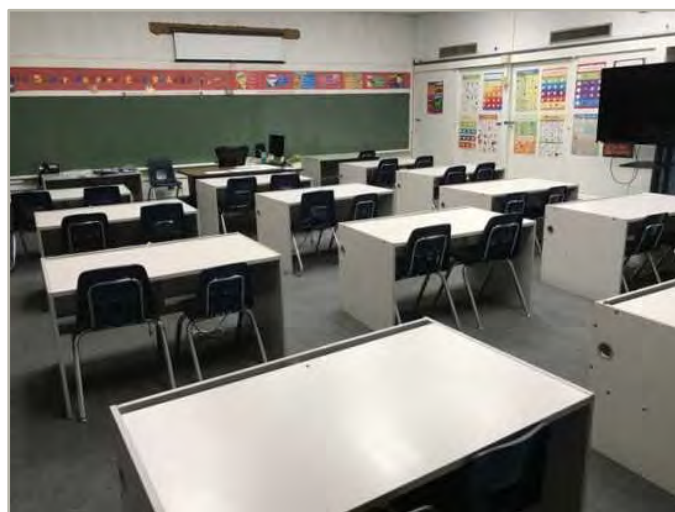
8. Building H

Electrical	Source & Distribution: Main panel with copper wiring Interior Lighting: Linear fluorescent Emergency Power: None	Fair
Fire Alarm	Alarm system with smoke detectors, alarms, strobes, pull stations, and exit signs	Fair
Equipment/Special	None	--
Accessibility	Presently it does not appear an accessibility study is needed for this building. See Appendix D.	
Key Issues and Findings	Packaged units have exceeded their useful life

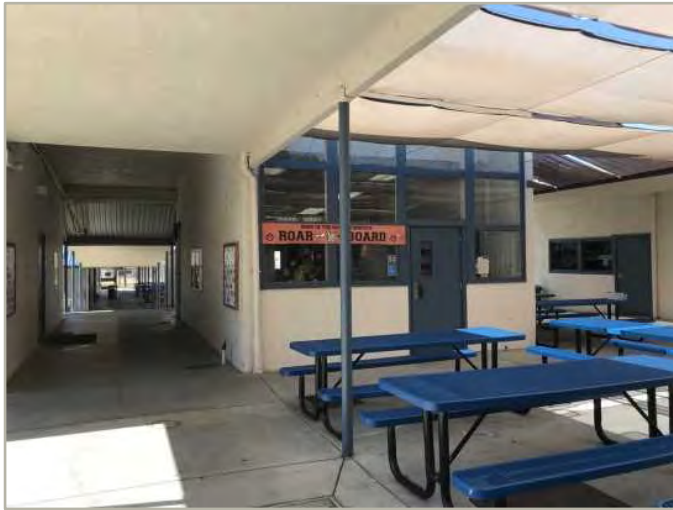
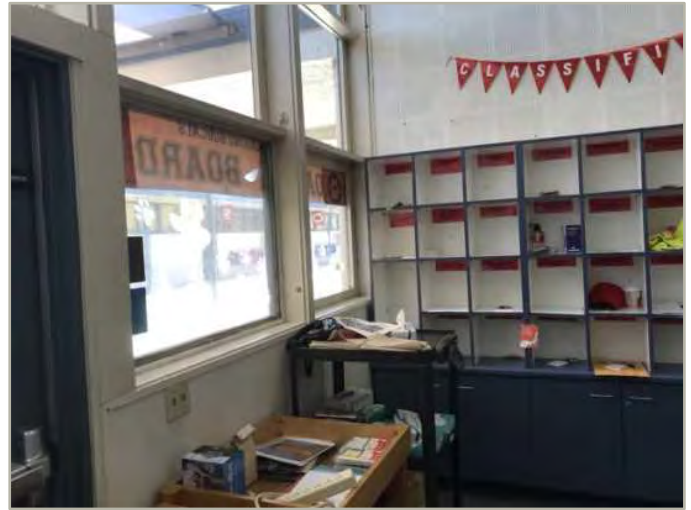
10. Building N

Building N: Systems Summary		
Electrical	Source & Distribution: Main panel with copper wiring Interior Lighting: Linear fluorescent Emergency Power: None	Fair
Fire Alarm	Alarm system with smoke detectors, alarms, strobes, pull stations, and exit signs	Fair
Equipment/Special	None	--
Accessibility	Presently it does not appear an accessibility study is needed for this building. See Appendix D.	
Key Issues and Findings	Packaged units have exceeded their useful life

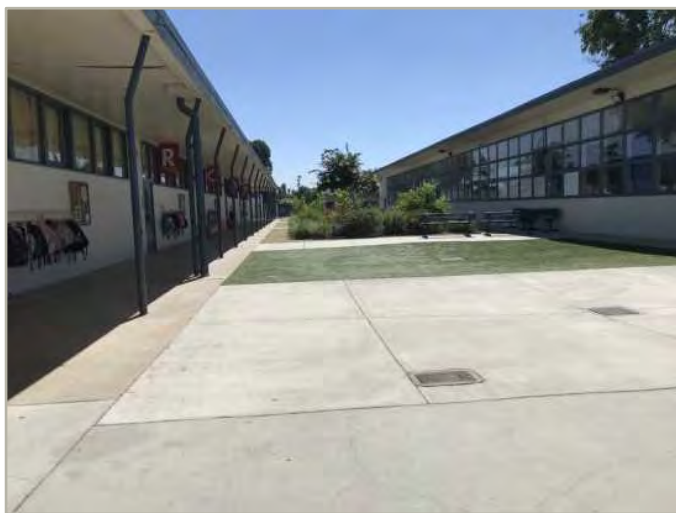
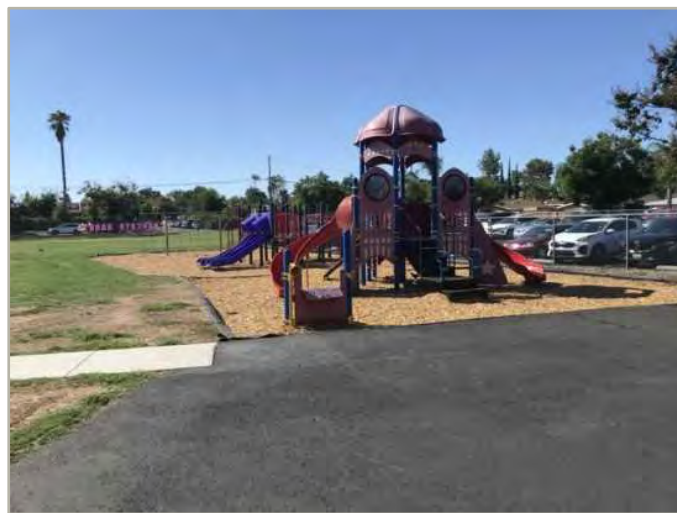
12. Site Summary

Site Information		
System	Description	Condition
Pavement/Flatwork	Asphalt lots with limited areas of concrete aprons and pavement and adjacent concrete sidewalks, curbs, and ramps	Fair
Site Development	Building-mounted signage; chain link fencing; Playgrounds and sports fields and courts Limited picnic tables, trash receptacles	Fair
Landscaping and Topography	Moderate landscaping features including lawns, trees, bushes, and planters. Irrigation present No retaining walls. Low to moderate site slopes throughout	Fair
Utilities	Municipal water and sewer Local utility-provided electric and natural gas	Good
Site Lighting	Pole-mounted: None Building-mounted: Incandescent	Fair
Ancillary Structures	Prefabricated modular buildings	Fair
Accessibility	Presently it does not appear an accessibility study is needed for this building. See Appendix D.	
Key Issues and Findings	Roadway pavement, and roof walkway
