FACILITY CONDITION ASSESSMENT

Glen View
2201 East Mission Avenue
Escondido, California 92025

Bureau Veritas
6021 University Boulevard, Suite 200
Ellicott City, Maryland 21043
800.733.0660
www.us.bureauveritas.com

September 6, 2023

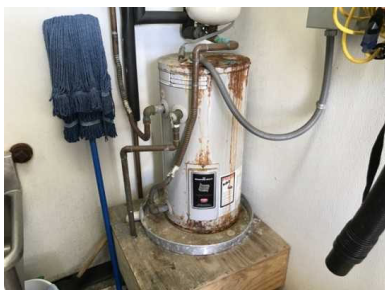
Water Heater in Poor condition.

Electric, Residential
Building-I Glen View Custodian room

The unit is corroded and is not fully functioning, replacement is required. - AssetCALC ID: 6901757

Uniformat Code: D2010
Recommendation: **Replace in 2024**

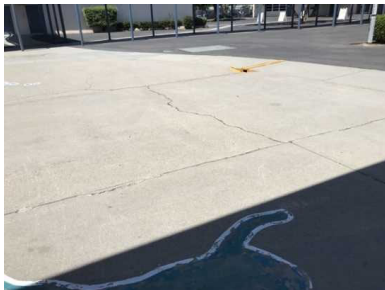
Sidewalk in Poor condition.

any pavement type, Sectional Repairs (per Man-Day)
Site Glen View Sidewalk

Isolated areas of cracks concrete, repair is required - AssetCALC ID: 6901925

Uniformat Code: G2030
Recommendation: **Repair in 2023**

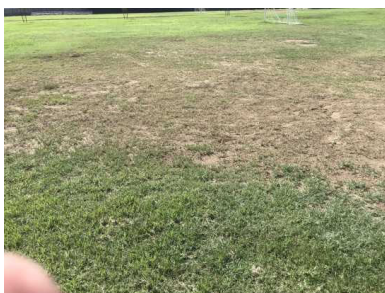
Landscaping in Poor condition.

Sod at Eroded Areas
Site Glen View Landscaping

Isolated areas of eroded landscaping areas, repair is required - AssetCALC ID: 6901938

Uniformat Code: G2080
Recommendation: **Repair in 2023**
