# FACILITY CONDITION ASSESSMENT

L.R. Green Elementary School  
3115 Las Palmas Avenue  
Escondido, California 92025

164076.23R000-009.017

July 6, 2025

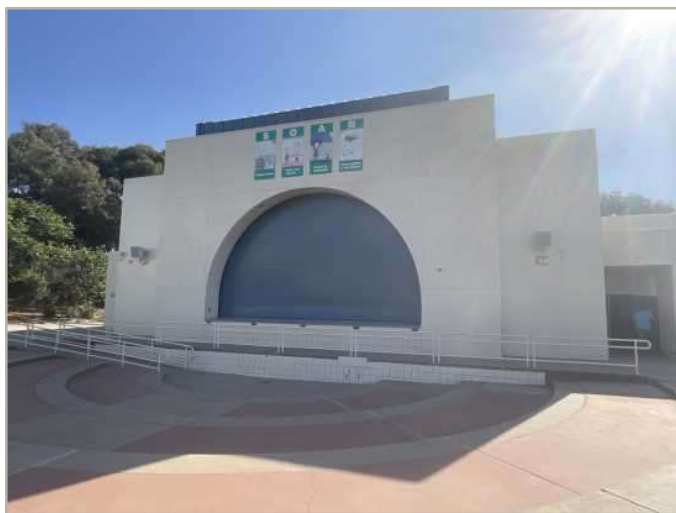
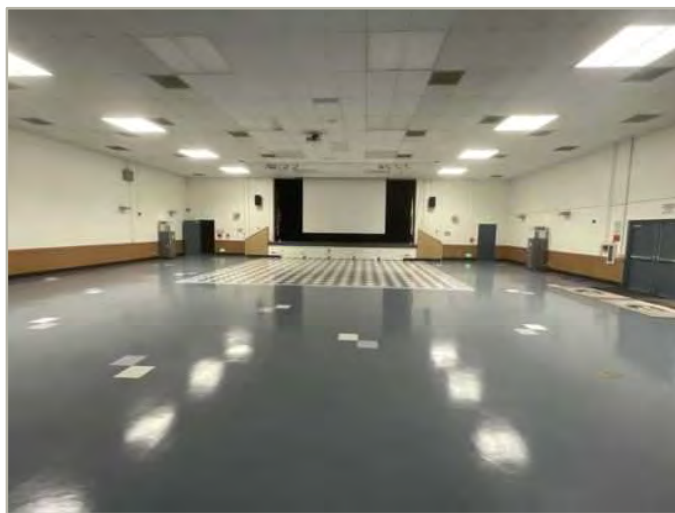
<b>Electrical</b>	Source & Distribution: Main panel with copper wiring Interior Lighting: LED Emergency Power: None	Fair
<b>Fire Alarm</b>	Alarm panel, smoke detectors, alarms, strobes, pull stations, back-up emergency lights, and exit signs	Fair
<b>Equipment/Special</b>	None	--
<b>Accessibility</b>	Presently it does not appear an accessibility study is needed for this building. See Appendix D.	
<b>Key Issues and Findings</b>	Theatre curtain is failing and beyond its useful life.

ID	Location	Location Description	UF Code	Description	Condition	Plan Type	Cost
6967254	L.R. Green Elementary / Building 3 - MPR/Classrooms	Stage	E1070	Theater & Stage Equipment, Flameproof Curtain, Medium Weight Velour, Replace	Poor	Performance/Integrity	\$16,400
<b>Total (1 items)</b>							<b>\$16,400</b>
