FACILITY CONDITION ASSESSMENT

Hidden Valley Middle School
2700 Reed Road
Escondido, California 92025

September 13, 2023

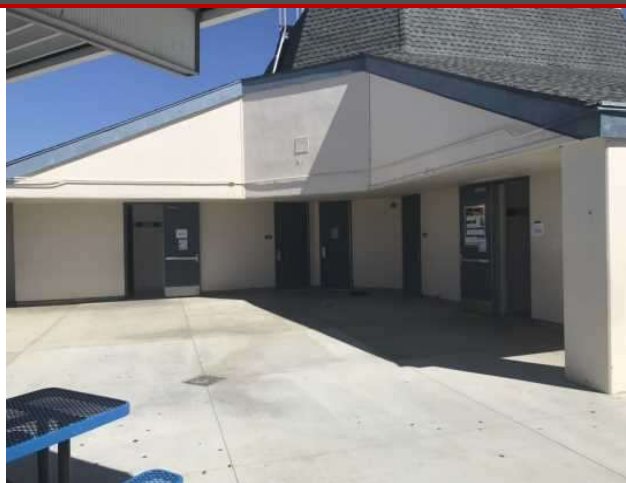
2 - BUILDING F

Building F: Systems Summary		
Fire Suppression	Fire extinguishers only	Fair
Electrical	Source & Distribution: Main panel with copper wiring Interior Lighting: Linear fluorescent Emergency Power: None	Fair
Fire Alarm	Alarm system with smoke detectors, alarms, strobes, pull stations, and exit signs	Fair
Equipment/Special	None	--
Accessibility	Presently it does not appear an accessibility study is needed for this building. See Appendix D.	
Additional Studies	No additional studies are recommended for this building at this time.	
Key Issues and Findings	Exterior walls are in need of painting

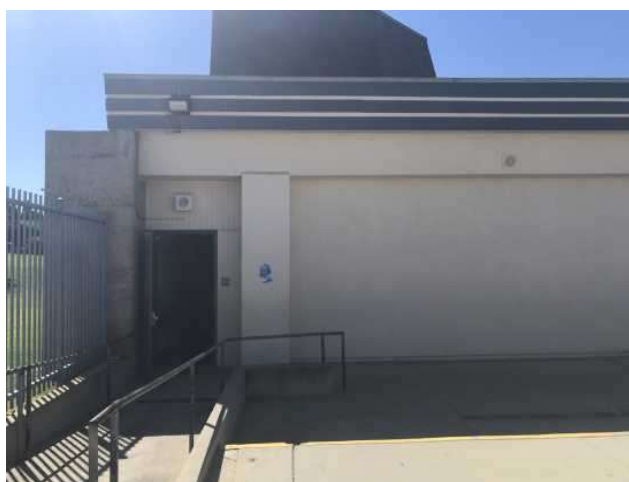
5 - BUILDING H

Electrical	Source & Distribution: Main panel with copper wiring Interior Lighting: Linear fluorescent Emergency Power: None	Fair
Fire Alarm	Alarm system with smoke detectors, alarms, strobes, pull stations, and exit signs	Fair
Equipment/Special	None	--
Accessibility	Presently it does not appear an accessibility study is needed for this building. See Appendix D.	
Additional Studies	No additional studies are recommended for this building/site at this time.	
Key Issues and Findings	Exterior wall is damaged and in need of repair

ID	Location	Location Description	UF Code	Description	Condition	Plan Type	Cost
6948769	Hidden Valley Middle School / Building H	Building exterior	B2010	Exterior Walls, Stucco, Repair	Poor	Performance/Integrity	\$1,300
Total (1 items)							\$1,300

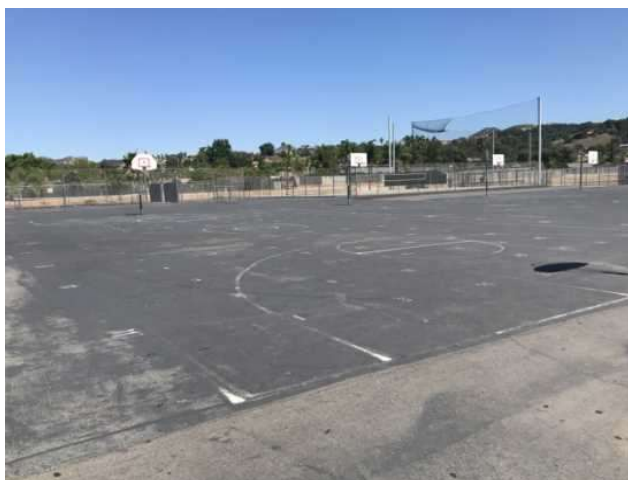
47 - BASKETBALL COURTS

Additional Studies	No additional studies are recommended for the general site at this time.	
Key Issues and Findings	Tennis and basketball courts pavements, and sidewalk repair

ID	Location	Location Description	UF Code	Description	Condition	Plan Type	Cost
6948848	Hidden Valley Middle School / Site	Tennis court	G2010	Roadways, Pavement, Asphalt, Repair	Poor	Performance/Integrity	\$5,000
6948846	Hidden Valley Middle School / Site	Basketball court	G2010	Roadways, Pavement, Asphalt, Repair	Poor	Performance/Integrity	\$10,100
6948856	Hidden Valley Middle School / Site	Sidewalk	G2030	Sidewalk, any pavement type, Sectional Repairs (per Man-Day), Repair	Poor	Performance/Integrity	\$2,200
Total (3 items)							\$17,300
