FACILITY CONDITION ASSESSMENT

Lincoln School
1029 North Broadway
Escondido, California 92026

164076.23R000-012.017

September 14, 2023

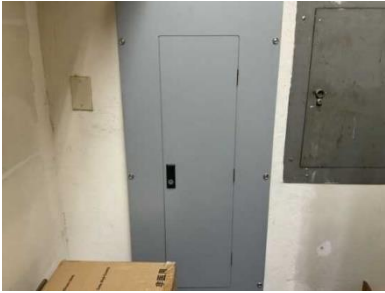
**Electrical System in Poor condition.**

Wiring and Switches, Average or Low Density/Complexity
Classrooms 1-5 Lincoln School Throughout building

Antiquated electrical infrastructure throughout - AssetCALC ID: 6953567

Uniformat Code: D5030
Recommendation: **Replace in 2024**

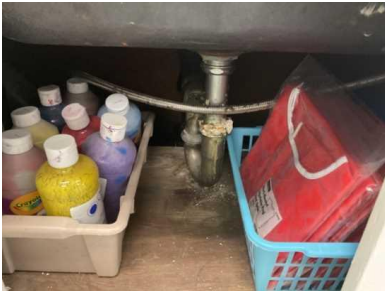
**Plumbing System in Poor condition.**

Supply and Sanitary, Medium Density (excludes fixtures)
Classroom 35 Lincoln School Throughout building

Antiquated plumbing supply system throughout - AssetCALC ID: 6953724

Uniformat Code: D2010
Recommendation: **Replace in 2024**

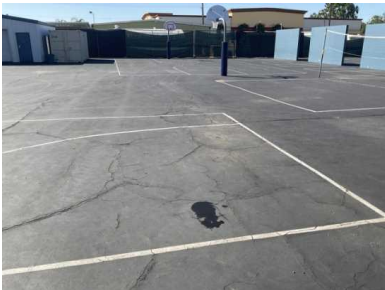
**Athletic Surfaces and Courts in Poor condition.**

Basketball/General, Asphalt Pavement
Site Lincoln School Site

Severe alligator cracking throughout. Poor drainage near main play structure - AssetCALC ID: 6953760

Uniformat Code: G2050
Recommendation: **Mill and Overlay in 2023**

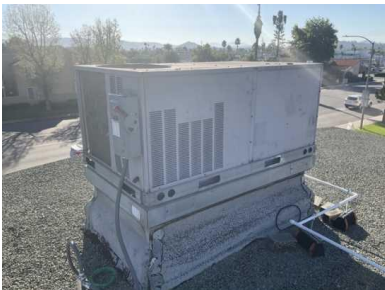
**Packaged Unit in Poor condition.**

RTU, Pad or Roof-Mounted
MPR/Kitchen Building Lincoln School Roof

All units currently being replaced - AssetCALC ID: 6953557

Uniformat Code: D3050
Recommendation: **Replace in 2023**

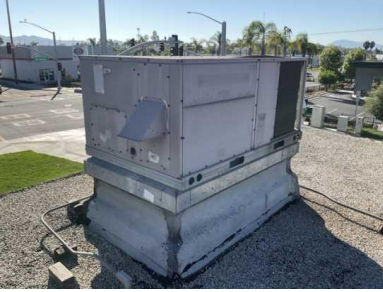
**Packaged Unit in Poor condition.**

RTU, Pad or Roof-Mounted
Classroom 35 Lincoln School Roof

All units currently being replaced - AssetCALC ID: 6953713

Uniformat Code: D3050
Recommendation: **Replace in 2023**

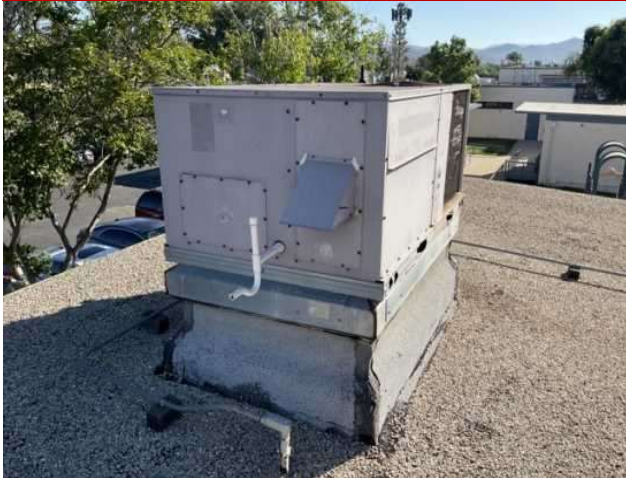
19 - OLDER PACKAGED UNIT
