FACILITY CONDITION ASSESSMENT

Miller Elementary School
1975 Miller Avenue
Escondido, California 92025

164076.23R000-013.017

July 6, 2025

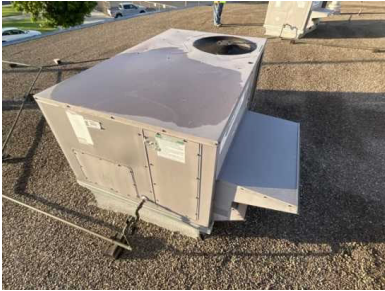
Packaged Unit in Poor condition.

RTU, Pad or Roof-Mounted
Building A Miller Elementary School Roof

Past useful life - AssetCALC ID: 6874571

Uniformat Code: D3050
Recommendation: **Replace in 2025**

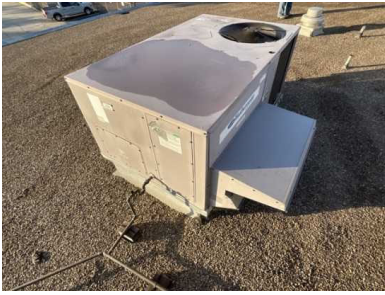
**Packaged Unit in Poor condition.**

RTU, Pad or Roof-Mounted
Building A Miller Elementary School Roof

Past useful life - AssetCALC ID: 6874575

Uniformat Code: D3050
Recommendation: **Replace in 2025**

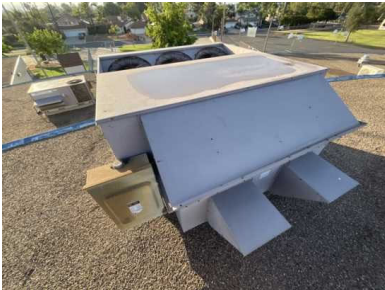
**Packaged Unit in Poor condition.**

RTU, Pad or Roof-Mounted
Building A Miller Elementary School Roof

Past useful life - AssetCALC ID: 6874623

Uniformat Code: D3050
Recommendation: **Replace in 2025**

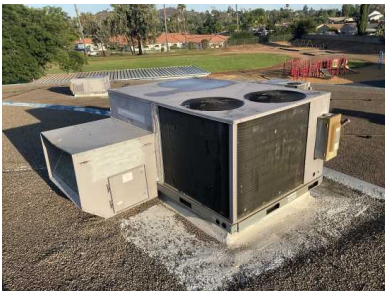
**Packaged Unit in Poor condition.**

RTU, Pad or Roof-Mounted
Building A Miller Elementary School Roof

Past useful life - AssetCALC ID: 6874602

Uniformat Code: D3050
Recommendation: **Replace in 2025**

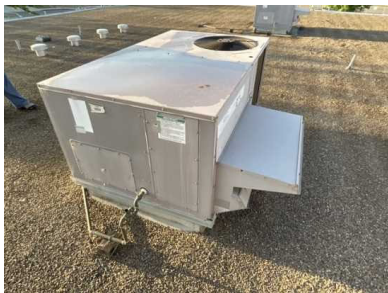
Packaged Unit in Poor condition.

RTU, Pad or Roof-Mounted
Building K1/K2 Miller Elementary School Roof

Past useful life - AssetCALC ID: 6874647

Uniformat Code: D3050
Recommendation: **Replace in 2025**
