FACILITY CONDITION ASSESSMENT

DLR Group

North Broadway Elementary
2301 North Broadway
Escondido, California 92025

September 5, 2023

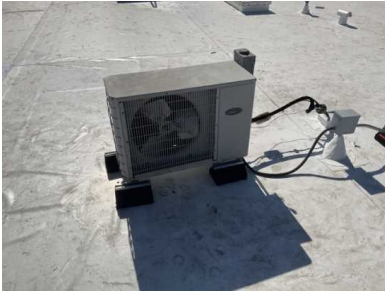
Split System Ductless in Poor condition.

Single Zone
Main Building North Broadway Elementary
Roof

HVAC equipment is aged and inconsistent between classrooms - AssetCALC ID: 6929397

Uniformat Code: D3030
Recommendation: **Replace in 2023**

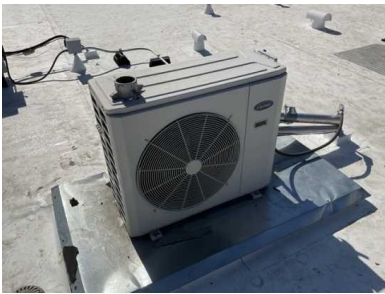
Split System Ductless in Poor condition.

Single Zone
Main Building North Broadway Elementary
Roof

HVAC equipment is aged and inconsistent between classrooms - AssetCALC ID: 6929407

Uniformat Code: D3030
Recommendation: **Replace in 2023**

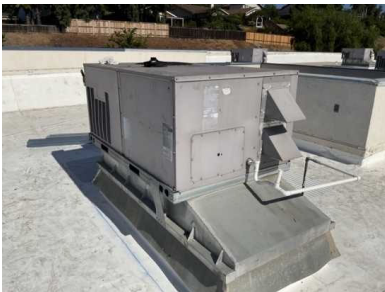
Packaged Unit in Poor condition.

RTU, Pad or Roof-Mounted
Main Building North Broadway Elementary
Roof

Uniformat Code: D3050
Recommendation: **Replace in 2024**
