FACILITY CONDITION ASSESSMENT

Quantum Academy 420 North Falconer Road Escondido, California 92027

Bureau Veritas 6021 University Boulevard, Suite 200 Ellicott City, Maryland 21043 www.us.bureauveritas.com

August 1, 2023

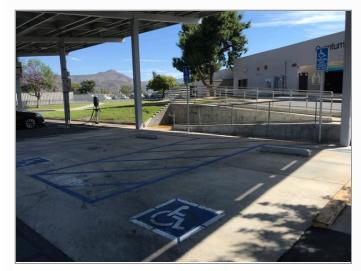
Overview of accessible parking area

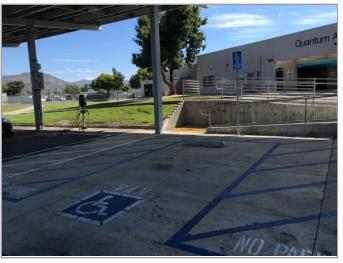
Close-up of stall or 2nd area of accessible parking

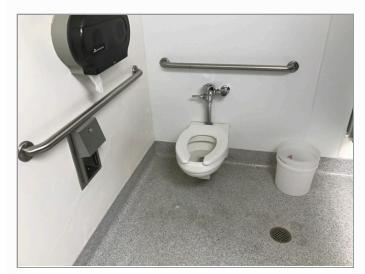
Toilet stall overview

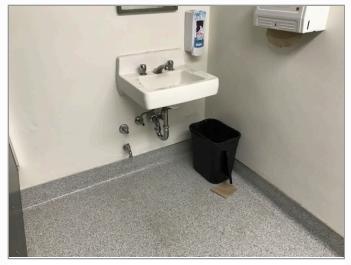
Sink, faucet handles and/or accessories

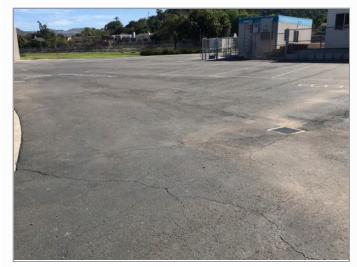
Overview of playground

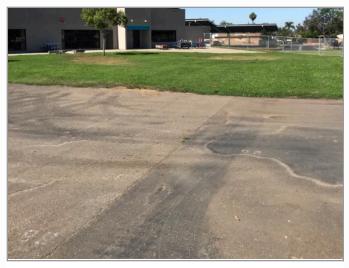
Accessible route to playground
