FACILITY CONDITION ASSESSMENT

DLR Group

Reidy Creek
2869 North Broadway
Escondido, California 92025

August 31, 2023

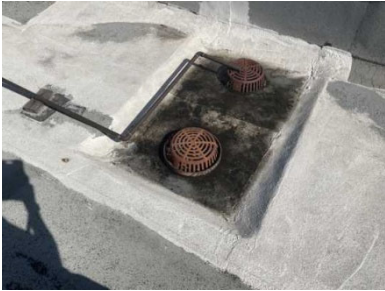
**Roofing in Poor condition.**

any type, Repairs per Man-Day
Building 3 Reidy Creek Roof

Condensate line leaking and not draining in the proper place - AssetCALC ID: 6900139

Uniformat Code: B3010
Recommendation: **Repair in 2023**

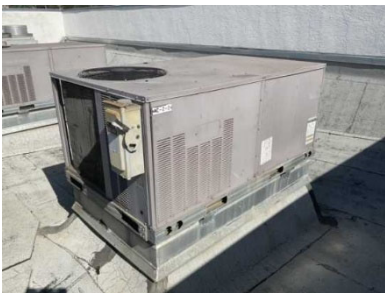
**Packaged Unit in Poor condition.**

RTU, Pad or Roof-Mounted
Building 6 Reidy Creek Roof

The heating and cooling was reported to be inconsistent throughout the building - AssetCALC ID: 6900295

Uniformat Code: D3050
Recommendation: **Replace in 2024**

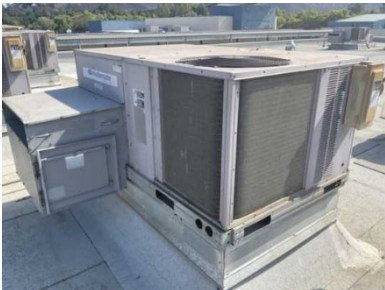
**Packaged Unit in Poor condition.**

RTU, Pad or Roof-Mounted
Building 4 Reidy Creek Roof

The heating and cooling was reported to be inconsistent throughout the building - AssetCALC ID: 6900193

Uniformat Code: D3050
Recommendation: **Replace in 2024**

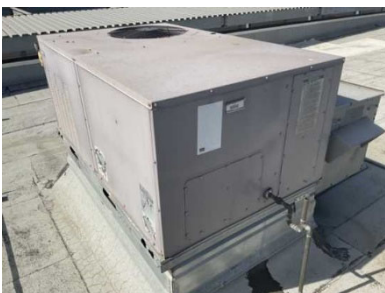
**Packaged Unit in Poor condition.**

RTU, Pad or Roof-Mounted
Building 3 Reidy Creek Roof

The heating and cooling was reported to be inconsistent throughout the building - AssetCALC ID: 6900138

Uniformat Code: D3050
Recommendation: **Replace in 2024**

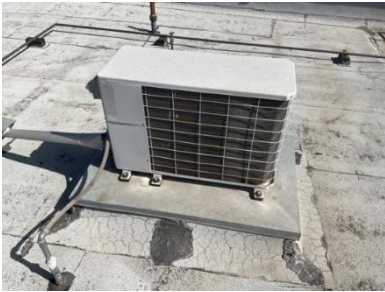
Split System Ductless in Poor condition.

Single Zone
Building 4 Reidy Creek Roof

Uniformat Code: D3030
Recommendation: **Replace in 2025**

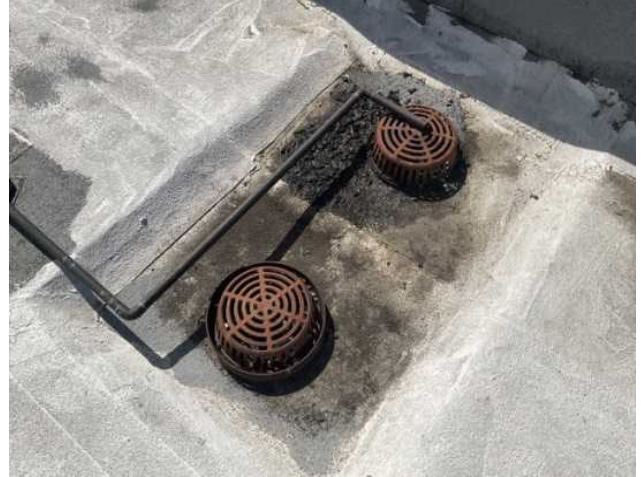
8 - CONDENSATE LINE DRAINAGE ISSUE
