FACILITY CONDITION ASSESSMENT

Rincon Middle School
925 Lehner Avenue
Escondido, California 92025

164076.23R000-021.017

August 22, 2023

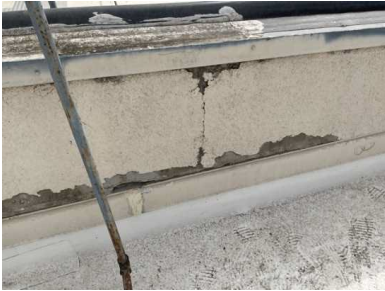
Painted glued-laminated (glulam) wood beams on cylindrical concrete columns are found throughout the site. The beams have begun to shrink, peel, delaminate, and rot, with some apparent termite damage also visible. An architectural/structural engineering study is recommended to determine an approach to these deteriorating beams.

Structural Flooring/Decking in Poor condition.

Wood
Rincon Middle School Throughout Building

Allowance for repair of decorative glulam beams. - AssetCALC ID: 6893164

Bureau Veritas recommends an architectural/structural engineering study to determine a solution to the deteriorating wood beams throughout the campus. The beams are a prominent and widespread design feature of the school. A design study should determine the most desirable approach to addressing the current deterioration and preventing further deterioration, whether it be repair, replacement, or removal of the beams.

Uniformat Code: B1010
Recommendation: **Repair in 2023**

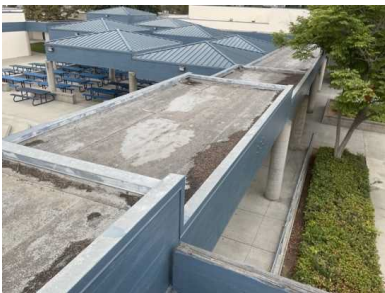
The areas of flat, modified bituminous roofing on buildings A, H, J, K, L, N, and M and covered walkways are generally cracked, leaking, and have been patched numerous times. These areas of roofing must be replaced.

Roofing in Poor condition.

Modified Bitumen
Site Rincon Middle School Covered Walkway

Roof is cracked and deteriorating - AssetCALC ID: 6893033

Uniformat Code: B3010
Recommendation: **Replace in 2023**

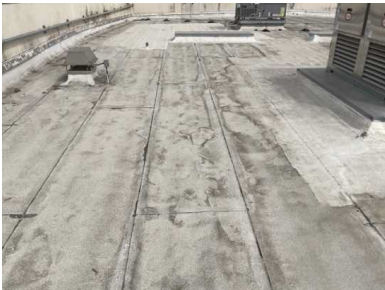
Roofing in Poor condition.

Modified Bitumen
A - Library/Food Service Rincon Middle School Roof

Roof is showing signs of ponding cracking and ongoing repairs - AssetCALC ID: 6893119

Uniformat Code: B3010
Recommendation: **Replace in 2023**

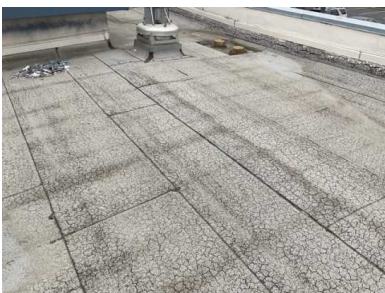
Roofing in Poor condition.

Modified Bitumen
M - Multipurpose Rincon Middle School Roof

Heavy surface cracking and deterioration - AssetCALC ID: 6893262

Uniformat Code: B3010
Recommendation: **Replace in 2023**

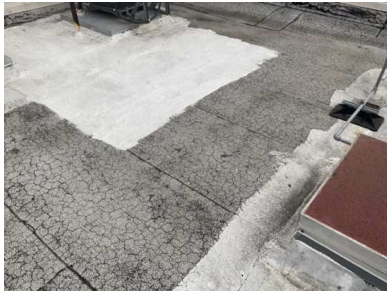
Roofing in Poor condition.

Modified Bitumen
H-J-K-L-N Classrooms Rincon Middle School
Roof

Heavy surface cracking and deterioration - AssetCALC ID: 6893242

Uniformat Code: B3010
Recommendation: **Replace in 2023**

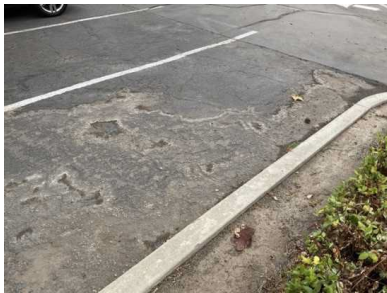
The site has a front asphalt parking lot, an asphalt access road to the trash area, and asphalt athletic courts. The asphalt areas are in fair condition other than a small area of ponding and deterioration in the middle parking stall area by the street. Steel tube fencing occurs at the entrance to the campus; the perimeter of the campus is enclosed in chain link fencing. Site lighting has been upgraded to LED. A basketball court covered with a metal roof is located beside Building P. The court is recessed below grade and surrounded by concrete retaining walls that form benches. Irrigated fields line the built-up area of the campus on two sides.

Parking Lots in Poor condition.

Pavement, Asphalt
Site Rincon Middle School Site

Uniformat Code: G2020
Recommendation: **Cut and Patch in 2023**

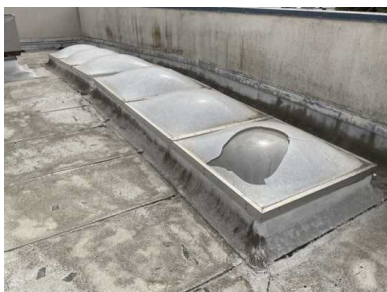
Roof Skylight in Poor condition.

Per Unit, Up To 20 Square Feet
A - Library/Food Service Rincon Middle School
Roof

Skylight is broken - AssetCALC ID: 6893116

Uniformat Code: B3060
Recommendation: **Replace in 2023**
