# FACILITY CONDITION ASSESSMENT

## **DLR Group**

Rock Springs Elementary School  
1155 Deodar Road  
Escondido, California 92025

September 12, 2023

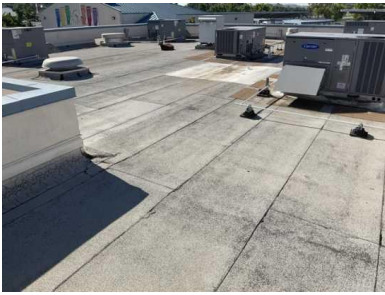
### Roofing in Poor condition.

Modified Bitumen  
Classroom Buildings Rock Springs Elementary  
School Roof

Roof leaks throughout, custodian reported the roof is set to be replaced in the near future - AssetCALC ID: 6951023

Uniformat Code: B3010  
Recommendation: **Replace in 2024**

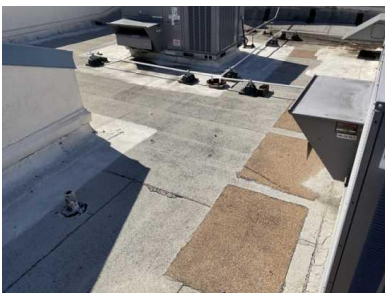
### Roofing in Poor condition.

Modified Bitumen  
Library Building Rock Springs Elementary  
School Roof

Roof leaks throughout, custodian reported the roof is set to be replaced in the near future - AssetCALC ID: 6950989

Uniformat Code: B3010  
Recommendation: **Replace in 2024**

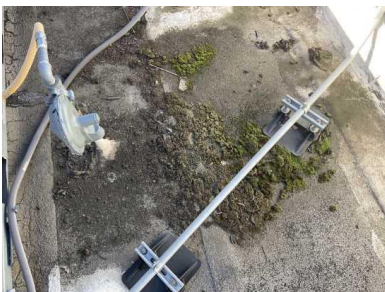
### Roofing in Poor condition.

Modified Bitumen  
Multi-Purpose Building Rock Springs  
Elementary School Roof

Roof leaks throughout, custodian reported the roof is set to be replaced in the near future - AssetCALC ID: 6950879

Uniformat Code: B3010  
Recommendation: **Replace in 2024**

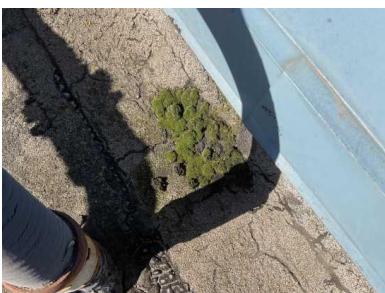
### Roofing in Poor condition.

Modified Bitumen  
Kindergarten Building Rock Springs  
Elementary School Roof

Roof leaks throughout, custodian reported the roof is set to be replaced in the near future - AssetCALC ID: 6950952

Uniformat Code: B3010  
Recommendation: **Replace in 2024**

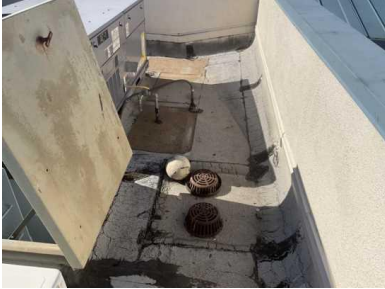
**Roofing in Poor condition.**

Modified Bitumen  
Office Building Rock Springs Elementary  
School Roof

Roof leaks throughout, custodian reported the roof is set to be replaced in the near future - AssetCALC ID: 6950813

Uniformat Code: B3010  
Recommendation: **Replace in 2024**

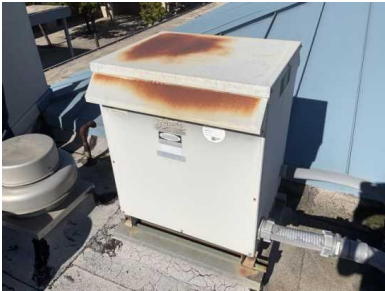
**Secondary Transformer in Poor condition.**

Dry, Stepdown  
Kindergarten Building Rock Springs  
Elementary School Roof

Unit is rusting, deteriorating, and has reached end of life - AssetCALC ID: 6950939

Uniformat Code: D5020  
Recommendation: **Replace in 2024**

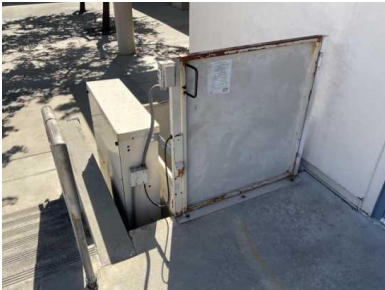
**Vertical Lift in Poor condition.**

Wheelchair, 5' Rise  
Multi-Purpose Building Rock Springs  
Elementary School Building exterior

Rusting and exposed to the elements - AssetCALC ID: 6950857

Uniformat Code: D1010  
Recommendation: **Renovate in 2025**
