FACILITY CONDITION ASSESSMENT

Rose Elementary School
906 North Rose Street
Escondido, California 92025

164076.23R000-023.017

August 31, 2023

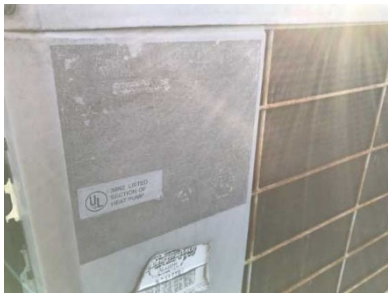
Condensing Unit/Heat Pump
Building-A Rose Elementary School Roof

Split System in Poor condition.

The units have passed their lifecycle, replacement is recommended. - AssetCALC ID: 6899713

Uniformat Code: D3030
Recommendation: **Replace in 2024**

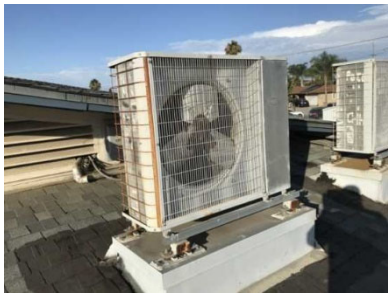
Condensing Unit/Heat Pump
Building-B Rose Elementary School Roof

Split System in Poor condition.

The units have passed their lifecycle, replacement is recommended. - AssetCALC ID: 6899726

Uniformat Code: D3030
Recommendation: **Replace in 2024**

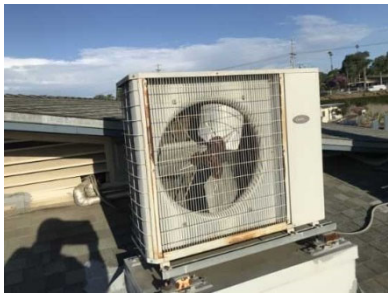
Condensing Unit/Heat Pump
Building-C Rose Elementary School Roof

Split System in Poor condition.

The units have passed their lifecycle, replacement is recommended. - AssetCALC ID: 6899764

Uniformat Code: D3030
Recommendation: **Replace in 2024**

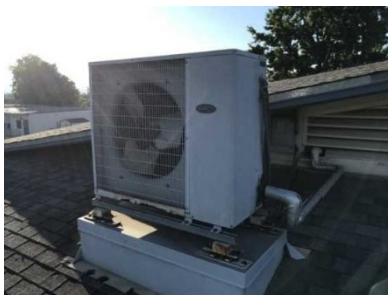
Condensing Unit/Heat Pump
Building-D Rose Elementary School Roof

Split System in Poor condition.

The units have passed their lifecycle, replacement is recommended. - AssetCALC ID: 6899769

Uniformat Code: D3030
Recommendation: **Replace in 2024**

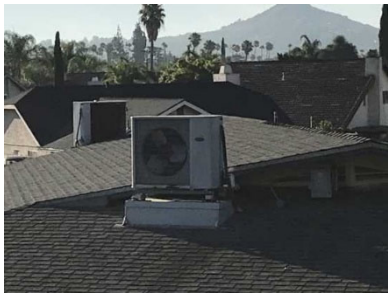
Condensing Unit/Heat Pump
Building-E Rose Elementary School Roof

Split System in Poor condition.

The units have passed their lifecycle, replacement is recommended. - AssetCALC ID: 6899794

Uniformat Code: D3030
Recommendation: **Replace in 2024**

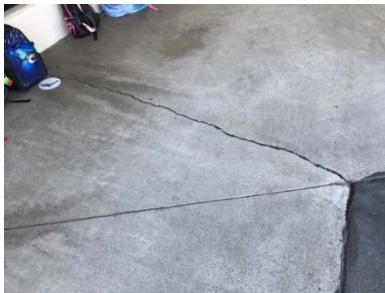
any pavement type, Sectional Repairs (per Man-Day)
Site Rose Elementary School Sidewalk

Sidewalk in Poor condition.

Isolated areas of cracks and broken sidewalks, repair is recommended. - AssetCALC ID: 6899909

Uniformat Code: G2030
Recommendation: **Repair in 2023**

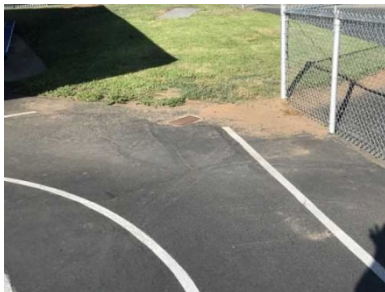
Civil, Site Drainage
Site Rose Elementary School Site-adjacent to building E

Recommended Follow-up Study: Civil, Site Drainage

This area has a drainage issue and gets flooded during heavy rain. A professional consultant must be retained to analyze the existing condition, provide recommendations and, if necessary, estimate the scope and cost of any required repairs. - AssetCALC ID: 6899887

Uniformat Code: P2030
Recommendation: **Evaluate/Report in 2023**

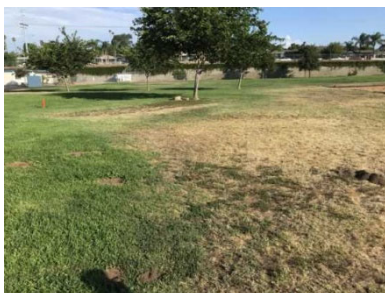
Sod at Eroded Areas
Site Rose Elementary School Landscaping

Landscaping in Poor condition.

Isolated areas of eroded landscaping surfaces, repair is required. - AssetCALC ID: 6899927

Uniformat Code: G2080
Recommendation: **Repair in 2023**
