# FACILITY CONDITION ASSESSMENT

## **Fallbrook Union Elementary School District**

Maie Ellis  
400 West Elder Street  
Fallbrook, California 92028

*February 7, 2023*

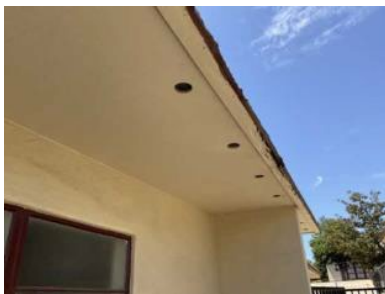
### Exterior Walls in Poor condition.

any painted surface  
Building 135-136 001 - Maie Ellis Building  
Exterior

The wood fascia is deteriorating. Paint around the building is peeling. - AssetCALC ID: 4149537

Uniformat Code: B2010  
Recommendation: **Prep & Paint in 2023**

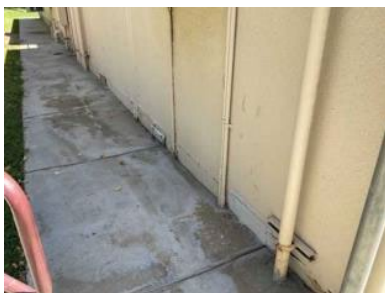
### Exterior Walls in Poor condition.

any painted surface  
Building 203-207 001 - Maie Ellis Building  
Exterior

Paint is peeling and walls are rusting in rear of building. - AssetCALC ID: 4149776

Uniformat Code: B2010  
Recommendation: **Prep & Paint in 2024**

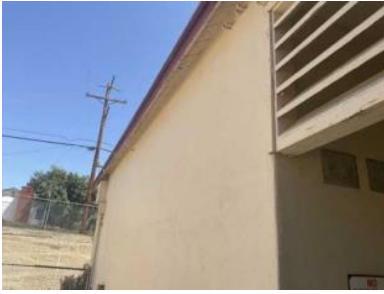
**Exterior Walls in Poor condition.**

any painted surface  
Building 109-128 001 - Maie Ellis Building  
Exterior

Some paint peeling around building. - AssetCALC ID: 4149563

Uniformat Code: B2010  
Recommendation: **Prep & Paint in 2024**

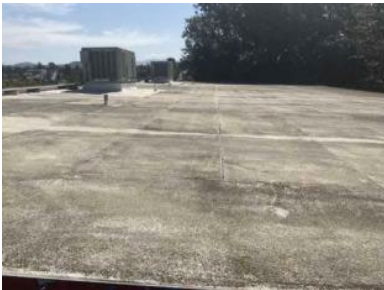
**Roofing in Poor condition.**

Modified Bitumen  
Building 135-136 001 - Maie Ellis Roof

Roof sealant is deteriorating. - AssetCALC ID: 4149685

Uniformat Code: B3010  
Recommendation: **Replace in 2024**

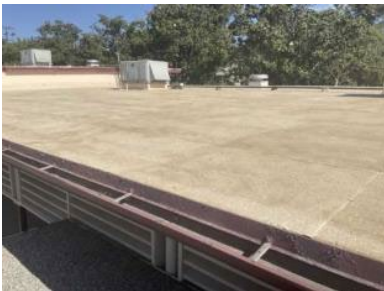
**Roofing in Poor condition.**

Modified Bitumen  
Building 109-128 001 - Maie Ellis Roof

Patchwork is bubbling and cracking throughout roof. - AssetCALC ID: 4149545

Uniformat Code: B3010  
Recommendation: **Replace in 2024**

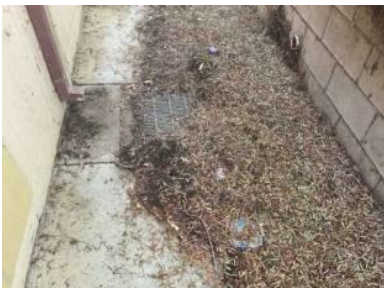
**Storm Drainage Components in Poor condition.**

Catch Basin, 6' Deep  
Site 001 - Maie Ellis Site

Drain is covered with debris behind room 102. - AssetCALC ID: 4149688

Uniformat Code: G3030  
Recommendation: **Replace/Install in 2023**

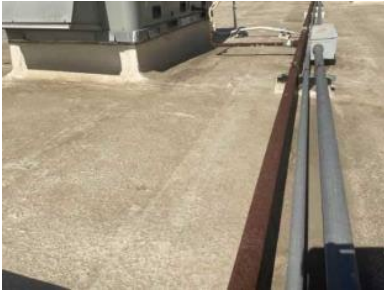
### Piping & Valves in Poor condition.

Flexible (Yellow), Natural Gas  
Building 109-128 001 - Maie Ellis Roof

Gas line to RTU has extensive rust. - AssetCALC ID: 4149501

Uniformat Code: D3010  
Recommendation: **Replace in 2024**

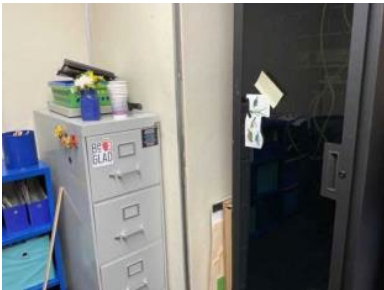
### Wall Finishes in Poor condition.

Vinyl  
Building 109-128 001 - Maie Ellis Room 112

Vinyl wall panel is detaching. - AssetCALC ID: 4149682

Uniformat Code: C2010  
Recommendation: **Replace in 2024**

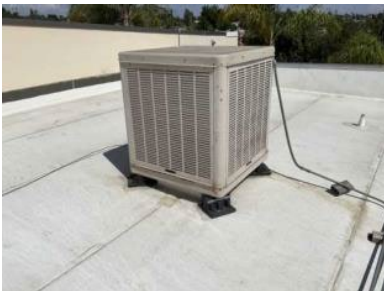
### Evaporative Cooler in Poor condition.

up to 0.33 HP  
Cafeteria 001 - Maie Ellis Roof

Evaporative pad is deteriorating and missing in some locations. - AssetCALC ID: 4149617

Uniformat Code: D3030  
Recommendation: **Replace in 2023**

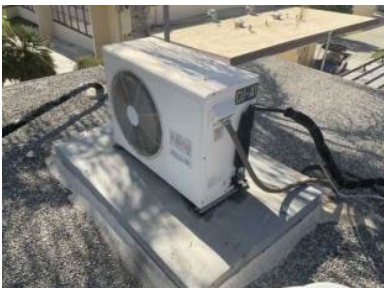
### Split System in Poor condition.

Condensing Unit/Heat Pump  
Building 109-128 001 - Maie Ellis Roof

Insulation on the lines to condenser is deteriorating. - AssetCALC ID: 4149618

Uniformat Code: D3030  
Recommendation: **Replace in 2024**

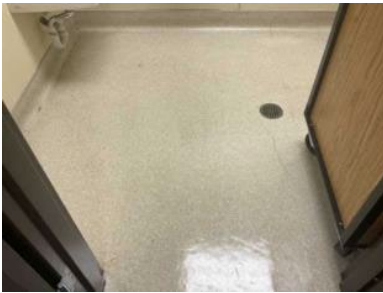
### Flooring in Poor condition.

Vinyl Sheetting  
Modulars 100-108 001 - Maie Ellis Throughout building

Some cracking around drain. - AssetCALC ID: 4149672

Unifomat Code: C2030  
Recommendation: **Replace in 2024**

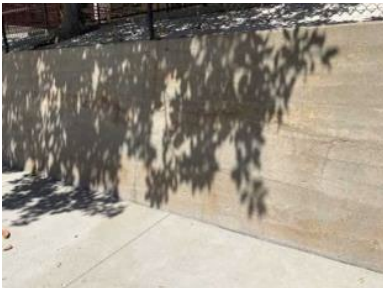
### Retaining Wall in Poor condition.

Concrete Cast-in-Place  
Site 001 - Maie Ellis Site

Large cracking in lower retaining wall. - AssetCALC ID: 4149510

Unifomat Code: G2060  
Recommendation: **Replace in 2024**
