# FACILITY CONDITION ASSESSMENT

**Fallbrook Union Elementary School District**  
321 North Iowa Street  
Fallbrook, California 92028

Fallbrook STEM Academy  
405 West Fallbrook Street  
Fallbrook, California 92028

*February 4, 2023*

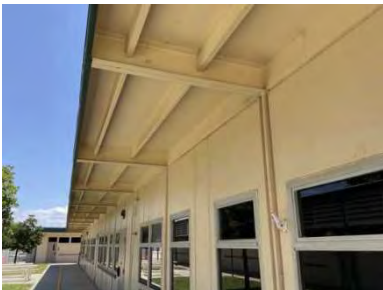
**Exterior Walls in Poor condition.**

90% of campus needs to be painted ASAP - AssetCALC ID: 4161073

Recommendation: **Prep and Paint in 2023**Priority Score: **89.7**Plan Type:  
Performance/Integrity

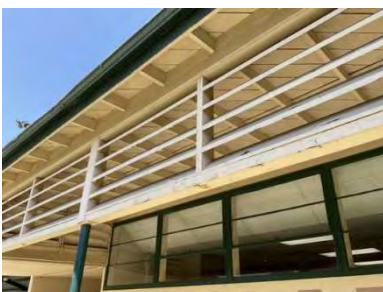
**Exterior Walls in Poor condition.**

90% of campus needs to be painted ASAP - AssetCALC ID: 4161063

Recommendation: **Prep and Paint in 2023**Priority Score: **89.7**Plan Type:  
Performance/Integrity

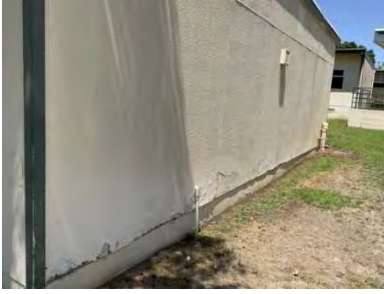
**Exterior Walls in Poor condition.**

90% of campus needs to be painted ASAP - AssetCALC ID: 4161055

Recommendation: **Prep and Paint in 2023**Priority Score: **89.7**Plan Type:  
Performance/Integrity

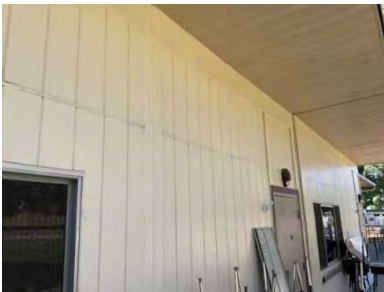
### Exterior Walls in Poor condition.

90% of campus needs to be painted ASAP - AssetCALC ID: 4161144

Uniformat Code: B2010  
Recommendation: **Prep and Paint in 2023**

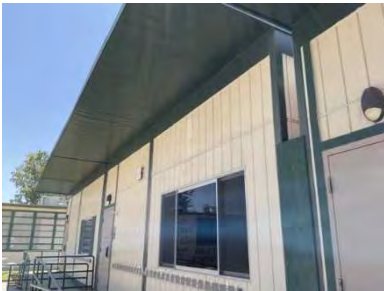
### Exterior Walls in Poor condition.

90% of campus needs to be painted ASAP - AssetCALC ID: 4160854

Uniformat Code: B2010  
Recommendation: **Prep and Paint in 2023**

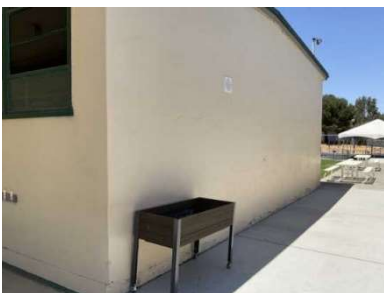
### Exterior Walls in Poor condition.

90% of campus needs to be painted ASAP - AssetCALC ID: 4160996

Uniformat Code: B2010  
Recommendation: **Prep and Paint in 2023**

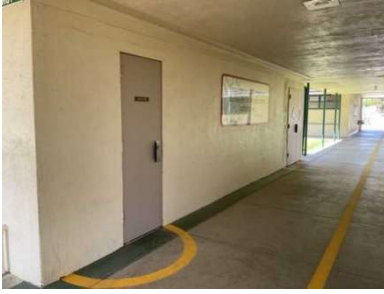
### Exterior Walls in Poor condition.

90% of campus needs to be painted ASAP - AssetCALC ID: 4161049

Uniformat Code: B2010  
Recommendation: **Prep and Paint in 2023**

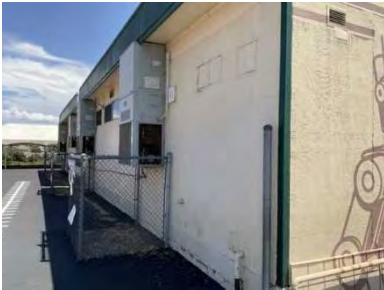
### Exterior Walls in Poor condition.

90% of campus needs to be painted ASAP - AssetCALC ID: 4161146

Uniformat Code: B2010  
Recommendation: **Prep and Paint in 2023**

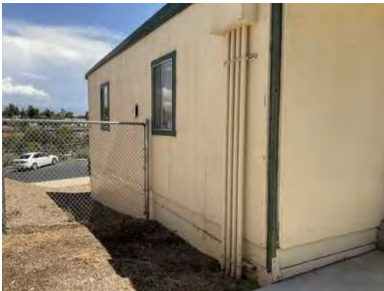
### Exterior Walls in Poor condition.

90% of campus needs to be painted ASAP - AssetCALC ID: 4160939

Uniformat Code: B2010  
Recommendation: **Prep and Paint in 2023**

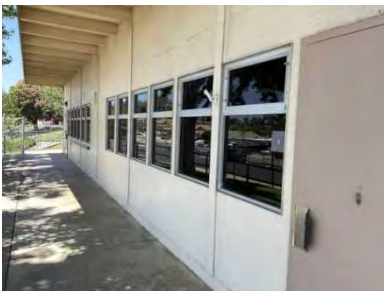
### Exterior Walls in Poor condition.

90% of campus needs to be painted ASAP - AssetCALC ID: 4161138

Uniformat Code: B2010  
Recommendation: **Prep and Paint in 2023**

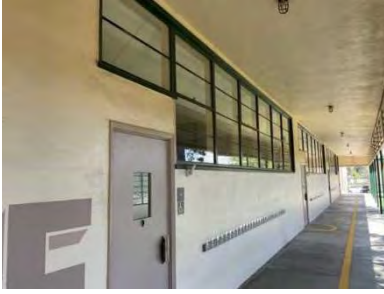
### Window in Poor condition.

Windows and siding on buildings 10-13, 26-29, 40-45, 50-56, 63-64 are all past their life and due for replacement. Some windows are inoperable all together. - AssetCALC ID: 4161064

Uniformat Code: B2020  
Recommendation: **Replace in 2023**

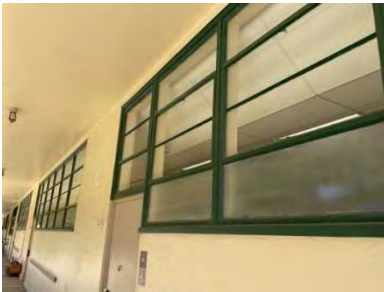
### Window in Poor condition.

Windows and siding on buildings 10-13, 26-29, 40-45, 50-56, 63-64 are all past their life and due for replacement. Some windows are inoperable all together. - AssetCALC ID: 4160988

Uniformat Code: B2020  
Recommendation: **Replace in 2023**

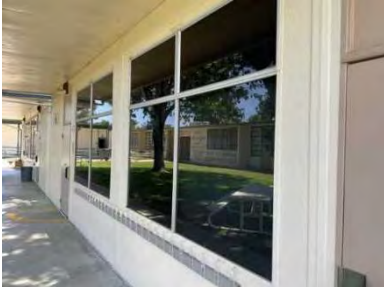
### Window in Poor condition.

Windows and siding on buildings 10-13, 26-29, 40-45, 50-56, 63-64 are all past their life and due for replacement. Some windows are inoperable all together. - AssetCALC ID: 4160958

Uniformat Code: B2020  
Recommendation: **Replace in 2023**

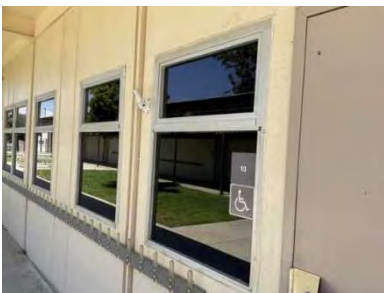
### Window in Poor condition.

Windows and siding on buildings 10-13, 26-29, 40-45, 50-56, 63-64 are all past their life and due for replacement. Some windows are inoperable all together. - AssetCALC ID: 4160831

Uniformat Code: B2020  
Recommendation: **Replace in 2023**

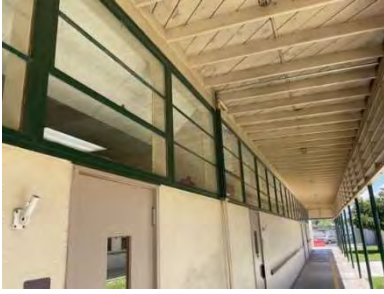
### Window in Poor condition.

Windows and siding on buildings 10-13, 26-29, 40-45, 50-56, 63-64 are all past their life and due for replacement. Some windows are inoperable all together. - AssetCALC ID: 4161142

Uniformat Code: B2020  
Recommendation: **Replace in 2023**

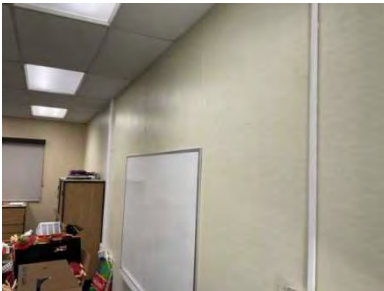
### Wall Finishes in Poor condition.

Paint over vinyl walls. Punctures found throughout walls. - AssetCALC ID: 4160895

Uniformat Code: C2010  
Recommendation: **Replace in 2024**
