# FACILITY CONDITION ASSESSMENT

**Fallbrook Union Elementary School District**  
321 North Iowa Street  
Fallbrook, California 92028

La Paloma  
300 Heald Lane  
Fallbrook, California 92028

*February 8, 2023*

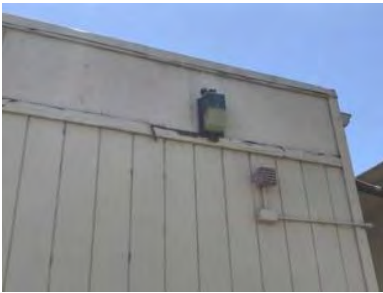
### Exterior Walls in Poor condition.

Wood Siding  
Building B 003 - La Paloma Building Exterior

Deteriorated wall areas, repair is required. - AssetCALC ID: 4113204

Uniformat Code: B2010  
Recommendation: **Replace in 2023**

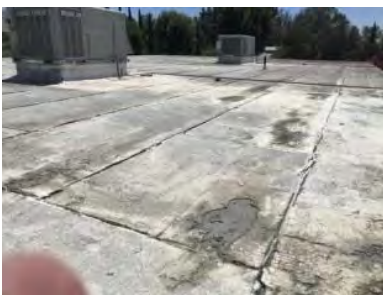
### Roofing in Poor condition.

any type, Repairs per Man-Day  
Building B 003 - La Paloma Roof

Isolated areas of deteriorated roof finishes, repair is required. - AssetCALC ID: 4113190

Uniformat Code: B3010  
Recommendation: **Repair in 2022**

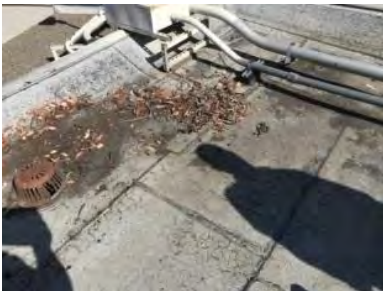
### Roofing in Poor condition.

any type, Repairs per Man-Day  
Building C 003 - La Paloma Roof

Isolated areas of deteriorated roof finishes, repair is required. - AssetCALC ID: 4112695

Uniformat Code: B3010  
Recommendation: **Repair in 2022**

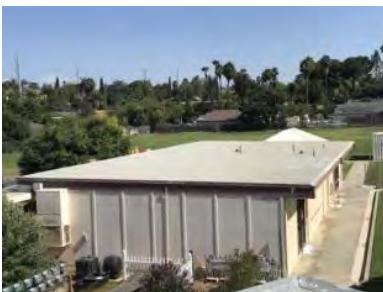
### Roofing in Poor condition.

any type, Repairs per Man-Day  
Portables F 003 - La Paloma Roof-57-58

Roof leaks were reported throughout, repair is required. - AssetCALC ID: 4113015

Uniformat Code: B3010  
Recommendation: **Repair in 2022**

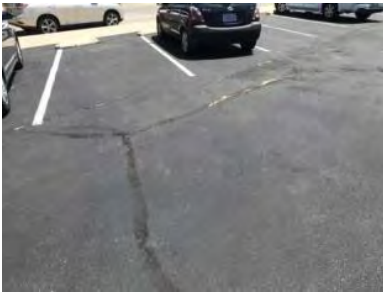
### Parking Lots in Poor condition.

Pavement, Asphalt  
Site 003 - La Paloma Parking lot

Isolated areas of alligator asphalt surface, repair is required. - AssetCALC ID: 4112867

Uniformat Code: G2020  
Recommendation: **Repair in 2022**

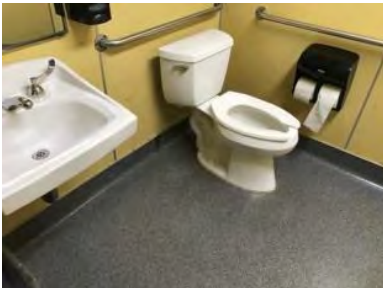
The plumbing system in portables 57-58 is in poor condition. A clogged plumbing was reported to be a problematic. A professional consultant must be retained to analyze the existing condition, provide recommendations and, if necessary, estimate the scope and cost of any required repairs. The cost of this study is included in the cost tables. Due to the ambiguity of the required repair scope at the time of this assessment, the cost for any possible subsequent repairs is not included.

### Recommended Follow-up Study: Plumbing, Sanitary Sewer System

Plumbing, Sanitary Sewer System  
Portables F 003 - La Paloma Restroom

Continual clogged plumbing was reported in this building. A professional consultant must be retained to analyze the existing condition, provide recommendations and, if necessary, estimate the scope and cost of any required repairs. - AssetCALC ID: 4113013

Uniformat Code: P2030  
Recommendation: **Evaluate/Report in 2022**

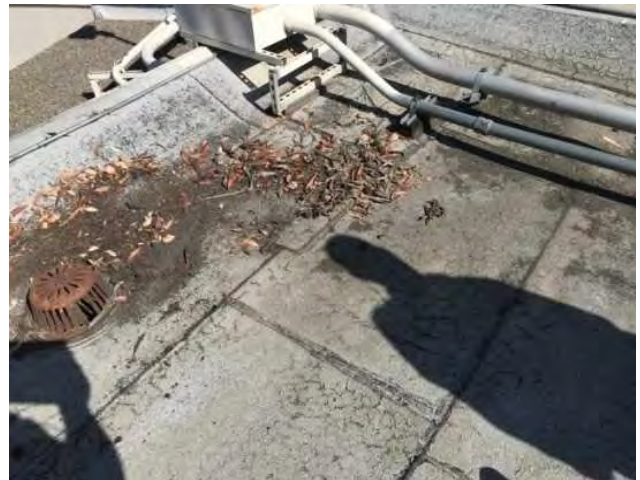
16 - LEAKING ROOF
