# FACILITY CONDITION ASSESSMENT

**Fallbrook Union Elementary School District**  
321 North Iowa Street  
Fallbrook, California 92028

Transportation  
825 Winterhaven Road  
Fallbrook, California 92028

*February 10, 2023*

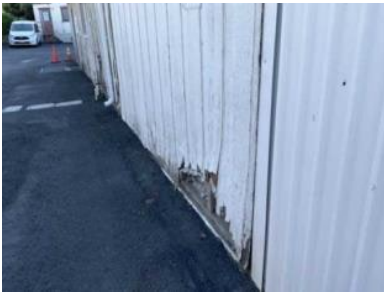
### Exterior Walls in Poor condition.

Wood Siding  
C 010 - Transportation Building Exterior

Wood siding is deteriorating and missing in some locations. - AssetCALC ID: 4177941

Uniformat Code: B2010  
Recommendation: **Replace in 2023**

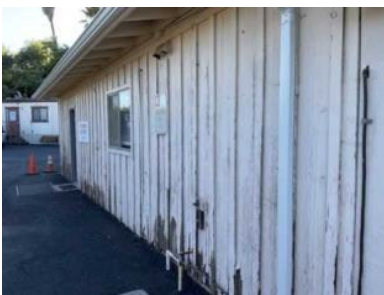
### Exterior Walls in Poor condition.

any painted surface  
C 010 - Transportation Building Exterior

Paint is peeling around building. - AssetCALC ID: 4177948

Uniformat Code: B2010  
Recommendation: **Prep & Paint in 2023**

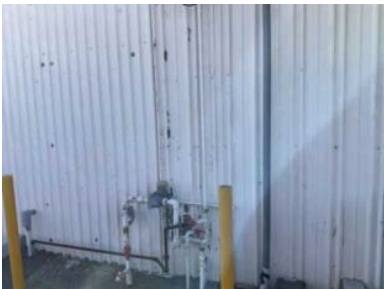
### Exterior Walls in Poor condition.

any painted surface  
B 010 - Transportation Building Exterior

Paint is peeling around building. - AssetCALC ID: 4177921

Uniformat Code: B2010  
Recommendation: **Prep & Paint in 2024**

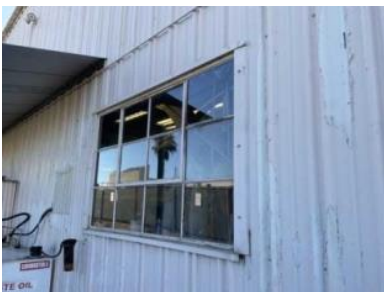
### Window in Poor condition.

Aluminum Double-Glazed, 16-25 SF  
B 010 - Transportation Building Exterior

Some rust and paint peeling around windows. - AssetCALC ID: 4177897

Uniformat Code: B2020  
Recommendation: **Replace in 2024**

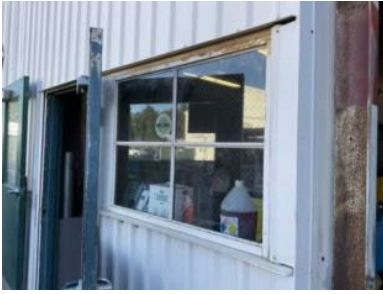
**Window in Poor condition.**

Aluminum Double-Glazed, up to 15 SF  
B 010 - Transportation Building Exterior

Some rust and paint peeling around window. - AssetCALC ID: 4177942

Uniformat Code: B2020  
Recommendation: **Replace in 2024**

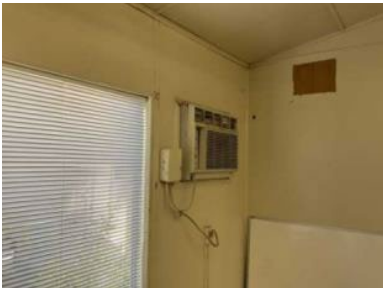
**Air Conditioner in Poor condition.**

Window/Thru-Wall  
C 010 - Transportation Throughout

Wall units are aged and insufficient for the area. - AssetCALC ID: 4177911

Uniformat Code: D3030  
Recommendation: **Replace in 2023**

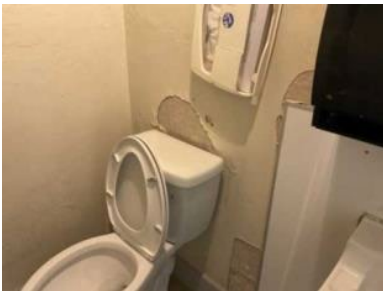
**Wall Finishes in Poor condition.**

any surface  
C 010 - Transportation Throughout building

Uniformat Code: C2010  
Recommendation: **Prep & Paint in 2023**
