Middle Head, Mosman

Former Ten Terminal Regiment Barracks Buildings & Laundry

HERITAGE IMPACT ASSESSMENT Supplementary Report

Date: 6th July 2023

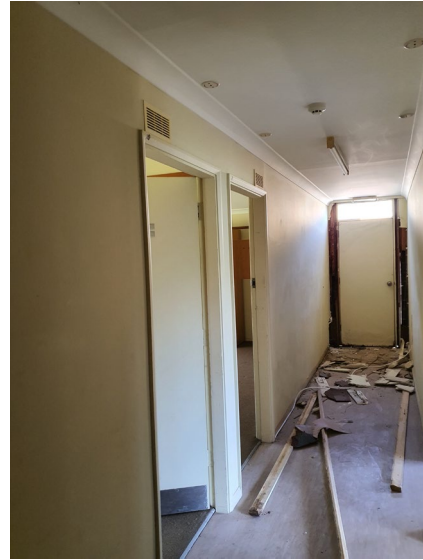
Figure 2. 10: View of bedroom door entries from central hallway. Note removed architraves to fire exit door and scattered debris.

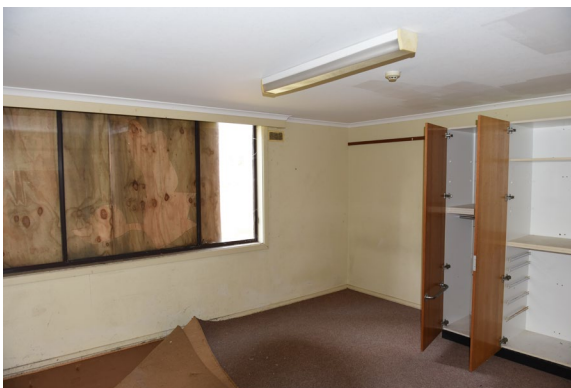
Figure 2. 11: View of typical bedroom with furniture. Note boarded over window.

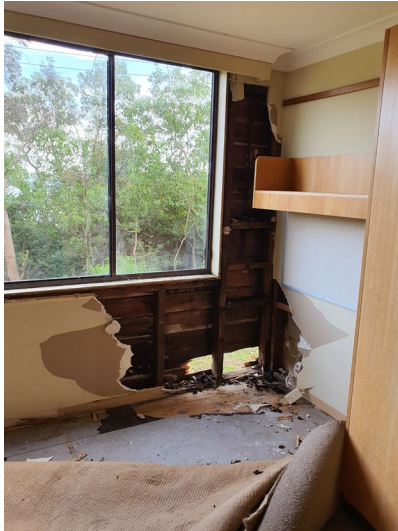
The condition of the interiors of the barracks buildings is fair to poor. Water damage is evident in each (due to assumed roof leaks), and termite damage is evident in Buildings B1 and B2. Paint is peeling to the walls of all amenities due to damp issues. Throughout each, previous Hazmat and pest inspections have resulted in large holes being made in walls, ceilings and floors which remain un-repaired.

Figure 2. 19: Internal wall lings removed revealing internal timber structure and missing external weatherboards to Building B3.

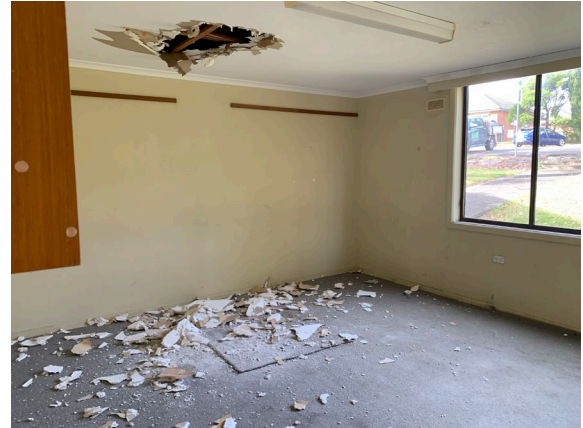
Figure 2. 20: Large hole in ceiling of bedroom in Building B1.

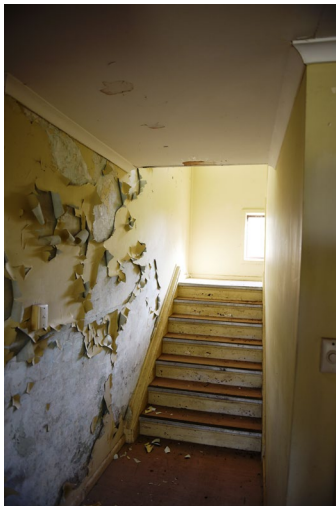
Figure 2. 21: Peeling paint to wall of amenities in stair hall in Building B2.

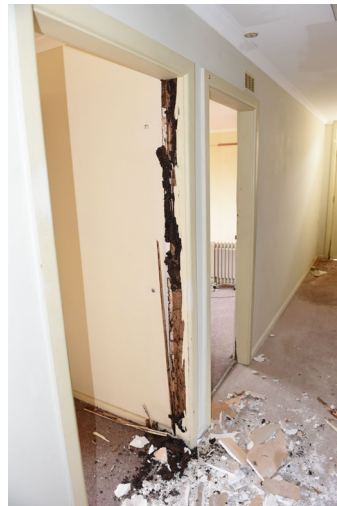
Figure 2. 22: Evidence of termite damage to architrave in Building B1.

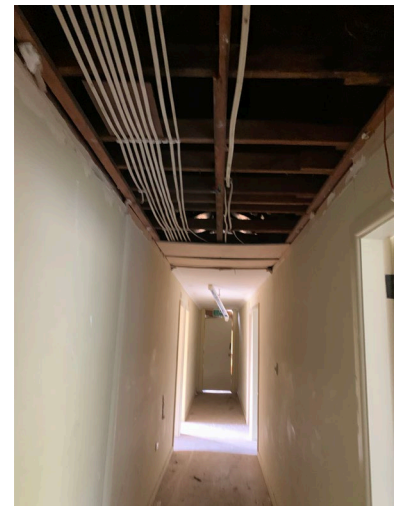
Figure 2. 23: Ceiling and cornices removed in hallway in Building B1.

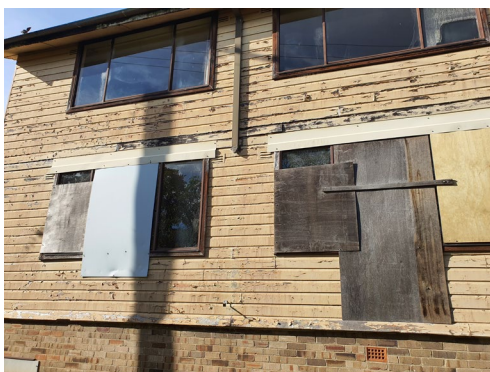
The condition of the exteriors of the three buildings is poor. The exterior paintwork is in poor condition and in some places the weatherboard planks are damaged or have been removed or patched. New openings in the face brick bases have been introduced to provide access into the underfloor areas and Building B3 has lost its external fire stairs at both its east and west elevations and some of the weatherboard is missing on its northern elevation. Across all three buildings, windows have broken glazing and have been boarded over.

Figure 2. 24: Boarded over windows in Building B3.

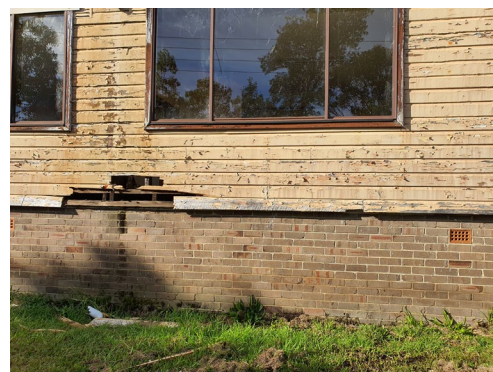
Figure 2. 25: Peeling paint and missing and damaged weatherboard cladding to Building B3.

Lead paint that was in poor condition (peeling) was identified on the external walls of all three buildings and to the concrete ceilings of ground floor bathrooms (above later false ceilings).
