Rare Environmental

22nd May 2023

STRUCTURAL CONDITION REPORT 3 EXISTING 2-STOREY TIMBER BARRACKS BUILDINGS Sydney Harbour Federation Trust Middle Head – Middle Head Road, Mosman NSW 2088

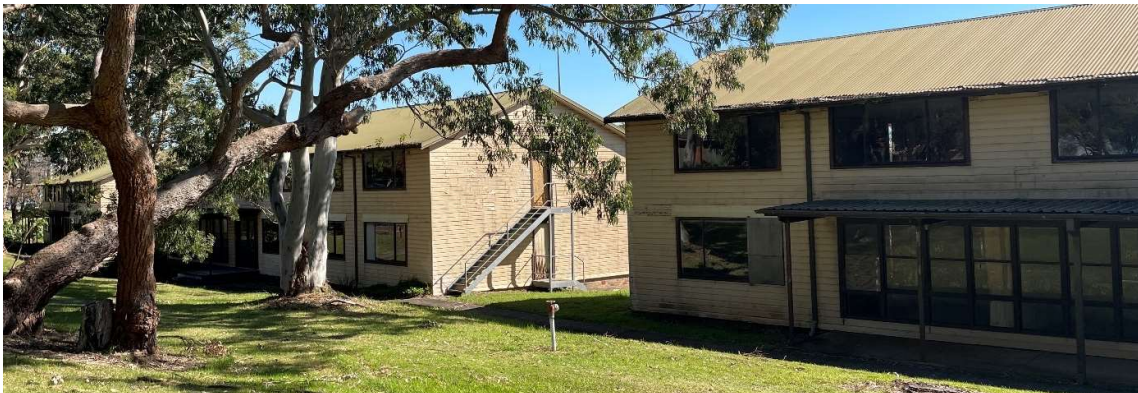
Figure 1 – 3 Existing 2-Storey Timber Barracks

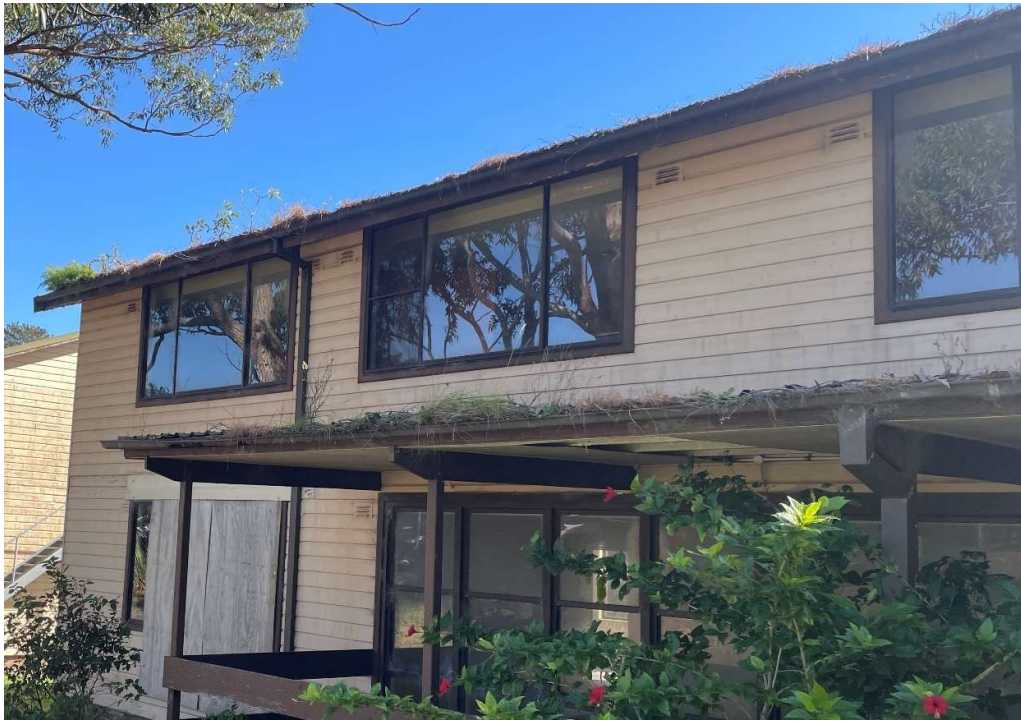
Figure 2 – Typical Front View of Barracks with Front Porch Shelter.
Growth within gutters at edge of roof typical

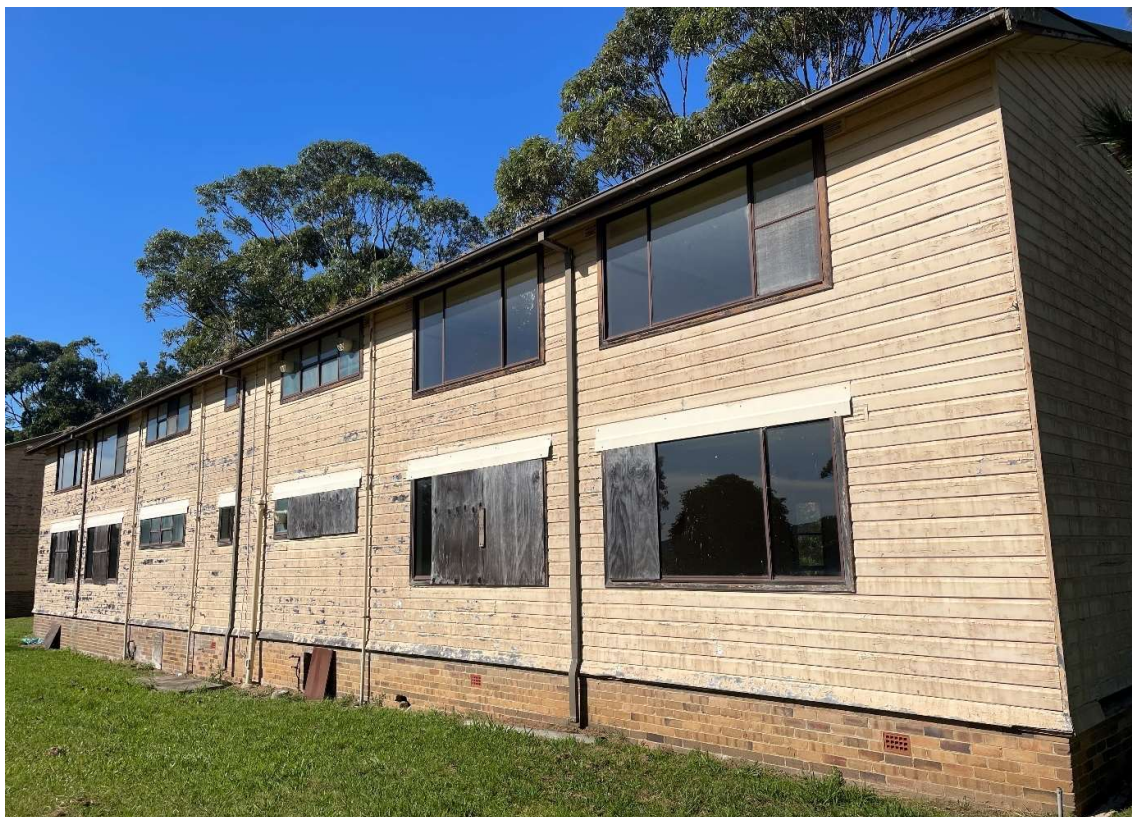
Figure 3 – Typical Rear View of Barracks.
Timber weather board-cladding conceals timber studwall on perimeter brick footings for sub-floor framing.

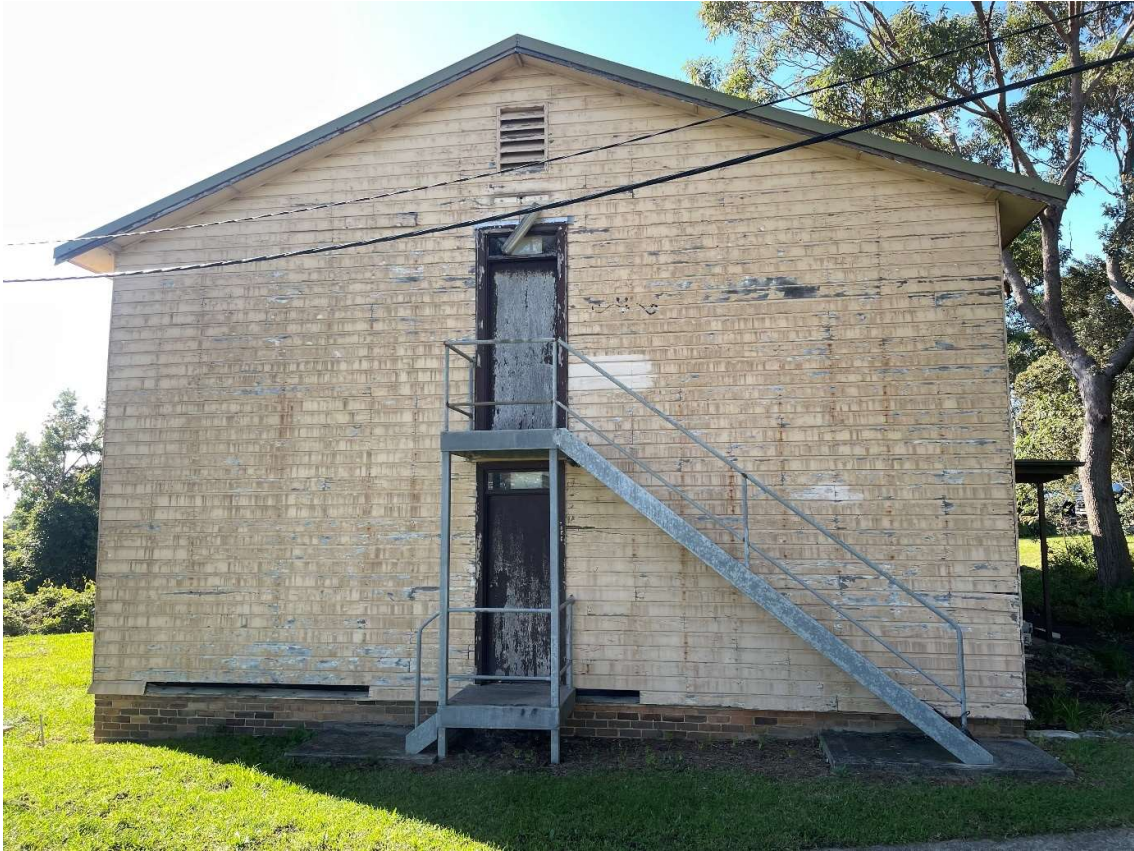
Figure 4 – Typical Side View of Barracks.
Gable Style Timber Framed Roof with metal sheeting. Weathering of timber cladding paint system evident.

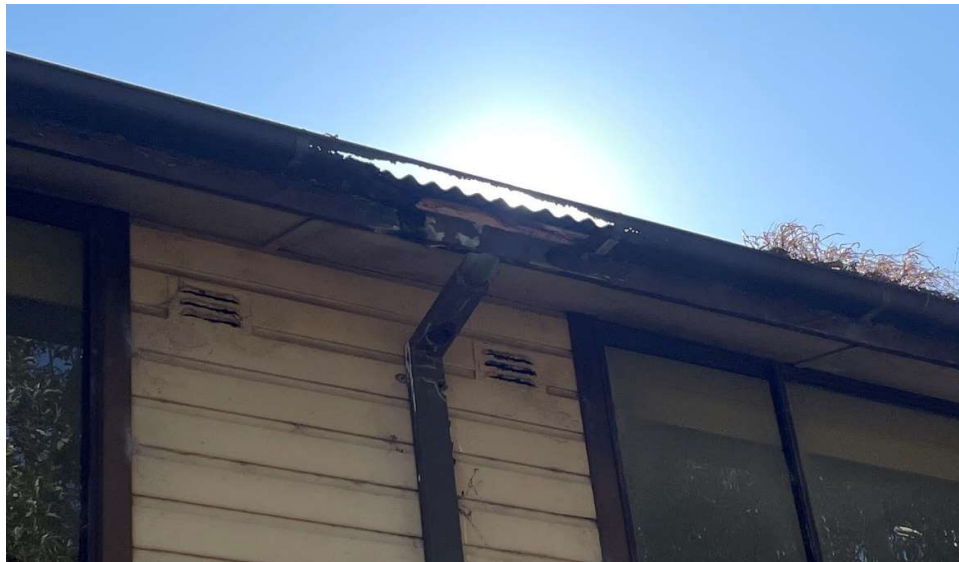
Figure 5 – Gutter Fully corroded through near downpipe due to likely pooling of water and failed drainage.

- Corrosion of timber fixing elements (nails) leading to timber splitting.
 - Long-term corrosion of the steel nails, mostly around the perimeters of the buildings where they are most vulnerable to long-term weather exposure. Consistently we noted that the expansive nature of this corrosion has led to splitting of timber studs near their fixings, leading to reduction of capacity. (*Figures 6, 7, 16*)
- Timber rot/dampness deterioration due to prolonged water exposure.
 - It was clear that the roof gutter system has failed at each of the 3 buildings inspected. The vegetation growth and fully corroded through gutters were clear indicators.

- The failed nature of the roof drainage system and weathering of the external timber weatherboard cladding have the implication that there will be long-term water exposure to certain regions of the buildings. Long-term water exposure leads to structurally compromised structure, which was observed at some locations during inspection. **It is recommended that in all regions where there is suggestion of long-term water exposure, that the structure in these areas is thoroughly investigated for any signs of structural defect and remediated effectively.**

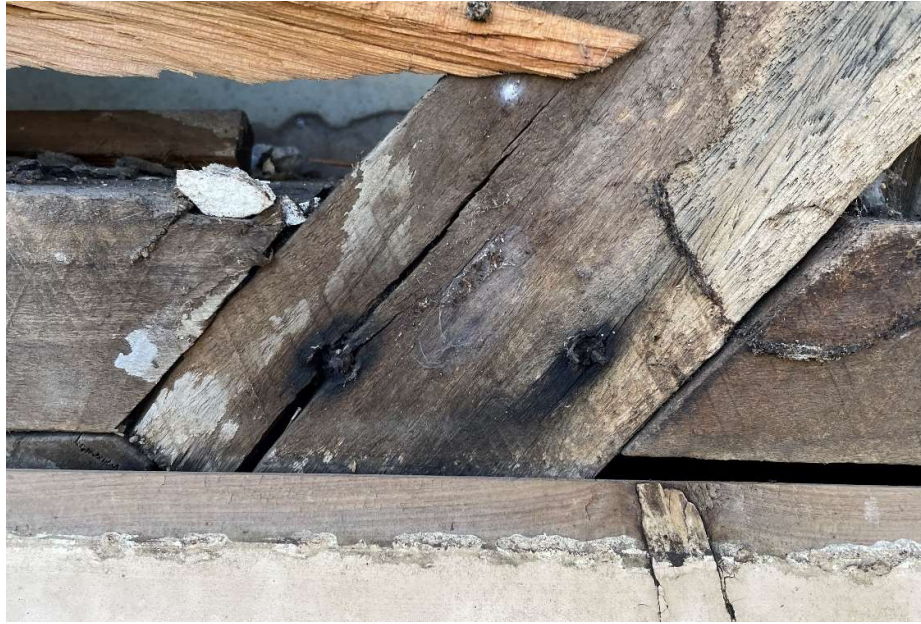
Figure 6 – Close-up of diagonal bracing member junction with perimeter Timber-Framed Wall Bottom Plate.
Long-term corrosion of nails evident leading to splitting of timber ends.

- Damp affected timber to be replaced.
 - Studwalls with corroded nails must have nails replaced with new nails.
 - Termite affected stud members must be replaced with termite resistant timber stud.

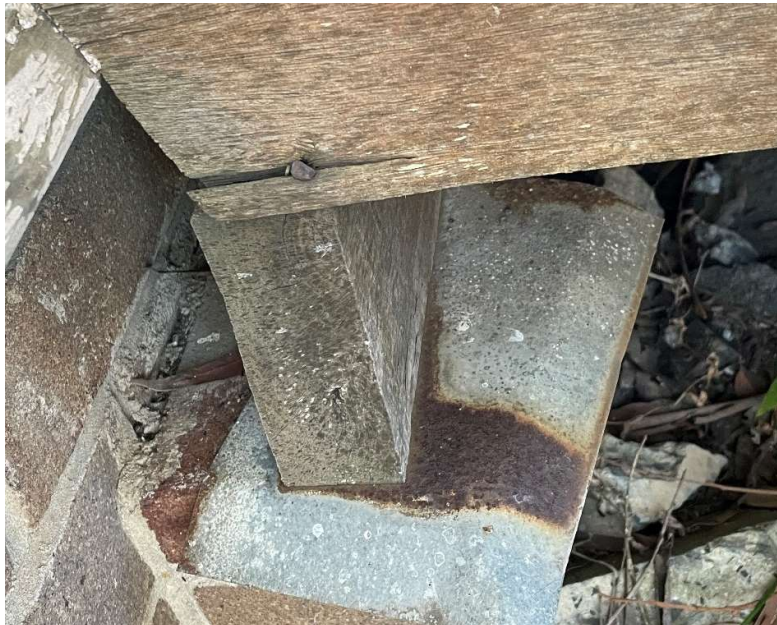
Figure 7 – Close-up of front porch timber floor framing bearing on brick footings.
Long-term corrosion of nail evident leading to splitting of timber ends.

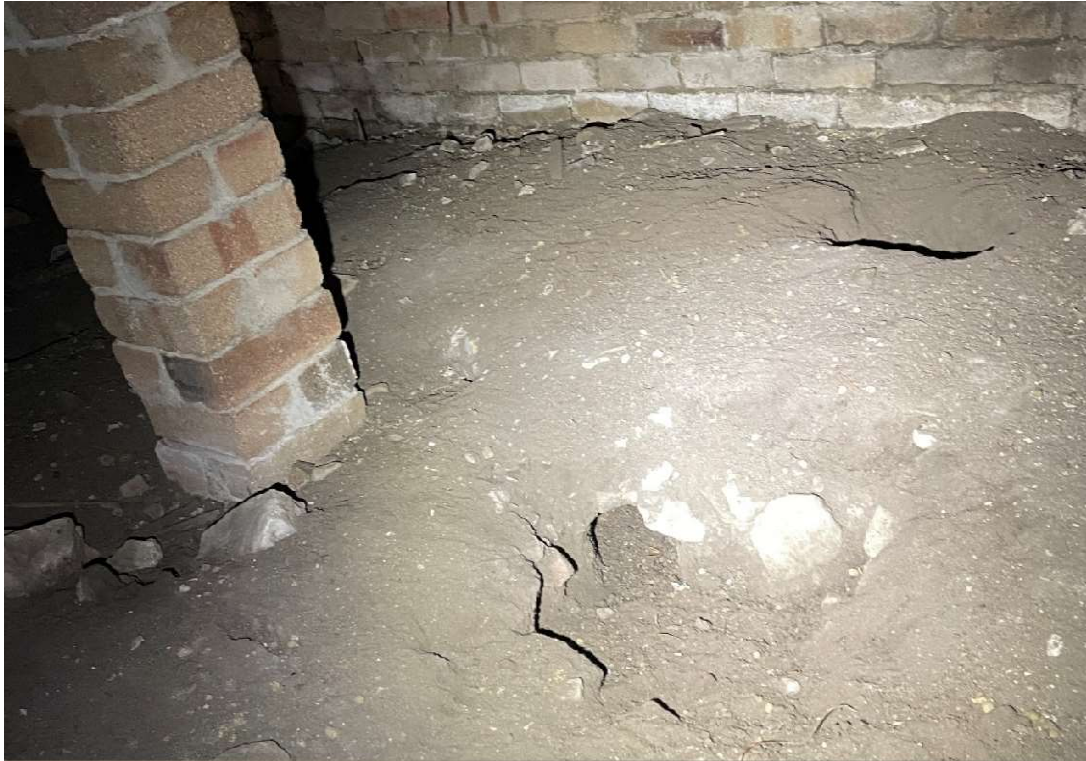
Figure 8 – Sub Floor footing conditions. Animal tunnelling evident in vicinity of brick pier. Structural impact and settlement to footing unclear without further investigation.

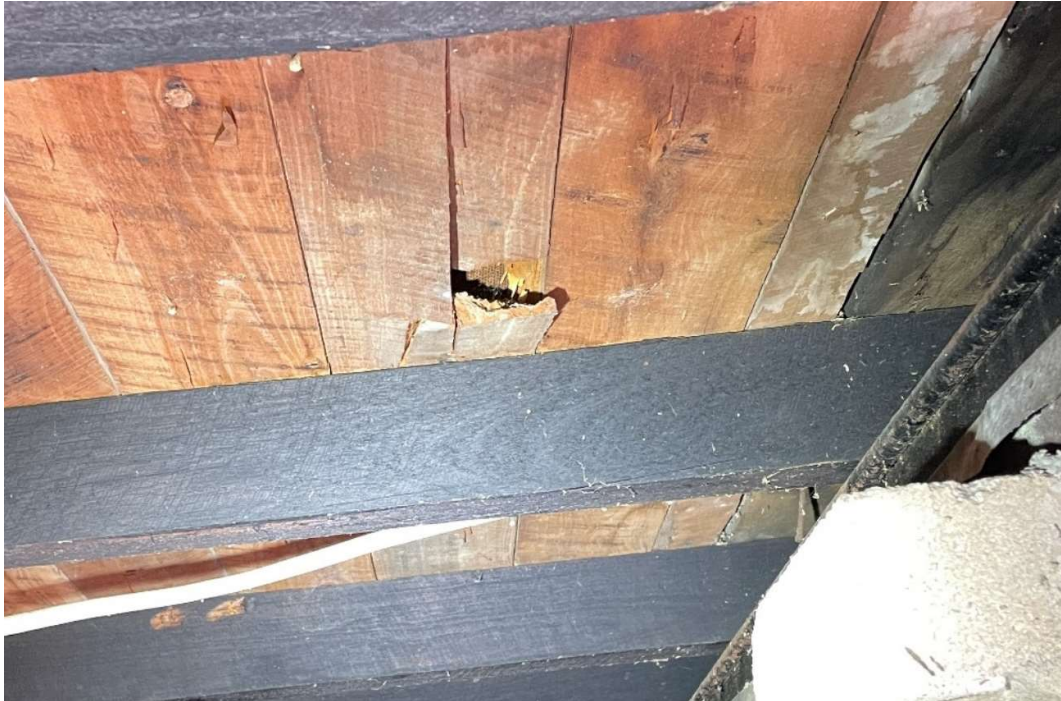
Figure 9 – Localised damage to timber floor plank due to possible overloading.

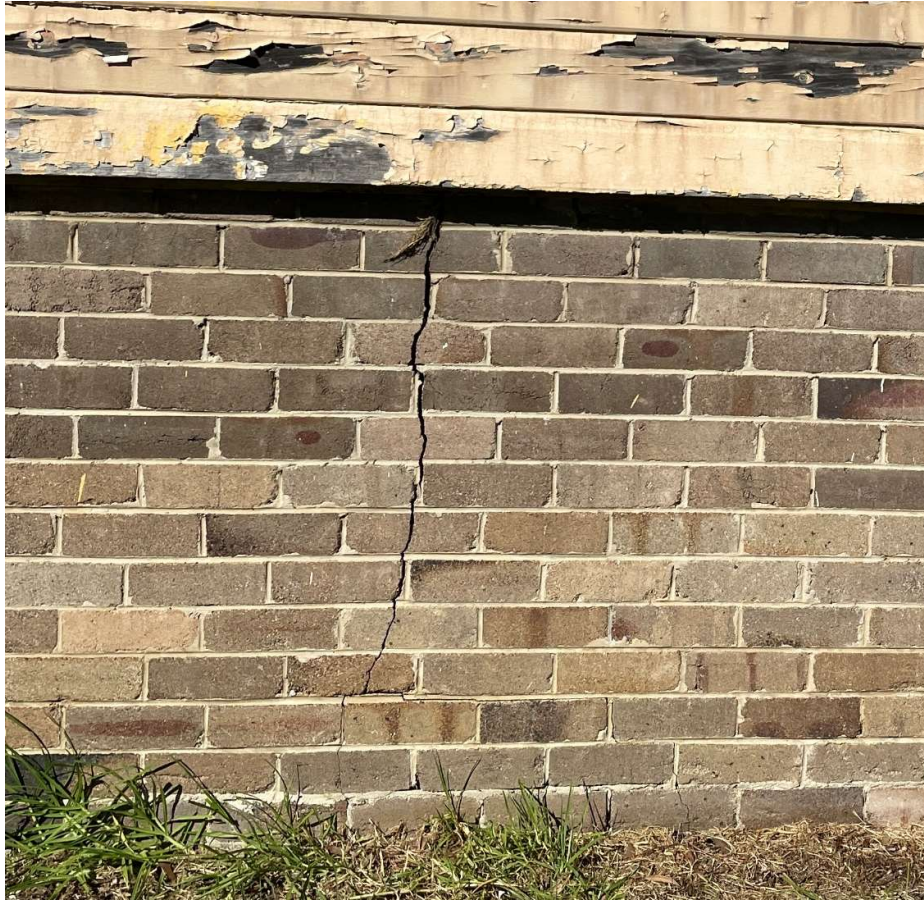
Figure 10 – Vertical Crack in Perimeter Brick Footing Structure due to possible footing settlement.

- Settlements of Footings
 - In some areas it was observed likely that footing systems had undergone differential settlement leading to structural defects. *Figure 10* indicates a fully propagated crack through the brick support footing system that is likely due to long-term differential-settling at the corner of the building that is noted to be sitting on an undulating slope that falls to the North. *Figure 13* shows a brick pier that is no longer supporting the floor structure leading to reduced floor capacity and greater deflection, likely due to long-term settlement. *Figure 8* indicates animal tunnelling in the sub-floor area within the vicinity of brick piers. The stability of these footings in these areas are reduced and cannot be quantified without further investigation.

- Settled footings must be remediated to prevent adverse structural damage.
 - Subfloor framing to be repacked to brick piers where not engaged.
 - Cracks in brick to be filled with construction approved epoxy/mortar.

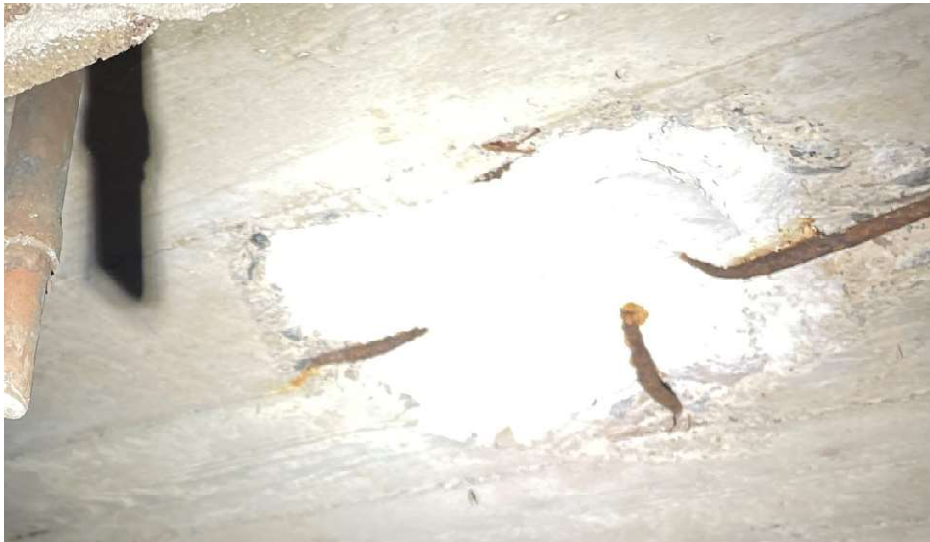
Figure 11 – Cementitious patchwork to underside of existing concrete bathroom slab.
Reinforcement bars exposed and indicate surface corrosion.

- Corroded, exposed reinforcement within Concrete slab areas within lower-level Bathrooms.
 - There were signs of exposed, corroded steel reinforcement during inspection of the sub-floor area. This is non-compliant with the requirements of AS3600. Further corrosion of these reinforcement bars may lead to sudden concrete failure/spalling due to the expansive forces of the corrosion, as well as reduced strength of the steel.

- Exposed corroded reinforcement within concrete slabs:
 - Removal of local cracked, degraded concrete to 20-30mm past reinforcement.
 - Mechanically brush back all corrosion and apply rust-kill system (FOSROC Nitoprime Zincrich).

- Apply concrete repair mortar to seal and smoothe concrete surface with minimum 50mm cover.

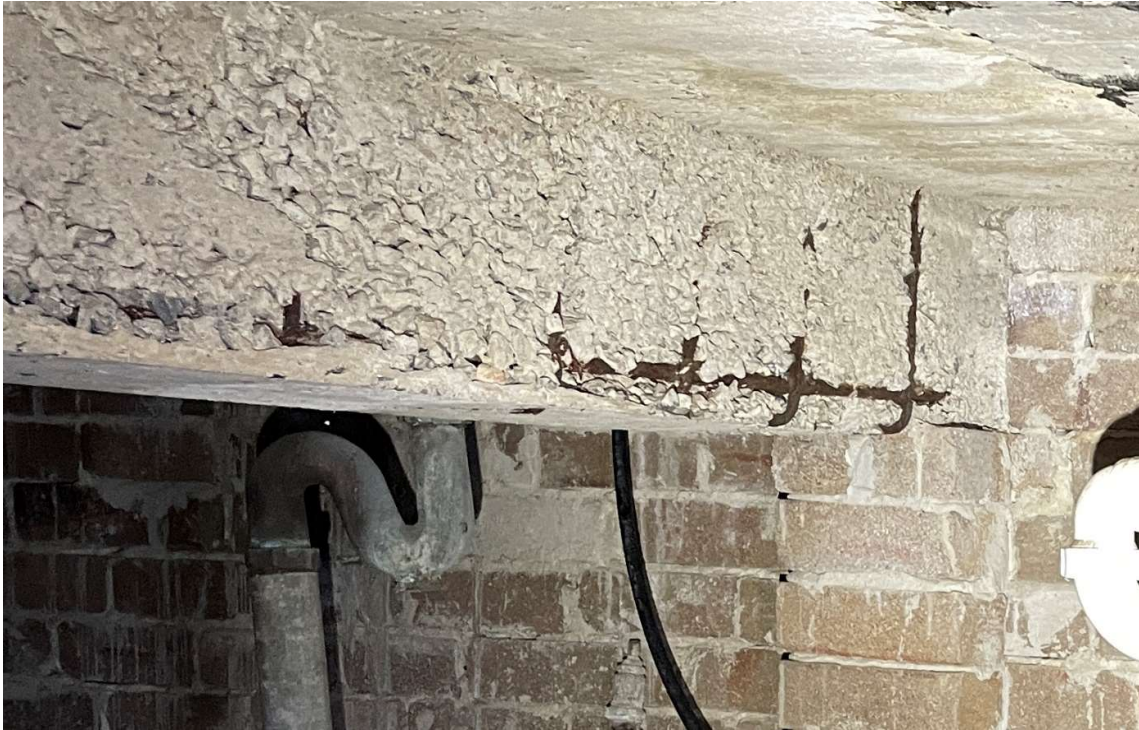
Figure 12 – Existing Concrete Beam in Bathroom under-slab.

Evidence of poorly cemented concrete with exposed reinforcement showing surface corrosion.

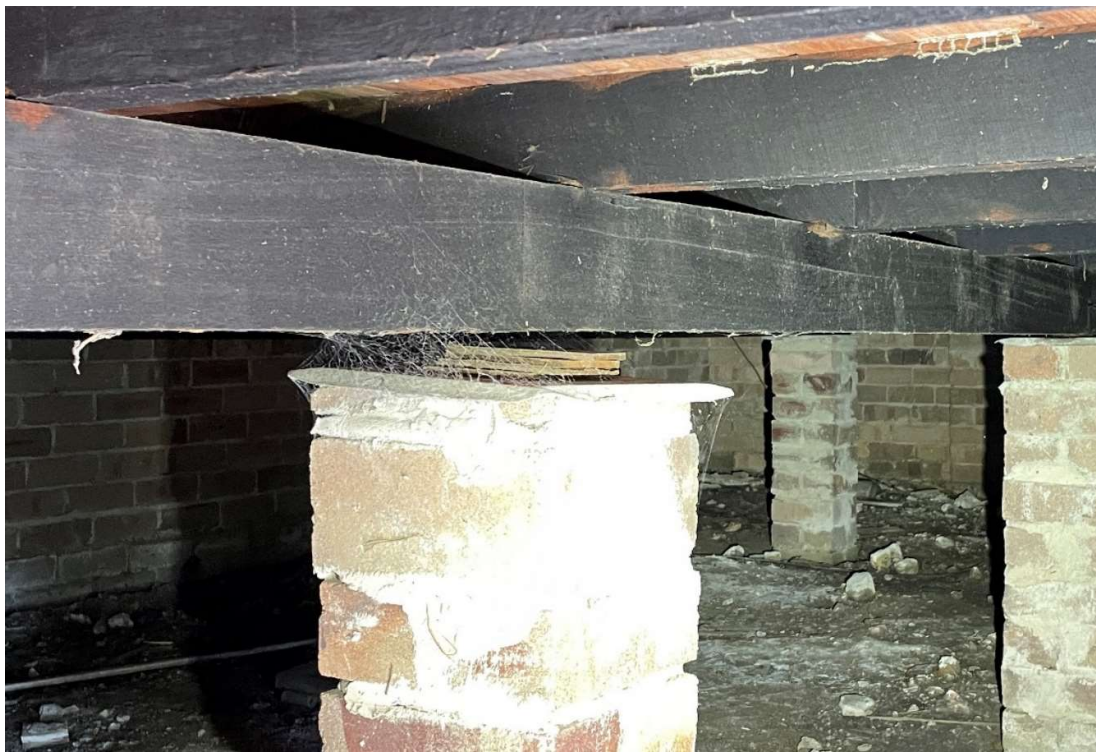
Figure 13 – Existing Sub-floor timber framing. Asbestos packers not engaged with brick pier due to dislodgement of packers or possible footing settlement.

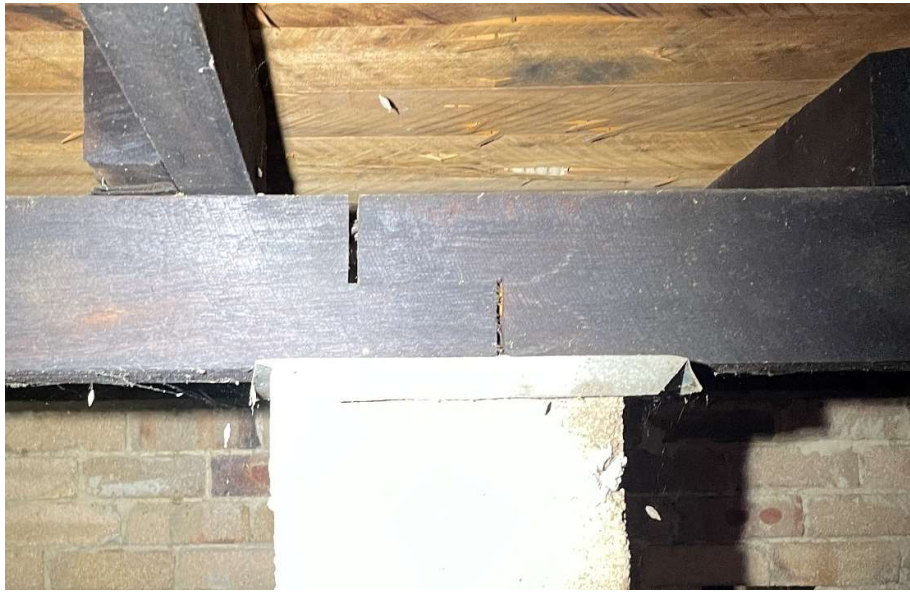
Figure 14 – Timber Flooring beams on brick pier footings supporting floor joists.
Vertical cuts in floor beams at support leading to reduced capacity.

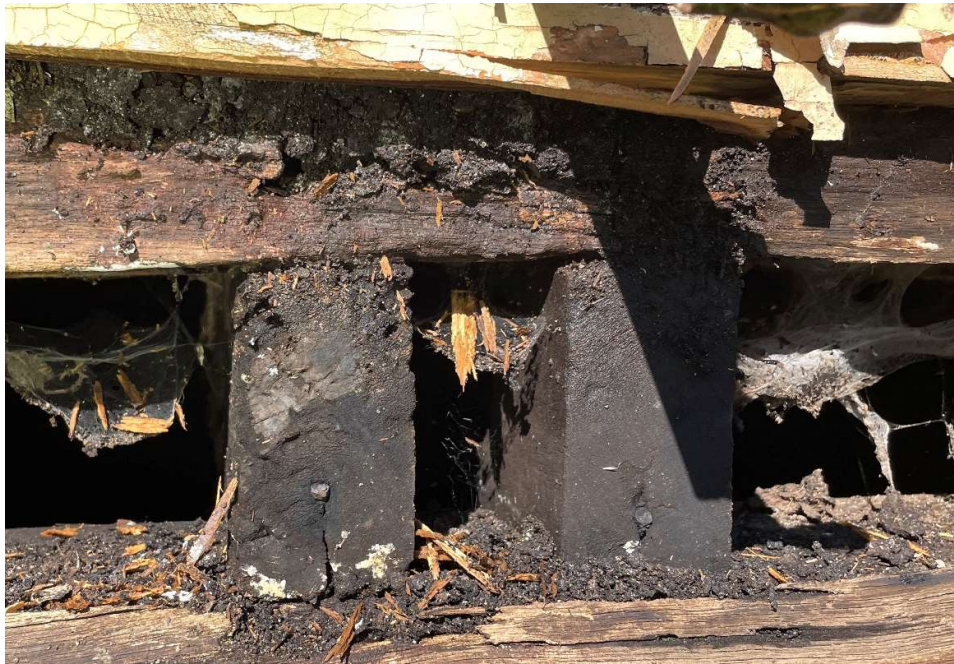
Figure 15 – Close-up of Timber Floor joists at external face of building.
Timber is damp likely due to constant water exposure from failing gutter system.

This has led to **prolonged water exposure** at various points around the buildings where the roof is not draining adequately. The structural consequences have been severe in some locations where it was noted that the timber has significant signs of dampness and was soft under touch, likely from wet-rot. (*Figure 15*)

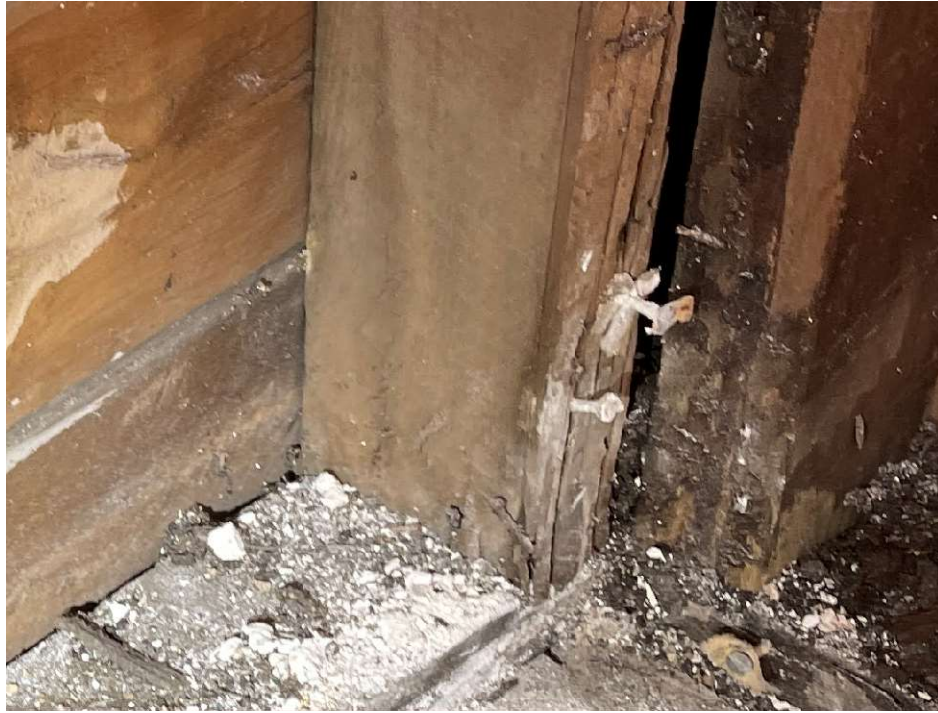
Figure 16 – Internal timber stud-wall. Splitting of timber stud members apparent at ends of studs

- The long-term degradation evident in some of the timber studwalls indicate that these are nearing the end of their serviceable life.
 - Studwalls that are exhibiting split ends within the timber elements should be replaced to ensure structural integrity of the connection.

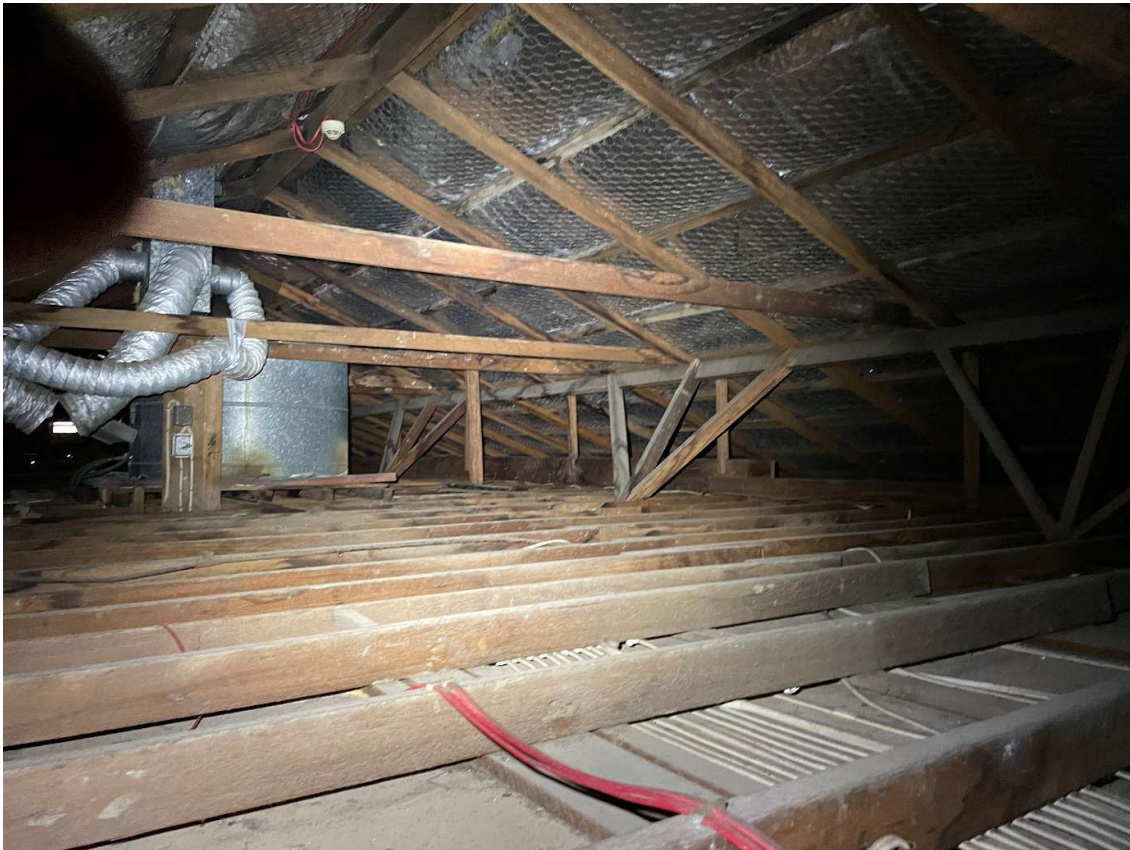
Figure 17 – Typical view of internal gable roof-structure. Sarking, metal mesh, sheeting appear to have been replaced within last 10-15 years. Roof/ceiling structure mostly in good condition.

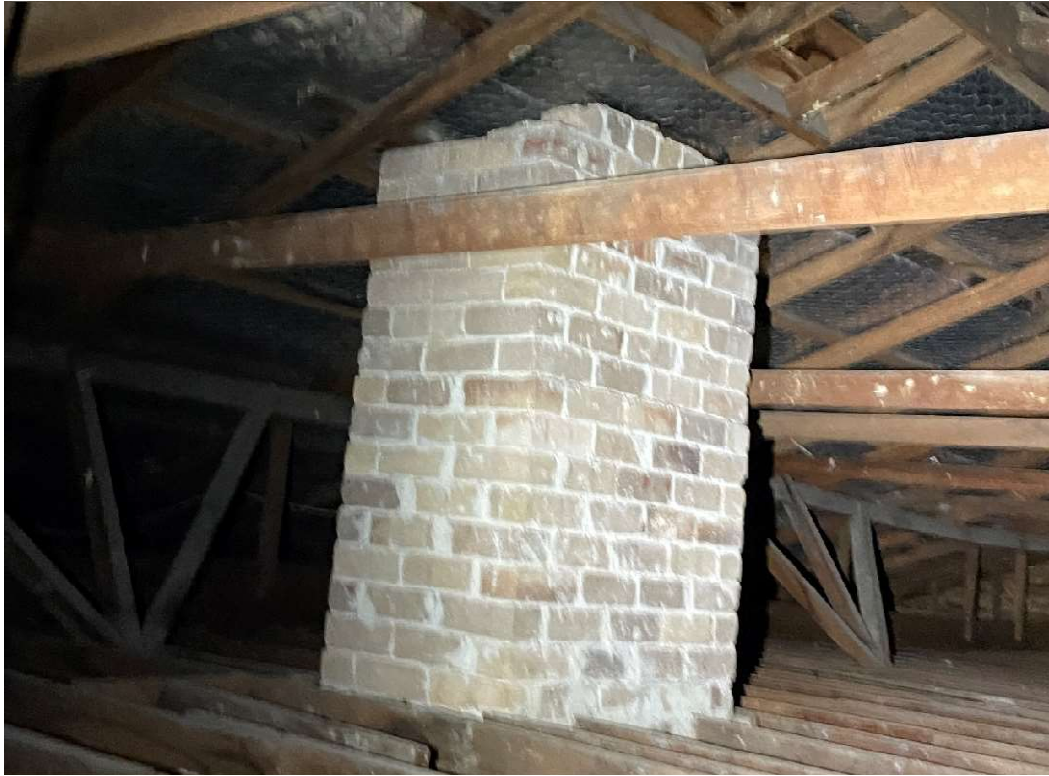
Figure 18 – Non-serviceable Brick chimney terminating within roof structure.

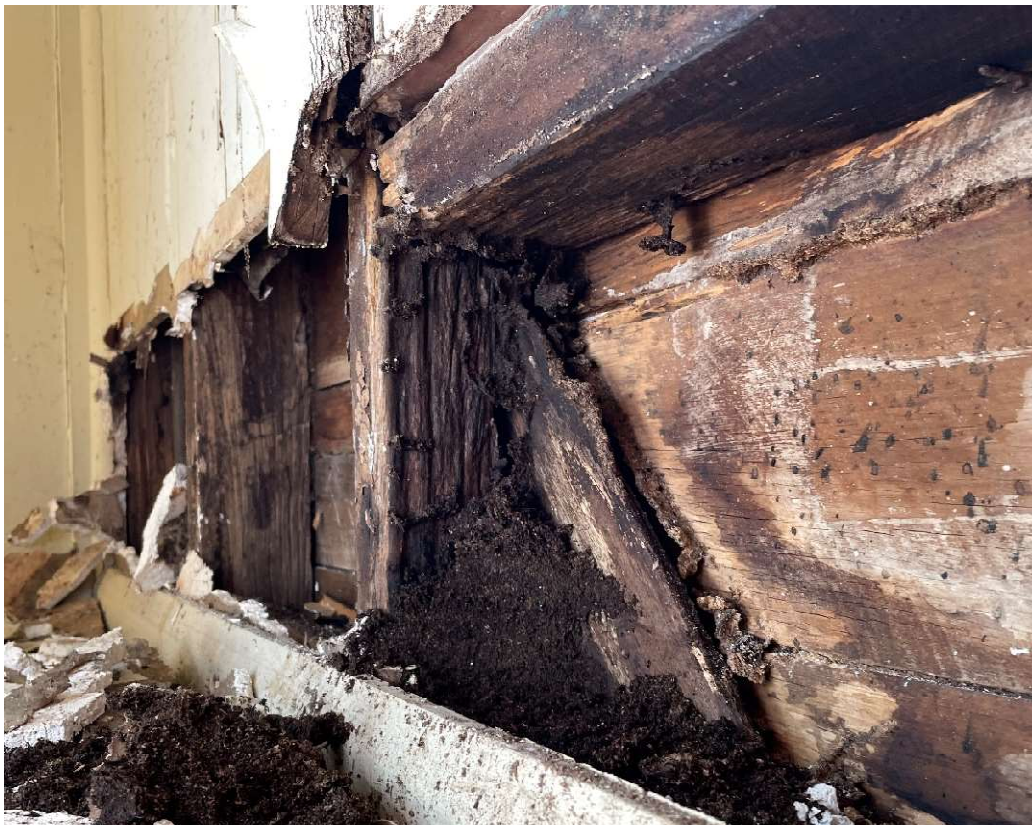
Figure 19 – Timber Stud-Wall at mid-landing of timber stairs joining 2 storeys. Insect faeces at base of studwall indicate likely termite activity within studwall.

- Termite damage
 - Timber Studwalls in some areas that we were able to expose showed significant signs of termite damage. This was obvious from the termite faecal matter observed at the base of these walls as well as the typical burrowing and hollowing of timber observed. (**Figure 19**)
 - Termite damage was observed extensively within the door casings of the buildings. (**Figure 20**)

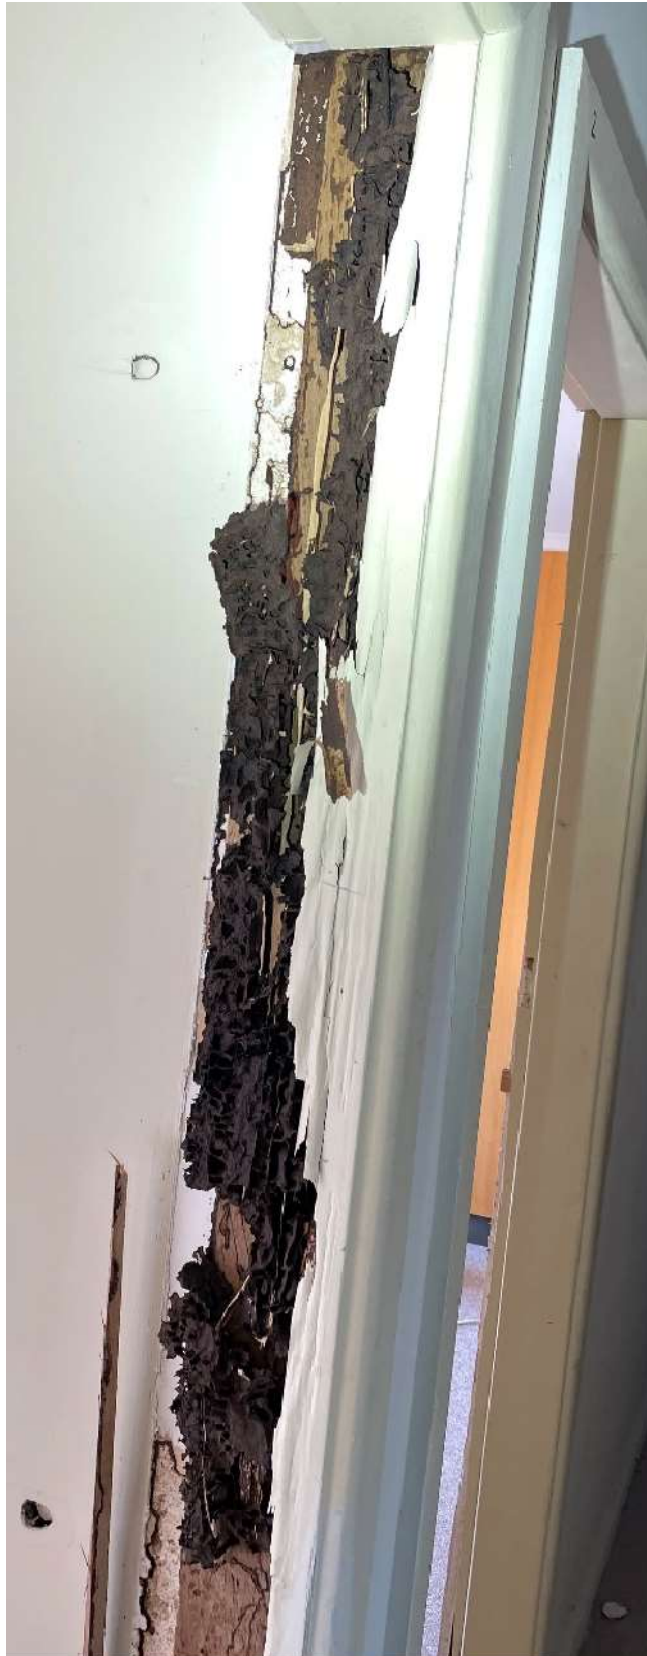
Figure 20 – Timber Casing around door-frame severely damaged from termites.

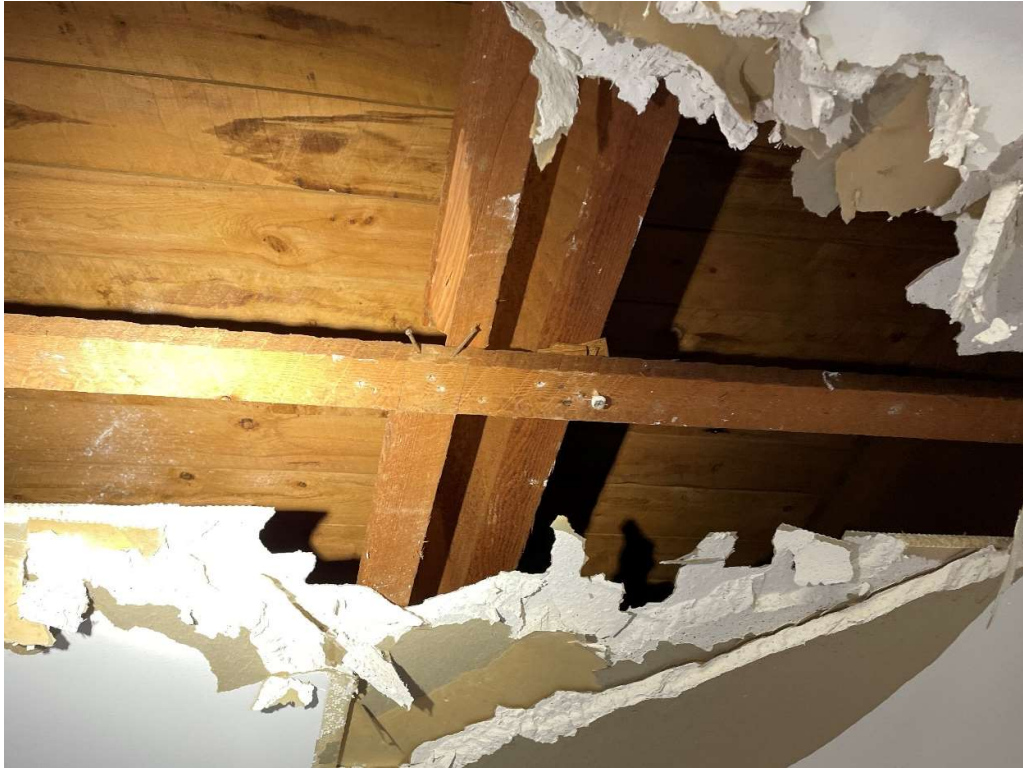
Figure 21 – Typical view of Upper Level Floor framing. No obvious signs of significant weathering or structural defect at this location.
