Building Audit and Risk Assessment
Middle Head Oval Amenities Building

1110 Middle Head Road
MOSMAN, NSW, 2088

Project: Middle Head Oval Amenities Building
 Document Type: Building Risk Assessment Report
 Report Number: P223_562-3 (BCA) LB

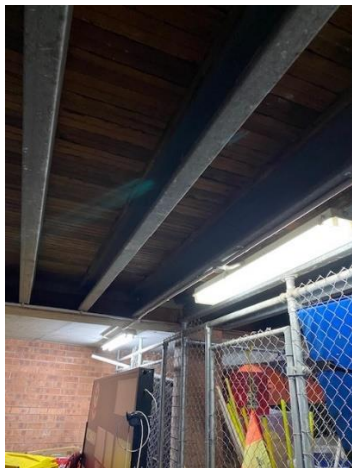
ITEM	ISSUE	PROPOSED MITIGATION MEASURES	LIKELIHOOD	CONSEQUENCE	RISK RATING
1.	<p>The floor separating the first floor is a timber floor and is not fire rated to achieve a minimum FRL of 30/30/30 or fire rated from the underside against the incipient spread of fire in accordance with Specification 5 of the BCA.</p>

ITEM	ISSUE	RISK RATING
1.	The floor separating the first floor is a timber floor and is not fire rated to achieve a minimum FRL of 30/30/30 or fire rated from the underside against the incipient spread of fire in accordance with Specification 5 of the BCA.	Very High

<p>Provide a fire-protective covering to the underside of the floor, including any beams incorporated in it in accordance with Specification 5 of the BCA.</p>	Possible	Severe	Very High
2.	<p>Each existing floor in the building does not appear to have any protection measures for openings for services in accordance with C4D13 of the BCA.</p>	<p>Protection is to be provided to services penetrating the floors separating ground floor and lower ground floor.</p> <p>This would be achieved with a system that achieves compliance with C4D15.</p>	Possible	Moderate	High

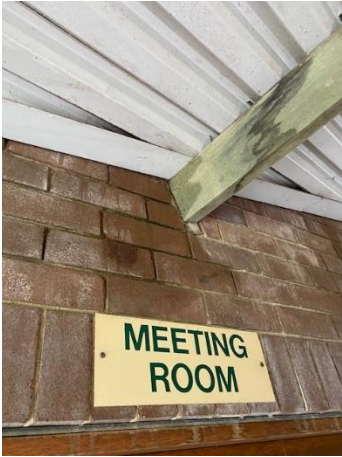
ITEM	ISSUE	PROPOSED MITIGATION MEASURES	LIKELIHOOD	CONSEQUENCE	RISK RATING
3.	<p>The ceiling throughout the top storey is not insulated, resulting in moisture travelling through to internal habitable areas. Creating conditions for damp related issues.</p>

9.	The ceiling throughout the top storey is not insulated, resulting in moisture travelling through to internal habitable areas. Creating conditions for damp related issues.	High

The roof is to be modified/ replaced to provide a compliant weatherproofed roof in accordance with the provisions of Part F and J of the BCA.	Almost Certain	Minor	High
4.	<p>Balustrades to landings of the pavilion do not achieve a height of 1m, have openings greater than 125mm and do not extend to all areas with a floor height greater than 1m from ground below.</p>

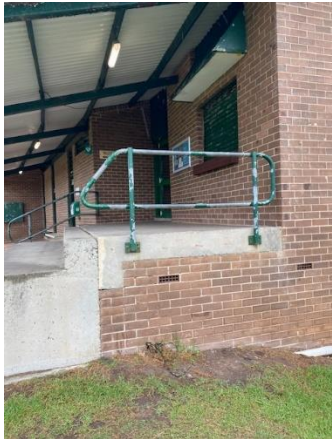
2.	Balustrades to landings of the pavilion do not achieve a height of 1m, have openings greater than 125mm and do not extend to all areas with a floor height greater than 1m from ground below.	Very High

Balustrades are to be upgraded to comply with a minimum height of 1m in accordance with D3D18 of the BCA.	Likely	Major	Very High

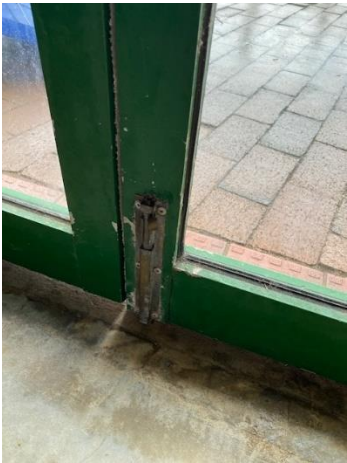
8.	<p>The door hardware for all external doors and some internal doors contain door hardware which is lockable from the outside preventing free egress. Deadbolts are also present on a number of doors.</p>

10.	The door hardware for all external doors and some internal doors contain door hardware which is lockable from the outside preventing free egress. Deadbolts are also present on a number of doors.	High

Door hardware to be replaced with hardware which complies with the provisions of D3D26 of the BCA.	Possible	Major	High

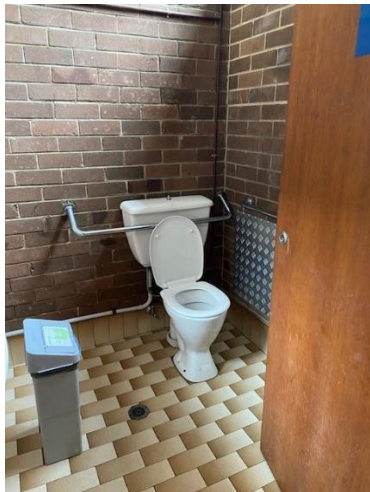
ITEM	ISSUE	PROPOSED MITIGATION MEASURES	LIKELIHOOD	CONSEQUENCE	RISK RATING
10.	<p>The steel awning covering the seating area of the pavilion appears to be heavily corroded. Concern is raised as to the structural integrity of the connections of the structure.</p>  	Have a structural engineer inspect and confirm structural integrity of the structure.	Possible	Severe	Very High
11.	<p>Existing sanitary facilities are not afforded with fully compliant accessible/ ambulant facilities.</p>

12.	Existing sanitary facilities are not afforded with fully compliant accessible/ ambulant facilities.	Low
13.	The building accessway from the road contains a ramp steeper than 1:20 and is not afforded with a compliant accessible entry to the building.	Low

<p>Toilets to be modified to comply with current AS1428.1-2009 standard.</p> <p>Minimum size of accessible cubicle is to be 2.3m x 1.9m. Current cubicle is 1.9m x 1.9m.</p>	Possible	Not Significant	Low

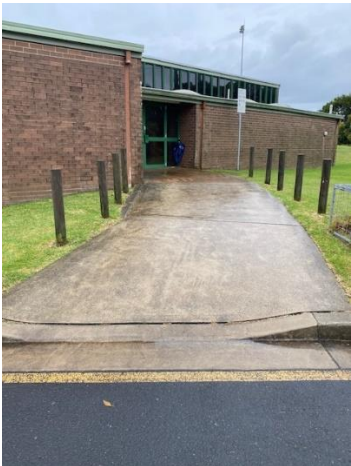
ITEM	ISSUE	PROPOSED MITIGATION MEASURES	LIKELIHOOD	CONSEQUENCE	RISK RATING
12.	<p>The building accessway from the road contains a ramp steeper than 1:20 and is not afforded with a compliant accessible entry to the building.</p>

<p>A compliant accessible entryway is to be provided in accordance with AS1428.1. This would necessitate regrading/ altering the landscape to provide compliant ramp and features.</p>	Almost Certain	Not significant	Low
13.	<p>The entry doors to the building do not contain a step down or drain which compromises the weatherproofing of the threshold.</p>

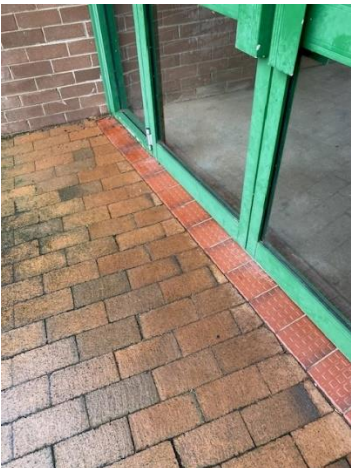
14.	The entry doors to the building do not contain a step down or drain which compromises the weatherproofing of the threshold.	Low
15.	Artificial lighting to the habitable areas of the building appears to be insufficient and not compliance with F6D5 of the BCA.	Low

<p>A strip drain is to be provided to the doorway to ensure risk of wind driven rain entering the building is mitigated.</p>	Almost Certain	Not significant	Low

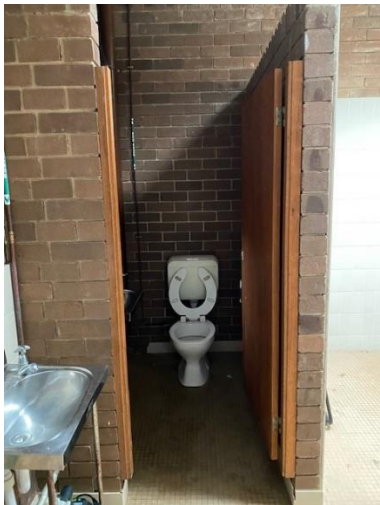
ITEM	ISSUE	PROPOSED MITIGATION MEASURES	LIKELIHOOD	CONSEQUENCE	RISK RATING
16.	Doors to sanitary compartments are located within 1200mm of the pans swinging inwards and not provided with lift off hinges in accordance with F4D8 of the BCA.

11.	Doors to sanitary compartments are located within 1200mm of the pans swinging inwards and not provided with lift off hinges in accordance with F4D8 of the BCA.	High

Provide lift-off hinges to all cubicles or re-swing outwards.	Possible	Moderate	High
17.	The habitable areas of the building the current form are unlikely capable of complying with the provisions of Section J of the BCA.	Investigate roof, wall, floor and services installation against the provisions of Section J. It is likely retrospective insulation, moisture management and services are required to be upgraded.	Almost Certain	Not significant	Low
