FACILITY CONDITION ASSESSMENT

Sonora High School
401 South Palm Street
La Habra, California 90631

162347.23R000-005.017

August 21, 2023

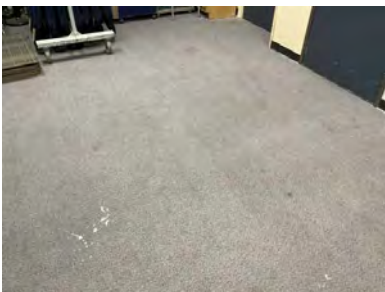
Flooring in Poor condition.

Carpet, Commercial Standard
 Building 800 005 - Sonora High School
 Throughout building

Stained and worn - AssetCALC ID: 6880411

Uniformat Code: C2030
 Recommendation: **Replace in 2024**

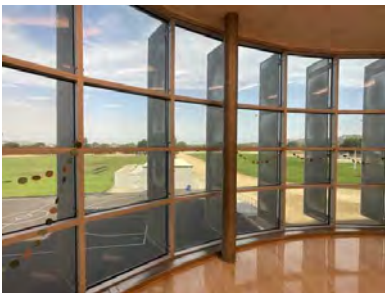
It was reported that in the new gymnasium building the curtain wall windows are leaking from poor construction.

Caulking in Poor condition.

Window Edge/Trim, per LF
New Gymnasium Building 005 - Sonora High School Building Exterior

It was reported that the window joints leak when raining. Builder did a poor job - AssetCALC ID: 6880553

ID	Location	Location Description	UF Code	Description	Condition	Plan Type	Cost
6880553	005 - Sonora High School / New Gymnasium Building	Building Exterior	B2010	Caulking, Window Edge/Trim, per LF, Replace	Poor	Performance/Integrity	\$400
Total (1 items)							\$400

Uniformat Code: B2010
Recommendation: **Replace in 2023**
