Wealth of Knowledge Frozen in Time: Innovative Breakout Shell Autopsy

Jackie Leung¹ and Joydeep Sengupta¹

¹ArcelorMittal - Global R&D Hamilton
1390 Burlington Street East, Hamilton, ON. L8N 3J5 Canada
Phone: 905-548-4759
E-mail: jackie.leung@arcelormittal.com

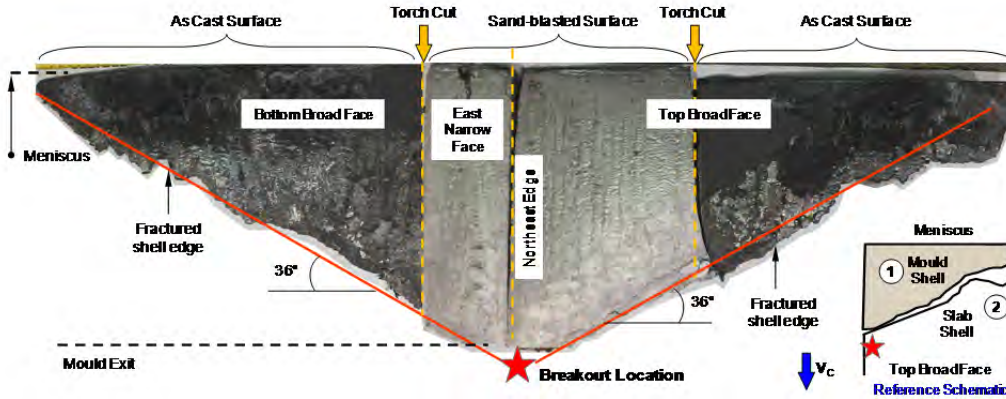
The breakout shell had fractured into two pieces during the breakout. Piece #1 (mould shell) remained inside the mould and Piece #2 (slab shell) was attached to the slab (refer to schematic in Figure 2). Global R&D Hamilton had retained the mould shell for analysis. The mould shell was cut into smaller pieces using a hand-torch cutter and laid out flat (Figure 2). As seen in the figure, the fracture edges on both broad faces are angled $\sim 36^\circ$ and converge onto the northeast edge. This angled fracture edge indicates a sticker-type breakout,³ originating from the top (inner radius) broad face near the northeast edge.

Figure 2. Mould shell after torch cutting and laid out flat

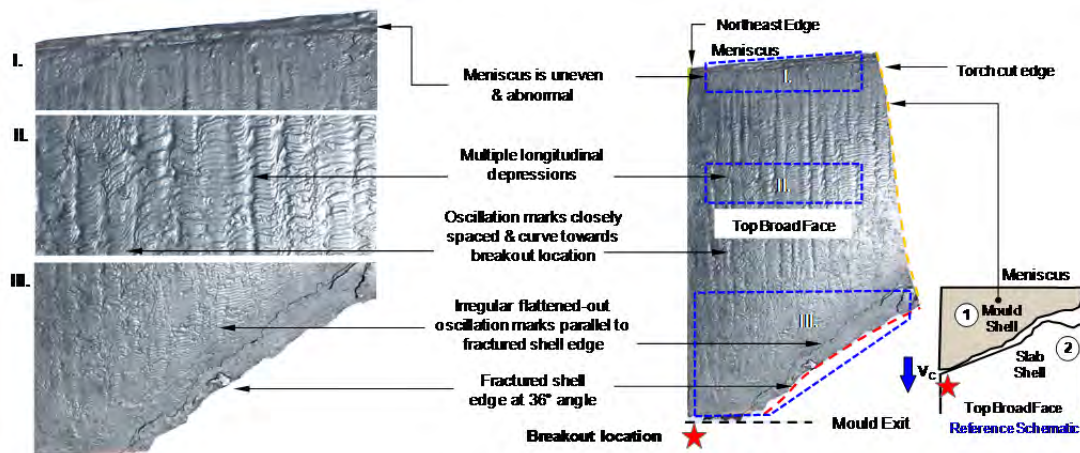
Sandblasting the broad face surface revealed intricate details (Figure 3). Breakout shell observations that were made clear:

1. The meniscus edge was very thick and irregular;
2. There were multiple longitudinal depressions along the broad face;
3. Oscillation marks were flattened out at the vicinity of the fracture edge;
4. Oscillation marks near the fracture edge were closely spaced and curved toward the breakout location.

These irregular and abnormal features on the shell indicated a sticker formation and propagation inside the mould.⁹

Figure 3. Breakout shell from mould after sandblasting

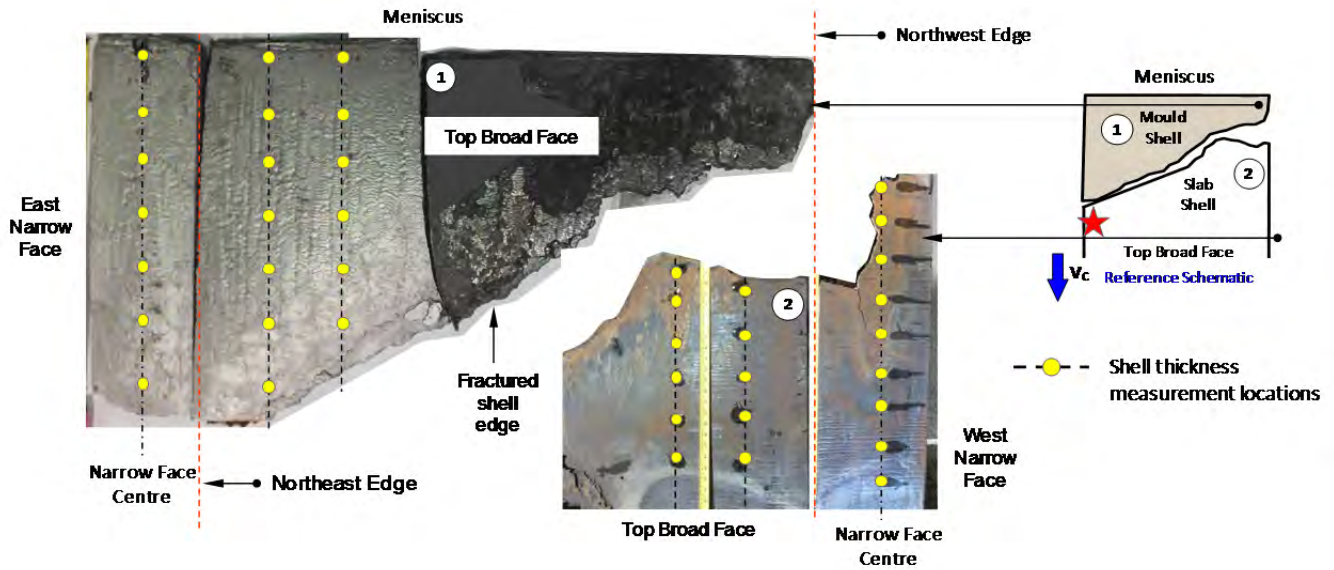
Measurement of the shell thickness was needed to quantify the abnormal meniscus and thinning near the fracture edge. Typically, a cross-section of the shell would be cut out and thickness would be measured using a ruler or calipers. However, cutting out the shell slab in the slab yard would have been time and labor-intensive. Therefore, an improved technique was applied to measure shell thickness quickly and effectively. A portable ultrasonic flaw detecting device, typically used for non-destructive testing of defects in products, was used to measure thickness of the breakout shell along the casting direction (Figure 4). A relatively flat surface was required for measurement, but when calibrated with standards of known thickness, the ultrasonic flaw detecting device provided quick and accurate thickness measurements. The device is more complex than a ruler or calipers. Hence, the signal needs to be properly interpreted by a trained operator. The device was both portable and durable so that it could be brought to the slab yard for *in-situ* measurements so additional cutting of the shell was not required. Similar ultrasonic measurements were made on the mould shell for consistency of measurement technique.

Figure 4. Ultrasonic measurement locations on shell from mould and slab

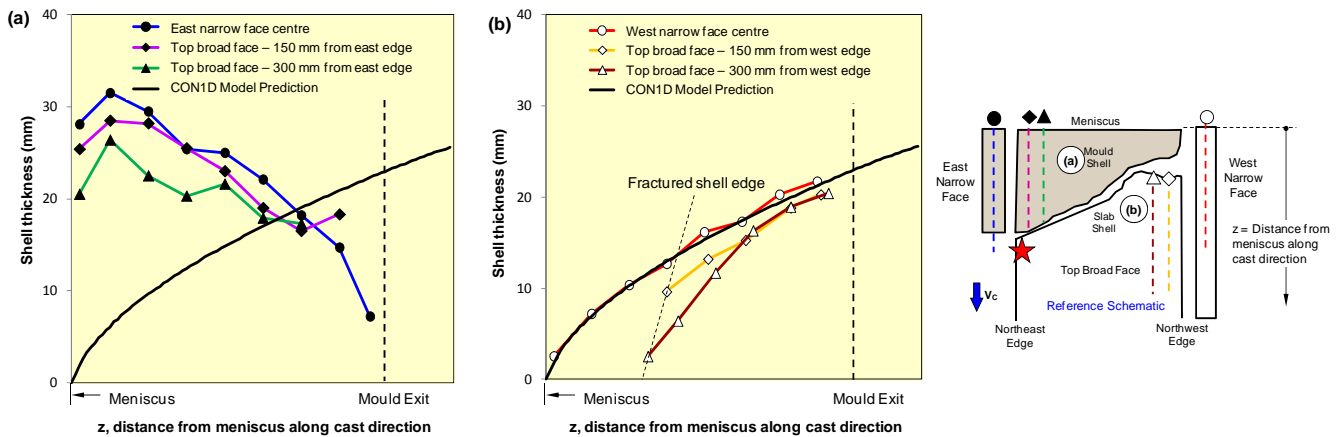
The shell thickness profiles were compared with CON1D prediction (Figure 5). From Figure 5a, the mould shell was thicker at the meniscus and thinner at the fracture edge near mould exit compared with CON1D. The shell was the thinnest near the fracture edge of the east narrow face centre, indicating the breakout originated from near this location. From Figure 5b, the thickness profile on the west narrow face centre, farthest away from the breakout location, has good agreement to CON1D. Therefore, shell growth at this location followed normal solidification behavior. However, the shell becomes thinner along the fracture edge. This is typical shell thickness behavior seen on breakout shells after a sticker breakout.

Figure 5. Thickness profiles for (a) mould shell and, (b) slab shell with CON1D model prediction

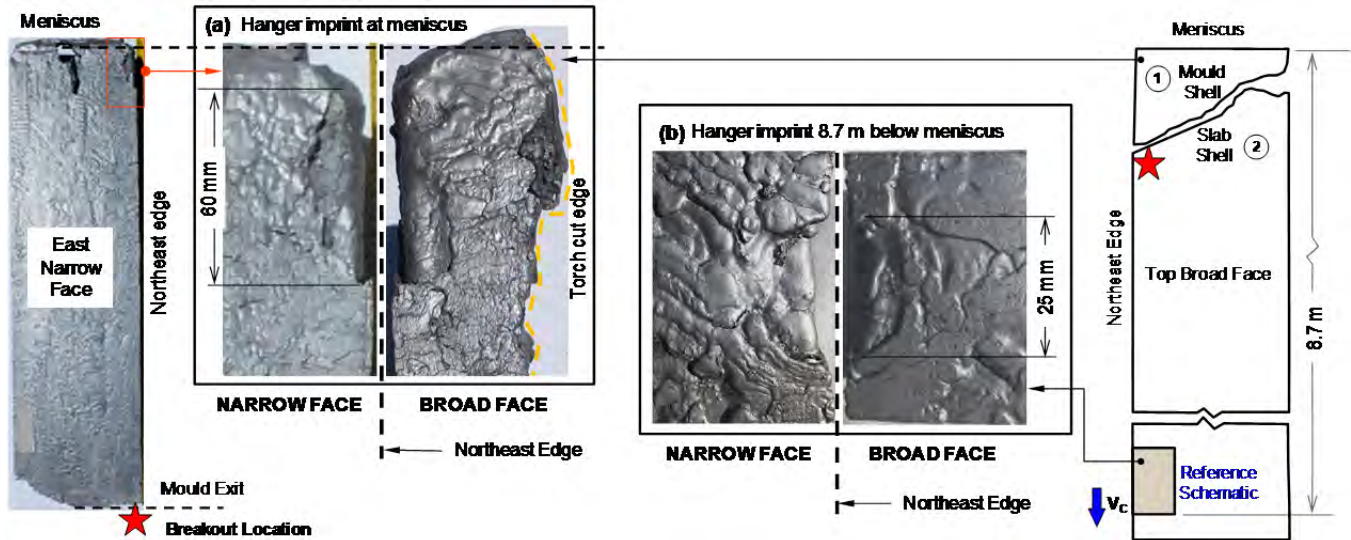
Sandblasting also revealed an abnormal feature below the meniscus on the mould shell (Figure 6a). A distinctive imprint along the northeast edge indicates a foreign object pushed up against the shell during the breakout. A similar imprint was observed on the slab on the same edge ~9 m below the meniscus (Figure 6b). The object was referred to as a “hanger” because it sticks and hangs onto the mould, but differs from a sticker because it is not part of the shell.

Figure 6. (a) Hanger imprint at meniscus, (b) Hanger imprint on breakout slab

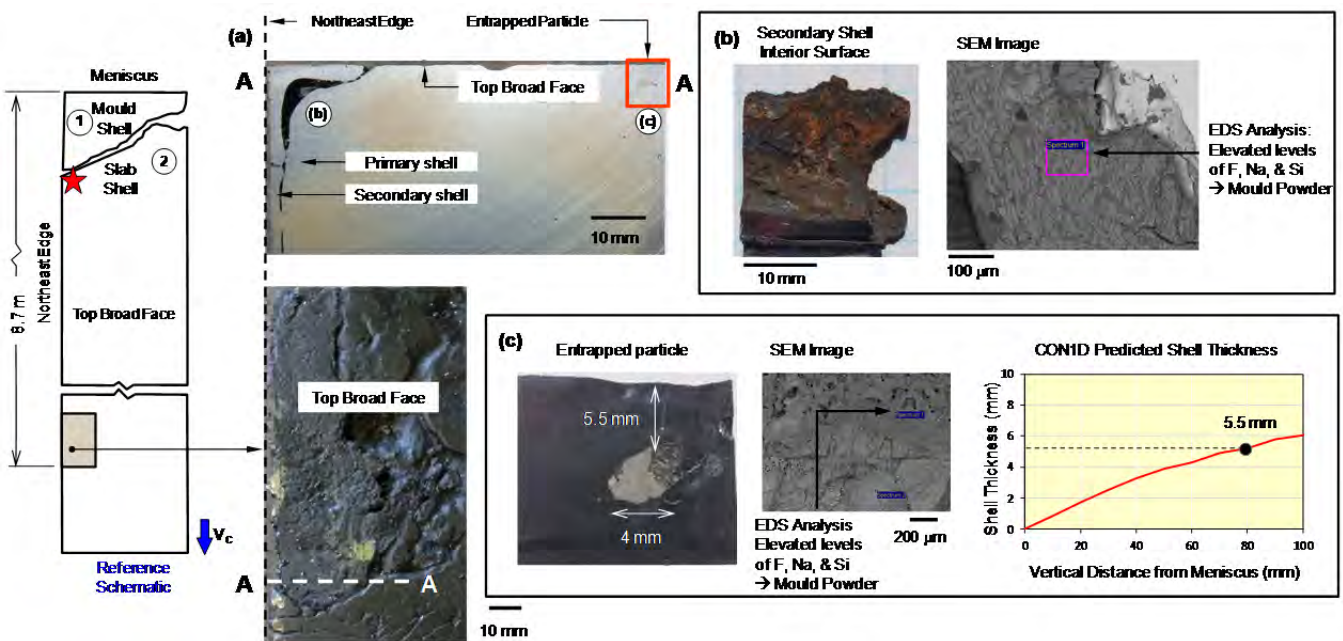
Another atypical feature was observed near the hanger imprint ~9 m below the meniscus. A section of this feature was cut and the transverse cross-section surface was milled for further analysis (Figure 7a). The cross-section revealed a secondary shell on the northeast corner of the slab. This was a piece of the hanger that detached with that portion of the slab. Scanning Electron Microscope Energy-Dispersive X-ray Spectroscopy (SEM-EDS) was applied and detected elements consistent with mould powder (Figure 7b). An entrapped particle was observed 5.5 mm beneath the top broad face surface (Figure 7c). SEM-EDS of the particle also detected elements consistent with mould powder. CON1D was used to determine that at 5.5 mm below the broad face surface, the particle was embedded on the shell 80 mm below the meniscus during casting.

Figure 7. (a) Abnormal feature on breakout slab; Analyses of (b) hanger interior surface and, (c) entrapped particle

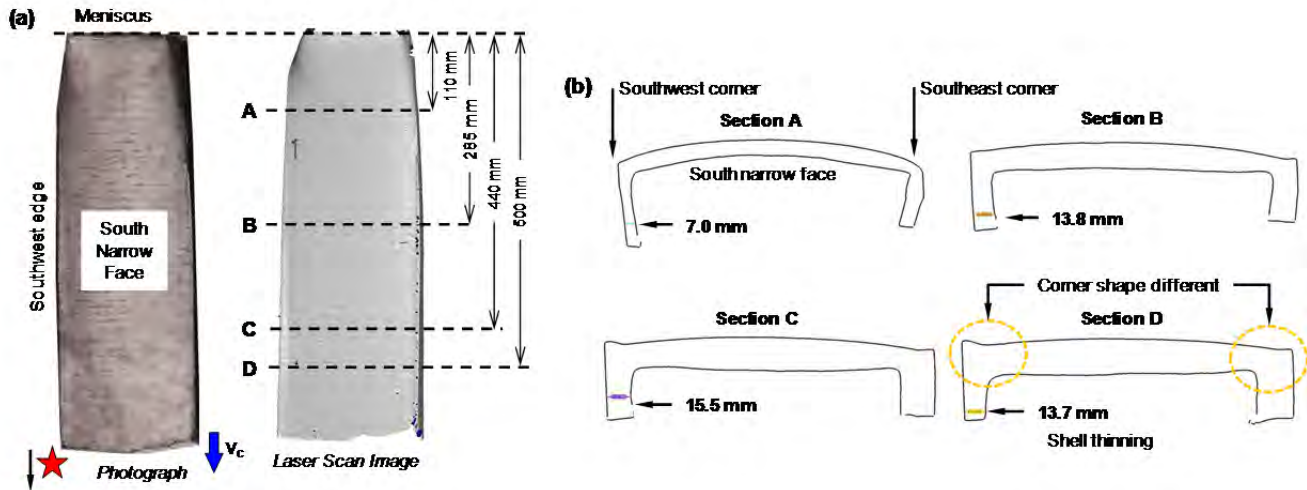
The breakout shell was hand-torch cut from the slab and into smaller pieces. Pieces of interest were sandblasted and scanned using the laser profilometer to acquire a digital copy of the shell (Figure 8a). The software could digitally acquire multiple cross-sections of the scanned breakout shell without having to spend the time or labor to manually cut and measure the shell (Figure 8b). From this figure, it can be seen that Section D experienced localized shell thinning near the breakout position and that corner shape of the southwest corner near the breakout position was clearly different from the southeast corner.

Figure 8. (a) Comparison of photograph and 3D laser scan of breakout shell; (b) digital transverse shell cross-sections

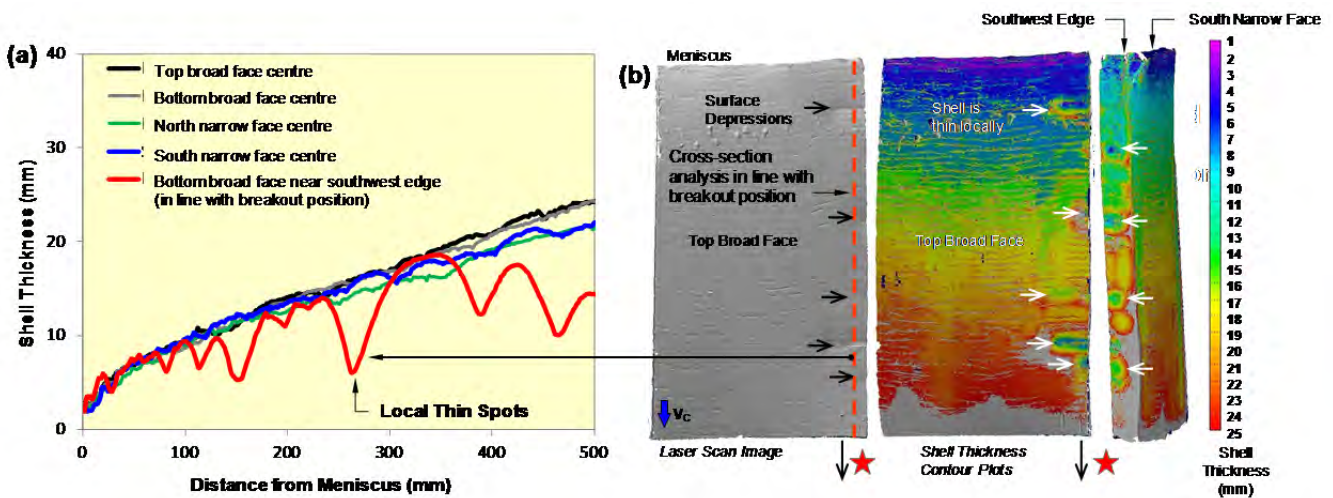
The software was used to acquire co-ordinates for selected cross-sections of the breakout shell. Thickness profiles of the narrow and broad face centrelines were compared to the profile at the breakout position (Figure 9a). From this figure, the shell thickness at the surface depressions are up to 50% thinner than the same position at the narrow and broad face centrelines. The software was used to quickly calculate thickness profile of the scanned piece and visualize the data as a color contour map (Figure 9b). From this figure, it can be seen that there were thin spots in line with the breakout position which corresponded to the locations of observed surface depressions.

Figure 9. (a) Thickness profiles of breakout shell, (b) Laser scan of breakout shell with thickness color contour plots

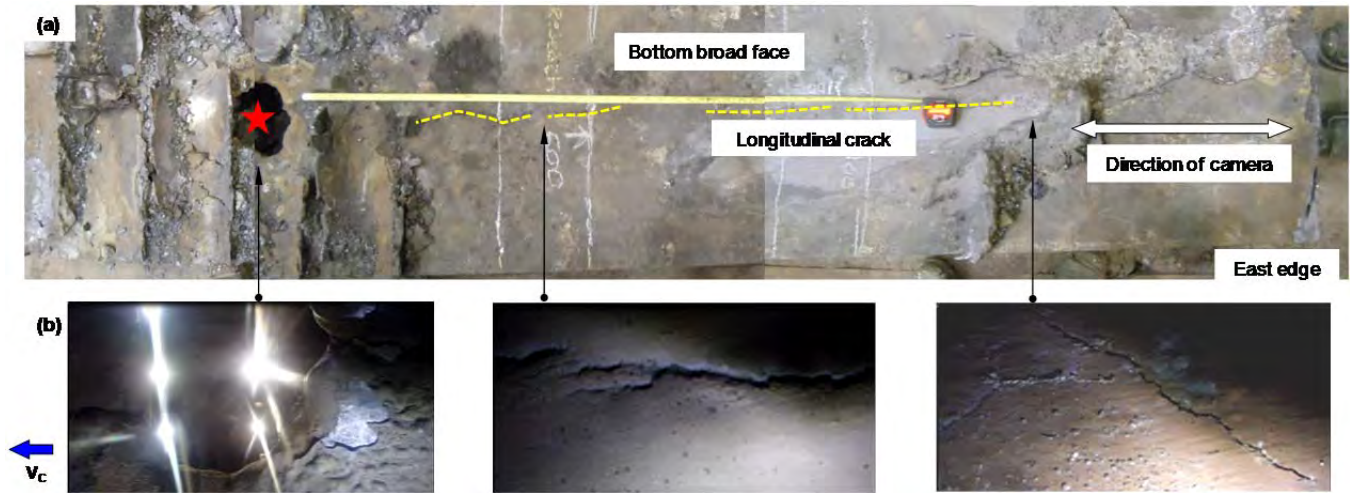
A breakout shell ~3 m in length was retained at the caster to determine if samples were required. Surface inspection revealed several depressions and longitudinal cracks in line with the breakout position (Figure 10a). To determine if the longitudinal crack was responsible for creating the breakout hole, it was necessary to inspect the interior shell surface, which was conventionally unreachable. It would have been very time and labor-intensive to cut the entire breakout shell into manageable pieces. Therefore, a digital camera attached to a pole was used to inspect the interior shell surface along the crack position. The longitudinal crack was visible in several locations along the interior of the breakout shell (Figure 10b). From the figure, the middle image shows the rounded crack edge which indicates that the crack had occurred during the breakout and not after. Areas of interest were selected to be cut out for further analysis.

Figure 10. (a) Breakout shell, (b) Images from camera inspection of interior surface of shell

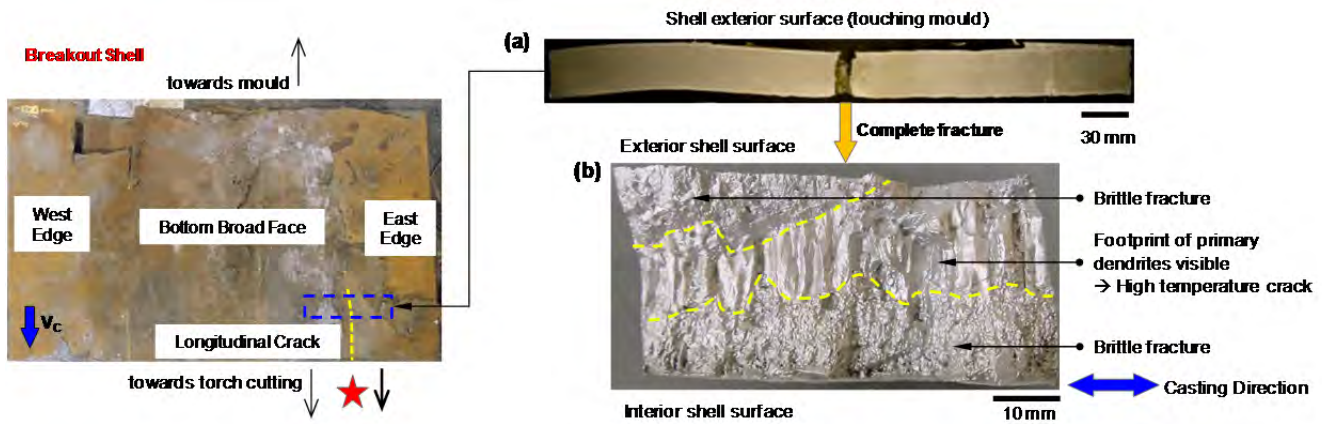
A section with a longitudinal crack was removed from the shell (Figure 11a). The fracture surface was sandblasted and examined (Figure 11b). The fracture surface shows two distinctive patterns of fracture: low and high temperature. The low temperature fracture is typical of a brittle fracture. In the high-temperature fracture, the imprint of primary dendrites formed during casting is clearly visible. This indicates that the crack occurred at high temperature during casting.

Figure 11. (a) Sample from breakout shell with crack, (b) Fracture surface after sandblasting

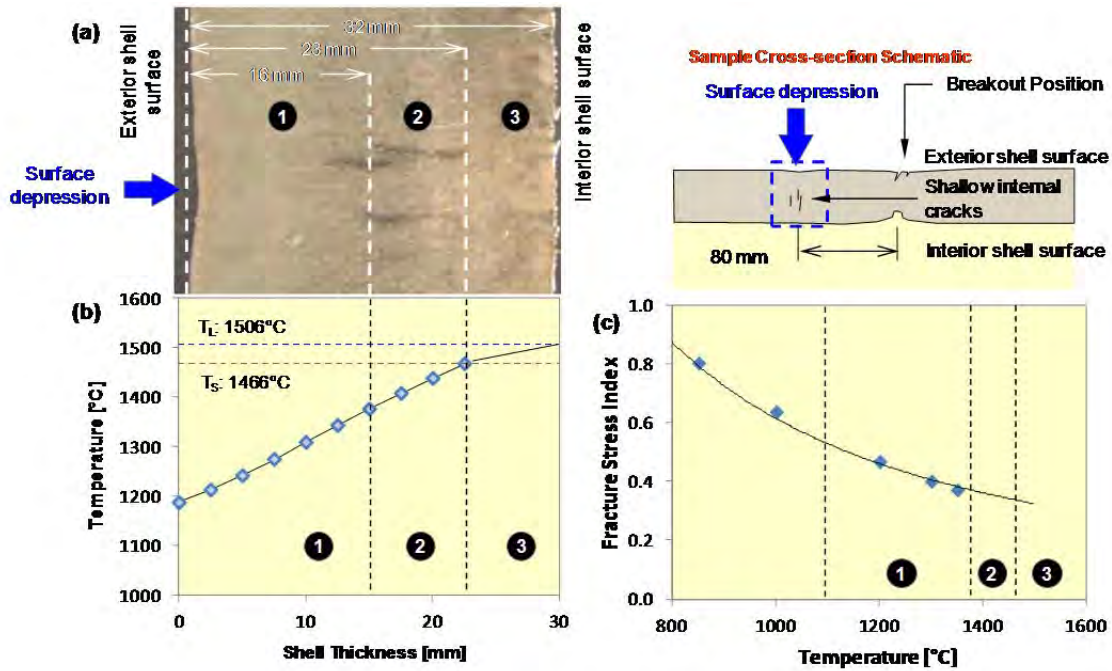
The sample from Figure 11(a) was deep etched¹⁰ to reveal the macrostructure. Several shallow internal cracks were observed beneath a surface depression (Figure 12a). The shell cross-section is divided into three zones: Area 1 - from exterior shell surface to crack start, Area 2 - from crack start to crack end, and Area 3 - from the crack end to interior shell surface. Using CON1D, these cracks were initiated ~1.5 m below the meniscus. CON1D also predicted the thermal profile of the shell at that machine location (Figure 12b). It indicates that the temperature of the area when the crack formed was at ~1400°C. Thermomechanical testing of this particular grade showed reduced fracture stress at such as high temperature (Figure 12c), making the area more susceptible to cracking.

Figure 12. (a) Macrostructure of breakout shell 80 mm from breakout position, (b) Shell thermal profile according to CON1D prediction, (c) Temperature & Fracture stress relationship for grade

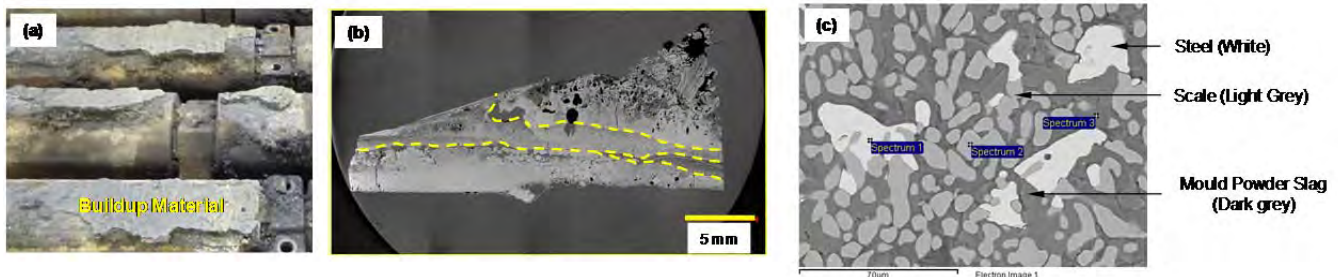
The clues from the shell directed the investigation to the segment rolls near the breakout location. A significant amount of material was found built up on several rolls on the same side as the breakout hole (Figure 13a). SEM-EDS showed that the buildup material formed in layers (Figure 13b), and the different layers revealed elements consistent of scale and mould powder slag (Figure 13c).

Figure 13. (a) Buildup material on segment rolls, (b) cross-section of buildup material, (c) SEM analysis of buildup material
