**ASSESSMENT AND REPAIR METHOD**  
**QUARANTINE FACILITY**  
**VELANA INTERNATIONAL AIRPORT**  
**JUNE 2023**

**CALMEN**

14<sup>th</sup> June 2023

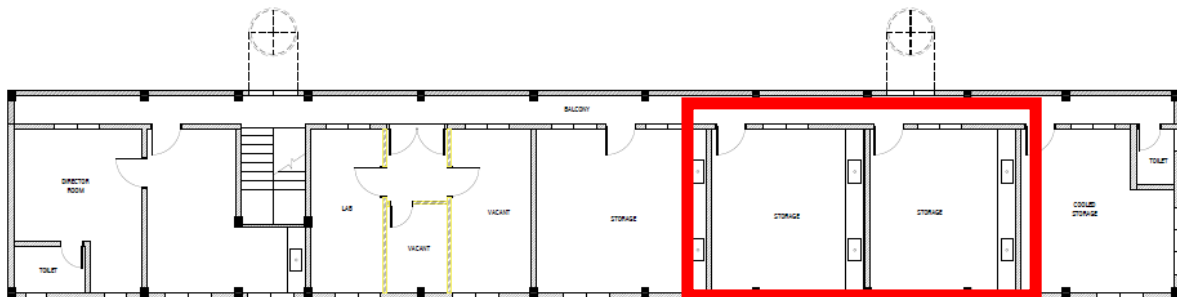
Figure 1. Location of first floor water pooling.

the severeness of the damping and seepage issues suggest that a water supply pressure pipe embedded in the walls or floor screed has been damaged. The continuous pooling of water in first floor rooms and the pattern of seepage suggests a compromised water pressure pipe in the area marked in figure 1.

The building needs to undergo extensive repairs as stated in this report. While many factors contribute to water leaks and seepage into the interior of the building, the severe condition developed in a short period of time suggests that main cause for the leakage is due to a compromised and damaged water pressure pipe embedded in the walls or floor screed.

- Identify and separate the onsite plumbing networks as per the building schematics.
- Isolate each network and attach a pressure gauge to the end of each plumbing network and monitor the reading for 48 hrs with readings taken hourly.
- Readings with pressure drops indicate a leak in the network.
- Once the network with a leakage is identified, pump water with dye colouring and visually observe to identify the area.
- Replace the damaged pipe and pressure test for 48hrs.

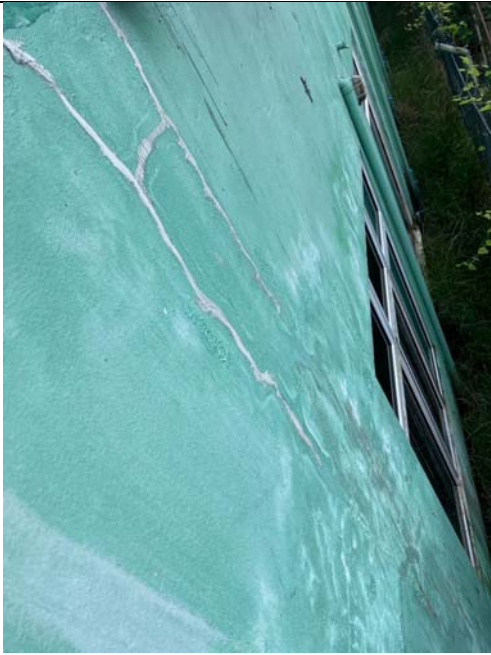
While cracks in walls can be a common issue, most cracks form in the plastering due to the hydration process of setting cement plaster mortar. Multiple cracks are observed in all the floors are scattered in formation allowing water seepage from the exterior side.

Damped exterior wall

- Identifying the cracks and their depth.
- Cutting concrete in V-shaped
- Chipping off the hardened plaster to the extent of the crack depth
- Clean with wire brush and clean water
- Make bonding slurry with "Mastercast 141" or equivalent bonding agent and apply the slurry to the repair area with a clean brush, slurry should be applied only after final cleaning done and washed with cleaned water

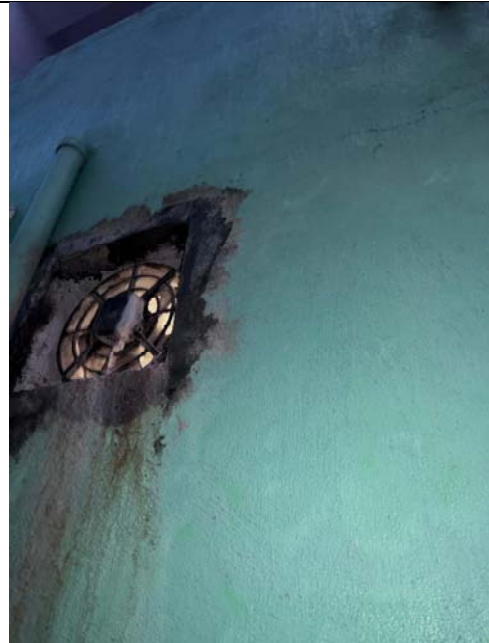
Water leakage to exterior wall from an internal wall pipe

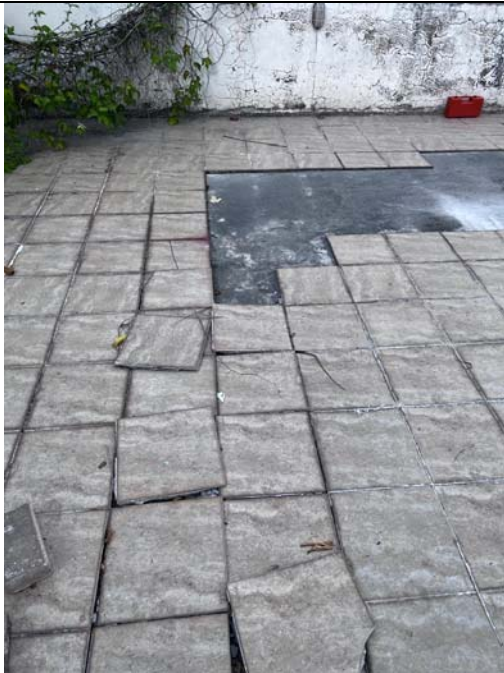
It is obvious that the terrace floor screeding and tiling is done without the provision of expansion joints. Multiple tiles are observed to have popped up which further enhances the water absorption and seepage from terrace floor screed to the bottom floors.

Terrace floor tiles

- Chip and remove the floor tiles
- Cut the floor screed to provide a "u" groove at every 3-meter span
- Fill the grooves with expansion joint filler compound
- Fill and void and uneven surface in the screed with repair mortar and bonding agent
- Clean the floor screed with wire brush and clean water.
- Apply 2 coats of water proofing on the surface of the screed. Water proofing shall be applied on all edges and cover 300mm vertically on adjoining walls.
- Let the water proofing membrane to cure for 3 days and test the area by ponding. Ponding shall continue for 48 hrs.
- Fix the tiles with an approved EU category C2 tile adhesive to achieve enhanced bonding to the screed.
- Leave a spacing of between 4mm to 6mm grooves between tiles and fill them with epoxy tile grout.
- Repeat the above two points and fix skirting tiles around the perimeter.

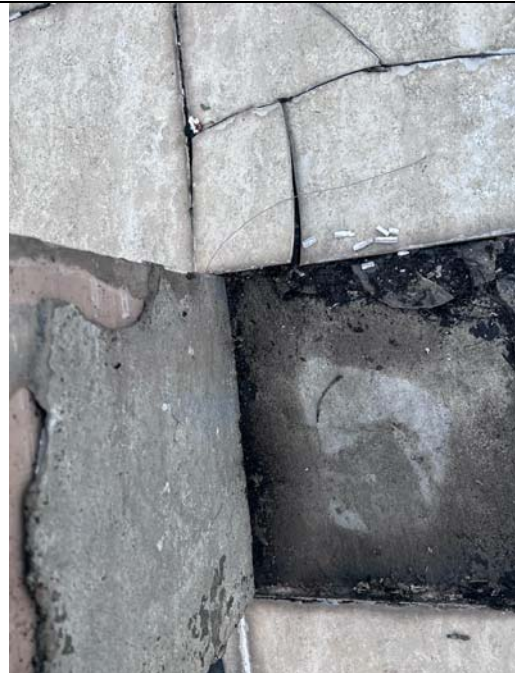
Water collected between tiles and terrace screed

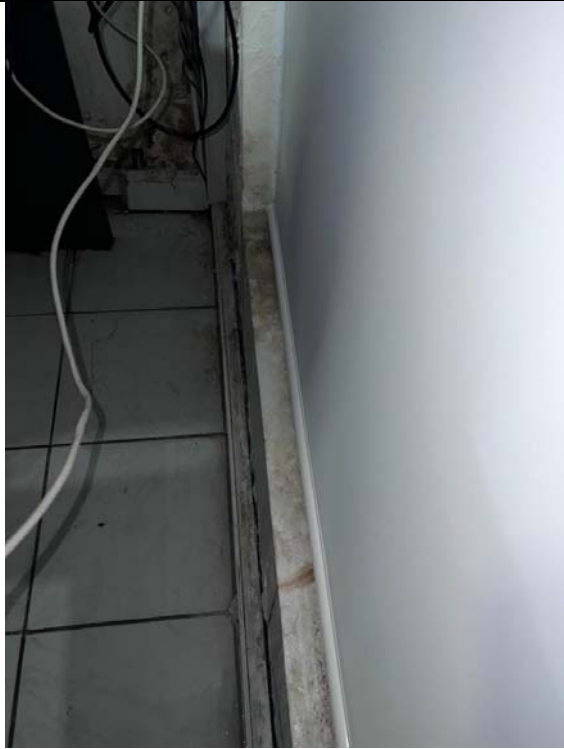
Continuous water leakage through the wall and first floor slab

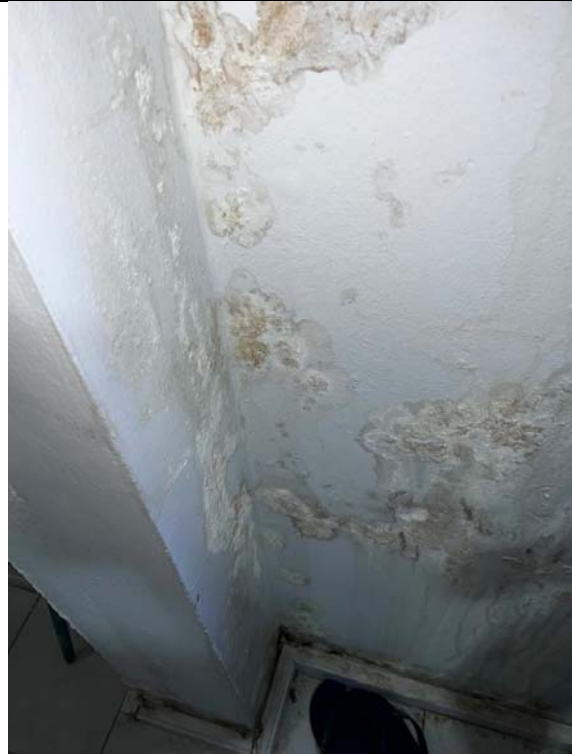
Continuous water leakage through the wall and first floor slab
