INTERIM REVIEW

LEAK OF RADIOACTIVE LIQUOR IN THE FEED CLARIFICATION CELL AT BNG THORP SELLAFIELD

REVIEW OF THE MANAGEMENT AND TECHNICAL ASPECTS OF THE FAILURE AND ITS IMPLICATIONS FOR THE FUTURE OF THORP

REPORT REF N° R3123-A2

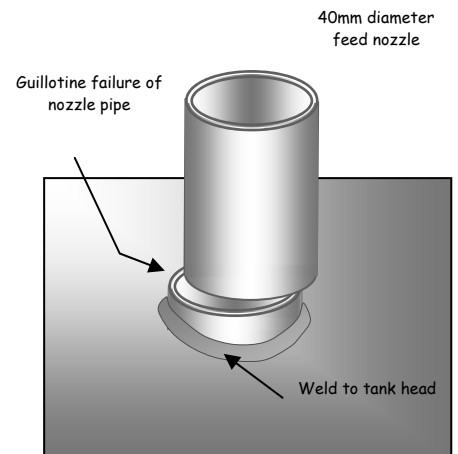
Accountancy Tank B – Nozzle Failure

Following the detection of the leak, an internal BNG Board of Inquiry³ reported in May 2005 states that remote cctv inspection of Cell 220 revealed a significant quantity of dissolver liquor in the base of the cell and that a feed pipe to one of the accountancy tanks (Tank B – nozzle N5) had failed by fatigue fracture at a location close to the head of the vessel.

The failure of the feed nozzle is in the form of a complete guillotine break of the 40mm diameter feed pipe just above the pipe to tank welded joint, with the disconnected pipe remaining slightly misaligned above the stub of the pipe. Because of this alignment, the gravity flow of the clarified feed liquor continued to run into the tank, with some of the flow splashing out and running down the tank side, spilling onto sections of the supporting steel frame.

- With the tank operating when suspended from the four tie rod hangers, the vibration of the tank induced by the internally mounted agitator (pulse jet) and during emptying by the reverse flow diverters produced both oscillatory and swaying motions of the tank that was, over time, sufficient to produce fatigue failure in the feed pipe.
- Although the tank system had been originally designed to be restrained within the seismic frame, for the pre-commissioning safety case the assumption was that the tanks would be uncoupled from the frame and, in accordance with this, the tank-frame restraint blocks were never fitted. Moreover, this modified design never seems to have been reviewed and reassessed in terms of induced vibration and the associated cyclic stressing of the pipework connections.⁴

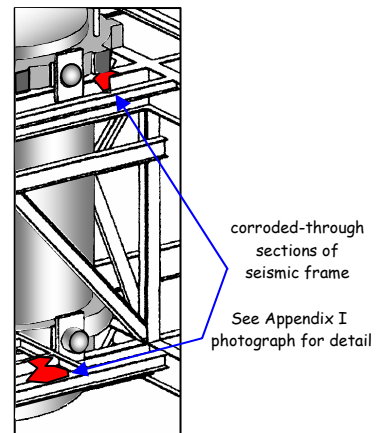
Associated Damage to Support Frame

Over the period of the leak, perhaps for about 9 months, the carbon steel frame sustained significant corrosion, with the spilling nitric acid etching into and completely eroding through the higher and lower south sections of the frame, including the 600mm wide web of the main I-beam at the lower level.

The damage to the steel frame appears to be extensive⁸ and repairs, even if possible by remote means operating within the cell, would require opening up the cell access hole which is presently only 300mm diameter to receive new sections of the 600mm web I-beam.

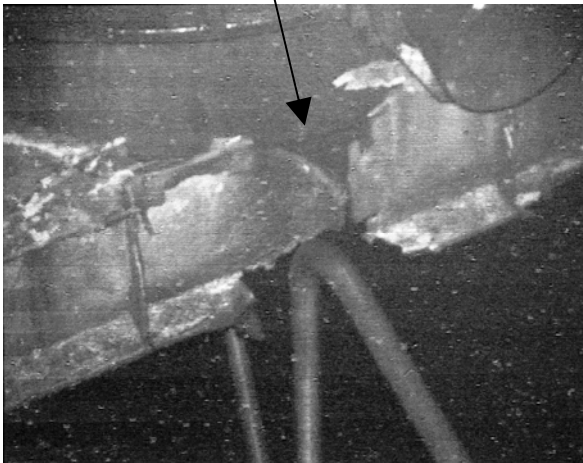
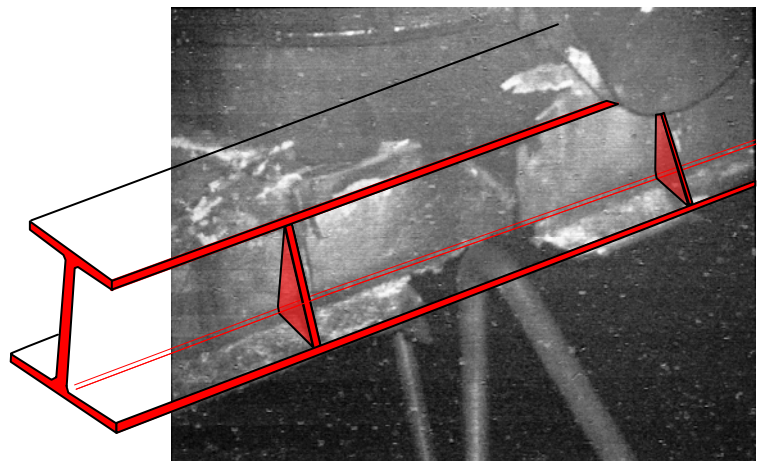
APPENDIX I – FRAME DAMAGE

Adequacy of Seismic Restraint Frame: Three of the principal members of the structural frame have been severed (see APPENDIX I) with other damage to the vessel trimmers and a further structural member of the frame.

- ⁸ The steel frame sections (I-beams) are only protected with paint and thus very susceptible to corrosion by the strong nitric acid content of the spilled clarified liquor. The extent of corrosion is given by some poor quality photographs in the NDA Review (12) which shows sections of both higher and lower level beams completely eroded through – Appendix 1.
