Hamilton City Council

Ruakiwi Reservoir Detailed Seismic Assessment

22 August 2025

3-39777.00/00DSA

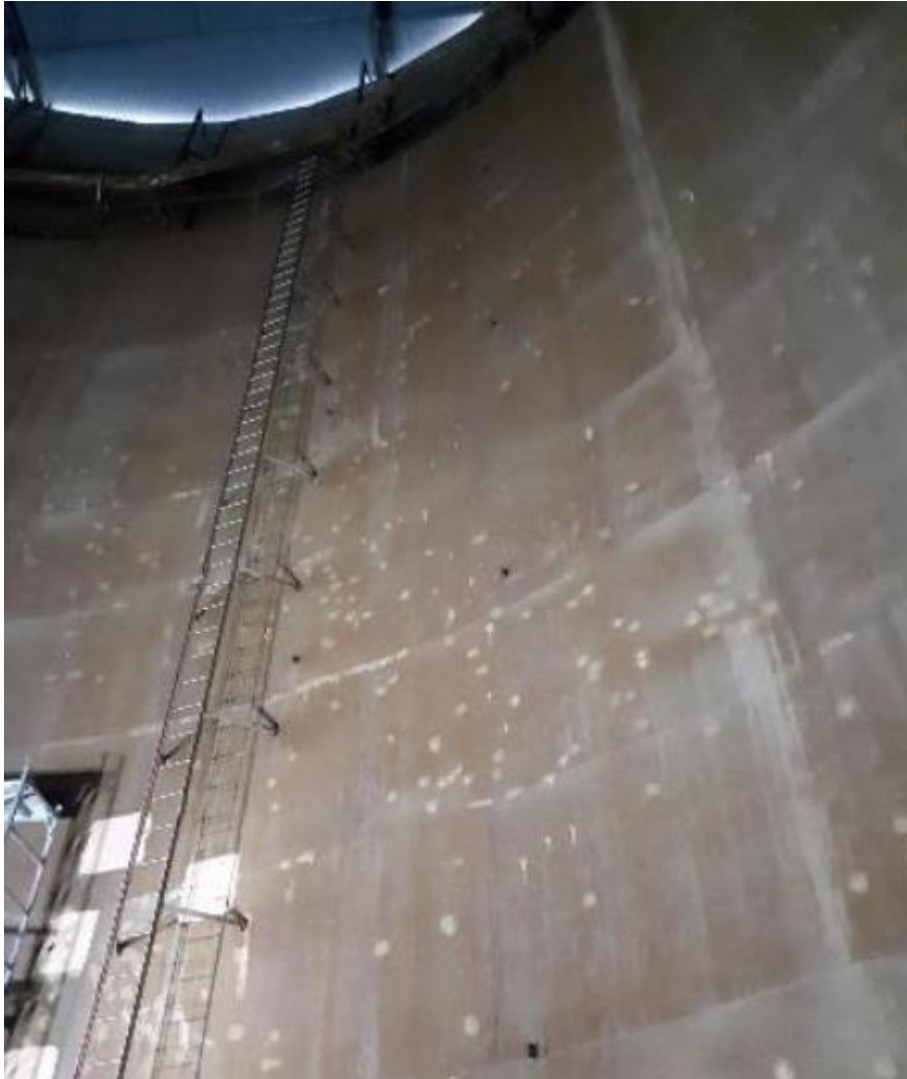
Figure 2-5. Overview of internal steel liner with spot corrosion (Altex Coatings, 2019)

A condition assessment of Ruakiwi Reservoir was completed in 2019 by Altex Coatings Limited. The assessment stated that the steel liner coating the walls has multiple cases of pitting corrosion as deep as 4 mm in some areas. Multiple areas of patch repairs were identified as having poor workmanship and needed repair. The assessment stated that *“of 200 panels, 35 would require full abrasive blast and 150 panels to varying spot repairs estimated at about 25% of the tank wall surface to be blasted and painted”*.

The floor lining was in good condition but requires localised patch repairs. Refer to Figure 2-5 for images of the steel liner condition in 2019.

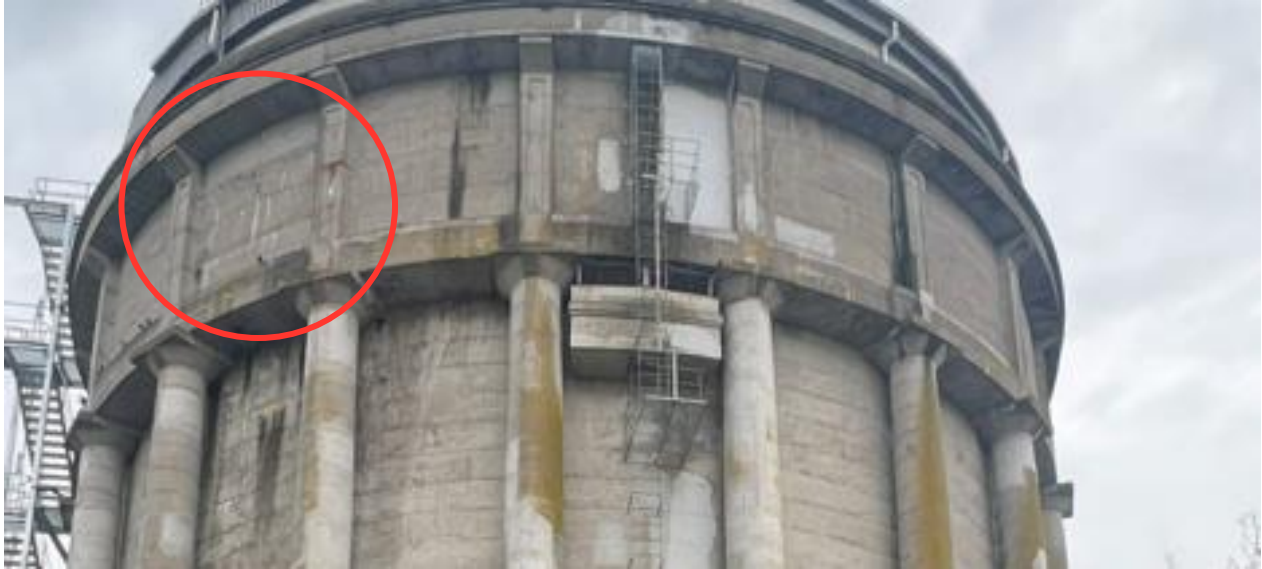
Figure 2-11. Evidence of leaking and reinforcement corrosion in the upper wall and rib (2025)

As stated in the 2002 Condition Assessment Report completed by Opus, the upper walls have no significant defects that are evident. There was evidence of leakage through construction joints, but they have not caused any significant defects. This was further observed in the Site Visit Record completed by WSP in July 2025.

The 2002 Condition Assessment report also made note of reinforcement corrosion in five of the ten stiffening ribs due to a lack of cover and spalling. This damage results in a minor reduction in structural capacity. Evidence of wall leakage and reinforcement corrosion is shown in Figure 2-11.

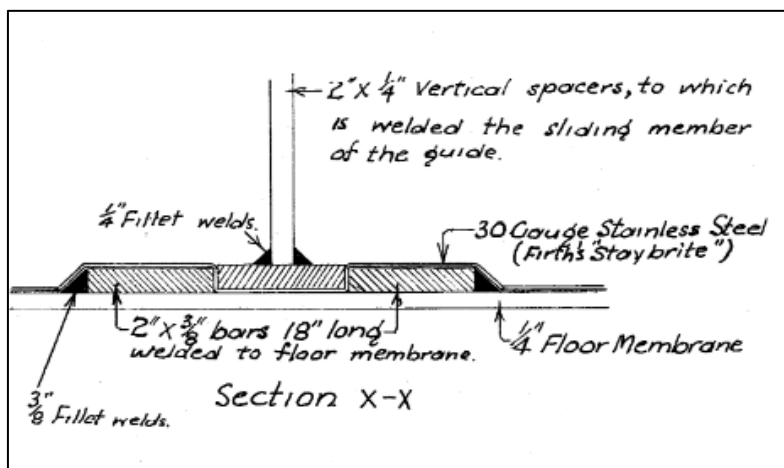
Figure 2-17. Detail of expansion guide

The wall does not appear to have any meaningful connection to the base slab to resist lateral loading. The vertical reinforcement is welded to an expansion guide which allows the reservoir walls to move independently of the base slab. The guide is made up of a 60x10 mm steel plate at the base of the wall and is slotted in between two 50x10 mm steel plates that are coated in stainless steel to allow sliding. The outside plates are then welded to the steel liner on the base slab. There is an expansion joint at each expansion guide location at the base of the wall that has been upgraded in 1948.

The critical structural weakness (CSW) within Ruakiwi Reservoir is the connection between the reservoir wall and the base slab. There is no meaningful connection between the wall and the base slab, and the shear at the base of the wall is entirely resisted by friction resistance.

The only element within Ruakiwi Reservoir that requires strengthening is the base to wall connection. The connection could be strengthened to either 34%NBS, 67%NBS or 100%NBS, depending on HCC's preference. The NZSEE guidance recommends strengthening all structures to 67%NBS with consideration of additional works required to reach 100%NBS or above.

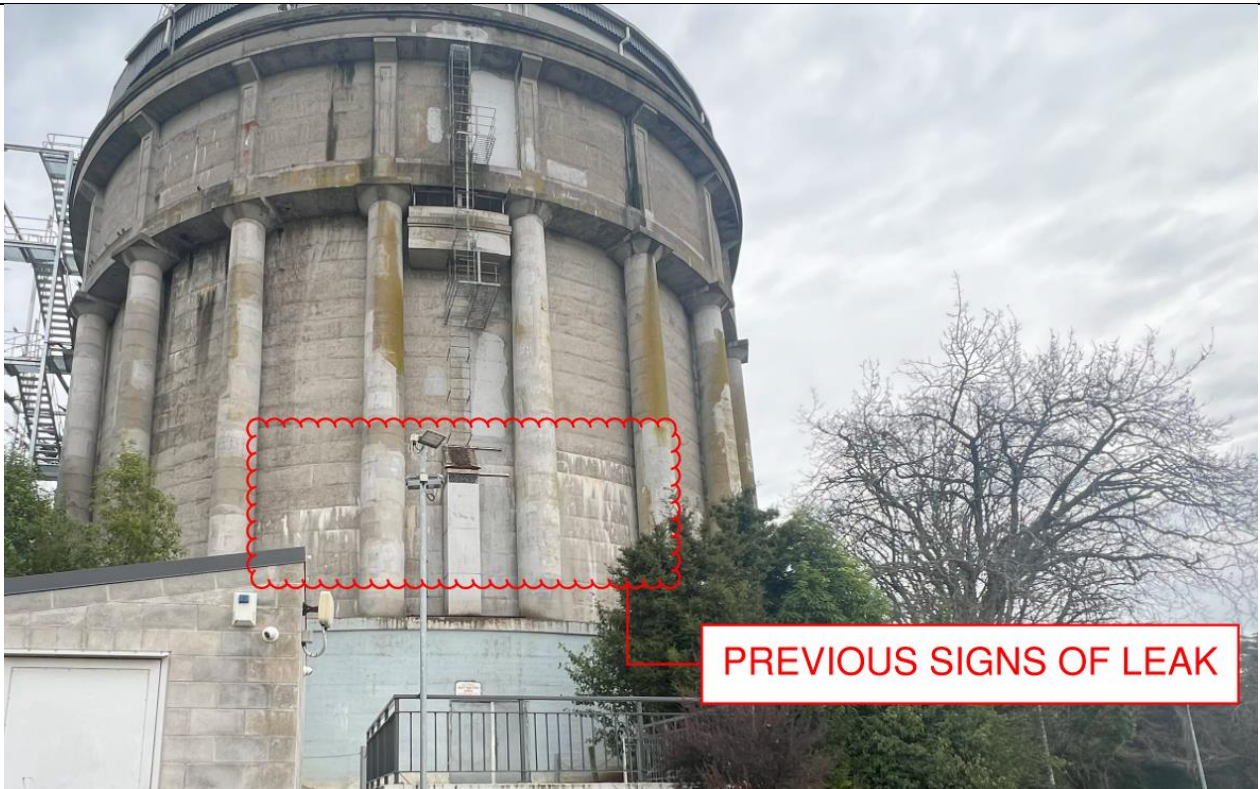
Upon walking around the reservoir, the external conditions of the reinforced concrete were in acceptable conditions where few locations appeared to have signs a leak from the inside the reservoir shown in photo below.

Upon discussing these signs with the staff from HCC, the staff member verbally confirmed that there were previous works to fix the leaks in the past. The staff also explained that there is an approximately 12mm thick steel plate that act as a seal, where the steel cold joints were welded using fusion weld techniques.

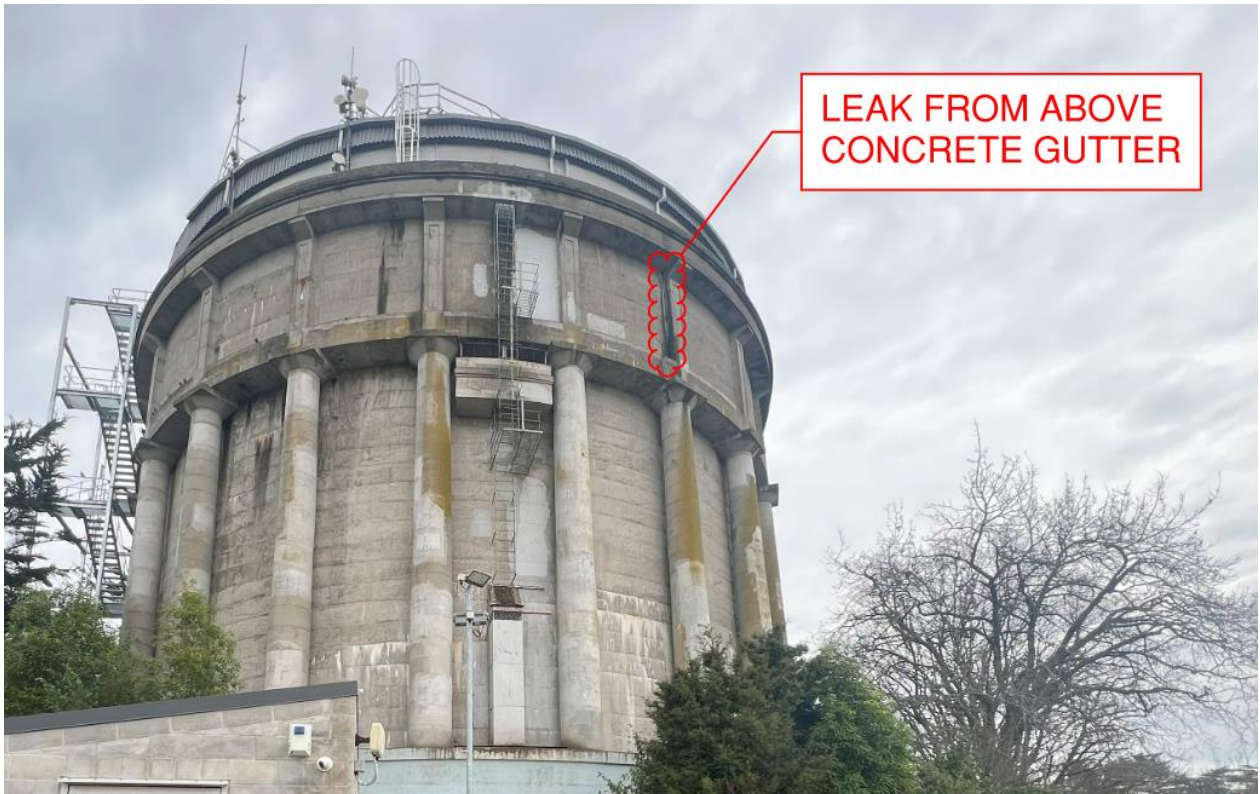
There were also signs of leaks in one of the columns acting as a downpipe as shown below.

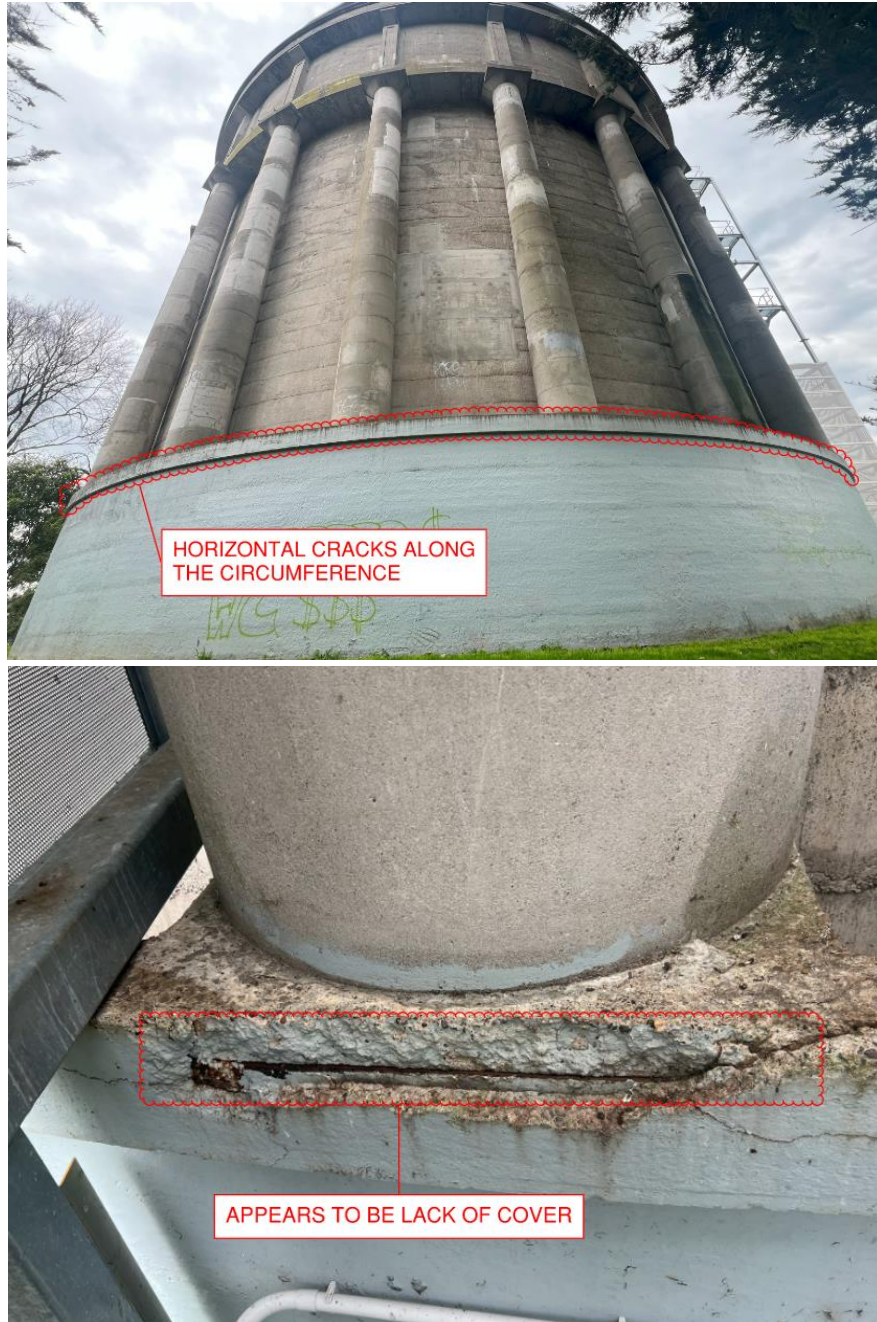
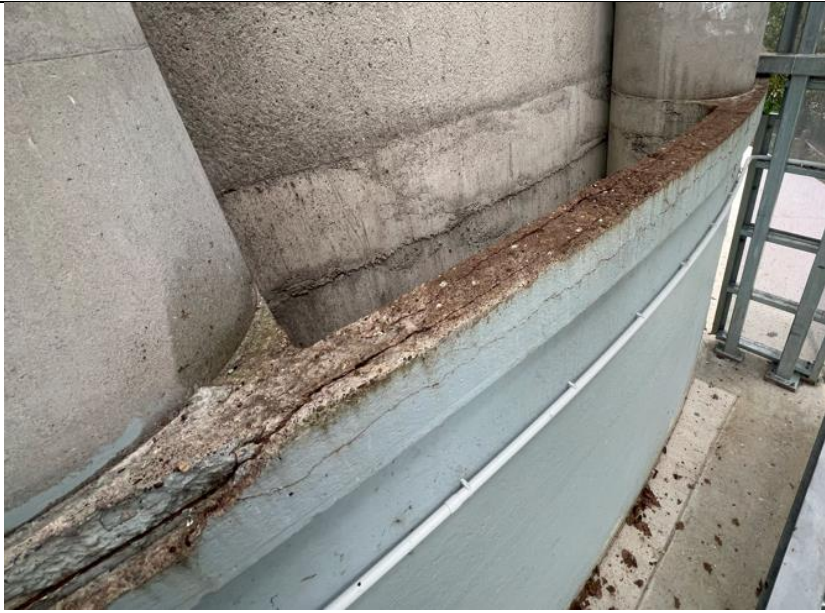
Furthermore, some cracking of the external lower wall was found along the circumference of the reservoir, however appeared to impose low risk to the main reservoir structure.

In summary, the external condition appeared to be in acceptable condition. However, further intrusive investigation in the inside of the reservoir where a leak has occurred will be required to fully determine the condition of the existing reinforced concrete.

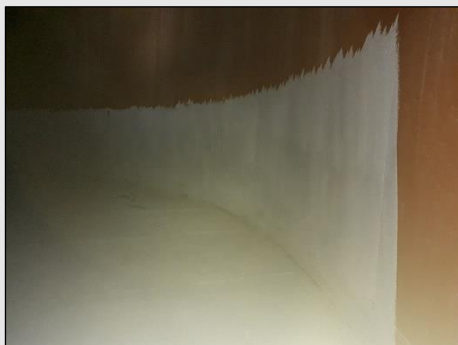
Figure 1 - 6-9 0'clock on wall to 2m roller coat applied coating DFT slightly less than existing

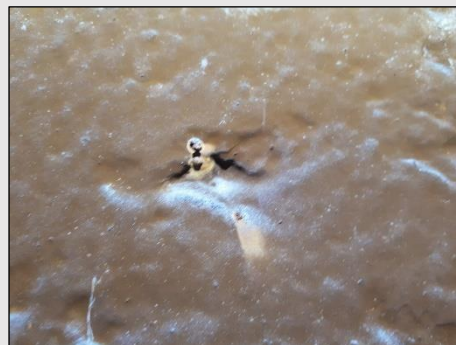
Figure 2 - Pitting corrosion at 6 o'clock closeup

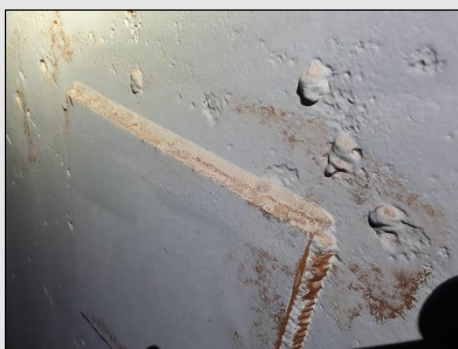
Figure 3 - Patch repair and ugly weld filling, rough edges heavy pitting along bottom strake

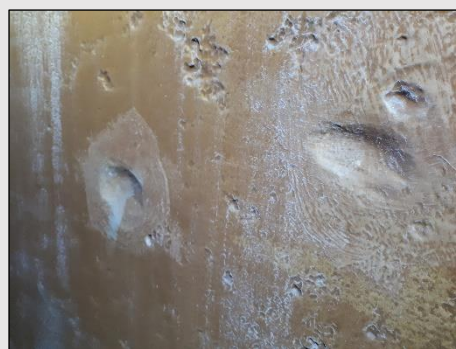
Figure 4 - Spot repairs on corrosion pitting about 4mm deep

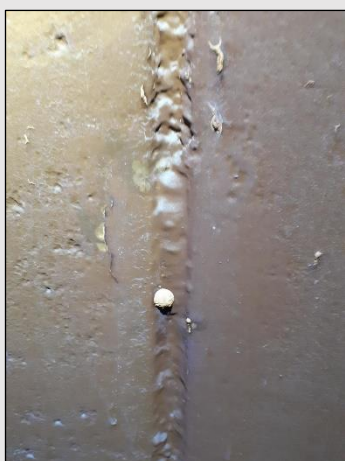
Figure 5 - Weld joint example with spot corrosion returned to power red oxide

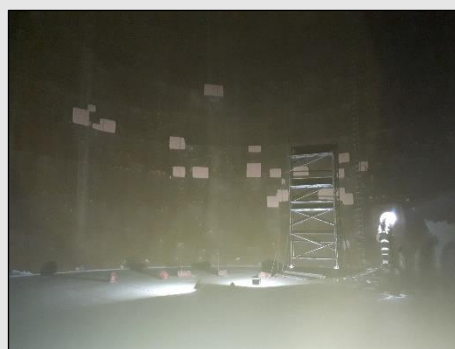
Figure 6 - Overview of patch repairs and corrosion cells looking at 3-6 o'clock worst area 2-7 o'clock corrosion pitting

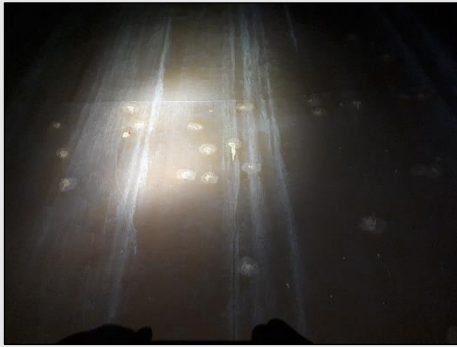
Figure 7 - Example of spot corrosion spaced at 300-400mm apart

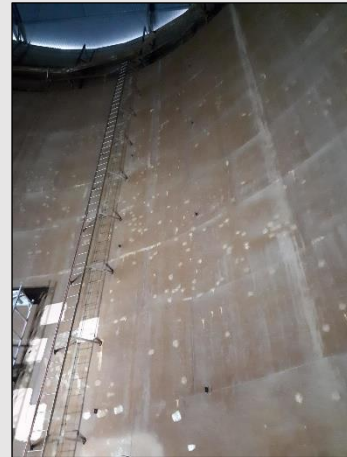
Figure 8 - 6 o'clock overview of spot corrosion on liner

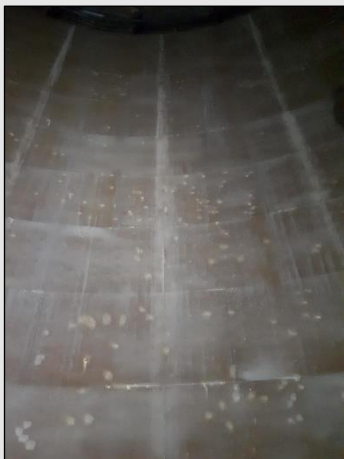
Figure 9 - 8 o'clock overview of spot corrosion on liner

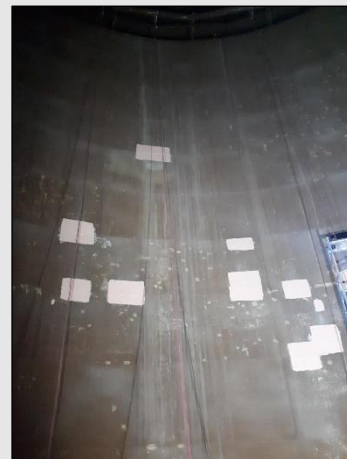
Figure 10 - 4 o'clock estimated surface area for repair at 25%

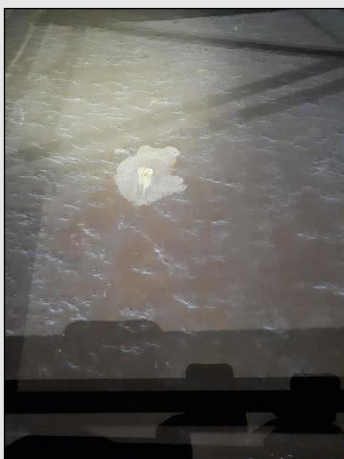
Figure 11 – Previous spot repairs which have failed

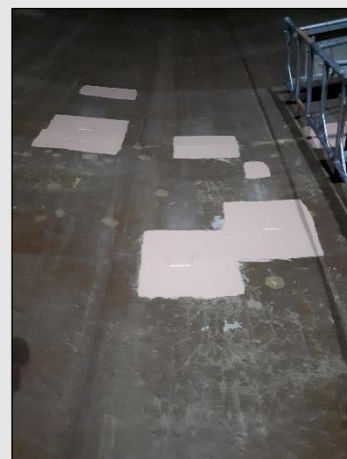
Figure 12 - New steel patch repairs welded and coated in Carboguard 504 and Altra~Shield 2000

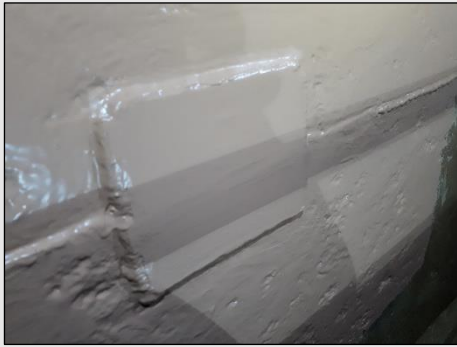
Figure 13 – Close up repair at 5 o'clock 3rd strake up full coating system

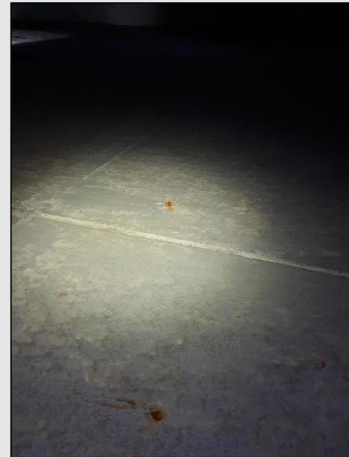
Figure 14 - Floor Spot corrosion at 4th panel in at 3 o'clock

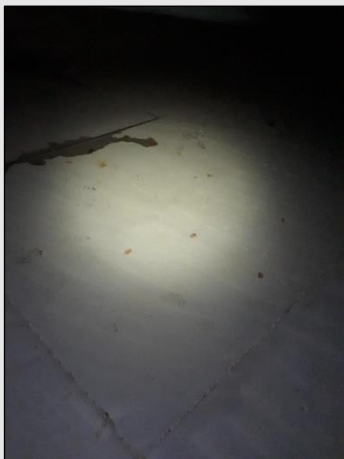
Figure 15 - Floor overview of 4th panels in at 9 o'clock
