Watercourse Assessment Report

Mangakōtukutuku Catchment

Final V4

Prepared for Hamilton City Council by Morphum Environmental Ltd

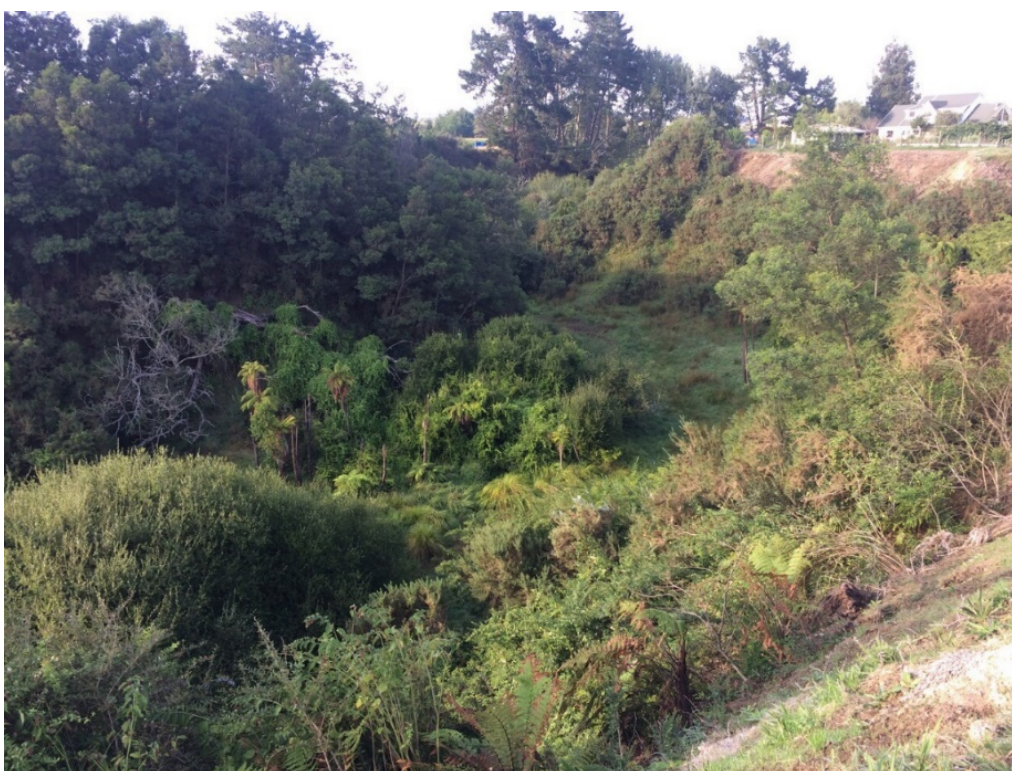
Figure 6: Extensive cover of weed species along gully floor in the eastern sub-catchment.

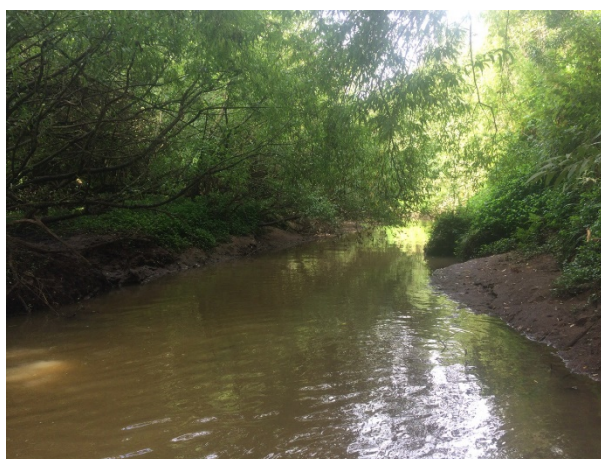
Figure 7: Sediment deposition on MGK_Main_2.

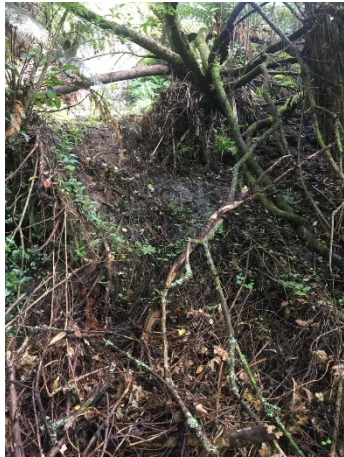
Figure 18: Landslip on true right bank on MGK_C_Trib1_1.

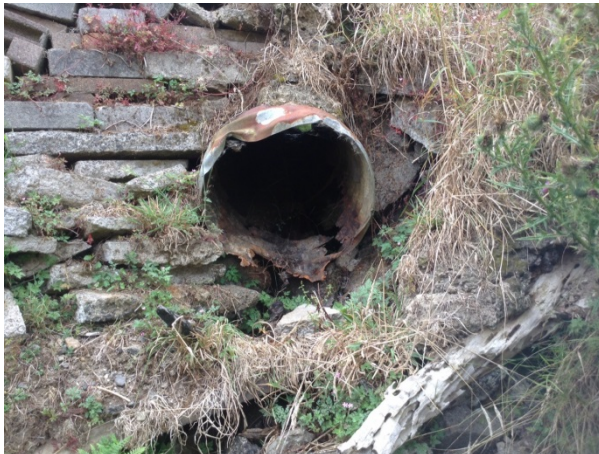
Figure 92: Culvert in poor condition upstream of MGK_E_Trib4_2.

Along tributary 4, a poor condition culvert upstream of MGK_E_Trib 4_2 presents a complete barrier to all fish species (Figure 92). There is good upstream habitat for fish including a large pond and wetland.

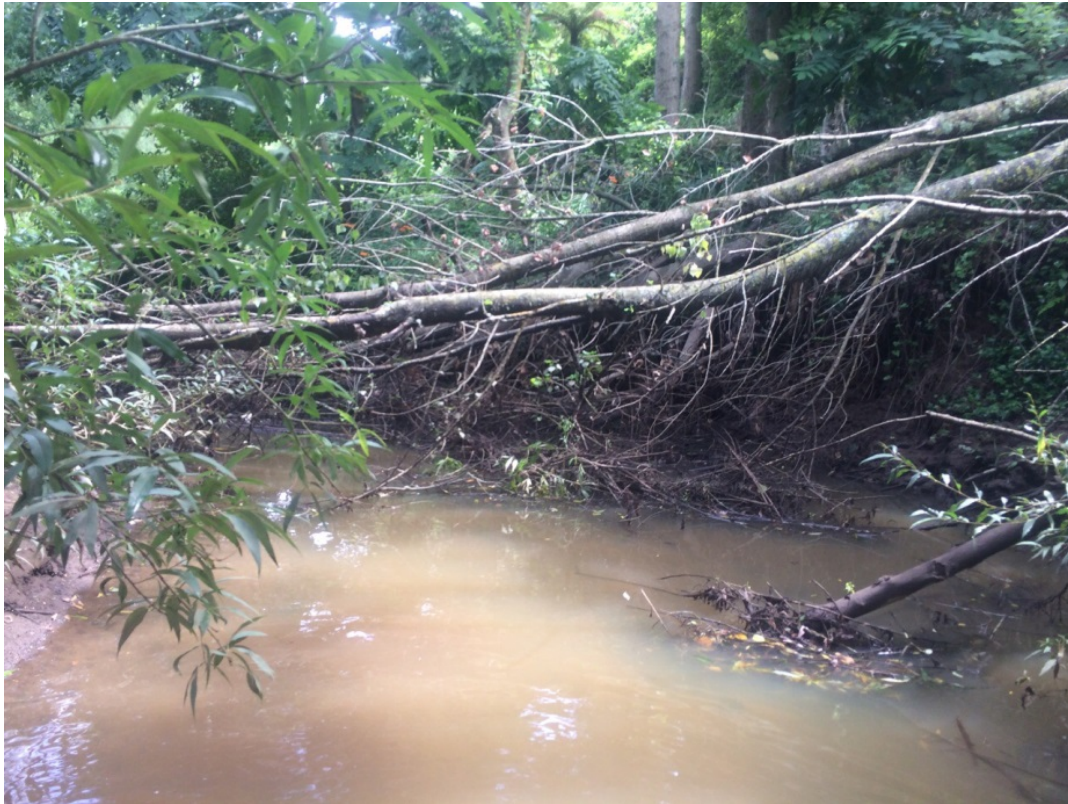
Figure 116: Debris jam where Koi Carp were sighted along MGK_Main_3.

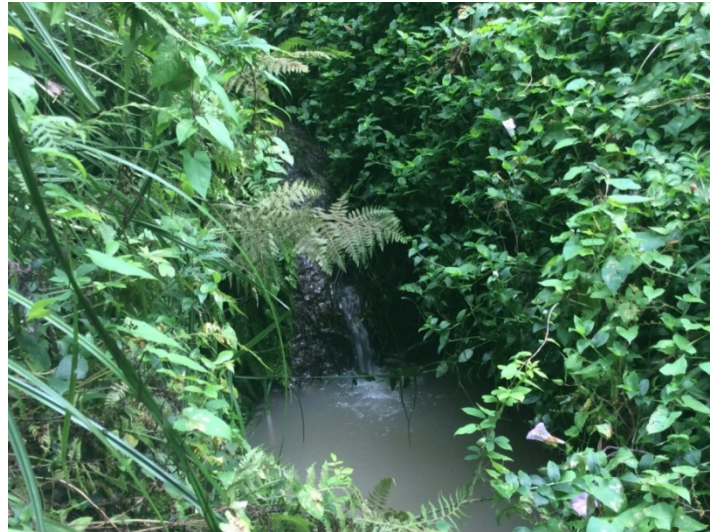
Figure 117: Fish passage barrier to swimming species along MGK_W_Trib2_1.

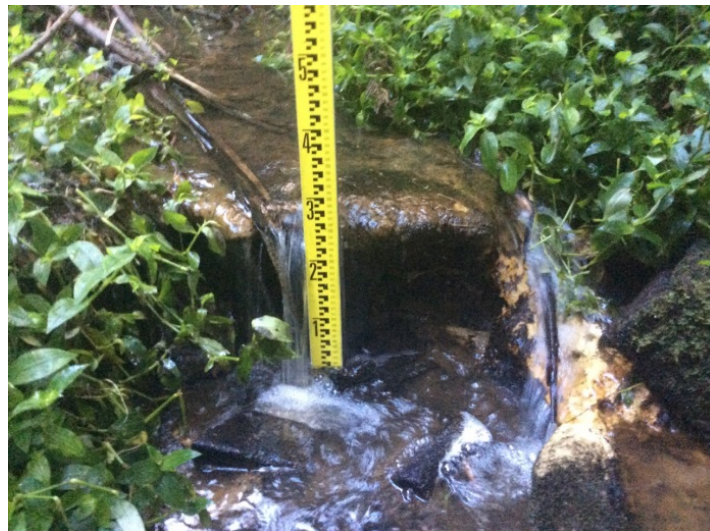
Figure 118: Fish barrier at MGK_W_Trib5_1.

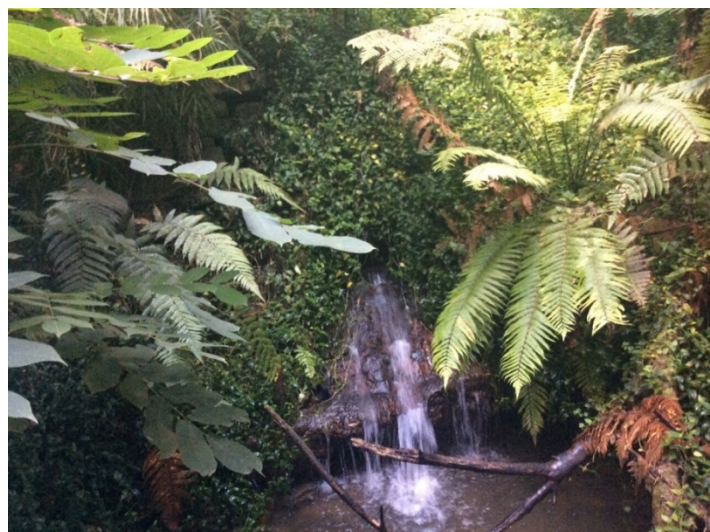
Figure 119: Culvert under driveway causing a fish barrier at the apron MGK_W_Trib5_1.

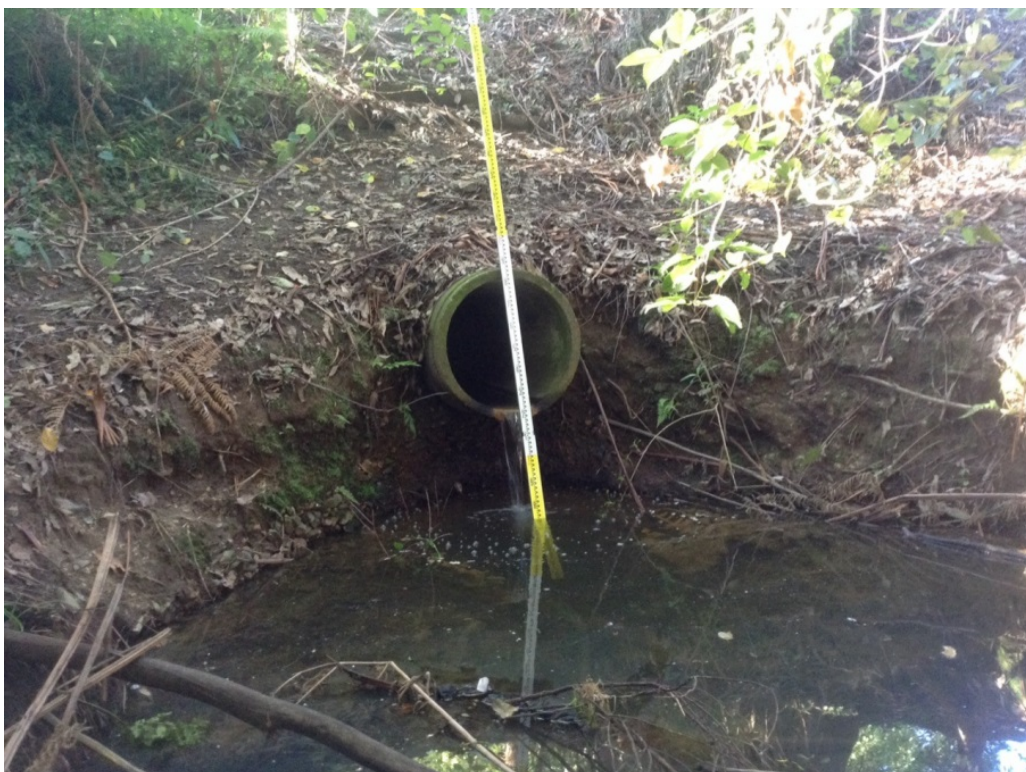
Figure 120: Perched culvert presenting a fish barrier in low flows.

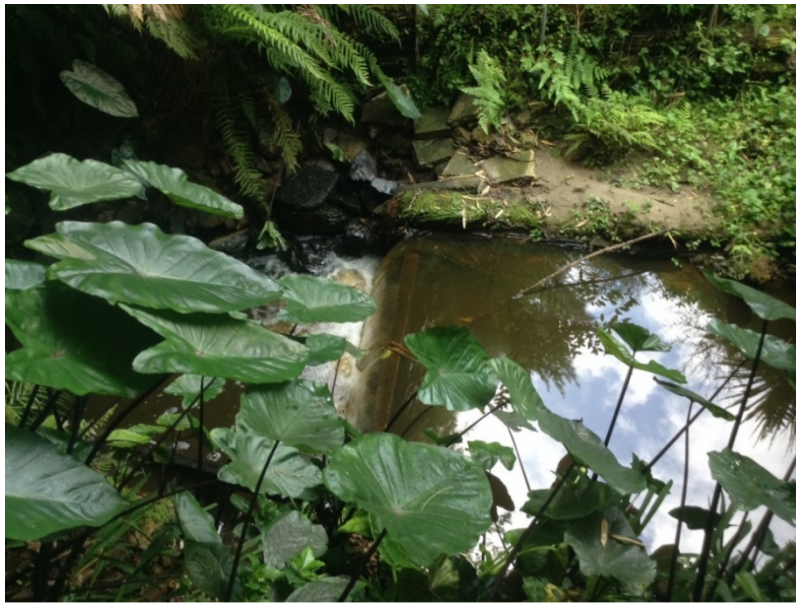
Figure 121: Weir structure upstream of Splitt Ave along MGK_C_Main_3.

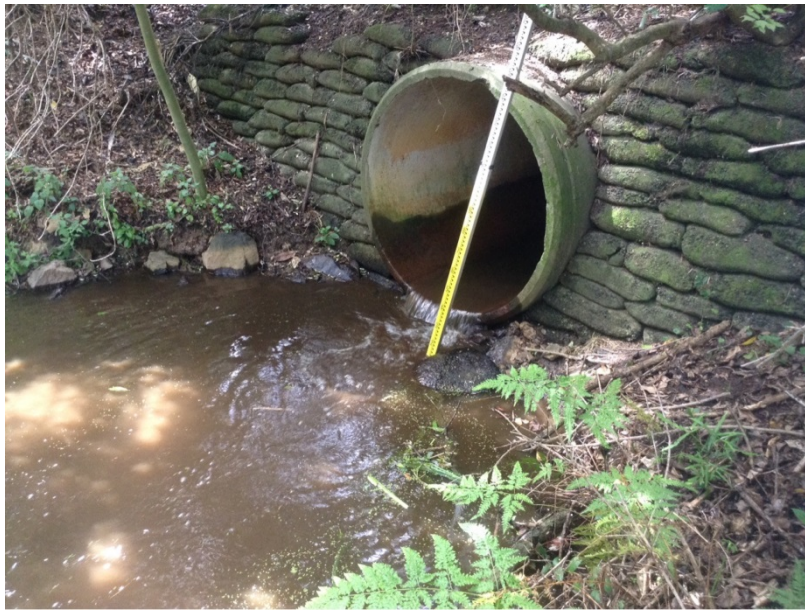
Figure 123: Fish barrier under John Webb Drive.

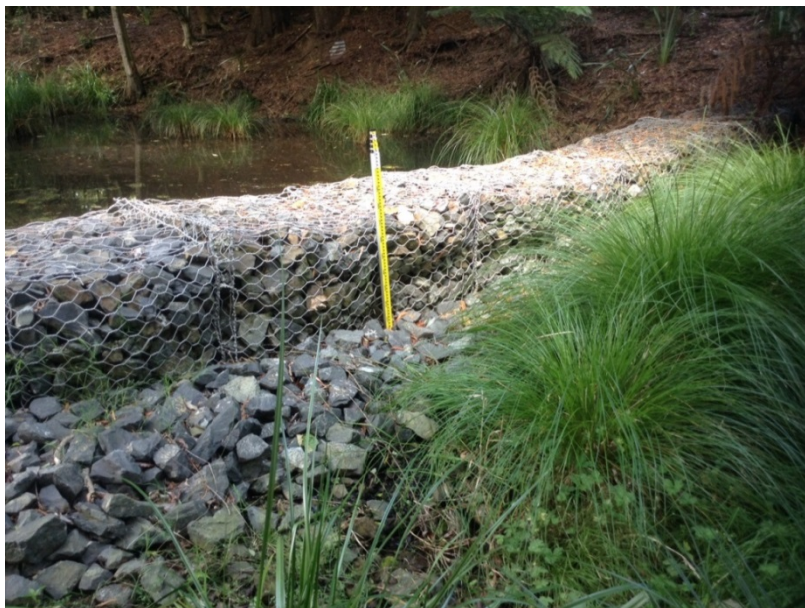
Along the small tributary off Fork 2 (MGK_C_Fork2_Trib1_1), the Carbourne wetlands and weir structures present a barrier to climbing species of fish (Figure 124). There is no significant upstream habitat upstream of the Carbourne Wetlands under the current development flows.

Figure 124: Carbourne Wetlands fish barrier.

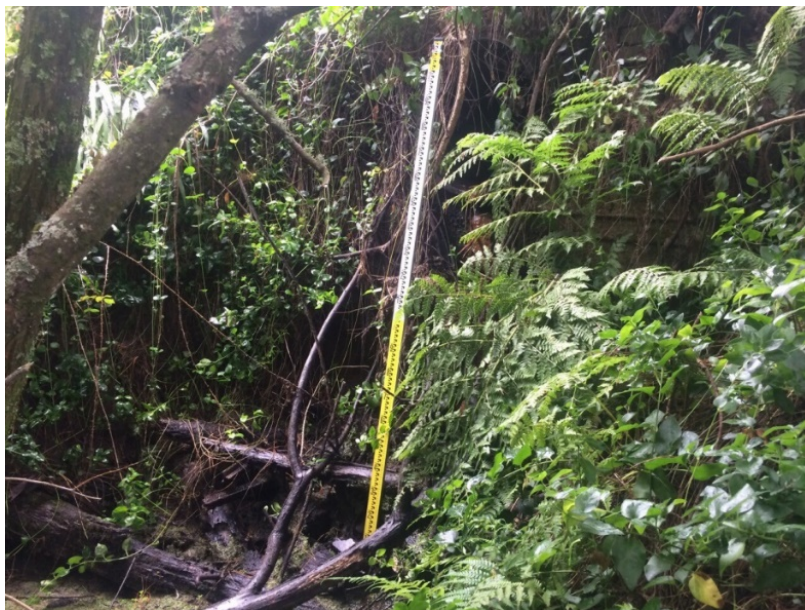
Figure 127: Fish barrier at perched culvert under farm crossing upstream of MGK_E_Trib3_3.

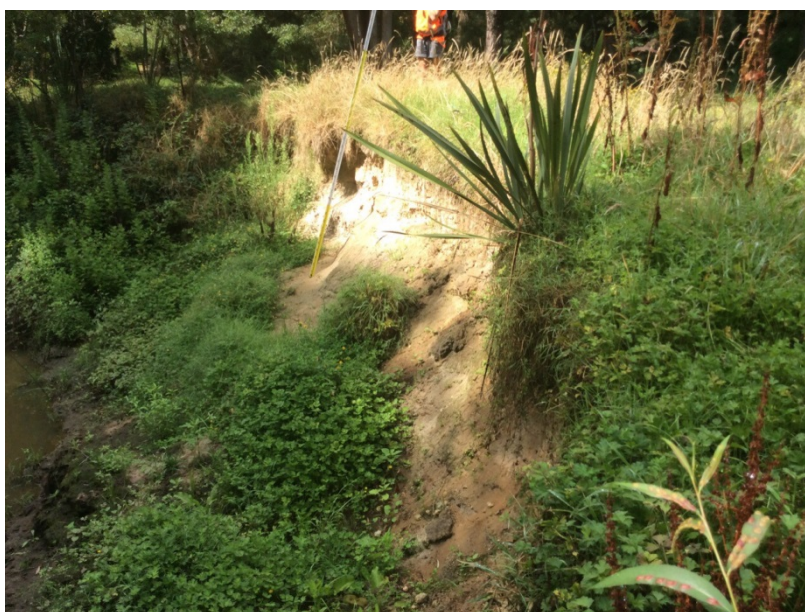
Figure 130: Erosion Hotspot along MGK_Main_2.

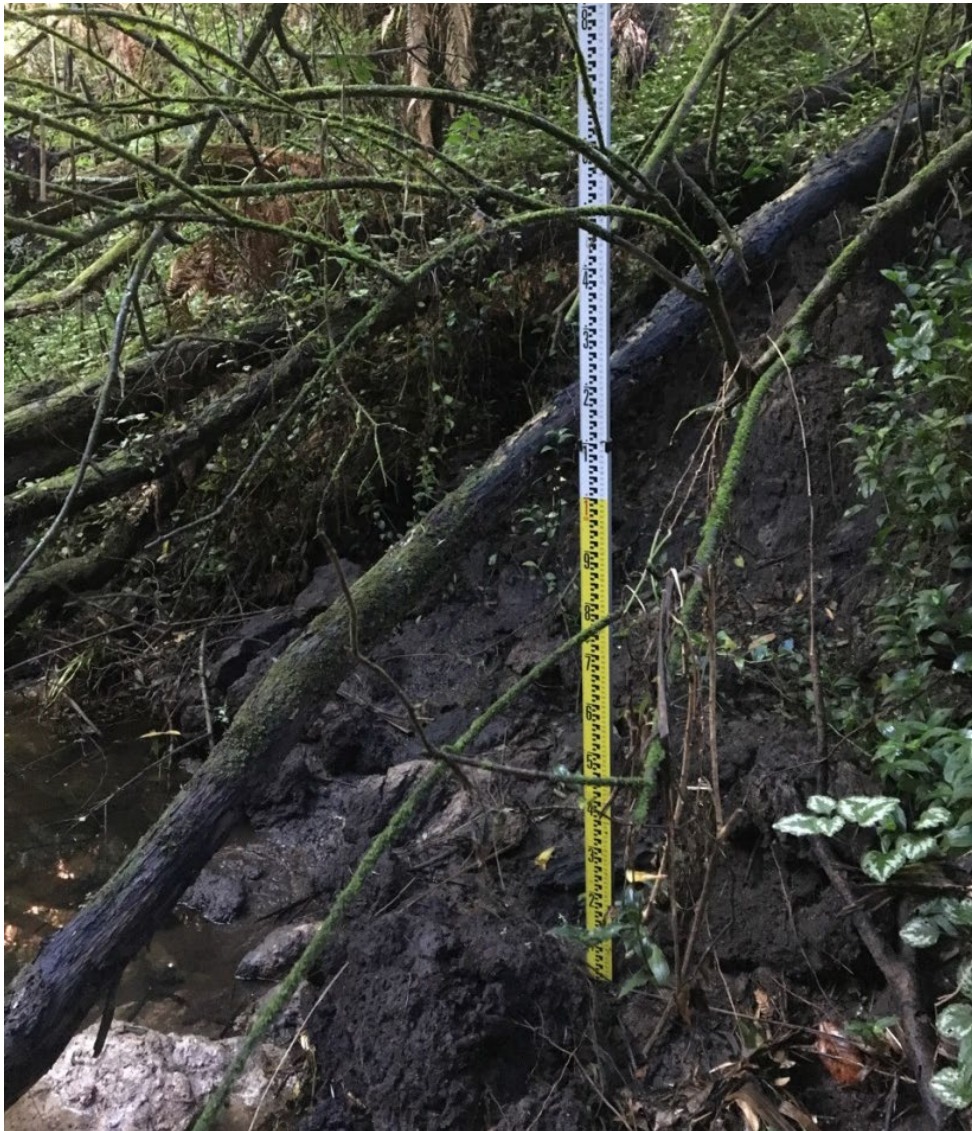
Figure 131: Erosion hotspot on MGK_C_Main_4.

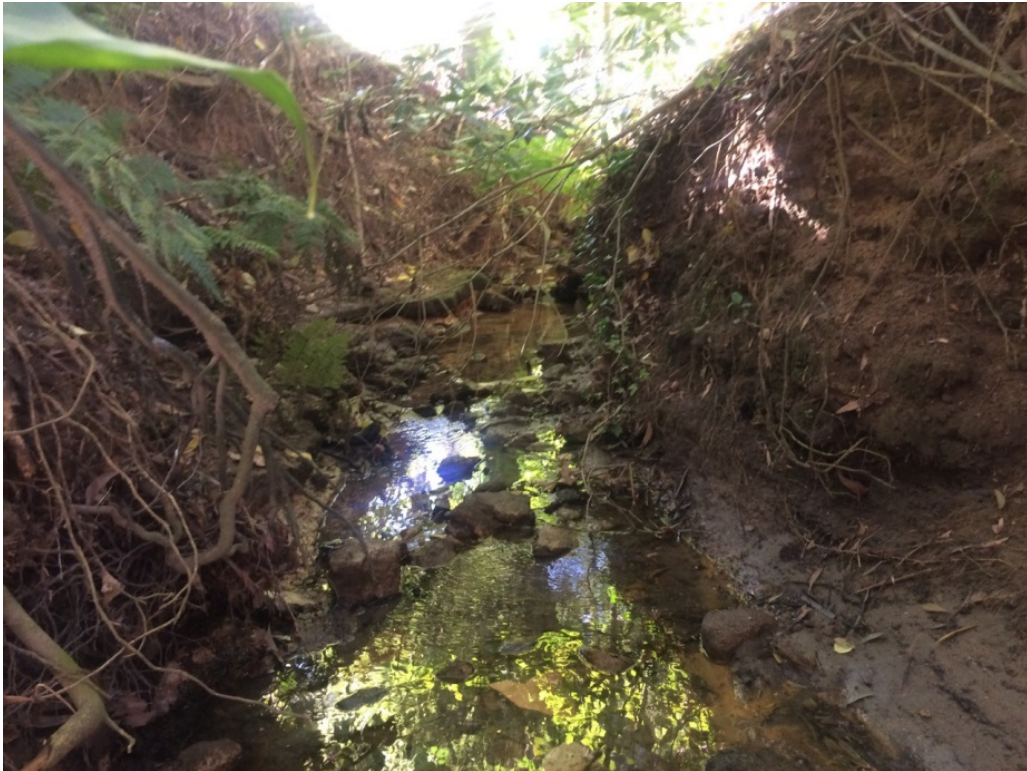
Figure 132: Down-cutting along MGK_C_Trib1_4.

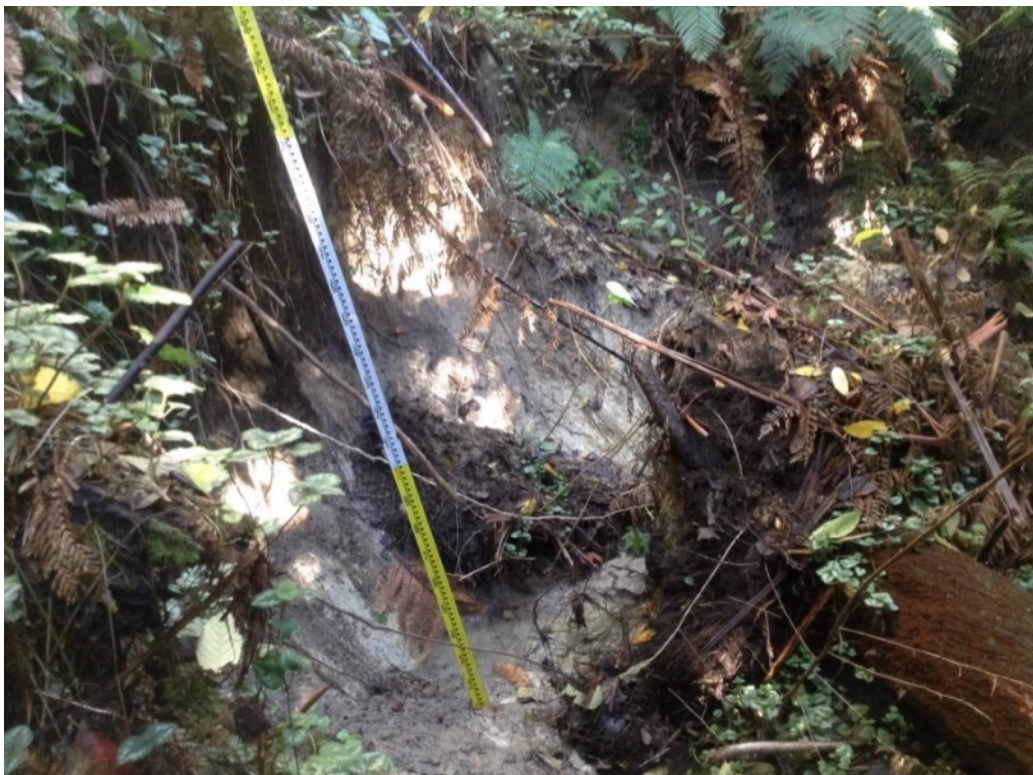
Figure 133: Bank slumping and scour along MGK_C_Trib1_2 assessed during June 2017 walkover.

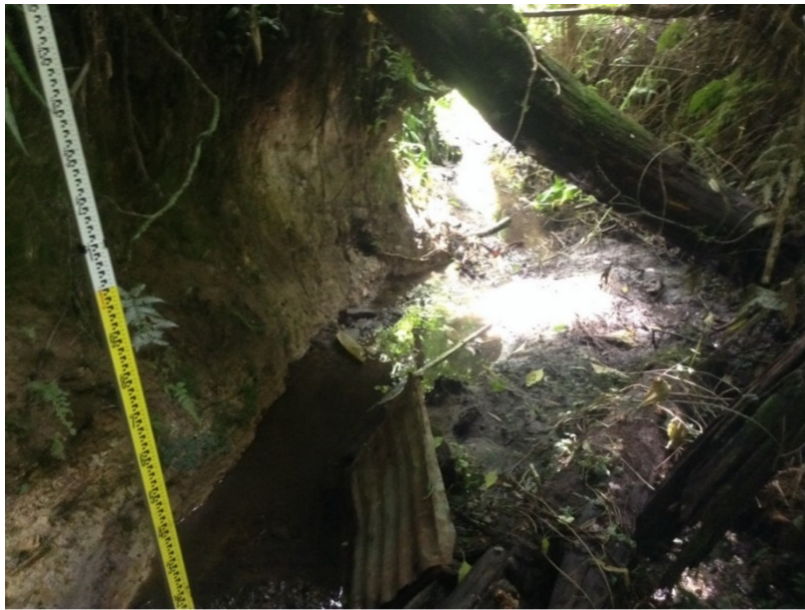
Figure 134: Erosion and scour along MGK_C_Trib2.

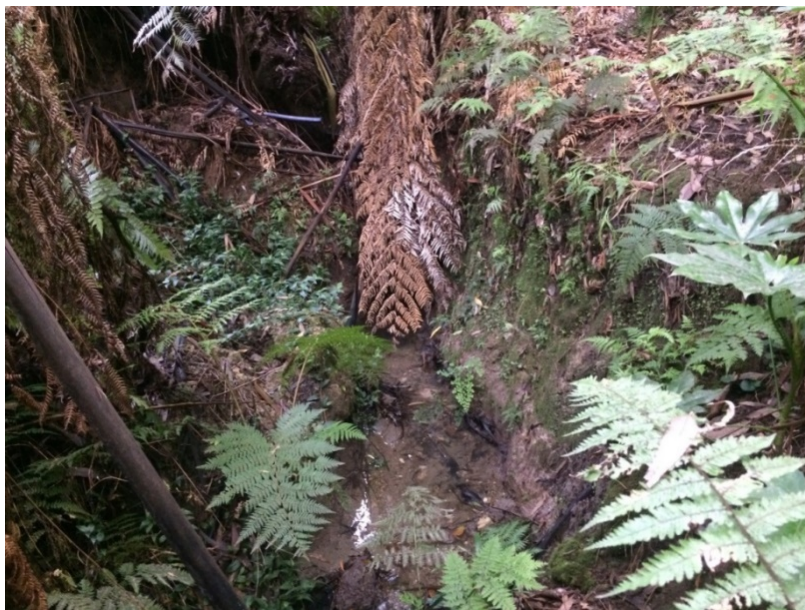
The fourth tributary of the central main channel (MGK_C_Trib4) is a highly incised 100 m reach which is assessed as >60% erosion scarring on both banks (Figure 135). The reach receives pipe discharge from the stormwater network through a 425 mm pipe. The immediate banks along the reach are vertical or near vertical and approximately 2.5 m high. The gully banks are steep with an overall stability score of poor. There is extensive planting along the reach with native understory and good overhead cover however; the reach has poor density of vegetation and root mass.

Figure 135: Incised reach at MGK_C_Trib4.

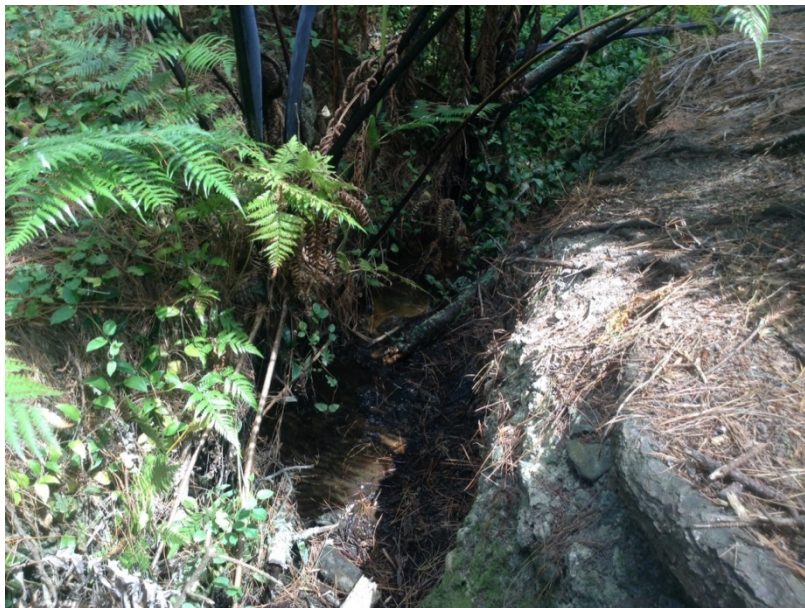
Figure 136: Incised channel and erosion scarring along MGK_W_Trib1_Fork1_2.

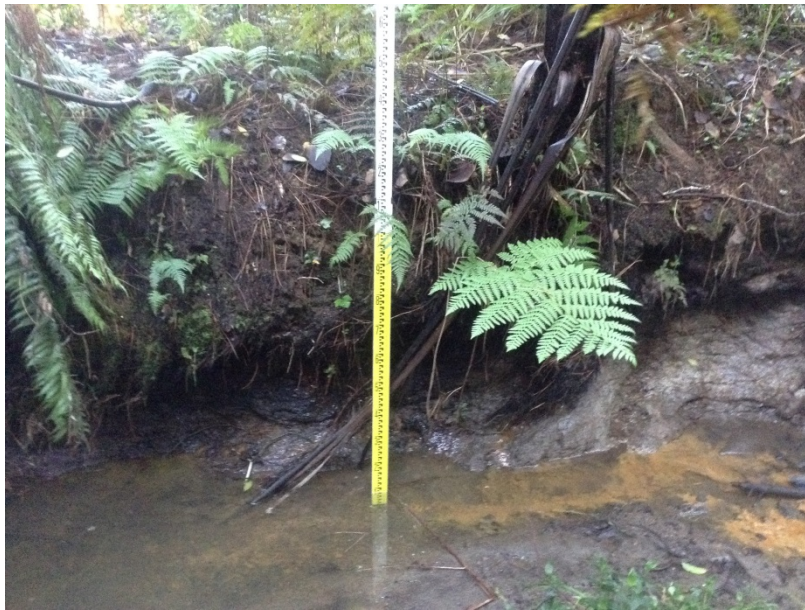
Figure 137: Bank undercutting along MGK_W_Trib1_Fork1_1.

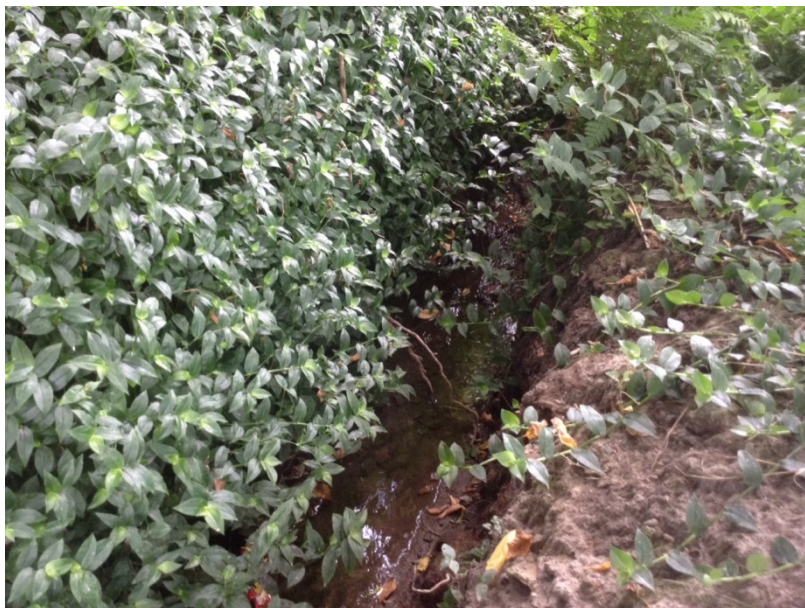
Figure 138: Incised channel along MGK_W_Trib1_Fork2.

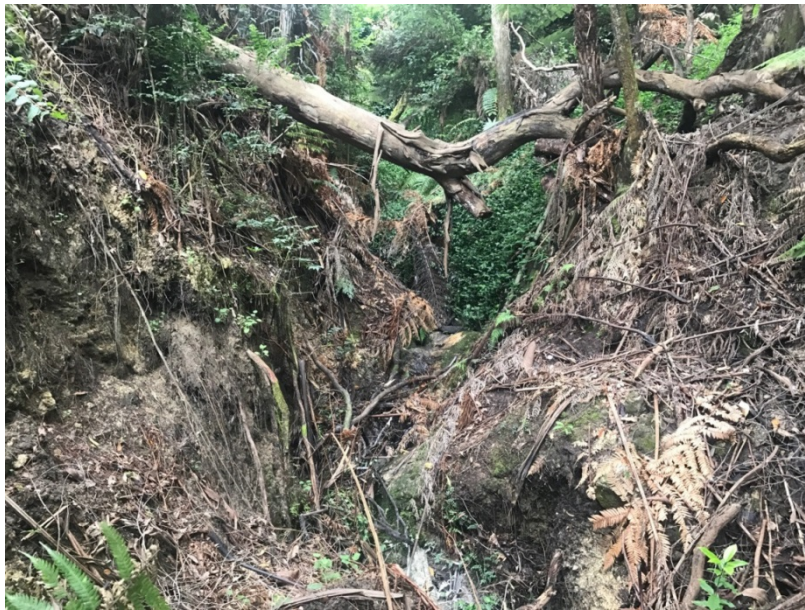
An isolated section (25 m) of the third tributary along the western main channel (MGK_W_Trib3_1) has >60% bank erosion on both banks. The section of stream is incised with steep gully banks >20 m and evidence of high flows from the amount of debris deposited on the upper banks (Figure 139). There was high sediment deposition with little to no flow during survey. There is limited vegetation on the immediate banks however there was good cover from the surrounding canopy. Upstream, a series of wooden weirs and bank lining structures were observed which may contribute to the erosion identified further downstream (see Figure 140).

Figure 139: High erosion reach along MGK_W_Trib3_1.

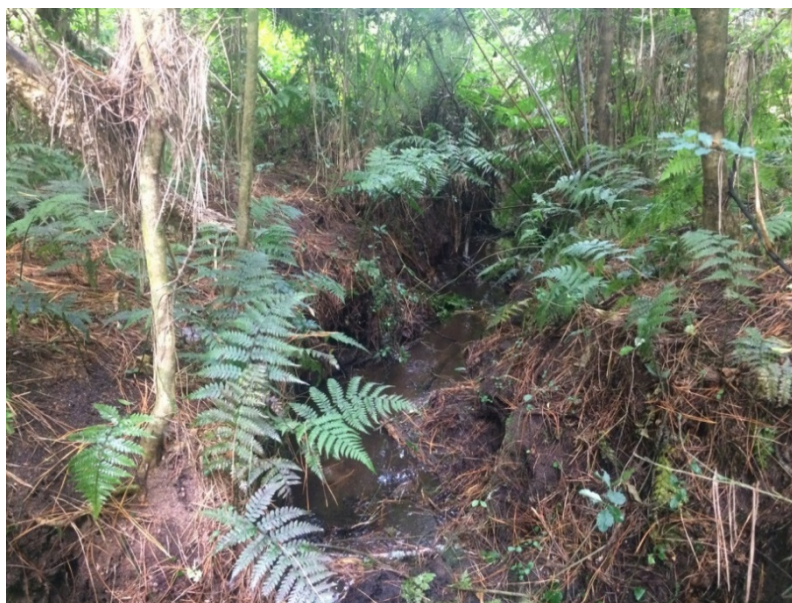
Figure 141: Erosion hotspot along MGK_E_Trib3_1.
