ROKOKAURI NORTH SHA

PRELIMINARY SITE INVESTIGATION

PROJECT NO: HD637
GREEN SEED CONSULTANTS LTD
REFERENCE: PSI/1
11 JULY 2018

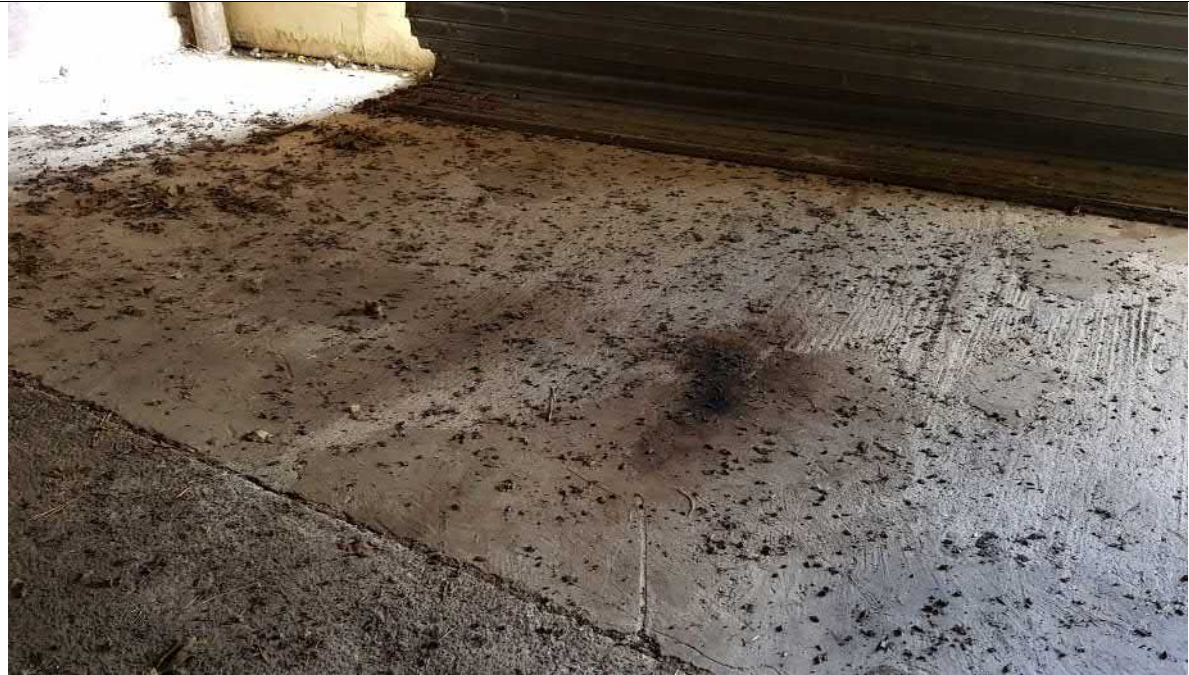
There were hazardous substances (e.g., pesticides, animal drench, paints, lubricants) found in multiple buildings across a majority of the Site. There was minor hydrocarbon staining found in the sheds in Lot 5 DPS 15123 (paved), and Lot 6 DPS 15123 and Lot 2 DP 485743 (unpaved). Rubbish, including empty containers of hazardous substances, was present around and within buildings in the site; the majority of this was located at a workshop/scrap yard in Lot 3 DPS 15123, three of the sheds in the northern side of Lot 6 DPS 15123, and the two sheds and rubbish pit located at the operational dairy farm (Lot 6 DP 359488, PT Lot 7 DPS 15255). The sheds around the Site (Sec 23 SO 495676, Lots 3, 5, 6 DPS 15123, Lot 2 DP 485743, Lots 3-4 DP 15254, Pt Lot 7 DPS 15255, Lot 10 DPS 15255, Lot 6 DP 359488) are

Photo 1. Hydrocarbon staining on floor of shed, facing west. Lot 5 DPS 15123.

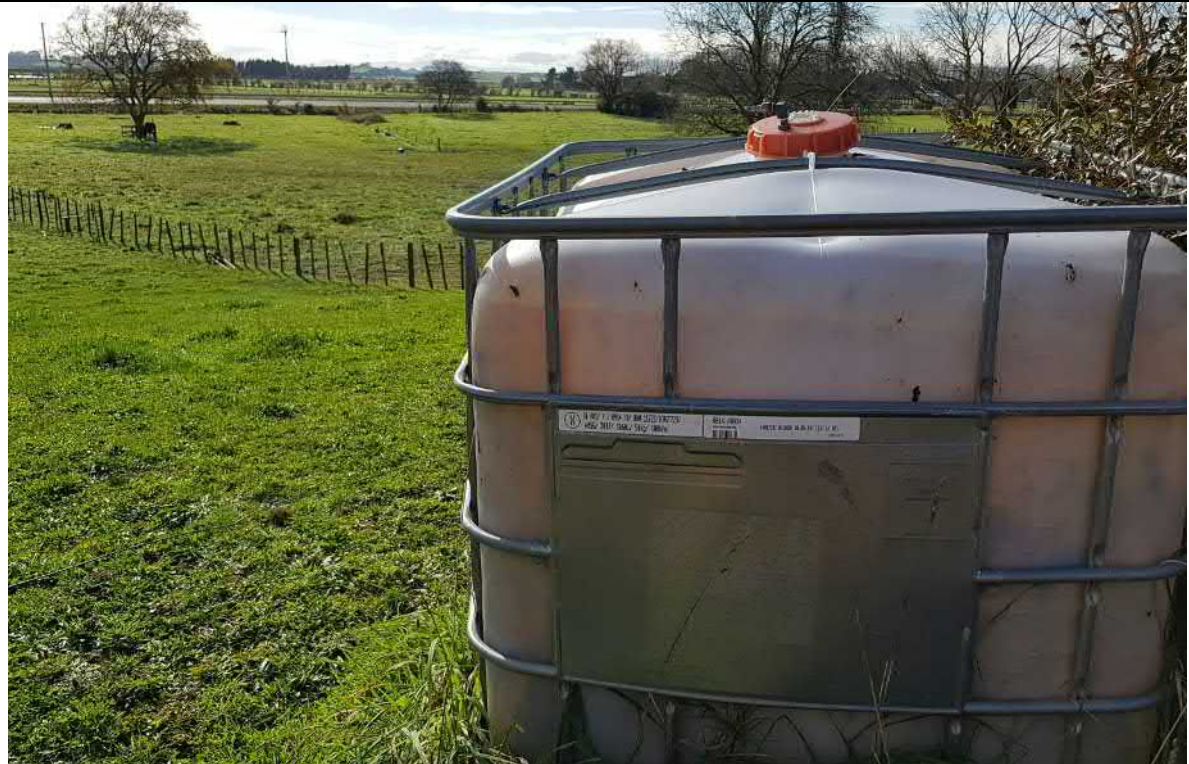
Photo 2. Unknown storage tank, facing north. SEC 23 SO 495676.

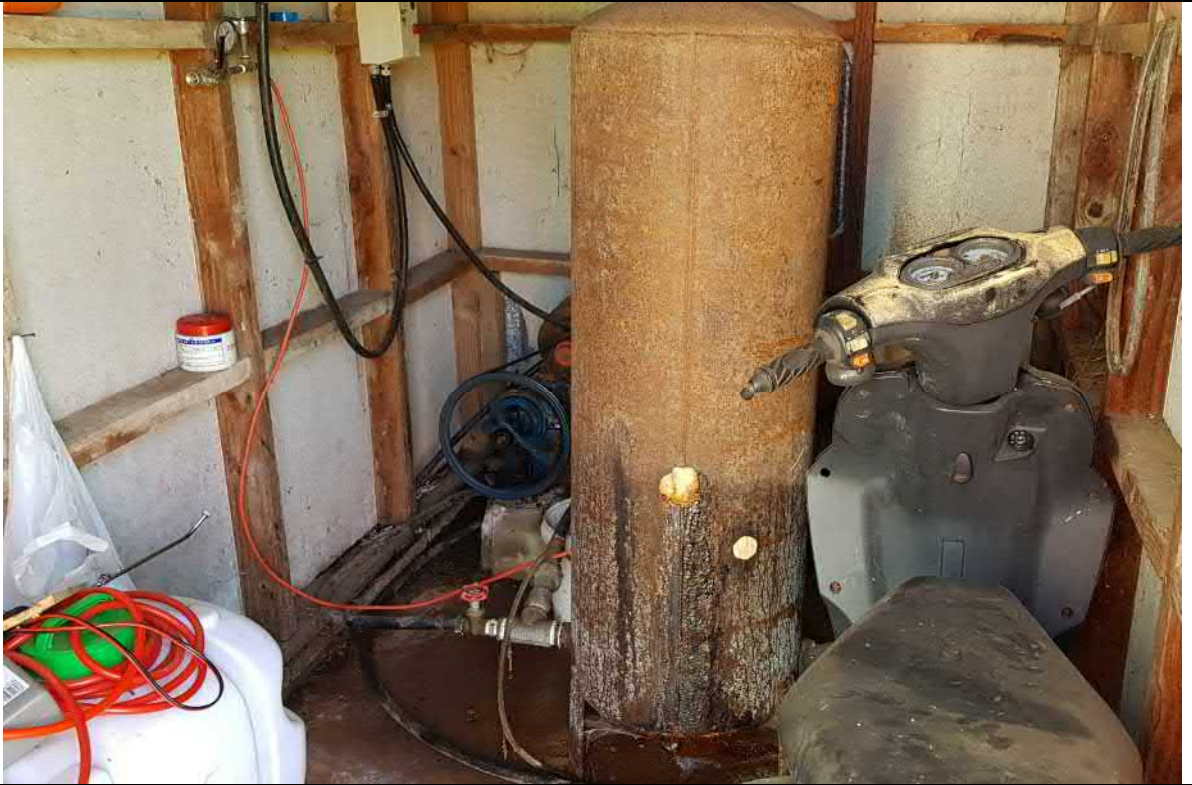
Photo 3. Unknown metal tank (leaking) with generator & herbicide tank, facing west. SEC 23 SO 495676.

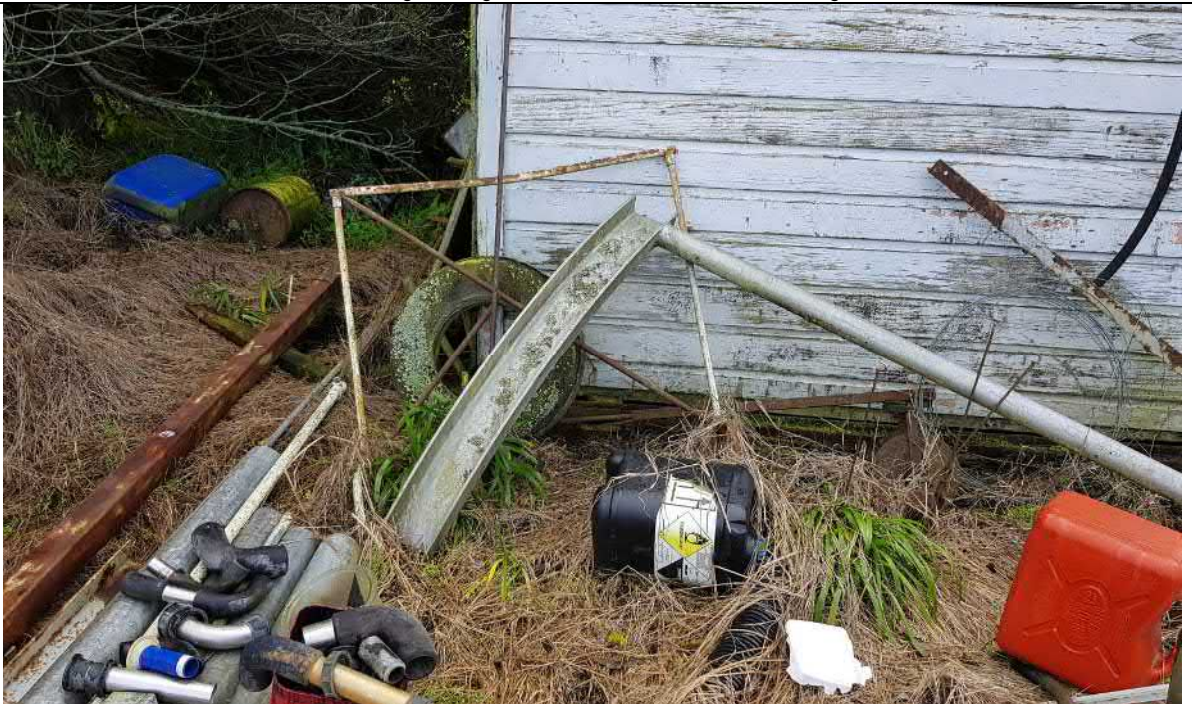
Photo 4. Fuel and oxidizing bottles, facing north. LOT 6 DPS 15123.

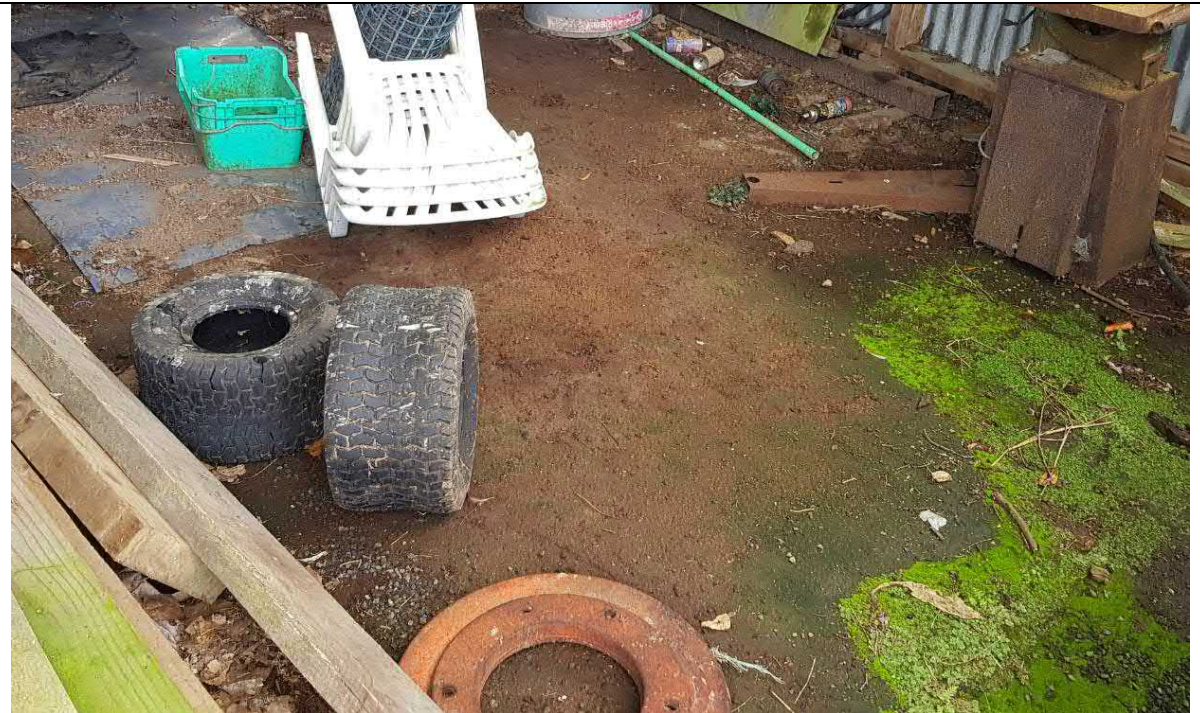
Photo 5. Potentially hydrocarbon stained soil, inside barn facing north-east. LOT 6 DPS 15123.

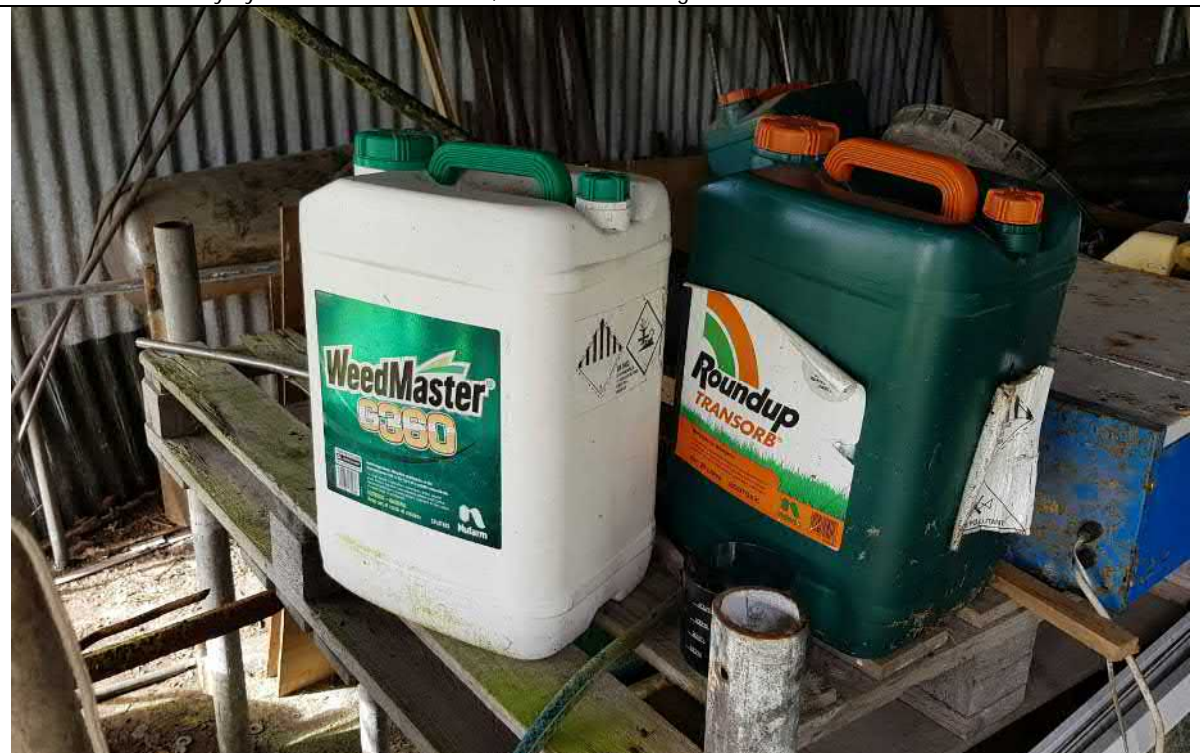
Photo 6. Glyphosate (organophosphorus) herbicides in shed. LOT 6 DPS 15123.

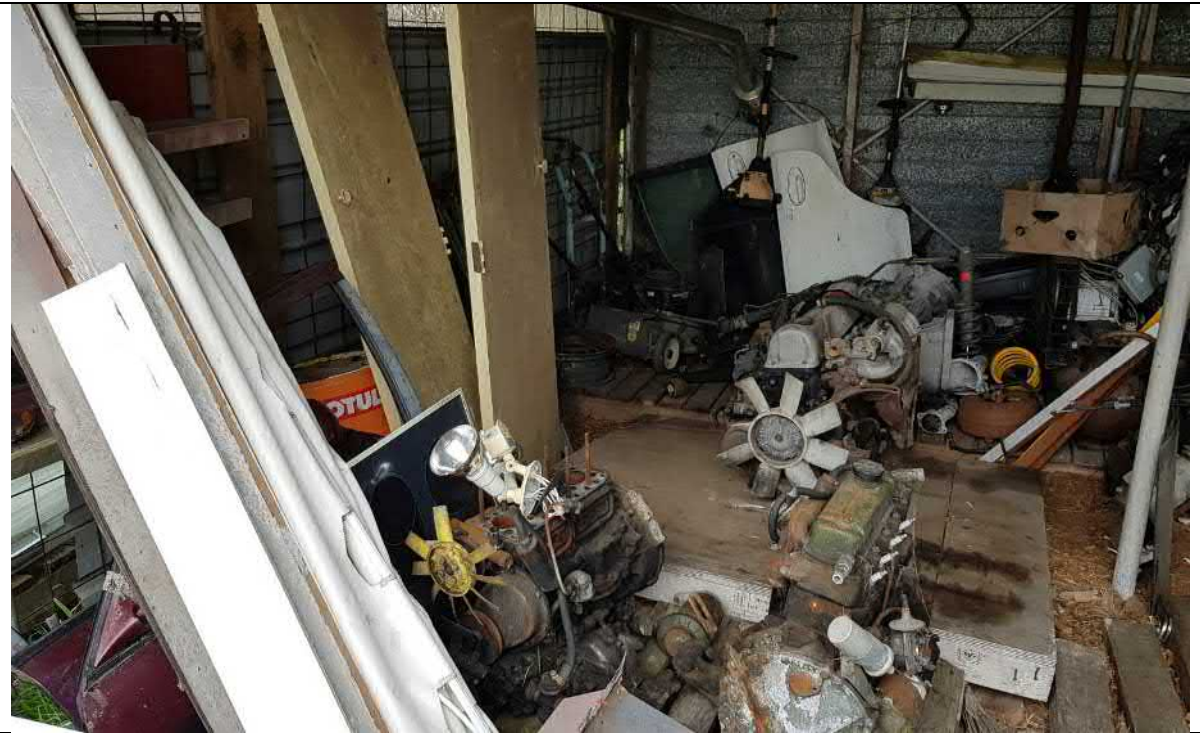
- The workshop/scrap yard at Lot 3 DPS 15123 is used to store hydrocarbons and other hazardous substances. Workshops and scrap yards are considered HAIL activities.

Photo 9. Multiple engine components in storage shed. LOT 3 DPS 15123.

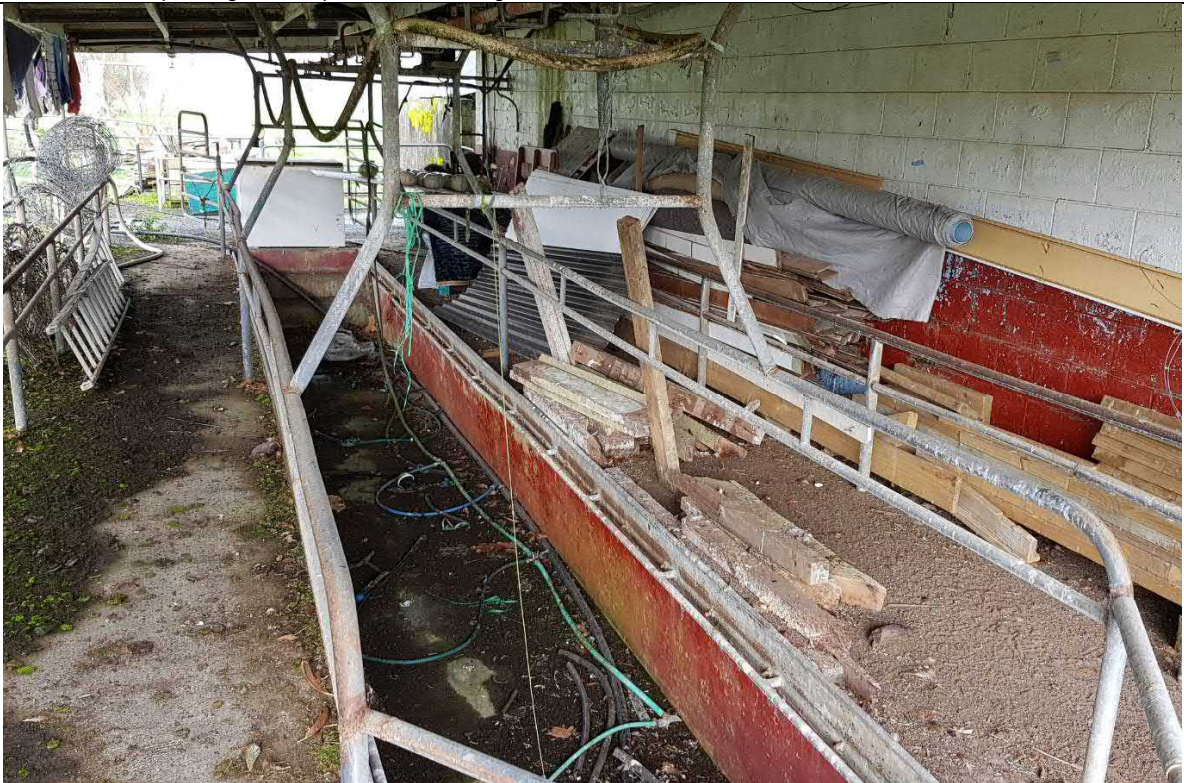
Photo 10. Dairy cattle milking station, facing south. LOT 2 DP 485743.

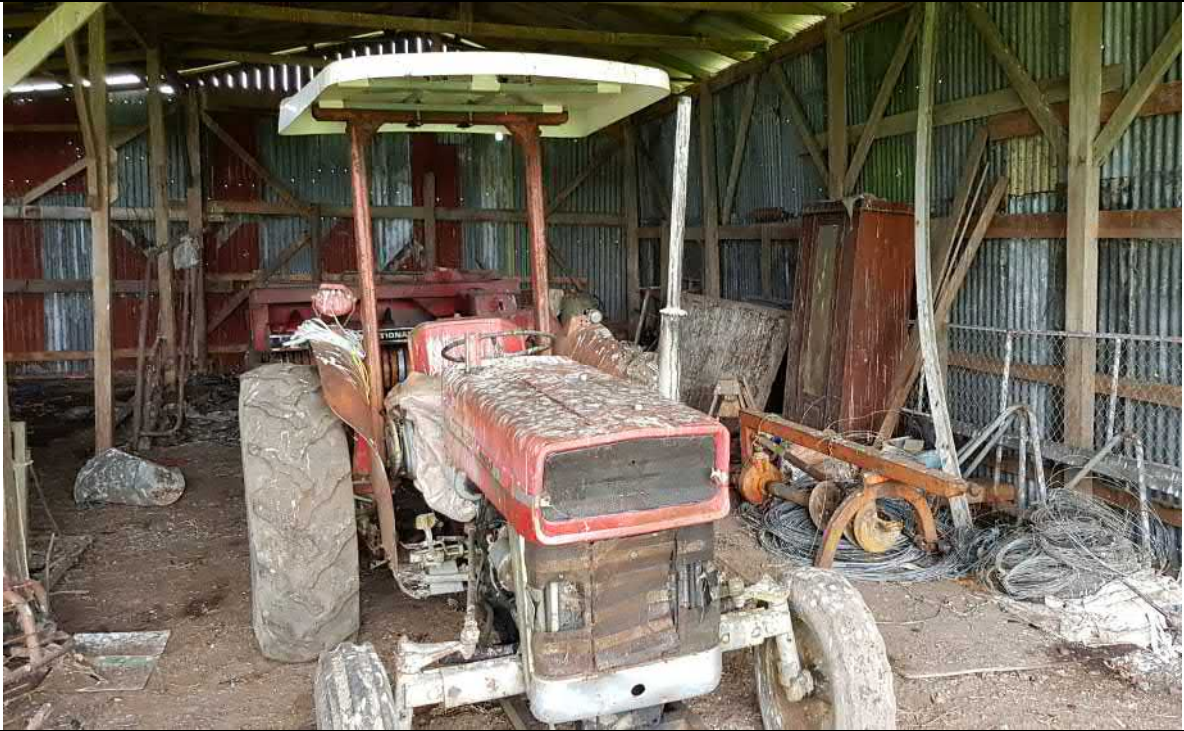
Photo 11. Hydrocarbon staining under vehicles in storage shed, facing south. LOT 2 DP 485743.

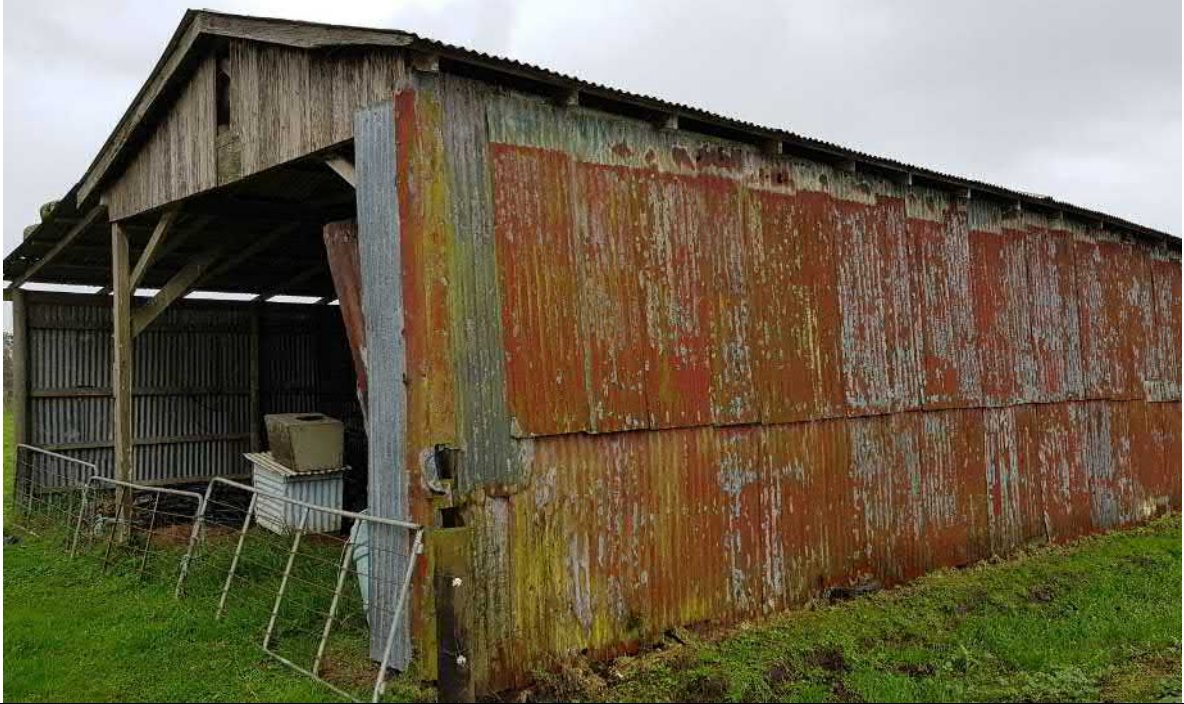
Photo 12. Storage shed, facing south-east. LOT 2 DP 485743.

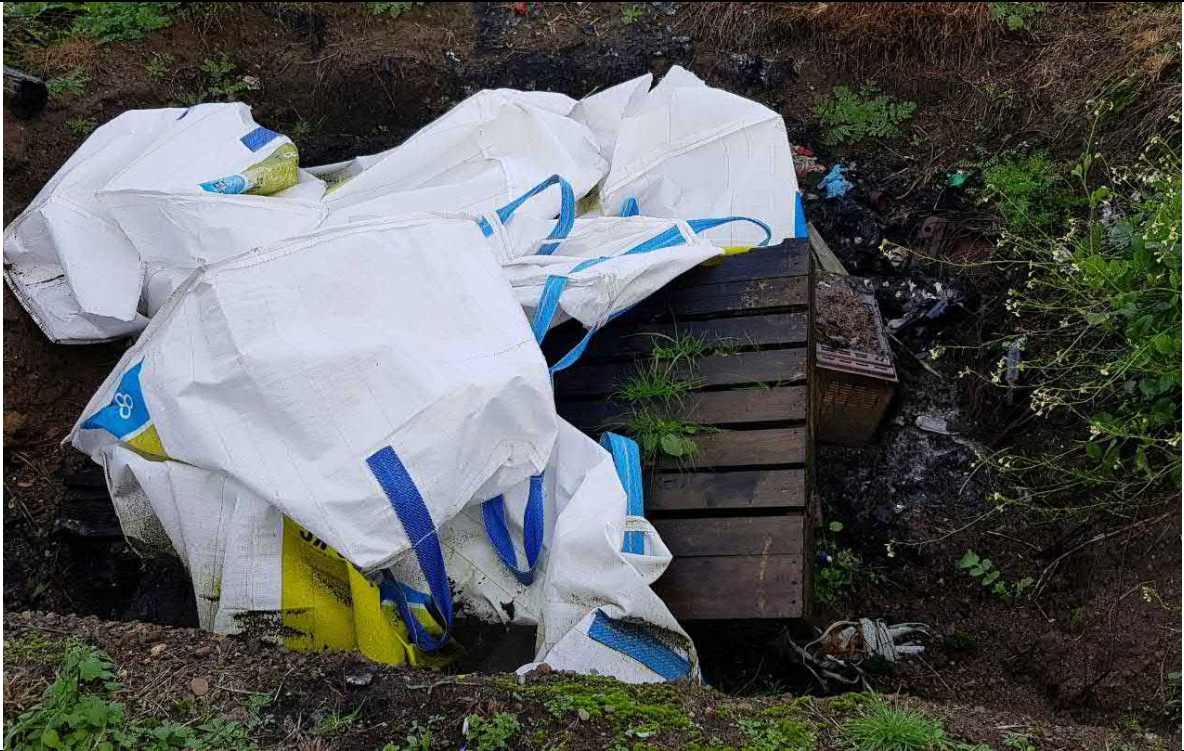
Photo 15. Rubbish pit, facing south-west. PT LOT 7 DPS 15255.

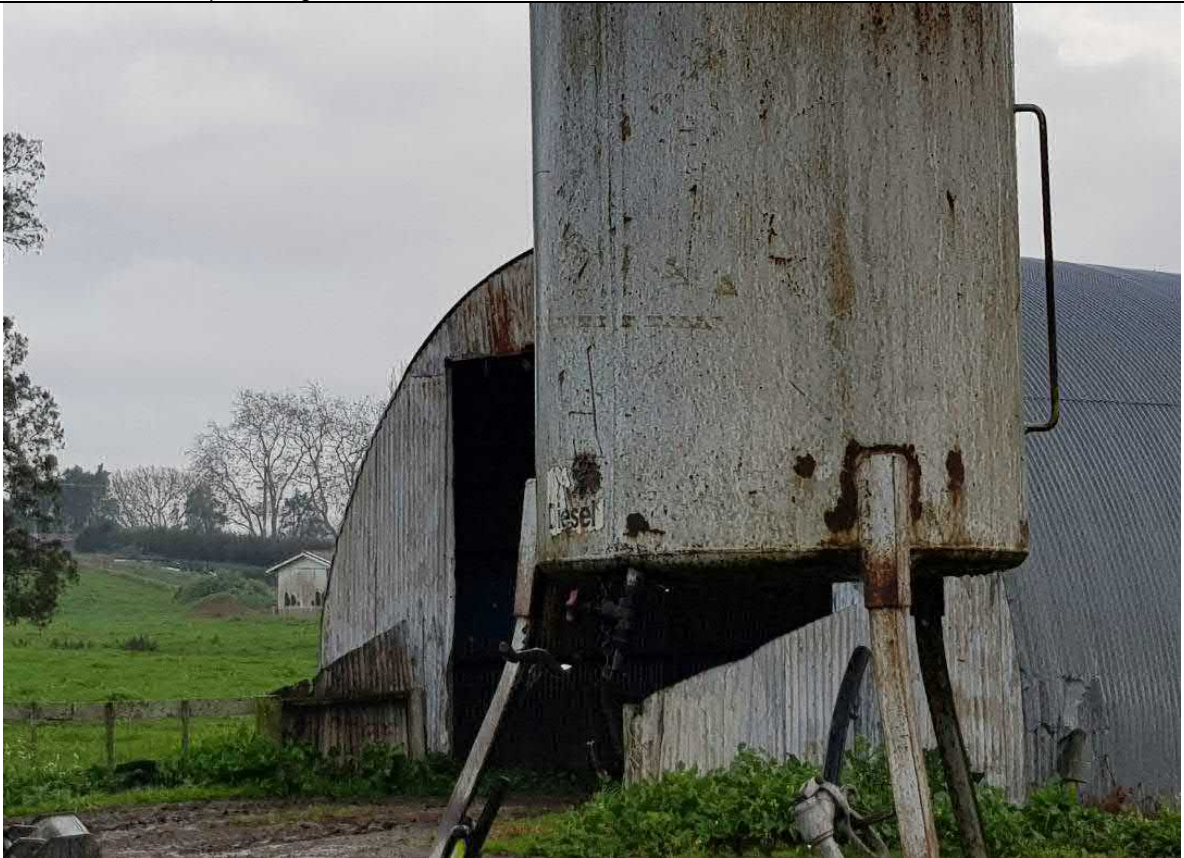
mostly constructed of concrete and metal in varying states of disrepair. Potential asbestos-containing material was observed. There is a dairy effluent sump located next to and connecting to the milking shed, as well as an above ground diesel storage tank/pump within Pt Lot 7 DPS 15255.

Photo 16. Standing diesel tank, facing south-west. PT LOT 7 DPS 15255.

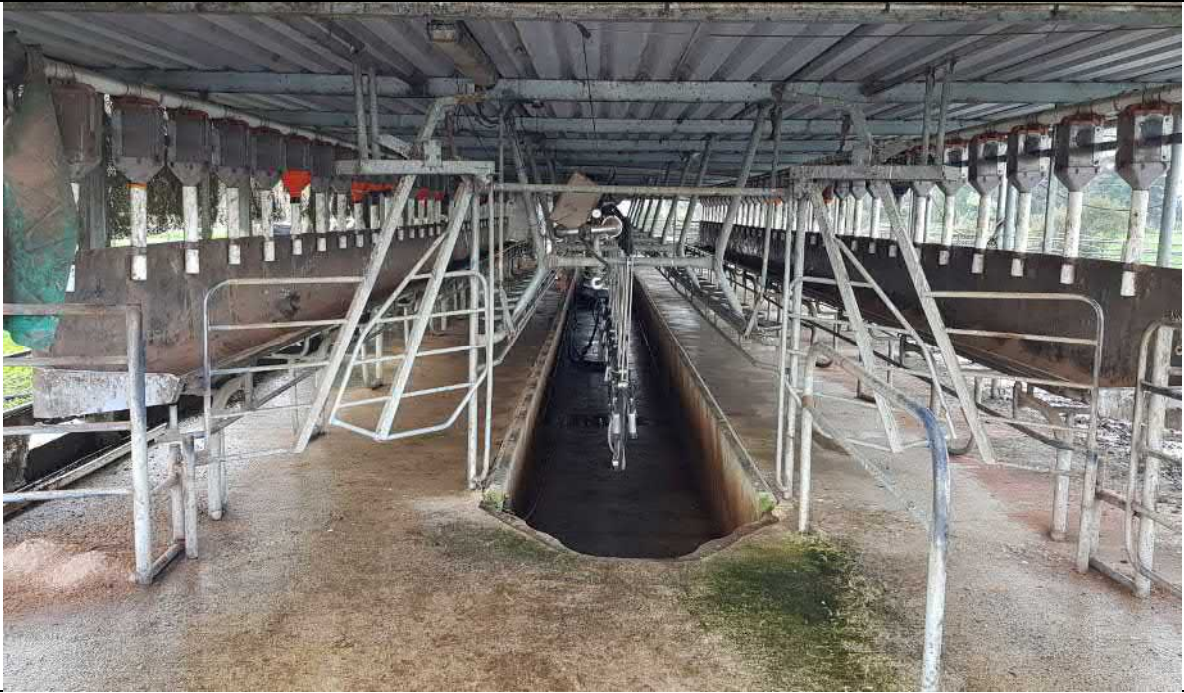
Photo 17. Operational dairy milking shed, facing south. PT LOT 7 DPS 15255.

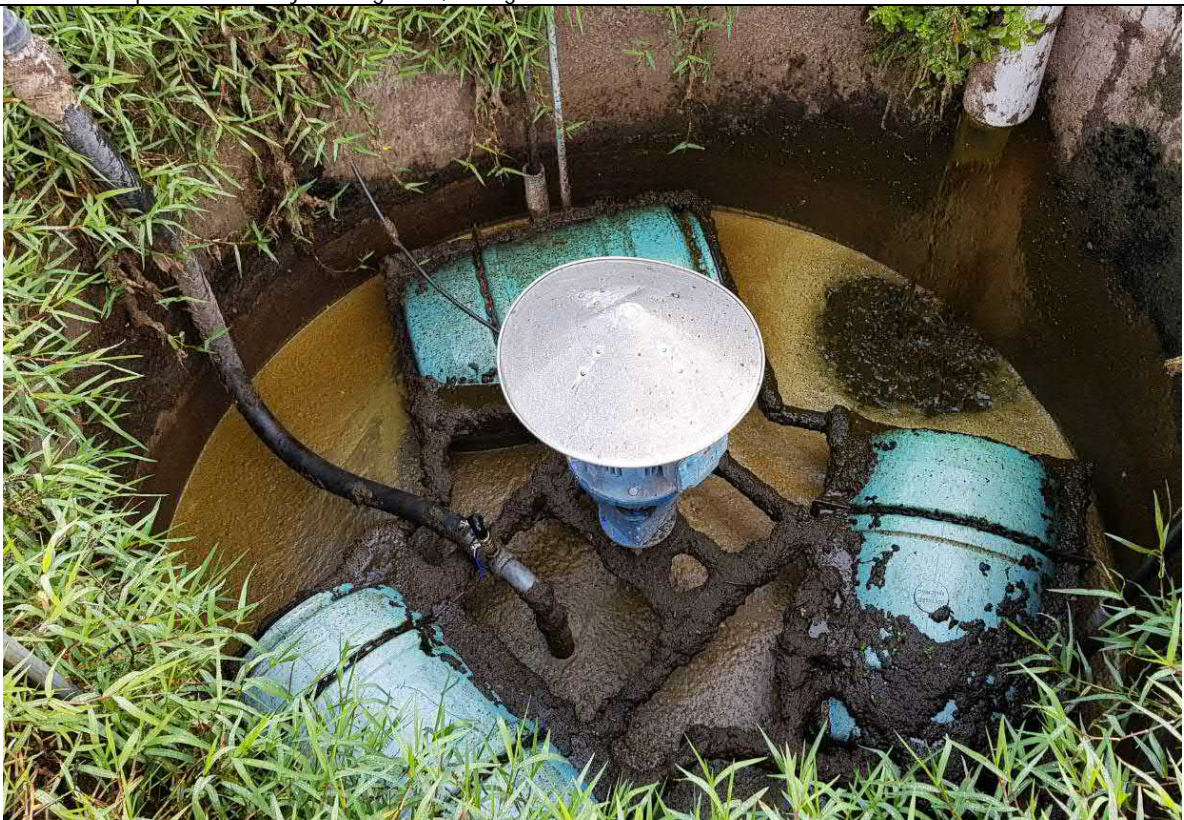
Photo 18. Effluent sump, connected to milking shed. PT LOT 7 DPS 15255.

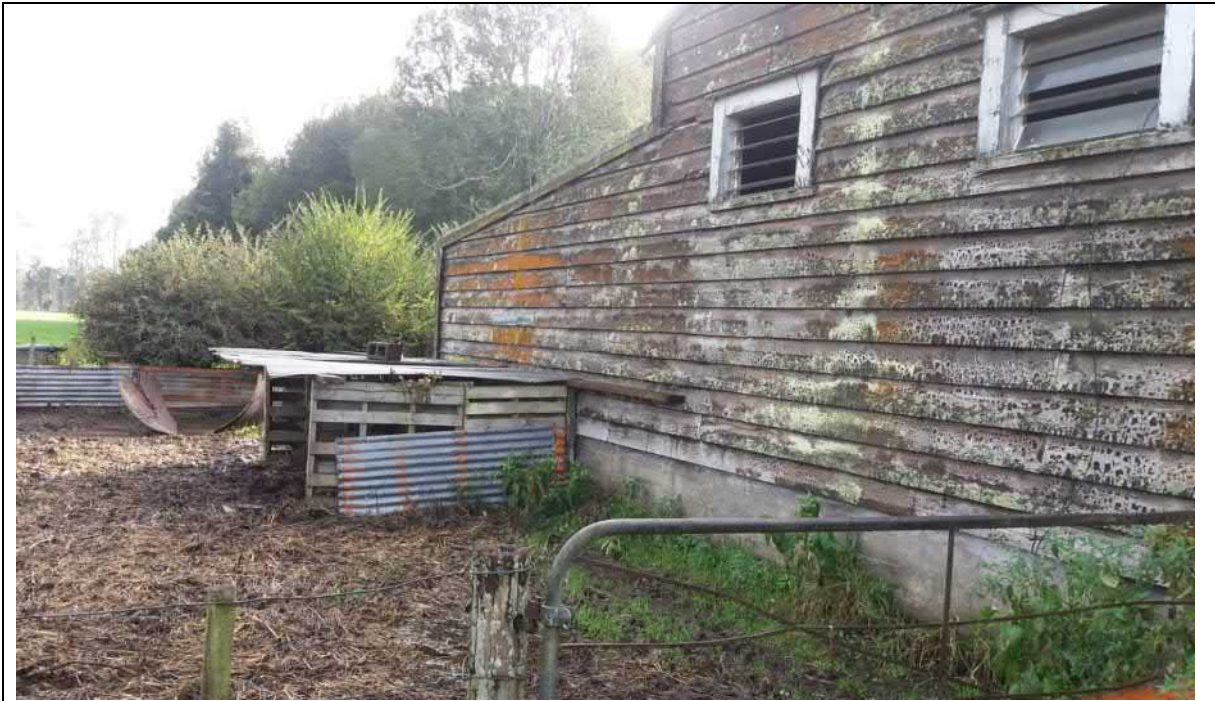
Photo 19. Wood storage shed with connecting pig pen, facing west south-west. LOT 3 DPS 15254.
