# ROTOKAURI NORTH SHA

## PRELIMINARY SITE INVESTIGATION

PROJECT NO: HD637  
GREEN SEED CONSULTANTS LTD  
REFERENCE: PSI/1  
11 JULY 2018

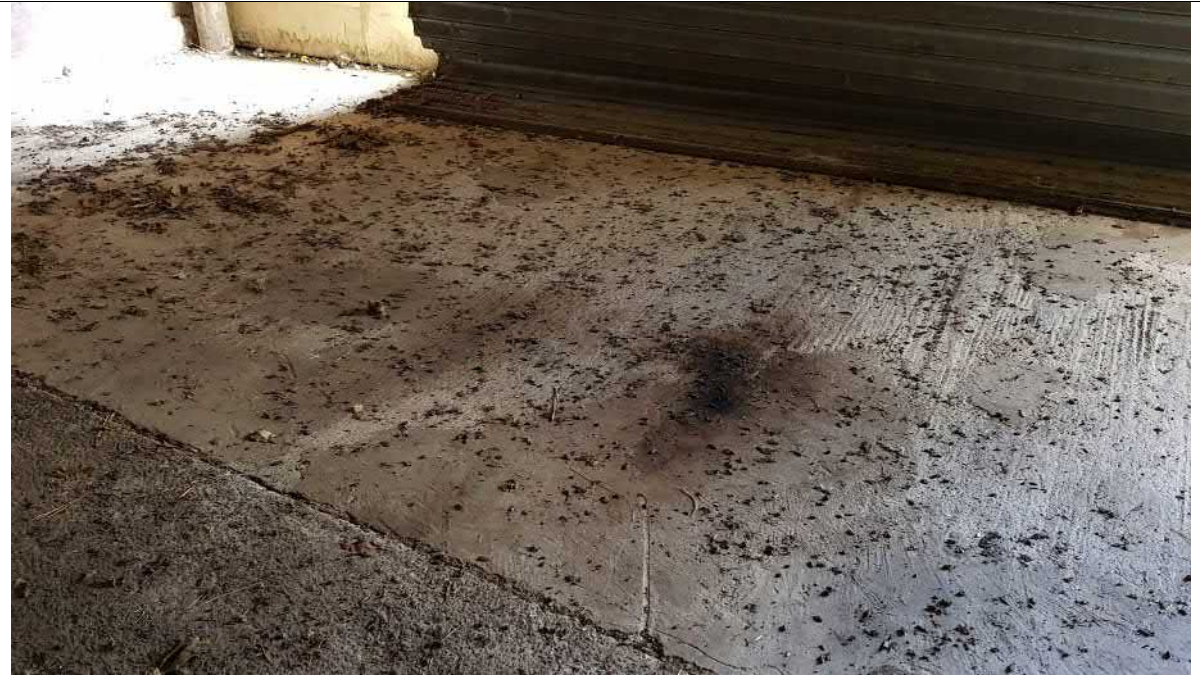
Photo 1. Hydrocarbon staining on floor of shed, facing west. Lot 5 DPS 15123.

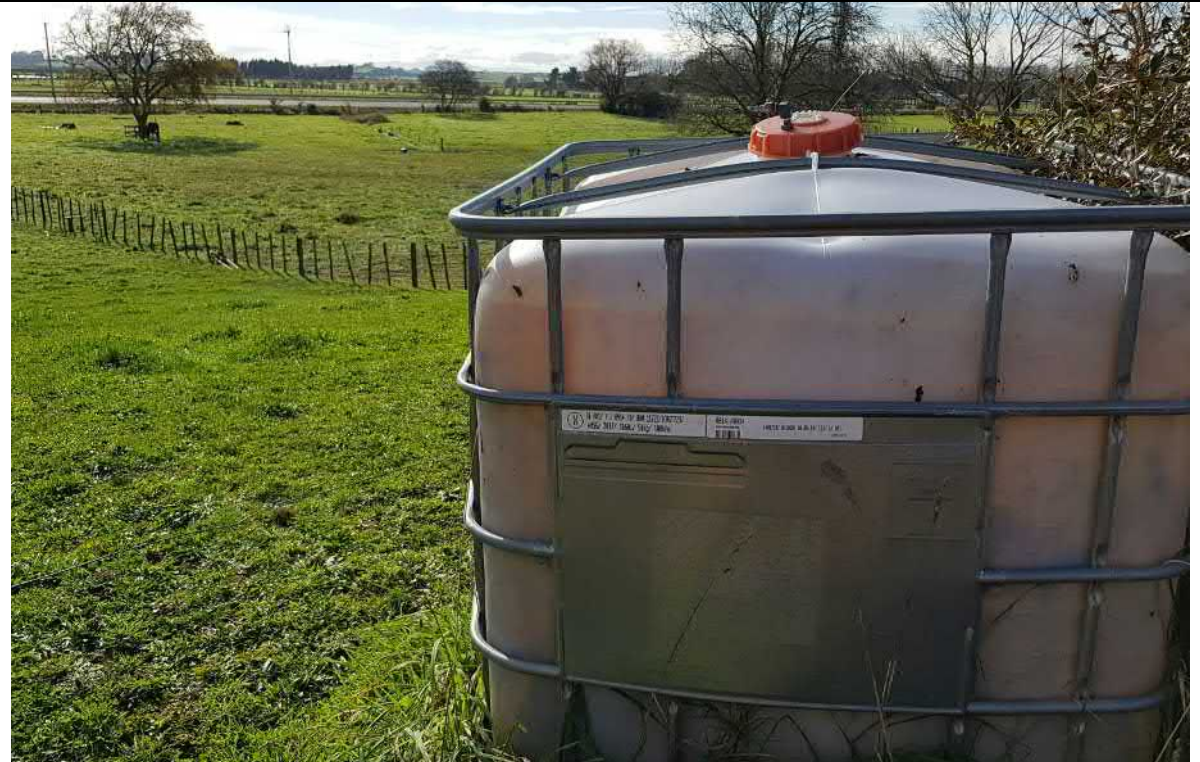
Photo 2. Unknown storage tank, facing north. SEC 23 SO 495676.

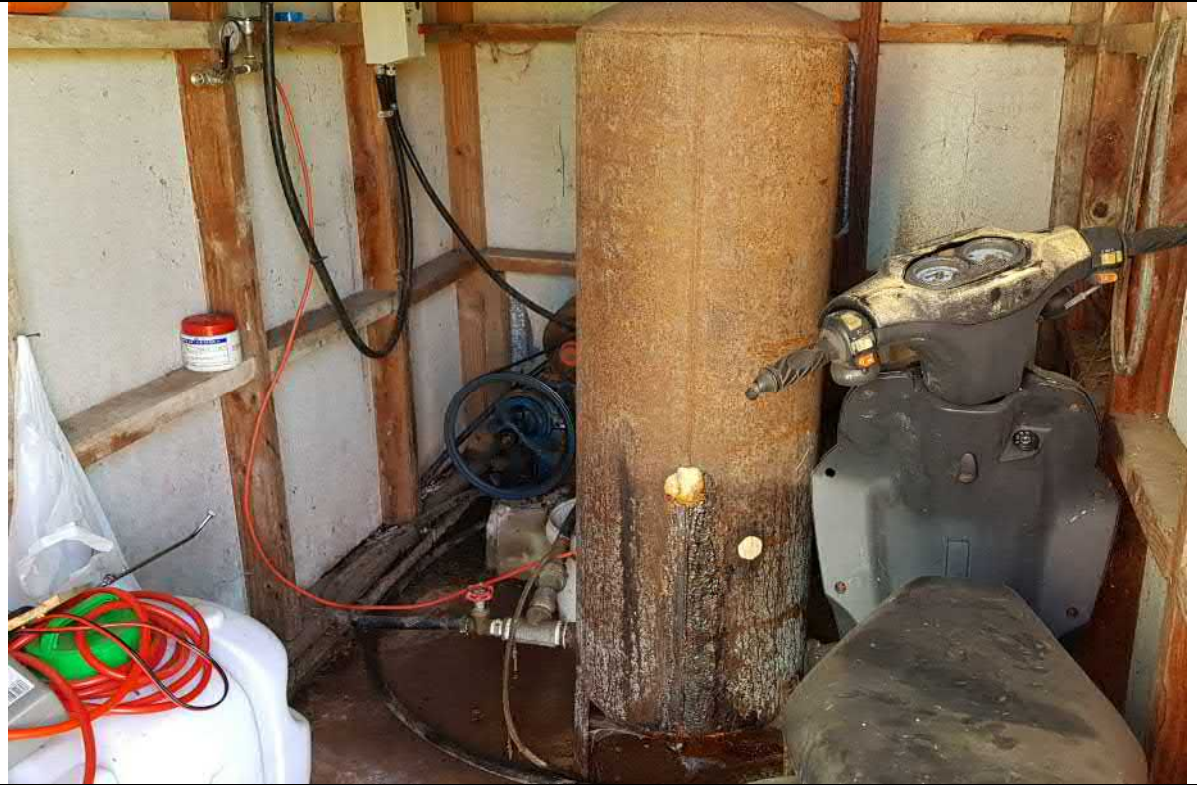
Photo 3. Unknown metal tank (leaking) with generator & herbicide tank, facing west. SEC 23 SO 495676.

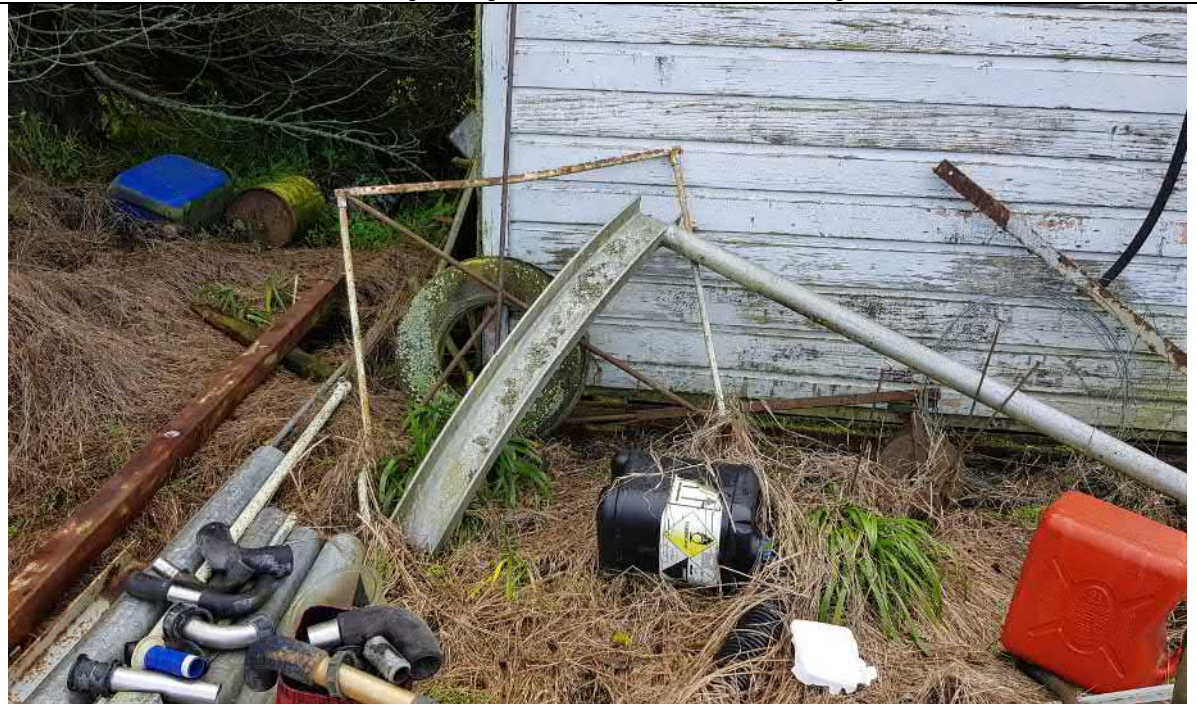
Photo 4. Fuel and oxidizing bottles, facing north. LOT 6 DPS 15123.

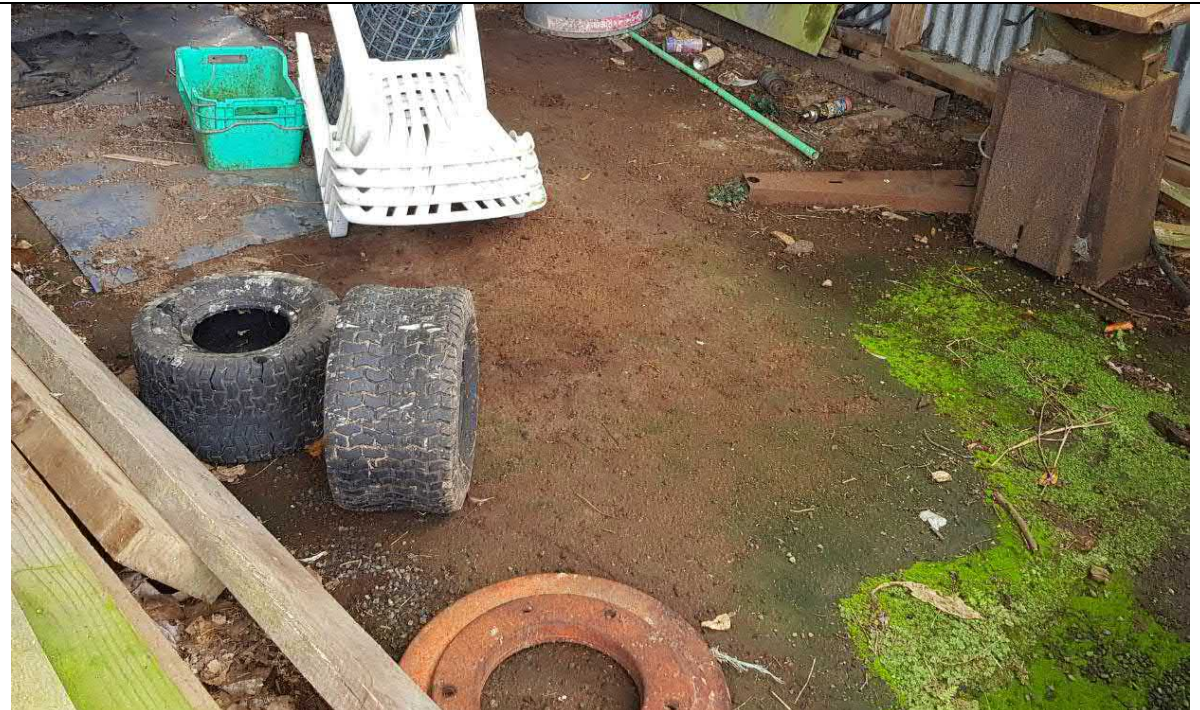
Photo 5. Potentially hydrocarbon stained soil, inside barn facing north-east. LOT 6 DPS 15123.

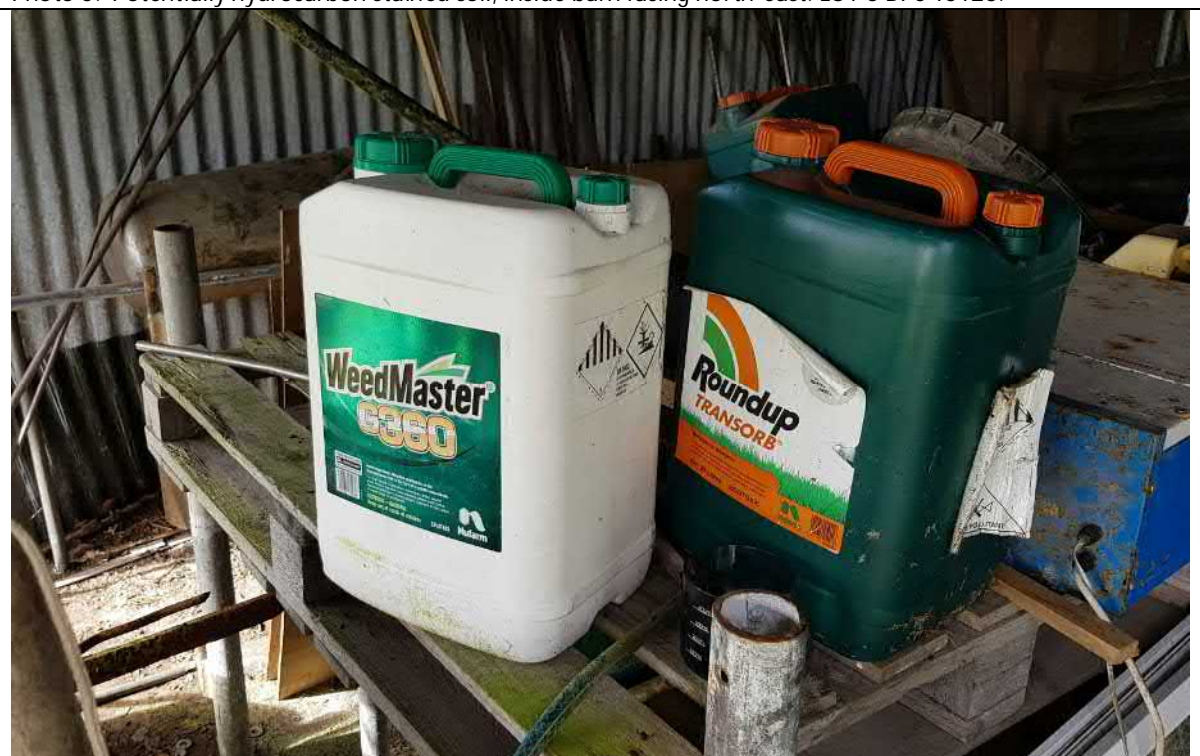
Photo 6. Glyphosate (organophosphorus) herbicides in shed. LOT 6 DPS 15123.

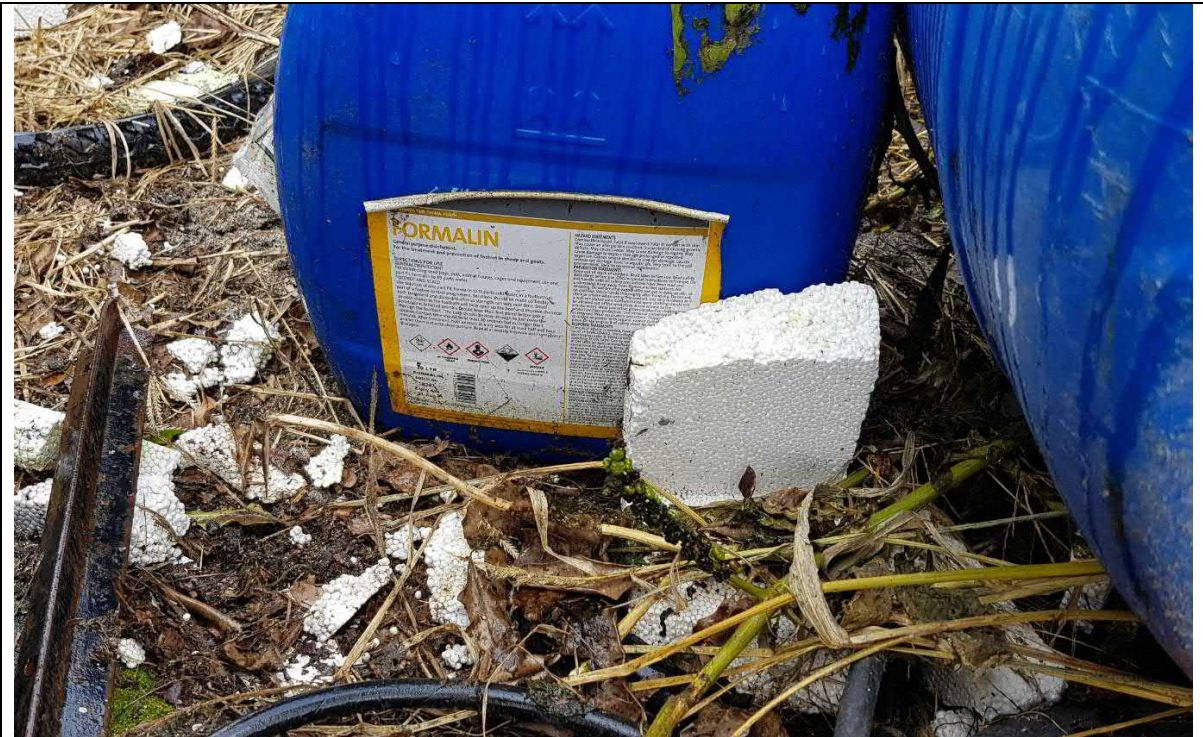
Photo 7. Formalin containers. LOT 3 DPS 15123.

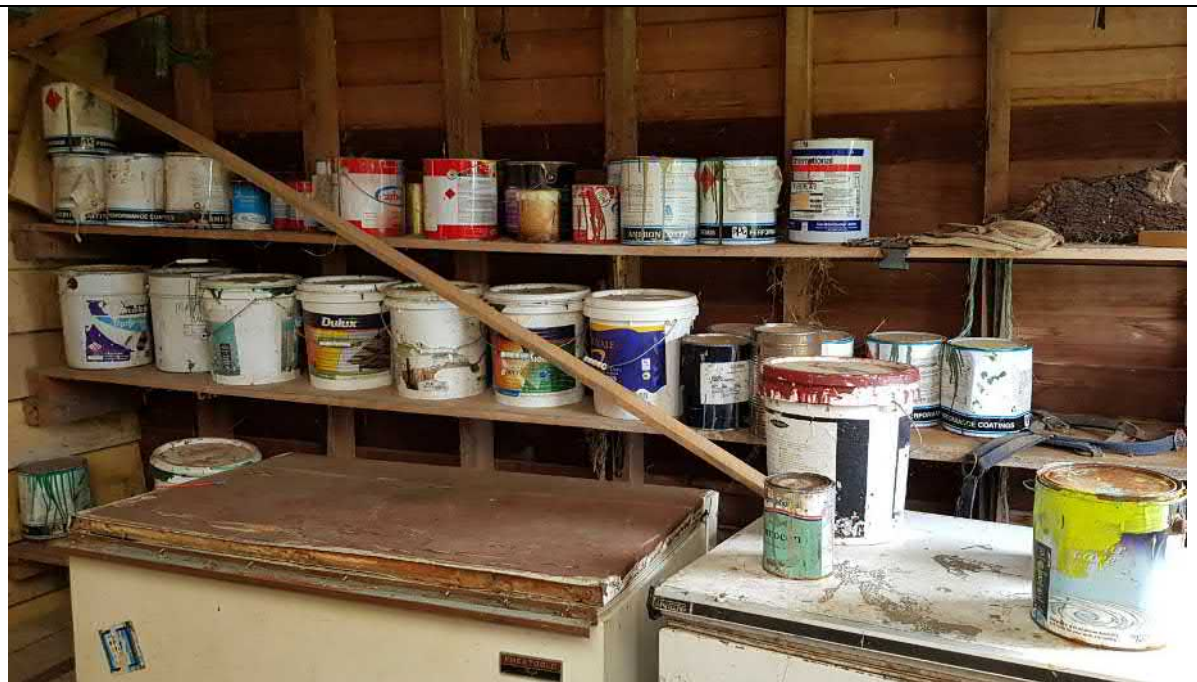
Photo 8. Shelves of paint in storage shed. LOT 3 DPS 15123.

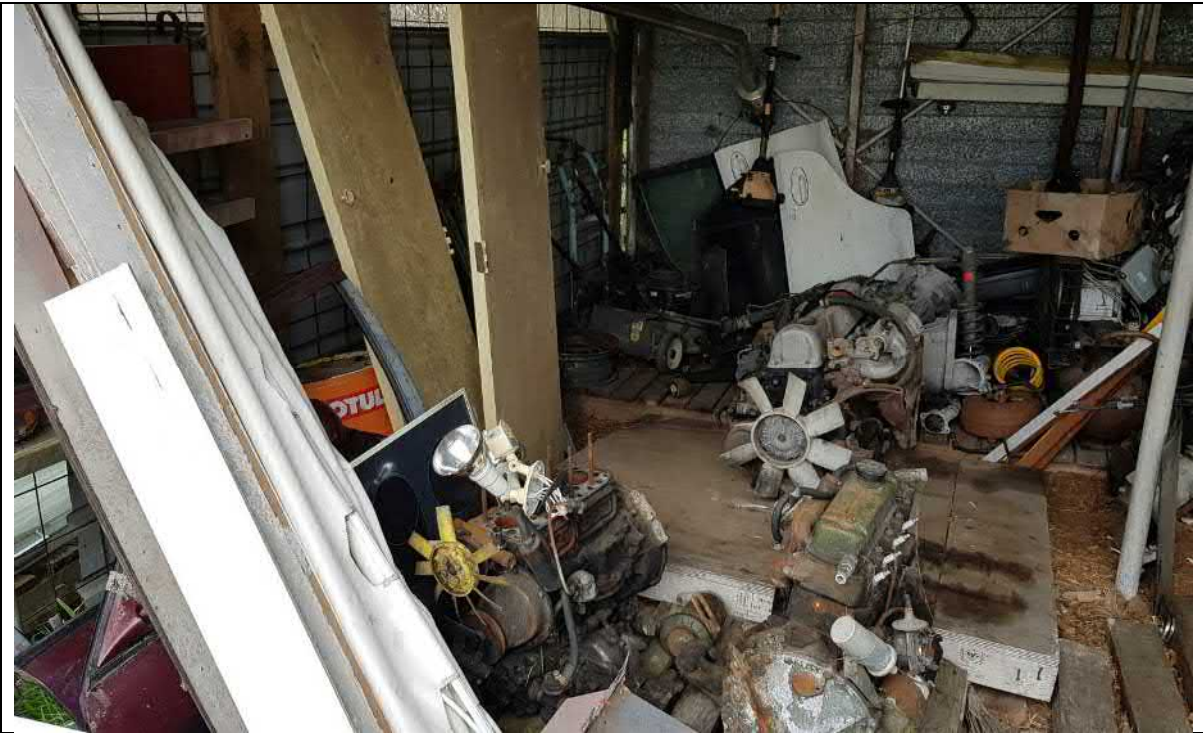
- The workshop/scrap yard at Lot 3 DPS 15123 is used to store hydrocarbons and other hazardous substances. Workshops and scrap yards are considered HAIL activities.

Photo 9. Multiple engine components in storage shed. LOT 3 DPS 15123.

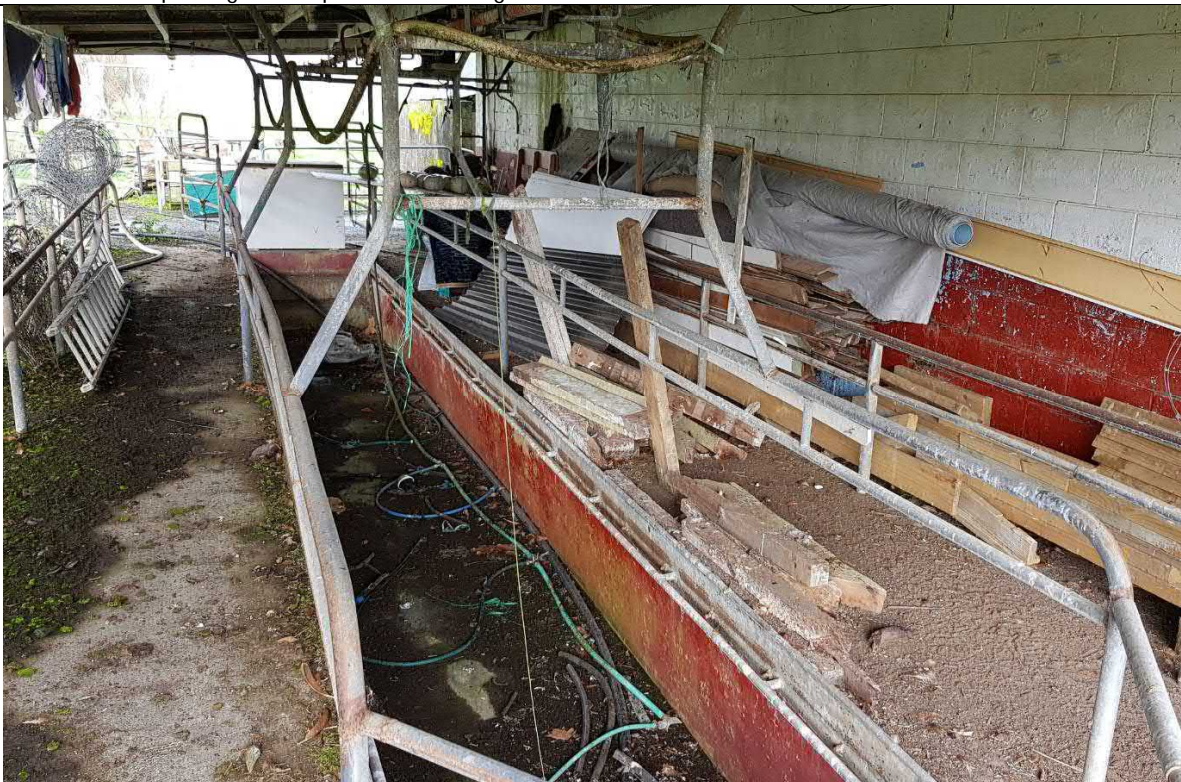
Photo 10. Dairy cattle milking station, facing south. LOT 2 DP 485743.

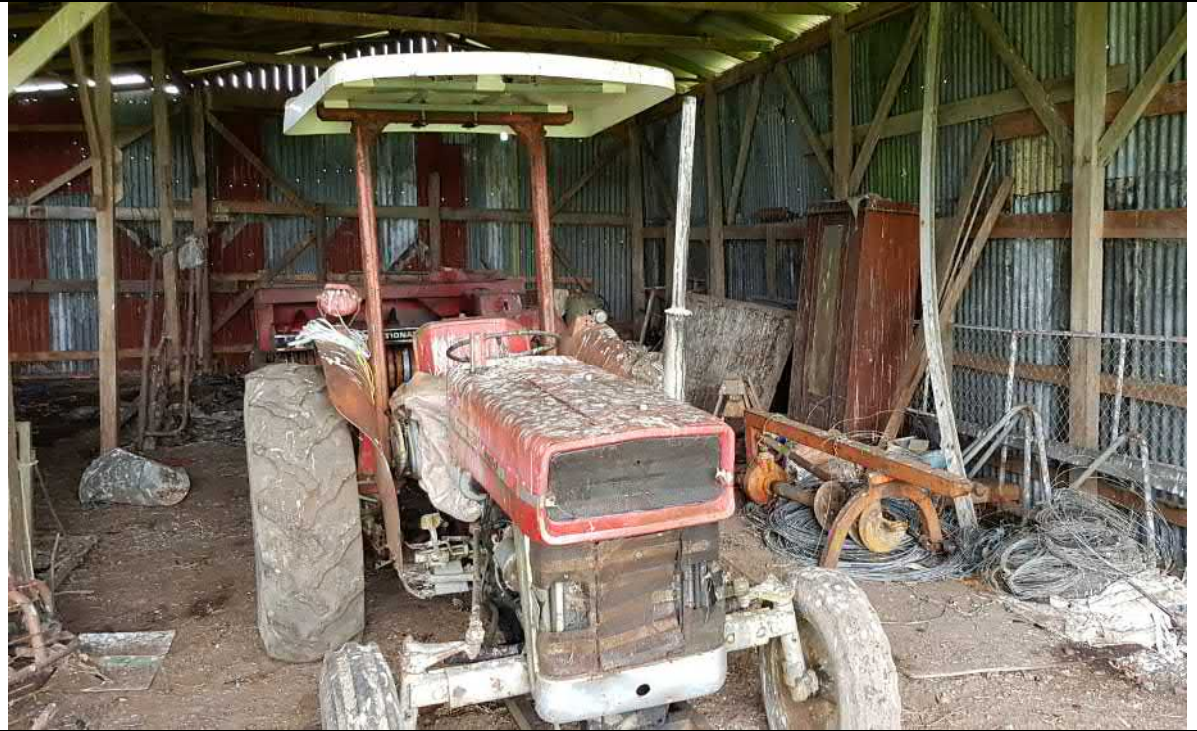
Photo 11. Hydrocarbon staining under vehicles in storage shed, facing south. LOT 2 DP 485743.

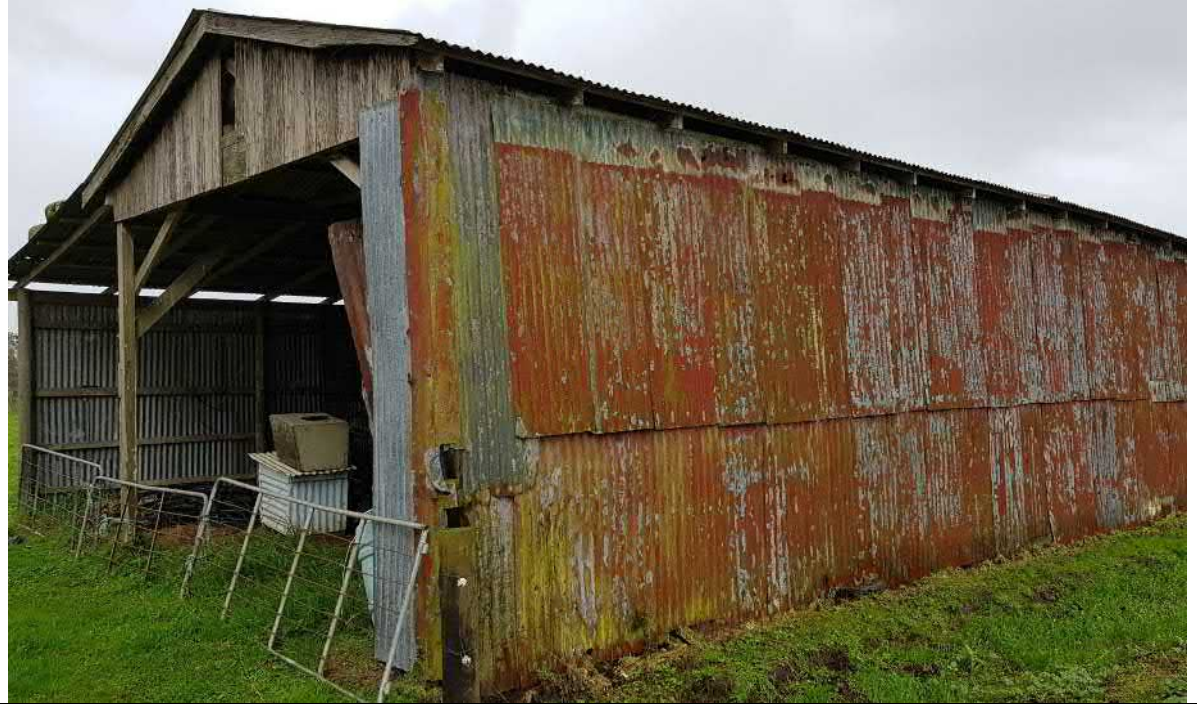
Photo 12. Storage shed, facing south-east. LOT 2 DP 485743.

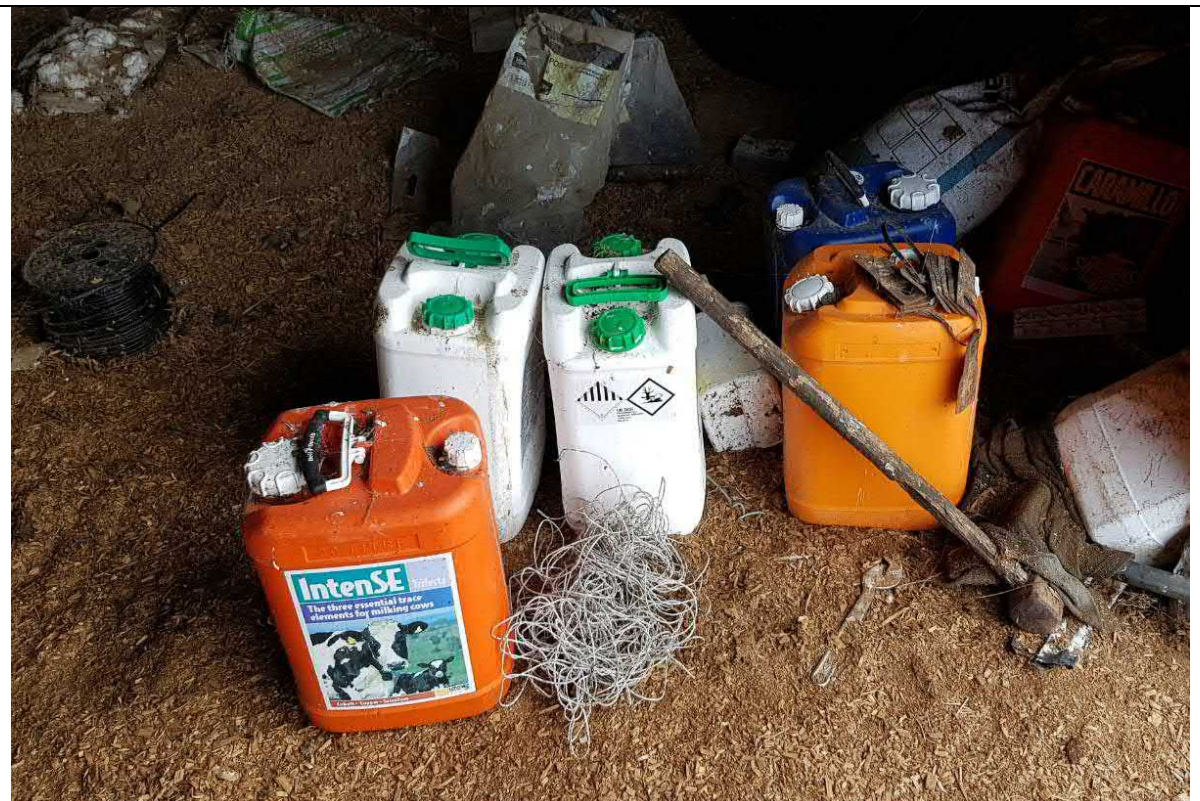
Photo 13. IntenSE container and picloram+triclopyr herbicide in storage barn. LOT 6 DP 359488.

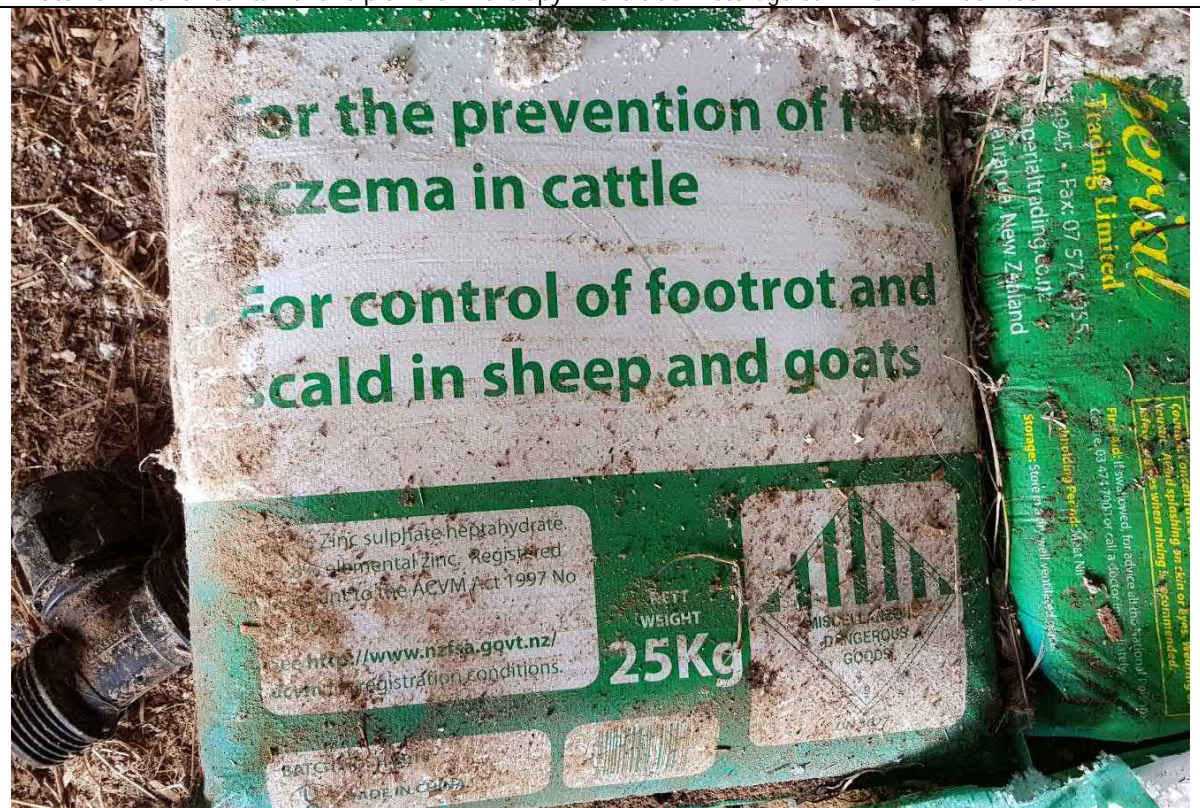
Photo 14. Zinc sulphate heptahydrate in storage barn. LOT 6 DP 359488.

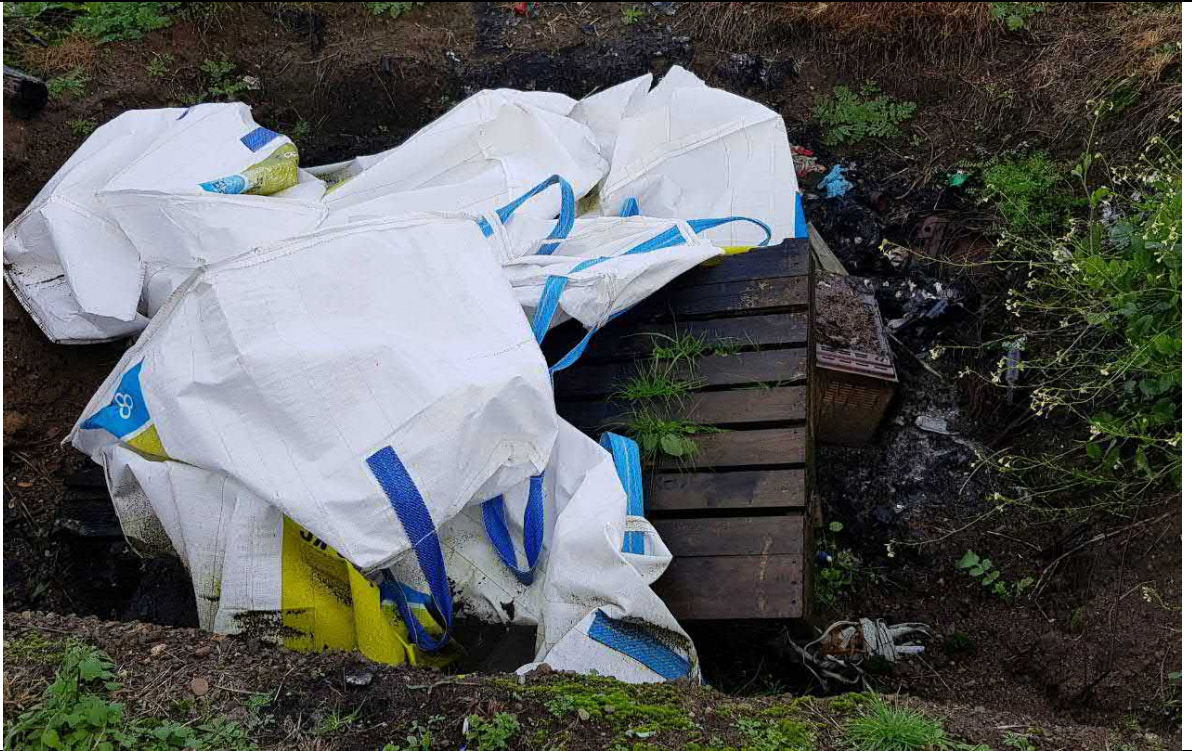
Photo 15. Rubbish pit, facing south-west. PT LOT 7 DPS 15255.

Note that the activities at the HAIL sites may change over time; therefore, sampling and analysis should not be conducted until activities cease at these sites. Activities must be re-verified before sampling and analysis is conducted and the above example plan amended as appropriate. In addition, it is recommended that rubbish is removed prior to sampling and analysis.

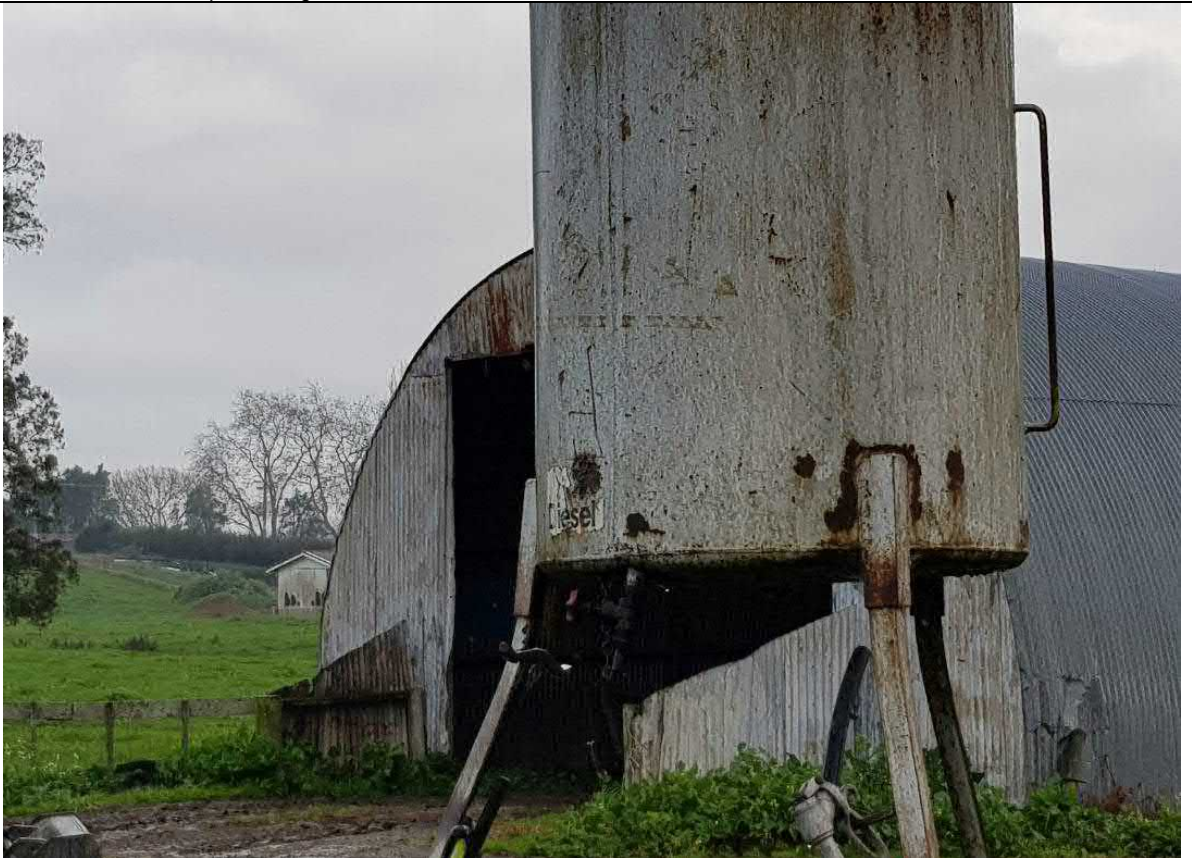
mostly constructed of concrete and metal in varying states of disrepair. Potential asbestos-containing material was observed. There is a dairy effluent sump located next to and connecting to the milking shed, as well as an above ground diesel storage tank/pump within Pt Lot 7 DPS 15255.

Photo 16. Standing diesel tank, facing south-west. PT LOT 7 DPS 15255.

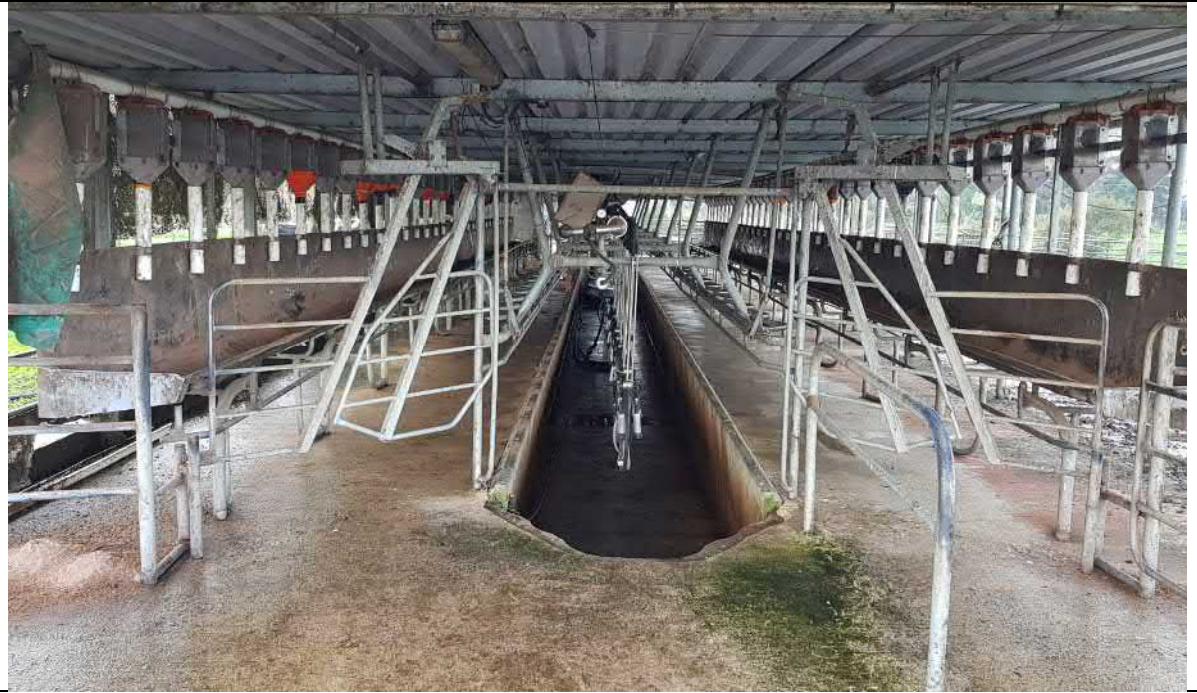
Photo 17. Operational dairy milking shed, facing south. PT LOT 7 DPS 15255.

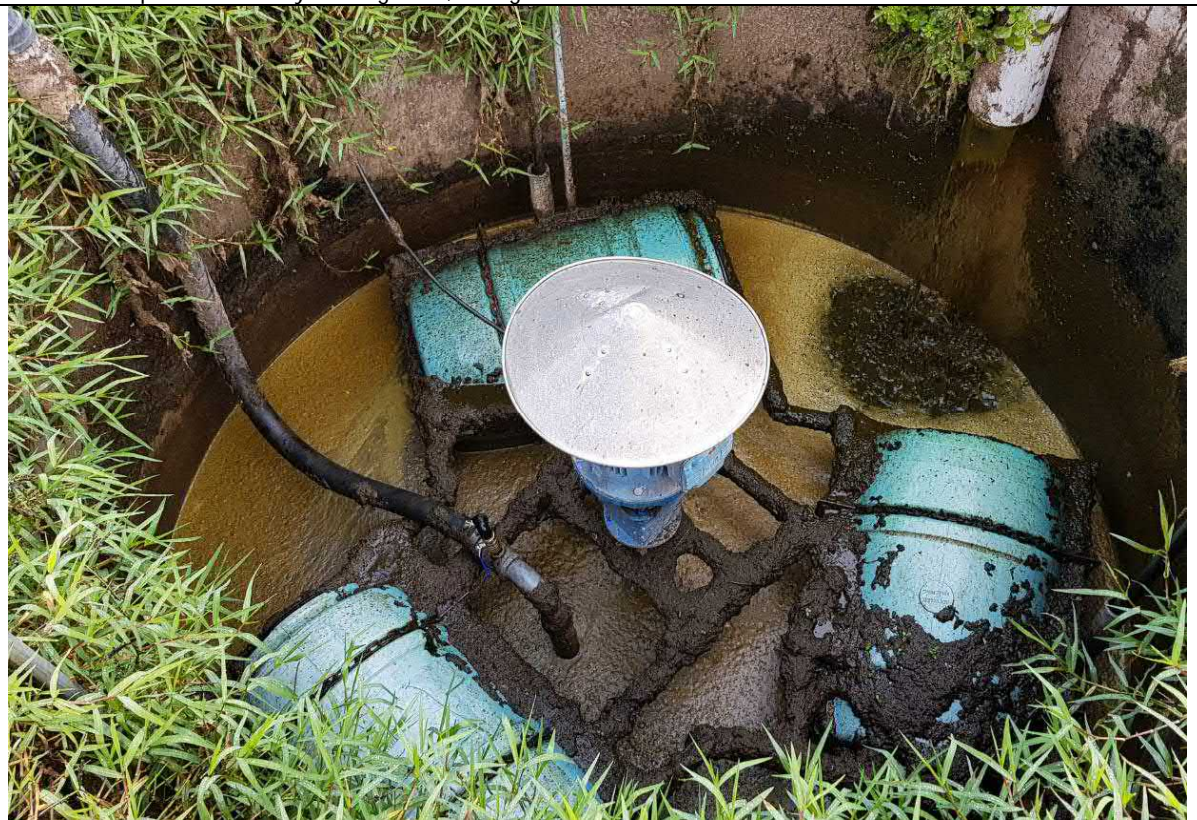
Photo 18. Effluent sump, connected to milking shed. PT LOT 7 DPS 15255.

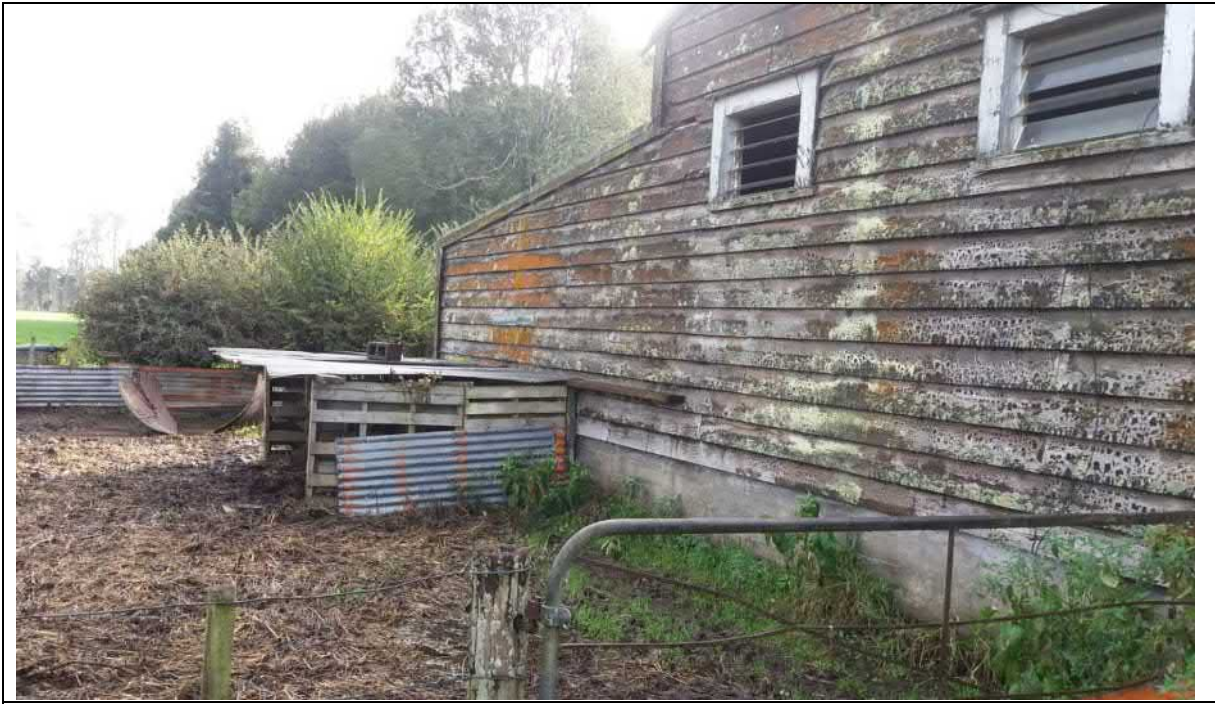
Photo 19. Wood storage shed with connecting pig pen, facing west south-west. LOT 3 DPS 15254.
