Preliminary Environmental Site Investigation

Amberfield Subdivision

Peacocke

14280.000.001_18

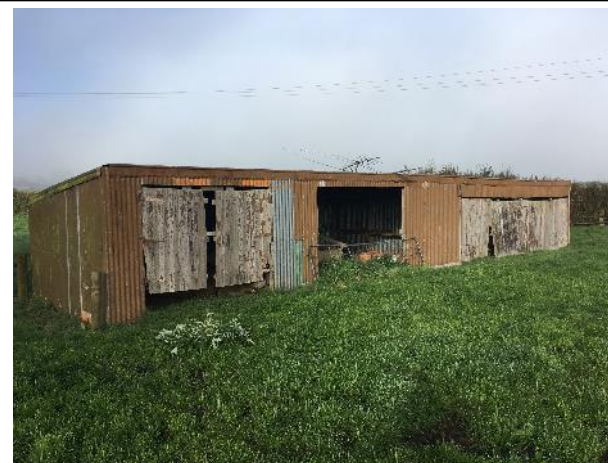
Site Condition	Comments
	<p>523 Peacockes Road:</p> <ul style="list-style-type: none"> The shed (refer Figure 2E) located on the property was observed to contain interior ACM cladding (see photographs 8-11). Storage of chemical containers and paint drums within Shed A. Containers noted to contain sodium hypochlorite and petroleum products (see photographs 8-11). Disused 200l drum (empty), contents unidentified (see photograph 12). Rubbish stockpile comprising steel, gravel and outdoor heater (see photograph 71). Dwelling, garage and storage shed with paint in a deteriorated condition (potential for contamination from lead based paint) (see photographs 14 -15). PACM construction materials used on dwelling, garage and shed (see photographs 14 -15).
	<p>Entire Site:</p> <ul style="list-style-type: none"> Potential for lead paint and ACM in all buildings observed on-site. Potential for historical use of superphosphate fertiliser across entire property. The location of all site features identified above are shown on Figures 2 A-E.

Photograph 8: 523 Peacocks Rd

As required by the Health and Safety at Work (Asbestos) Regulations (2016), an asbestos demolition survey should be undertaken before demolition of any buildings located on-site constructed prior to the year 2000. If asbestos is known or suspected to be present in the exterior of the building, the soil directly surrounding the buildings should also be tested to determine if it has been impacted by the deterioration or damage of external walls. Samples should also be collected from all areas where fill has been identified on the site to assess whether the soil has been impacted by ACM.

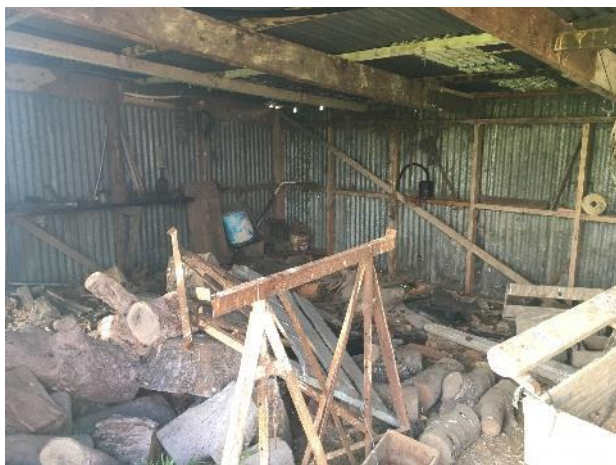
Photograph 9: 523 Peacockes Road interior

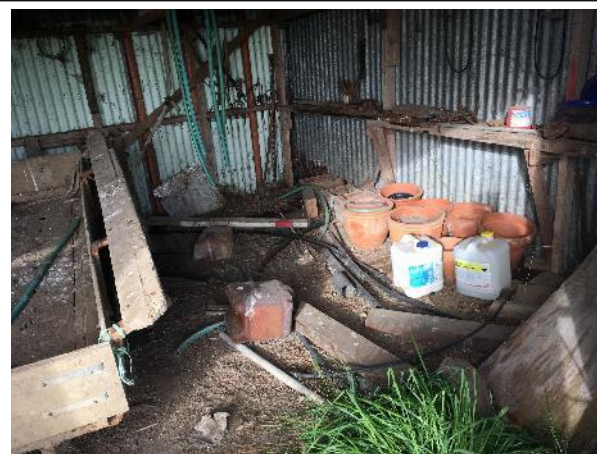
Photograph 10: 523 Peacockes Road interior

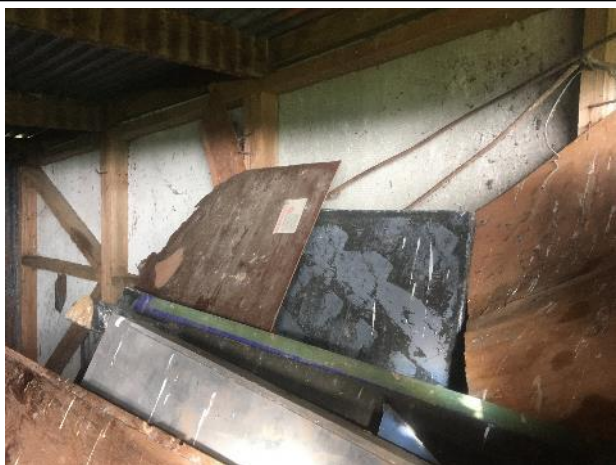
Photograph 11: 523 Peacockes Road - interior with Asbestos

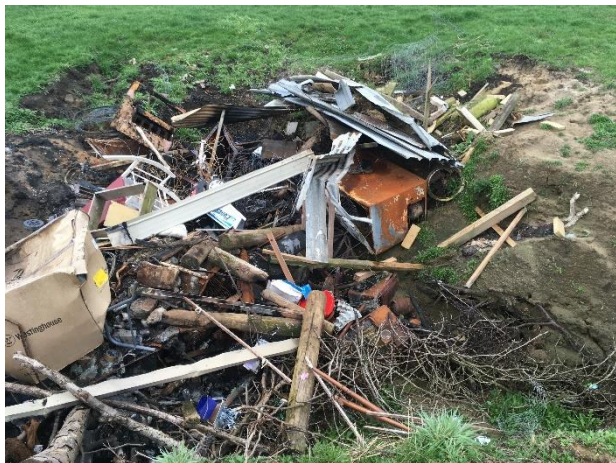
Photograph 25: Burnt rubble pit identified in valley at 461 Peacockes Road

Evidence of burning activities: Samples should be collected from soil directly impacted by burning activities (i.e. where ash and blackened soil is observed). All samples should be tested for heavy metals and PAHs.

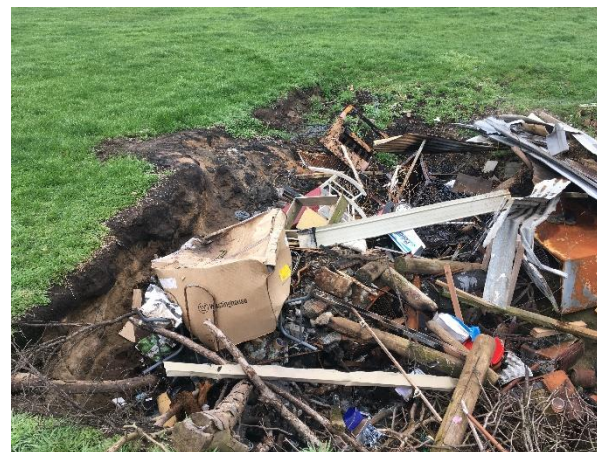
Photograph 26: Burnt rubble pit identified in valley at 461 Peacockes Road

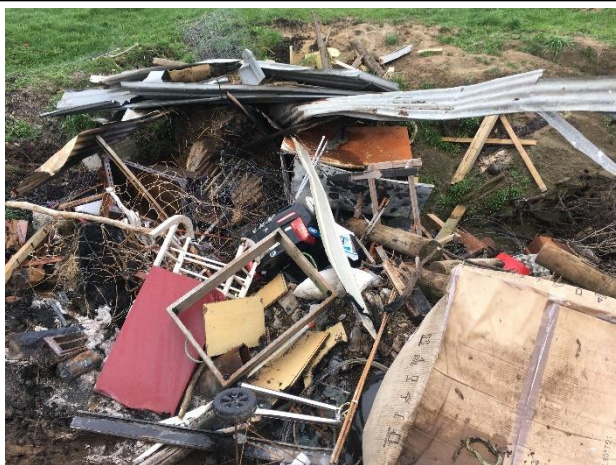
Photograph 27: Burnt rubble pit identified in valley at 461 Peacockes Road

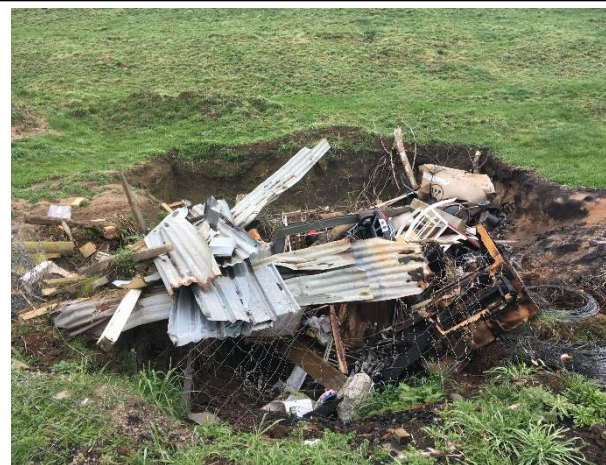
Photograph 28: Burnt rubble pit identified in valley at 461 Peacockes Road

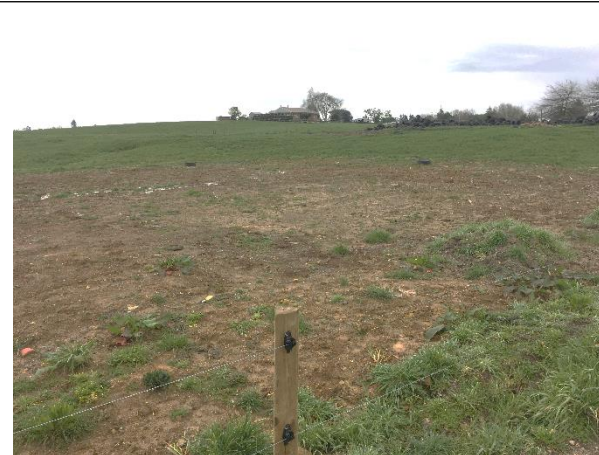
Photograph 30: Filled land adjacent to old milking shed

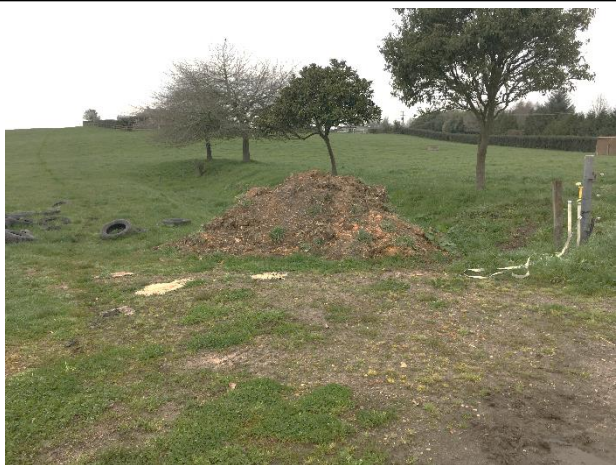
Photograph 31: Stockpiles of fill adjacent to old milking shed

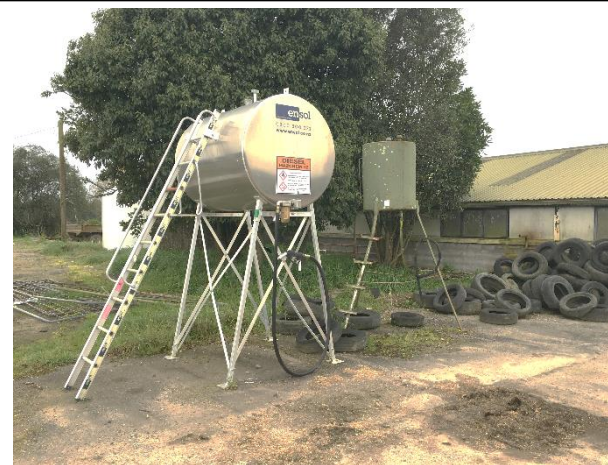
Photograph 32: New and old diesel AST adjacent to old milking shed

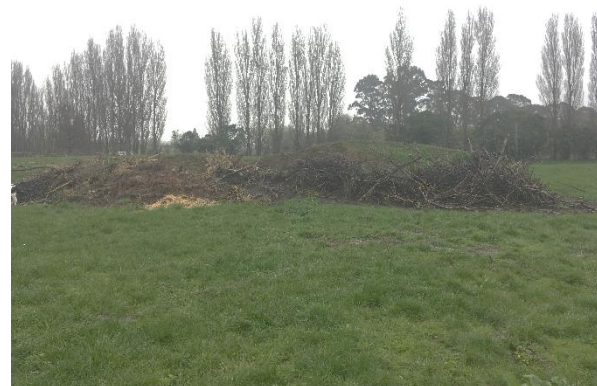
Photograph 46: Burnt rubble pit - 337 Peacockes Road

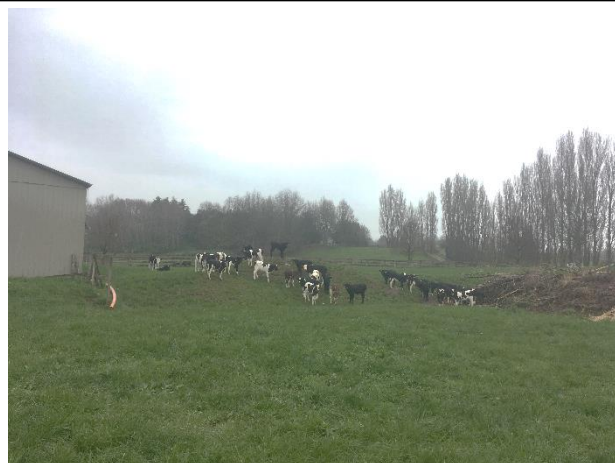
Photograph 47: Burnt Rubble Pit - 337 Peacockes Road

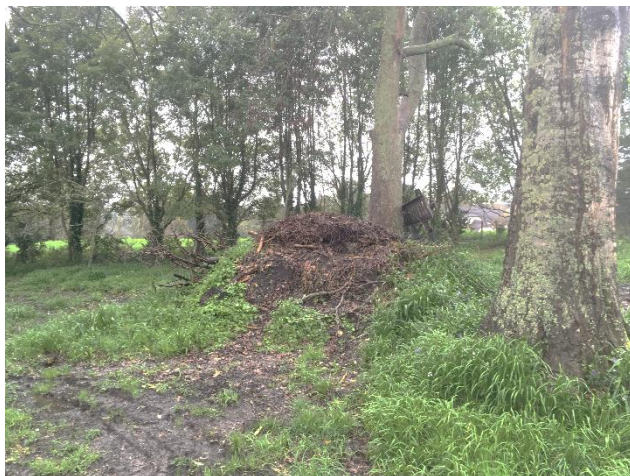
Photograph 51: Burnt stockpiles adjacent to shed at 361 Peacockes Road

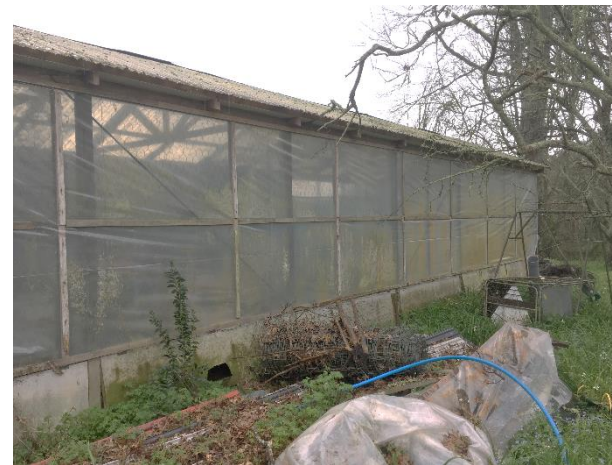
<p>361 Peacockes Road:</p> <ul style="list-style-type: none"> • Shed containing deteriorated ACM cement board (see photograph 52). • A burnt rubble pit comprising wood, steel, paper, soil and chemical containers. Evidence of recent burning observed (ash and blackened soil) (see photographs 58-59). • Dumped chemical containers (various sizes) adjacent to northern boundary of shed. Inspection of containers revealed that most contained petroleum products (i.e. Havoline etc.) (see photograph 57). • PACM piping adjacent to access way (see photograph 64). • Various stockpiles comprising household rubbish, soil, wood and gravel fragments (see photographs 54-55 and 63). • Crushed empty 200l drums - type of chemicals unable to be identified during inspection (see photograph 60). <p>Shipping container – unknown storage but potentially used for dangerous goods (see photograph 62).</p>

Photograph 52: Shed containing asbestos at 361 Peacockes Road

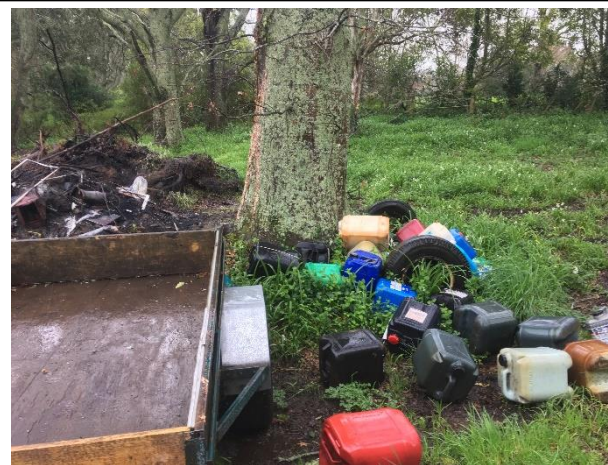
Photograph 56: Chemical containers south of the shed at 361 Peacockes Road

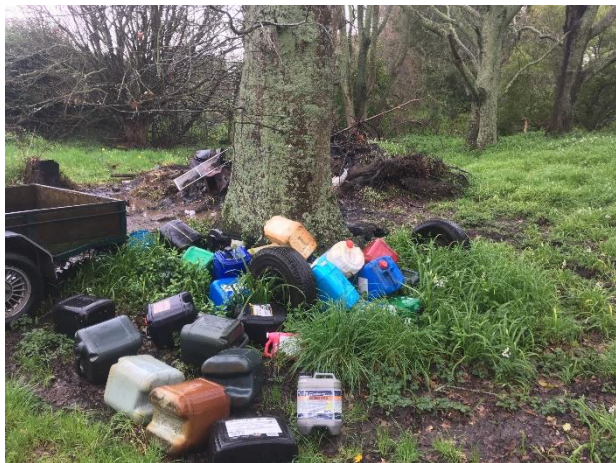
Photograph 57: Chemical containers south of the shed at 361 Peacockes Road

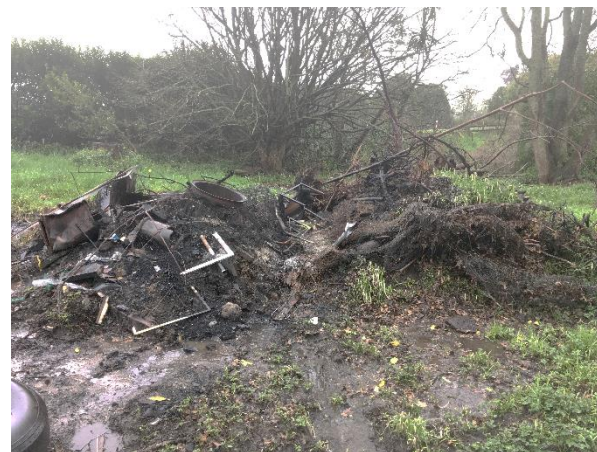
Photograph 58: Burnt rubble pit adjacent to chemical containers at 361 Peacockes Road

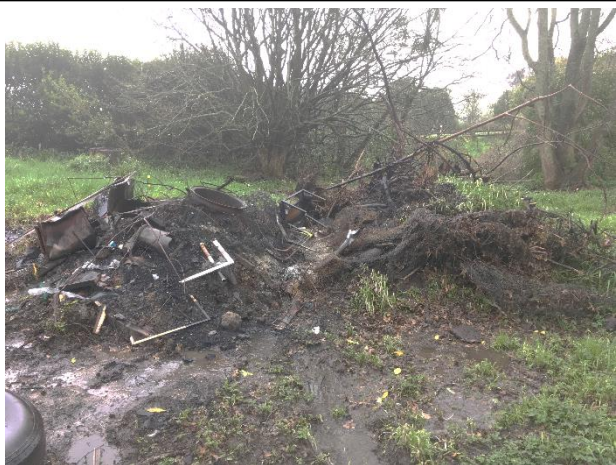
Photograph 59: Burnt rubble pit - 361 Peacockes Road

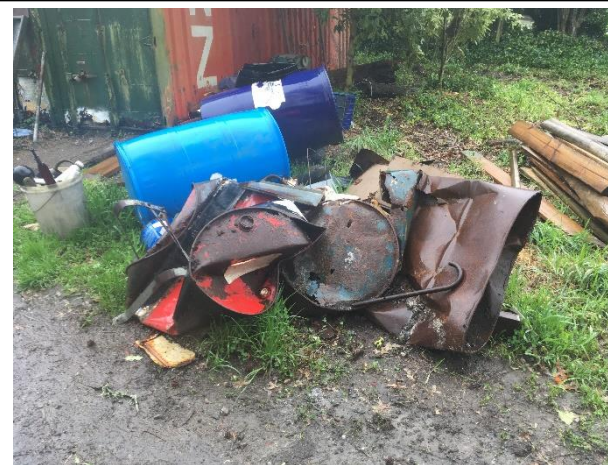
Photograph 60: Used and empty chemical drums adjacent to container at 361 Peacockes Road

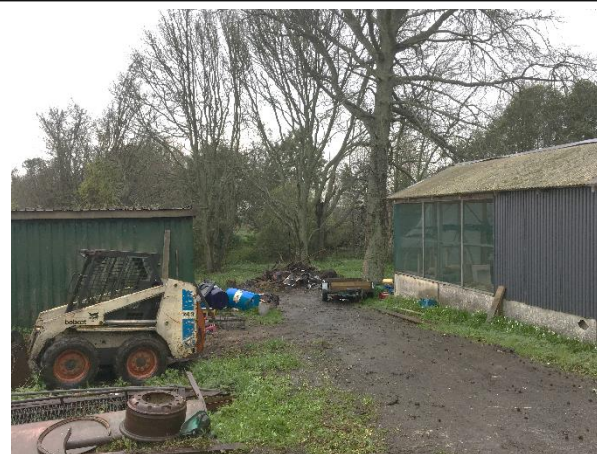
Photograph 62: -View looking south of contaminants at 361 Peacockes Road

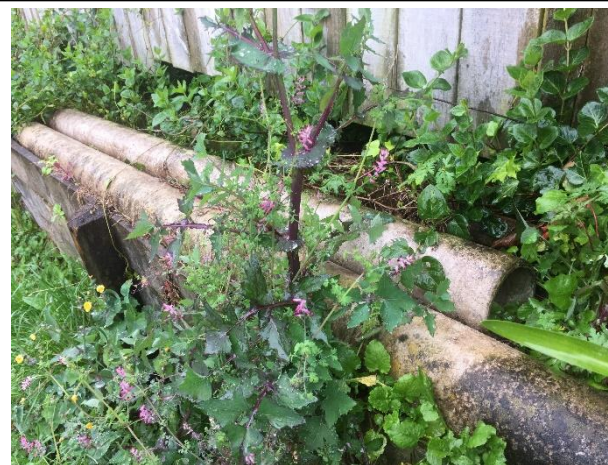
Photograph 64: PACM adjacent to accessway at 361 Peacockes Road

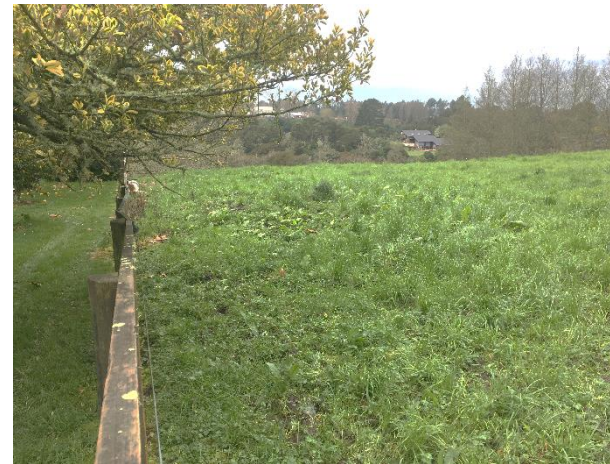
Photograph 68: Potential filled area adjacent to fence line behind garage at 337 Peacockes Road

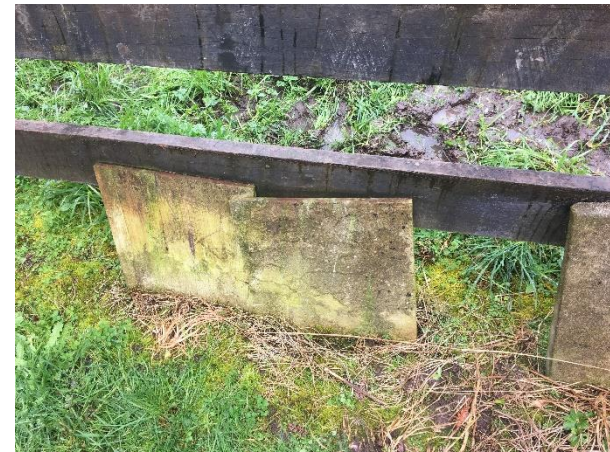
Site Condition	Comments
Presence of Visible Signs of Potential Contamination Sources	<p>During the site walkover a number of potential contamination sources were noted. These are summarised below by address.</p> <p>337 Peacockes Road:</p> <ul style="list-style-type: none"> • Four soil stockpiles in the northwest quadrant of the site comprising soil, wood, steel and gravel fragments (see photographs 48-50). • A burnt rubble pit comprising wood, household rubbish and soil. Evidence of recent burning observed (ash and blackened soil) (see photograph 46). • An area of filled ground containing brick and concrete fragments. <p>An area of potential filled ground on northern side of dwelling boundary (see photograph 68).</p> <ul style="list-style-type: none"> • An incinerator used for burning household rubbish (see photographs 65 - 66). • PACM tiles adjacent to the eastern boundary of tennis court and southern boundary of the garage by the residential dwelling (see photographs 69 and 70).

Photograph 70: PACM tiling at 337 Peacockes Road behind garage

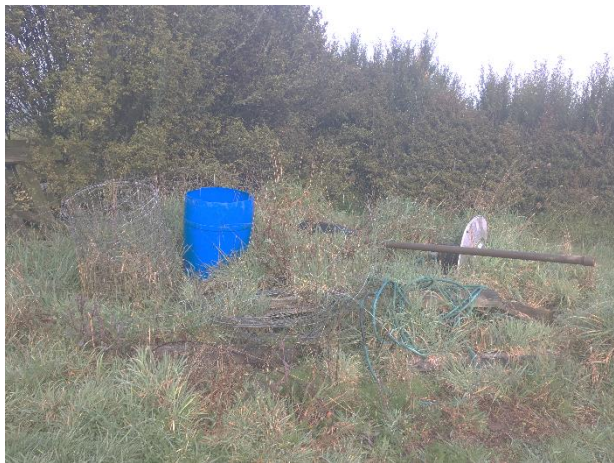
Photograph 71: Stockpiled material adjacent to dwelling at 523 Peacockes Road
