| Building No. 3230 | Street Williams Road | | Zip 95008 | Date of Inspection 02/14/13 | Page 1 of 9 |
| Silver Creek Termite Contro | P.O. Box 8361 San Jose, CA 95 Phone: (408) 224 | I-4688 Fax: (408) 224-4577 | | | Report # 3131 |
| General Desc | REPORT X LIMITED R ription: y, single family, stucco, | - | | REINSPECTION Fion Tag Posted: | REPORT 🗌 |

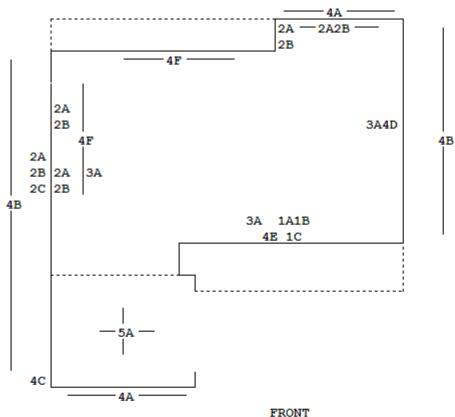
1A. FINDING: Evidence of subterranean termites was found, noted as 1A on the diagram.

1B. FINDING: Evidence in the form of SHELTER TUBES for subterranean termites was observed and noted as

1B on the diagram.

1C. FINDING: There is cellulose debris in earth contact in the substructure area. There is evidence of infestation

by SUBTERRANEAN TERMITES in this debris, noted as 1C on the diagram.

2A. FINDING: Evidence of drywood termites was observed at the areas noted as 2A on the diagram.

2B. FINDING: Evidence of drywood termites, in the form of drywood PELLETS, was observed, noted as 2B on

the diagram.

2C. FINDING: Drywood termite damage was observed at the door threshold, noted as 2C on the diagram.

3A. FINDING: There was a SURFACE FUNGUS condition observed at the subfloor as viewed from crawl space.

noted as 3A on the diagram.

4F. FINDING: Damp soil was observed in the crawl space, noted as 4F on the diagram.

RECOMMENDATION: Perform a guaranteed soil treatment for the control of subterranean termites using a registered

RECOMMENDATION: REMOVE all shelter tubes in these areas. (SECTION I ITEM)

RECOMMENDATION: Remove cellulose debris of a size that can be raked from the substructure area. See additional

RECOMMENDATION: Tarp, seal and FUMIGATE with the lethal gas, Vikane or other similar chemical. SECTION I ITEM.

RECOMMENDATION: MASK and/or remove all pellets that are accessible. (SECTION I ITEM)

RECOMMENDATION: REMOVE and REPLACE the damaged wood members. If possible, we will chisel or cut out

RECOMMENDATION: SCRAPE or wire brush this area and then treat with a registered fungicide. (SECTION I ITEM)

RECOMMENDATION: Recommend periodic inspection or owner should consult with appropriate drainage specialist to
