Property Inspection Report

714 Pershing Ave., San Jose, Ca.

Inspection Date: 02-25-13

Report Number: 130224714PEB

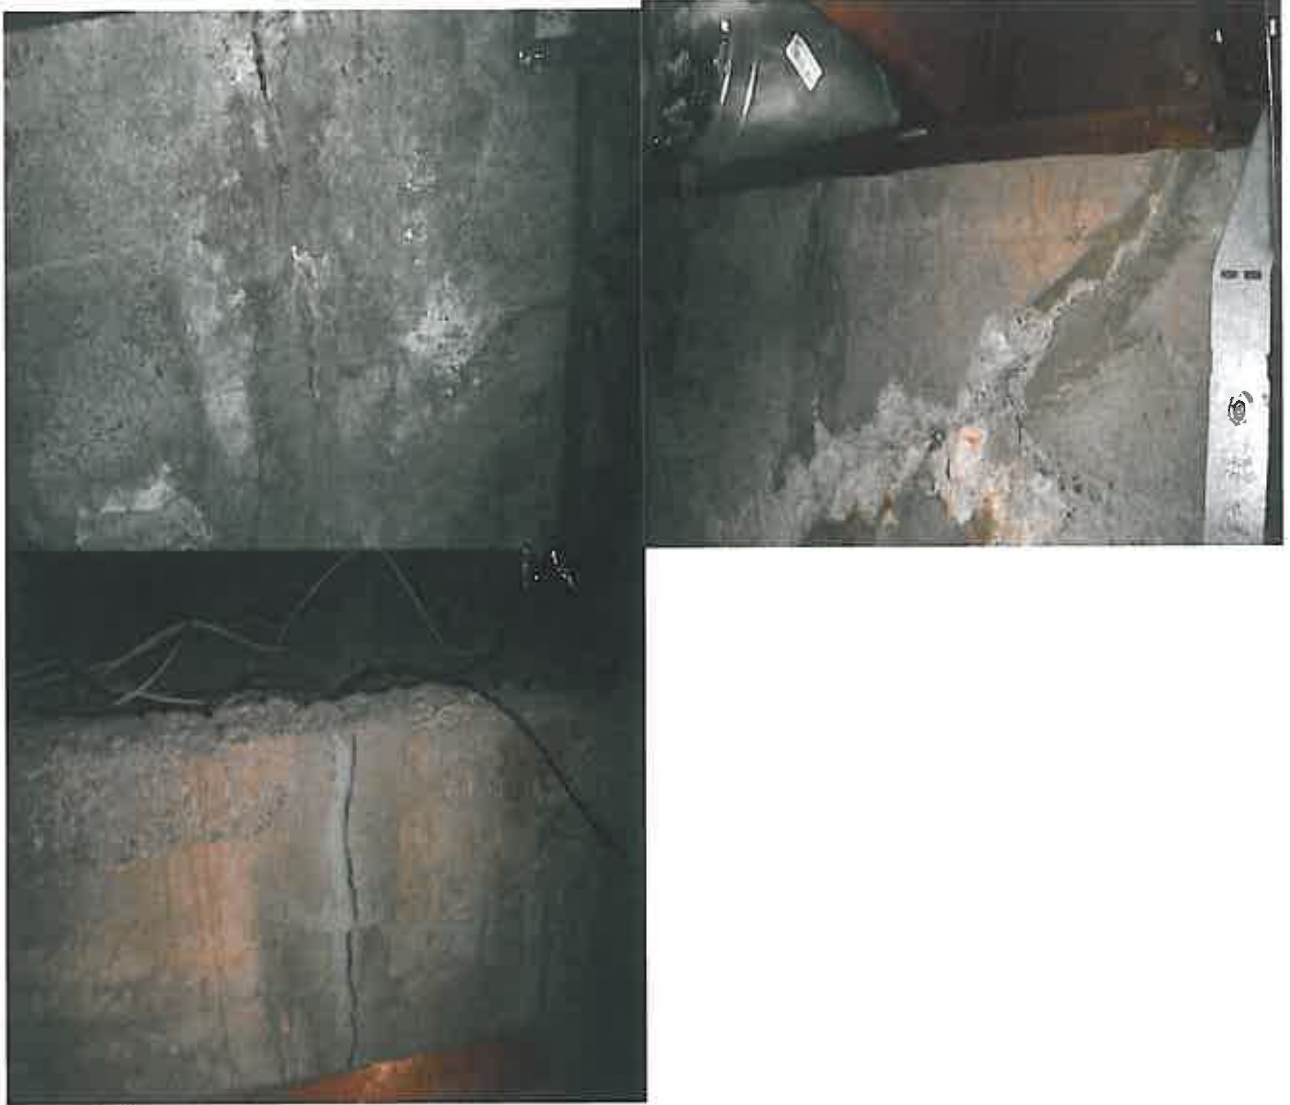
- ☒ **Repair:** Several cracks in the foundation were observed from the exterior walls, the basement and crawl space areas. The amount of movement and associated damage is consistent with homes of this type and age in this general area. The soils conditions and the lack of structural reinforcing steel commonly are related to foundation damage. The rate of movement cannot be predicted during a one-time inspection. Additional information may be desirable, consultation with a structural engineer or qualified foundation contractor will provide a more in-depth evaluation.

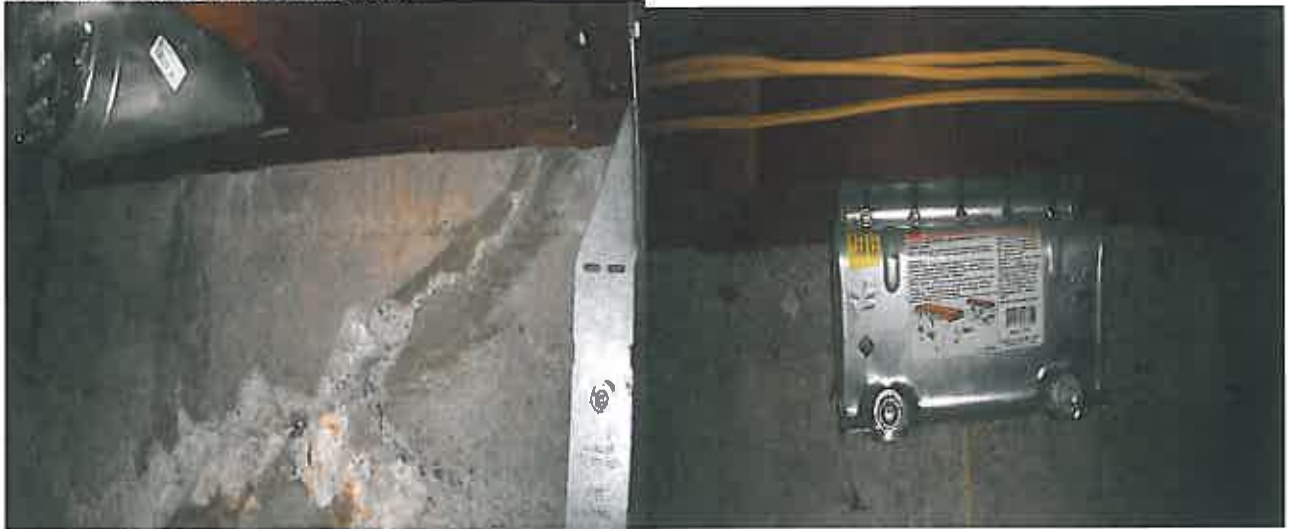
The mudsill around the raised perimeter foundation of the home, where visible, was found to be in acceptable condition. Upgrading and retrofitting including the installation of anchor or strapping plates to secure the wood framing of the home to the foundation was noted. The anchor or strapping plates were observed through out the sub area, with size and spacing not determined. Consulting with the current occupant and review of the building permits associated with the seismic upgrades for additional information is recommended.

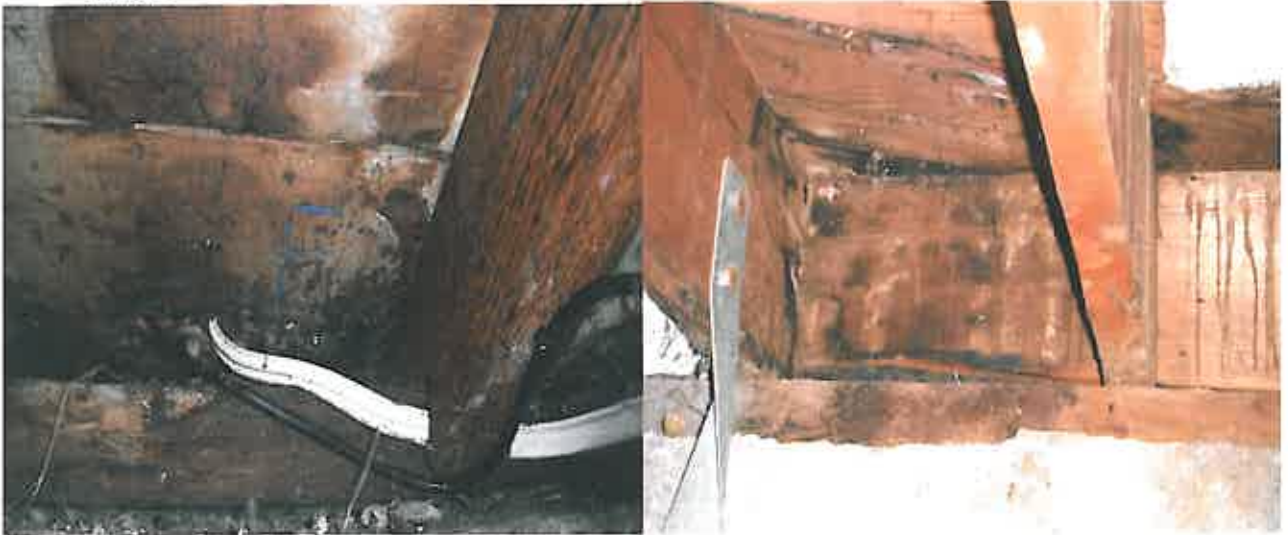
- ☒ **Monitor:** Evidence of moisture staining on the wood subfloor material was observed from the crawl space in various locations. The wood surface was dry at the time of the inspection. Therefore, this is suspected to be from past leakage. Review of a current pest control report is suggested and may provide additional information on this matter.

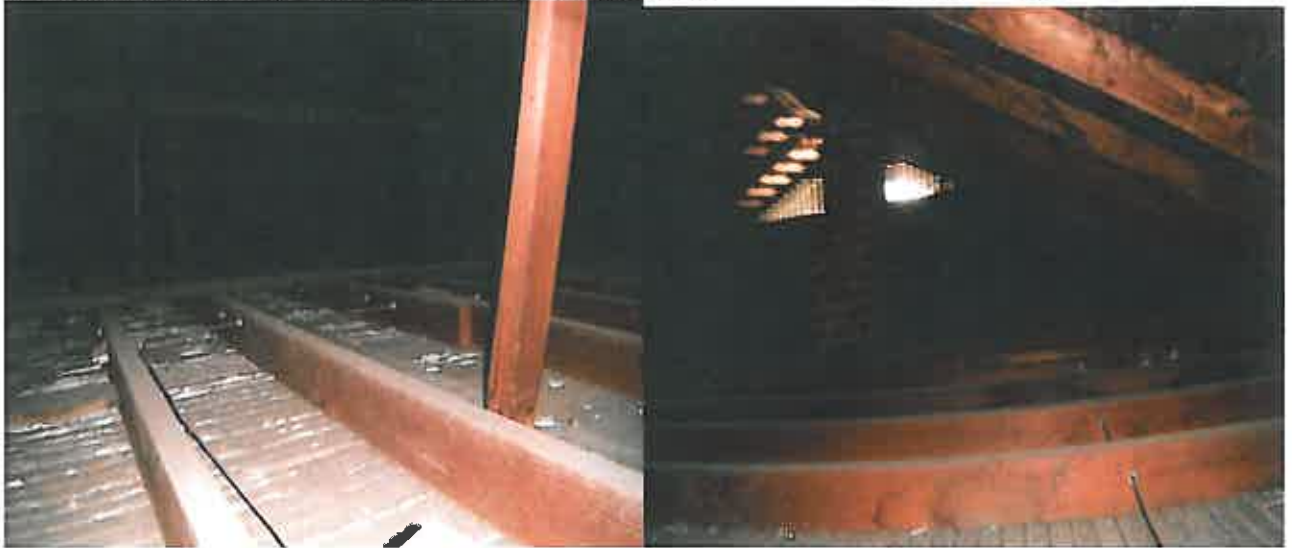
The attic access opening is located in laundry room. The attic was found to have minimum clearance at the opening limiting the inspection to observations from the access opening. Where visible, the attic area appeared to be dry.

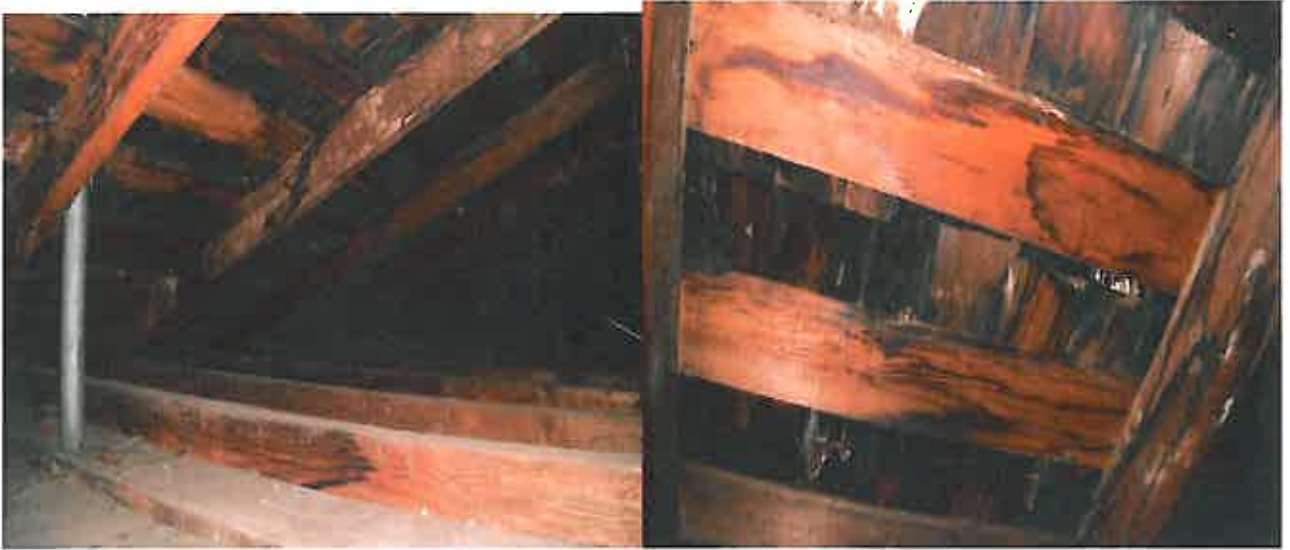
- ☒ **Monitor:** Some moisture staining was noted in the attic on the roof sheathing. Moisture staining of this type is commonly caused by past/current roof leaks. Review of the roofing page in this report may provide additional information on the current condition of the roof covering. Further evaluation may be advisable.

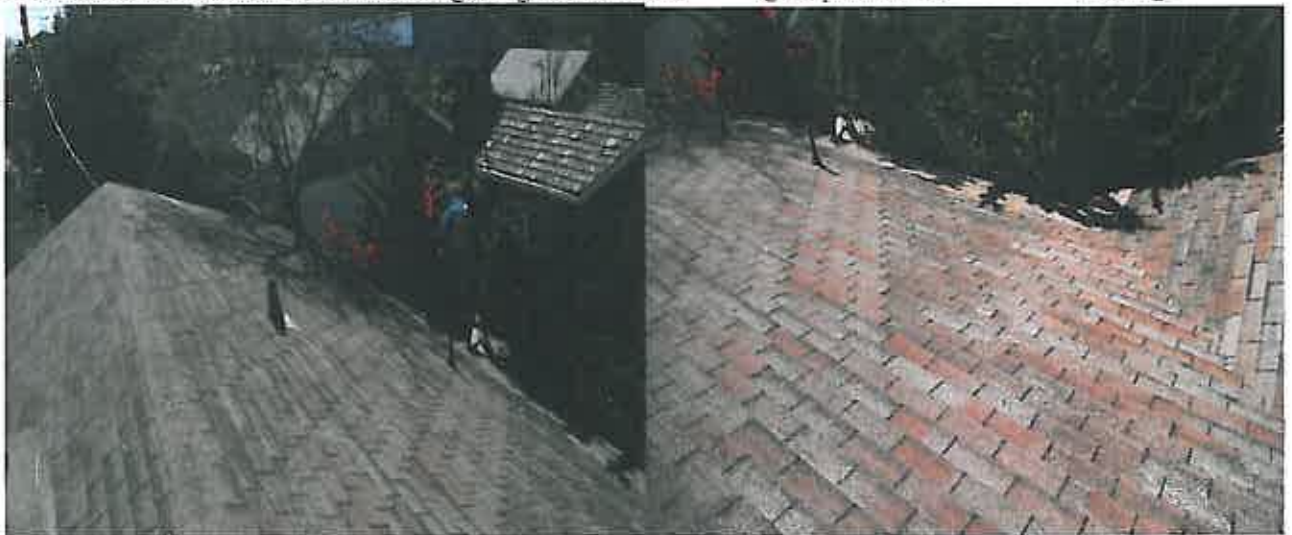
An asphalt shingle roof covering is in use on this home. Generally, asphalt shingles are installed on a solid surface such as plywood or solid plank sheathing. The individual asphalt shingles are fastened over an underlayment comprised of asphalt felt paper. The asphalt roof covering is older and considered to be in poor condition with a limited life expectancy. Refer to the observations below for further details regarding the conditions affecting the performance of this roof covering.

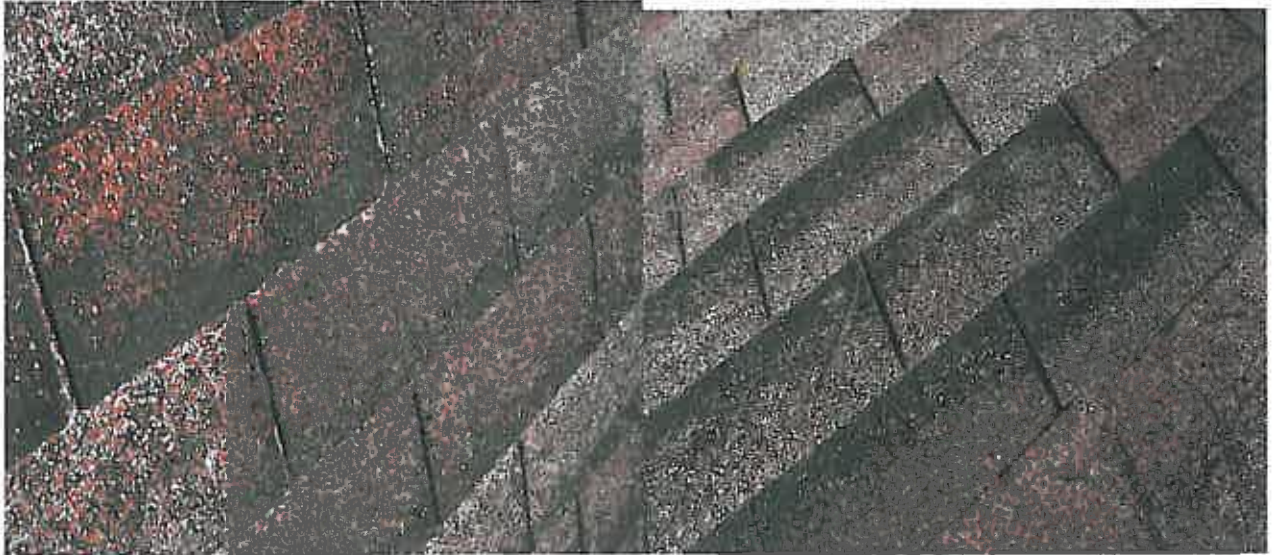
- ☒ **Repair:** Damage of the asphalt roof covering was noted. This type of damage is likely to cause roof leakage at this location and requires repair. Further evaluation and repair by a qualified roofing contractor is recommended.

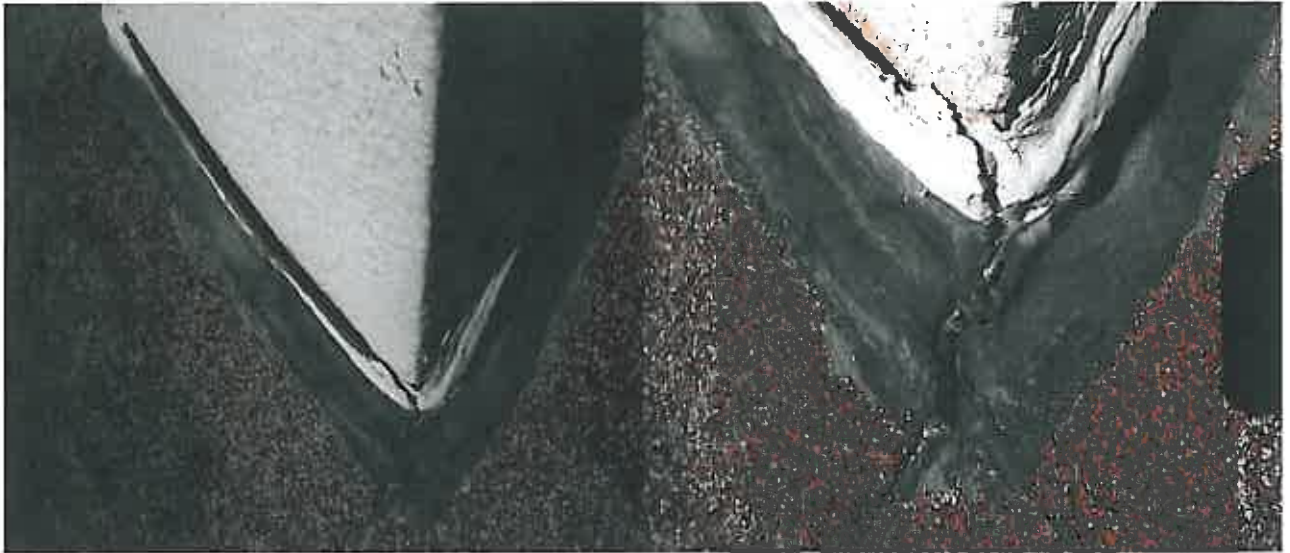
- ☒ **Repair:** The roof flashing in various locations was found to have voids or openings at the roof. Poorly sealed roof flashing is susceptible to leakage and resultant moisture damage. Improvement to seal the voids or opening is recommended.

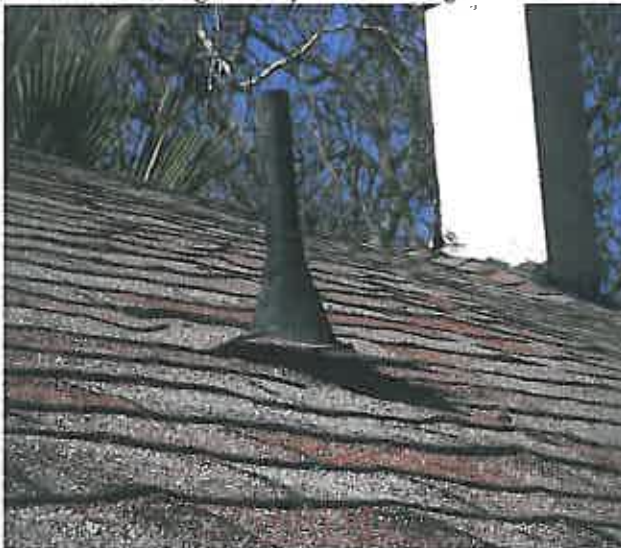
- ☒ **Repair:** The roof flashing in various locations was found to be loose and/or inadequately secured. Loose flash is not likely to perform as intended and should be repaired. Improvement to better secure this flashing is suggested. Consulting with a qualified roofing contractor for additional information on this matter is suggested.

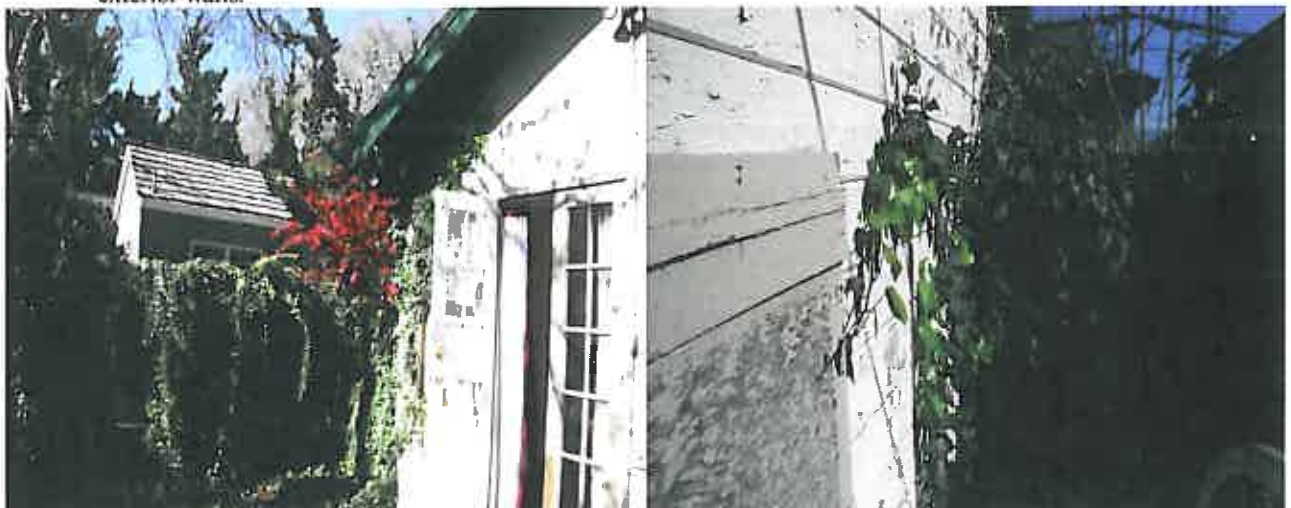
- ☒ **Improve:** The landscaping in various areas is overgrown and prevents a complete inspection of the exterior walls. Trimming back of bushes and trees is recommended to provide proper air circulation and access to the exterior walls.

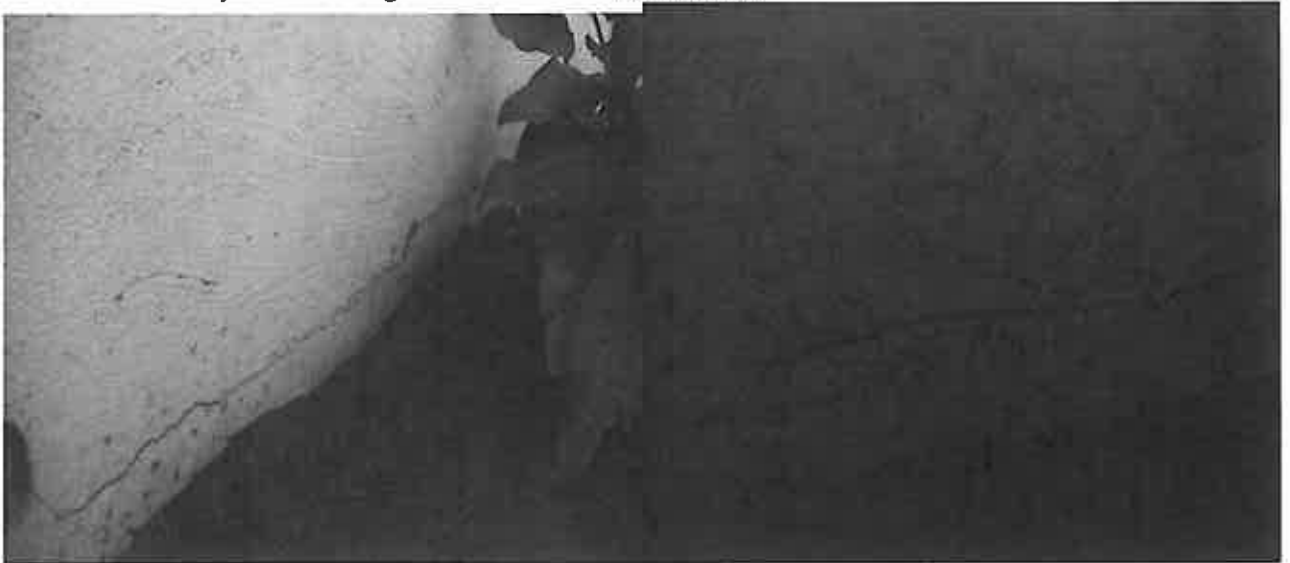
- ☒ **Repairs:** Cracking on the exterior walls near the top of the foundation are signs of possible settlement. Further evaluation by a structural engineer or contractor is recommended.

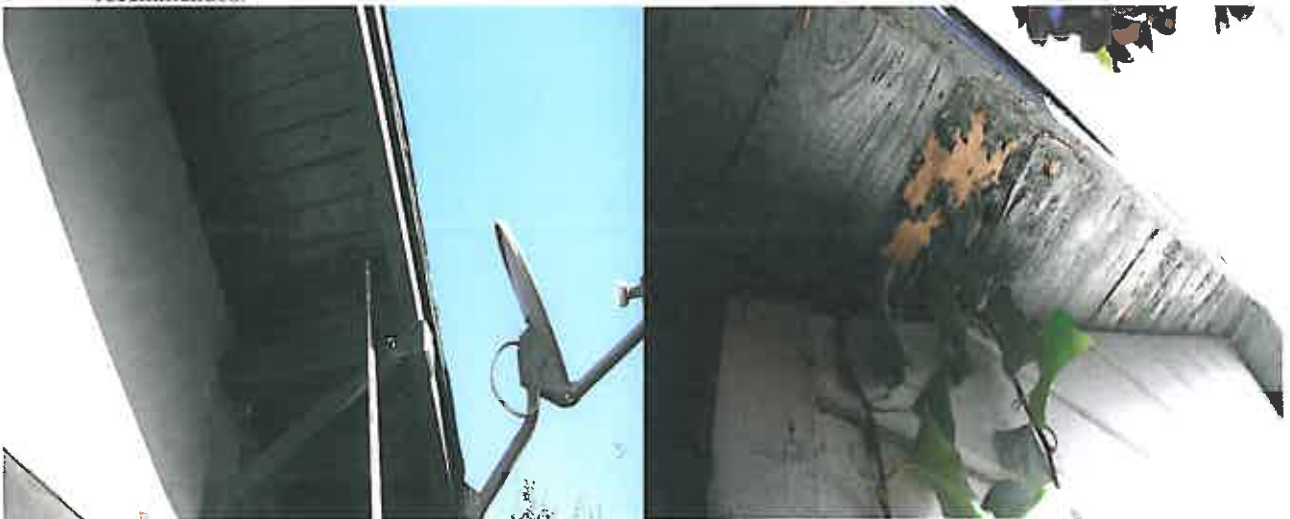
- ☒ **Improve:** Damage was observed in the eaves in various locations. Repairs will be needed at this location. Review of a current pest control report may provide additional information on this damage and the corrective action recommended.

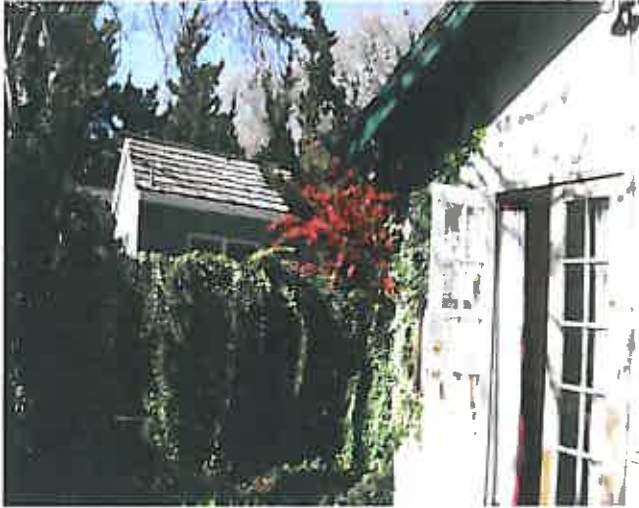
- ☒ **Monitor:** Foliage covers a majority of the fence in various locations. The foliage obscures a visual inspection of the fencing in this area. Further evaluation may be desired once the foliage has been trimmed away in the future.

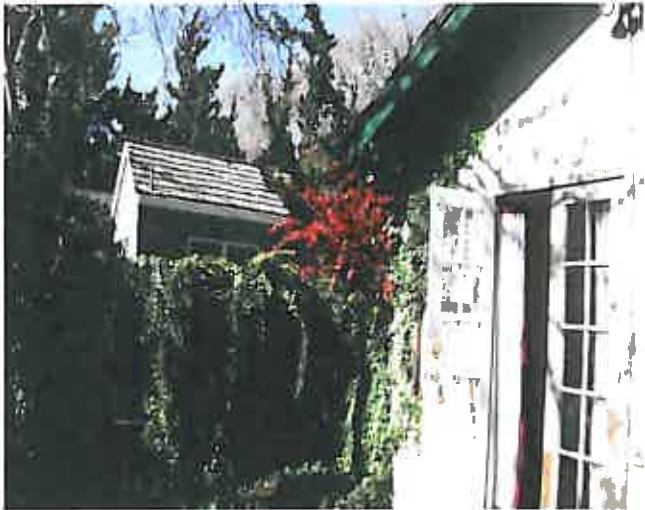
- ☒ **Improve:** Vines growing on exterior walls in various locations should be kept trimmed away from siding, window trims, and the eaves.

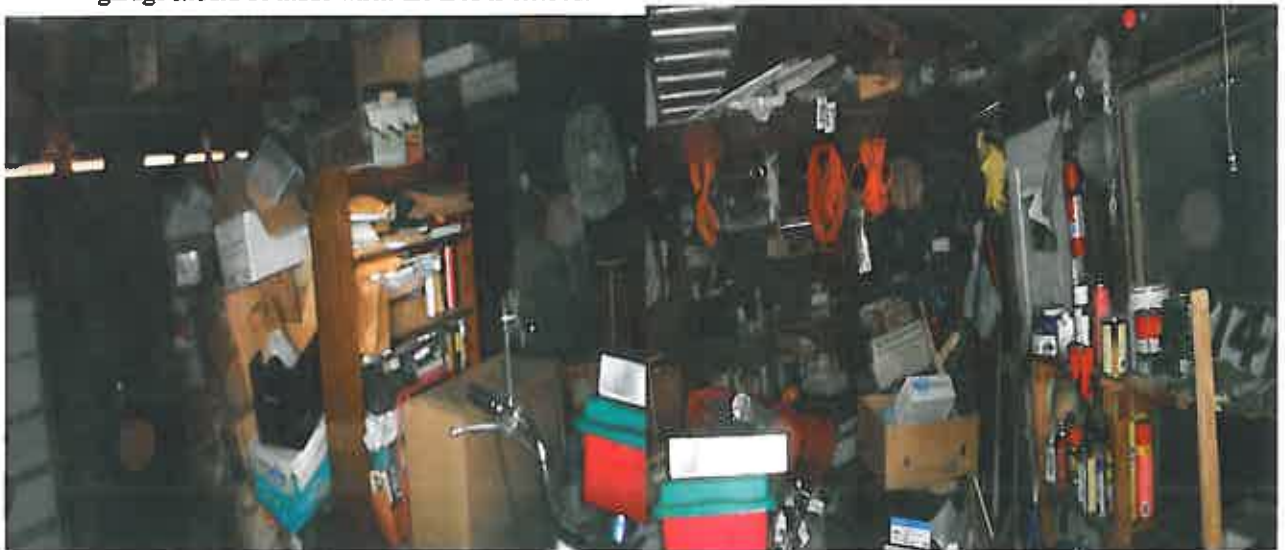
- ☒ **Monitor:** The concrete garage floor was not fully visible at the time of the inspection. Personal belongings covered all or part of the floor surface preventing a complete evaluation. Inspection of the concrete floor in the garage should be made when the area is cleared.

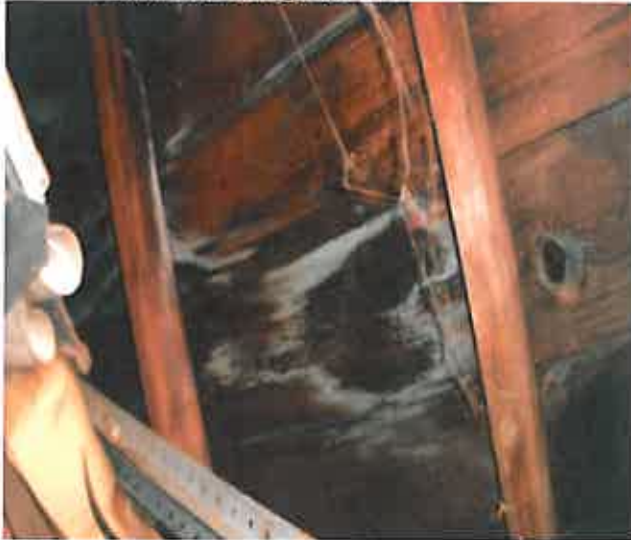
- ☒ **Monitor:** All areas of the garage wall were not available for inspection. Personal belongings blocked access to portions of the firewall. These areas of the firewall were not evaluated.
- ☒ **Monitor:** Water staining was noted on the interior wall and/or of the garage. The water stain appears to be from past leakage and was dry at the time of the inspection. Monitoring this area in general is recommended to determine if additional leakage occurs.
