May 10, 2012

Property: 3230 Williams Road, San Jose CA 95117

Inspector: Duane Serrano

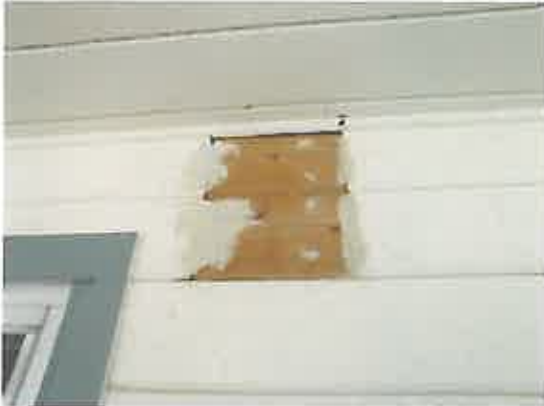
i. Siding has been repaired incompletely located at the front porch area. Minor stucco cracks exist. Stucco is cracked & loose at the rear left lower corner. Water stains exist at the front porch overhang near the skylight.

View of the incomplete repair to the siding at the front elevation

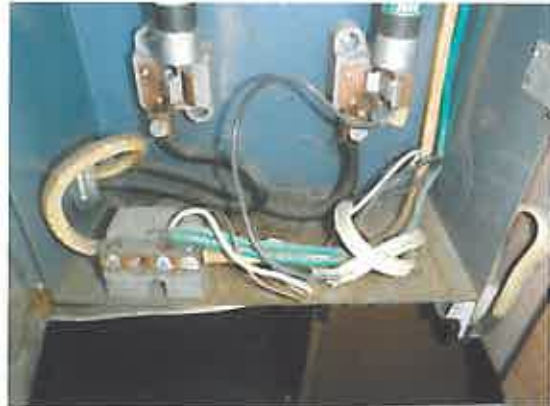
A. Due to the added circuits, the main panel may be inadequately sized. Have further inspected by a qualified electrical contractor.
D. Wiring has been added improperly in the main panel & the subpanel & this installation is a fire hazard & a major safety issue. A 20 amp breaker has been added improperly located in the garage wall & the wiring is also a contact hazard. Have further inspected & repaired ASAP by a qualified electrical contractor.

View of improperly installed wiring in the main electrical panel

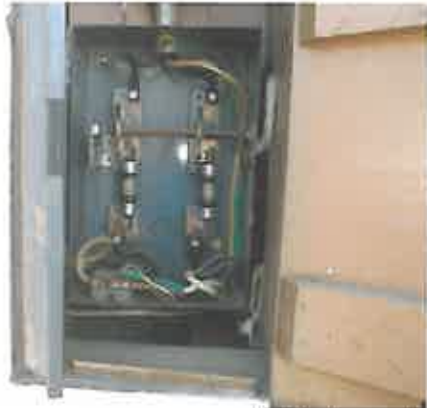
View of the interior of the main electrical panel

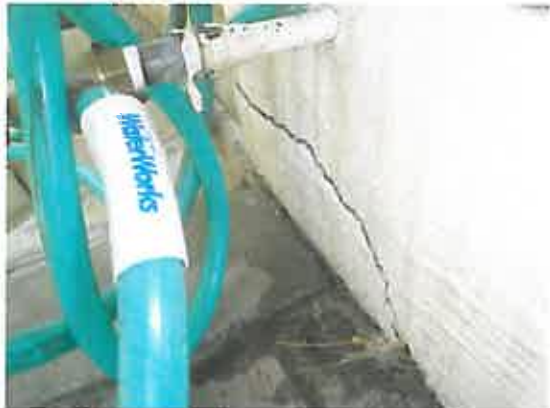
View of the cracked & loose stucco at the rear left lower corner

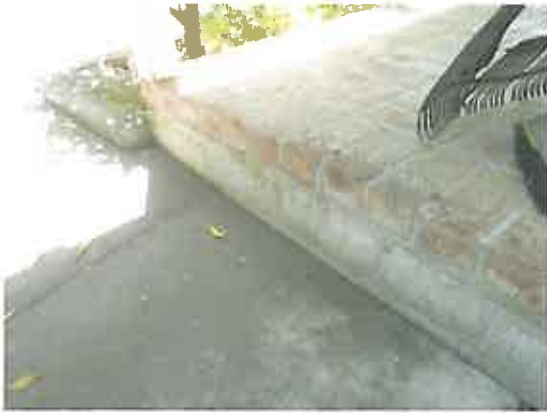
M. Front porch & rear porch step heights are above proper height limits-tripping/falling hazards. Patio concrete & bricks are unlevel at many areas-tripping hazards. Concrete slab is cracked & unlevel at the front elevation-tripping hazards.

View of a high step at the rear elevation porch area

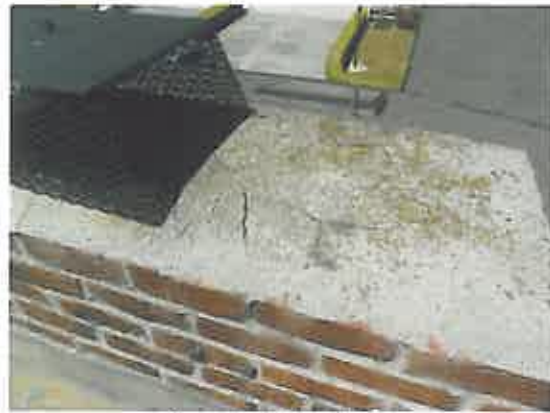
c. Chimney mortar cap is cracked.

Sample view of cracks in the chimney mortar cap

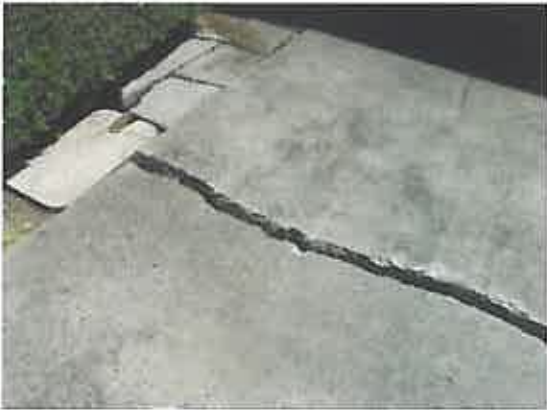
Sample view of cracked & unlevel concrete at the front elevation

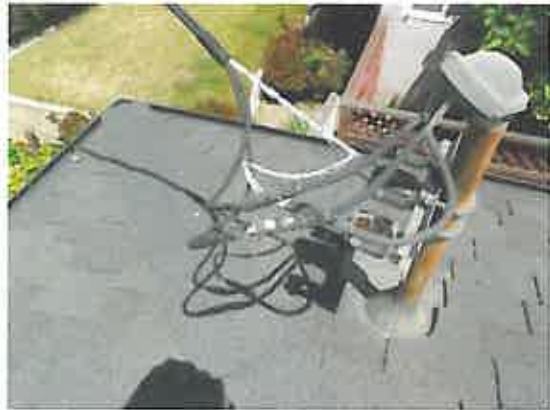
m. Main cable wires are frayed-contact the power company for repairs.

View of frayed insulation leaving wiring exposed at the main electrical supply cables

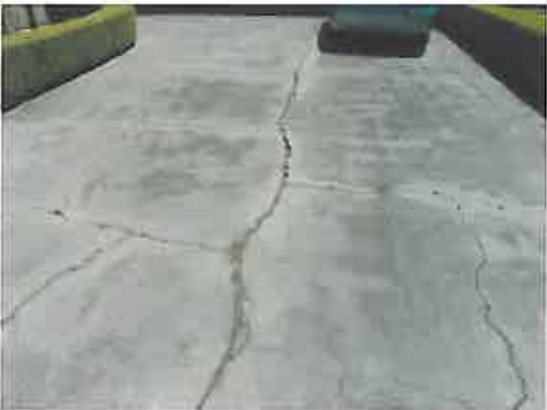
N. Driveway is cracked at many areas.

Sample view of cracks in the driveway concrete

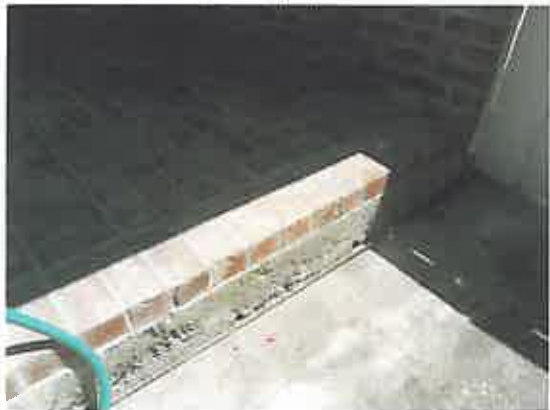
View of the high step at the front porch area

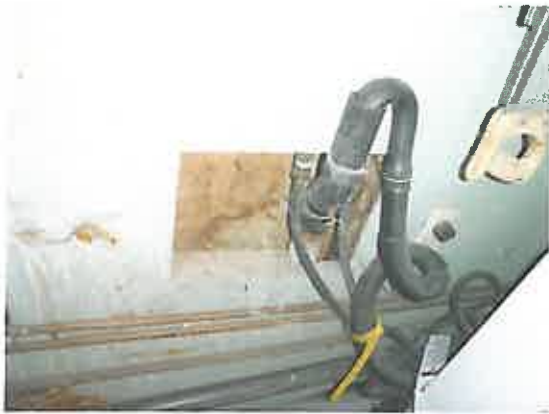
View of the void in the garage firewall at the washing machine drain line

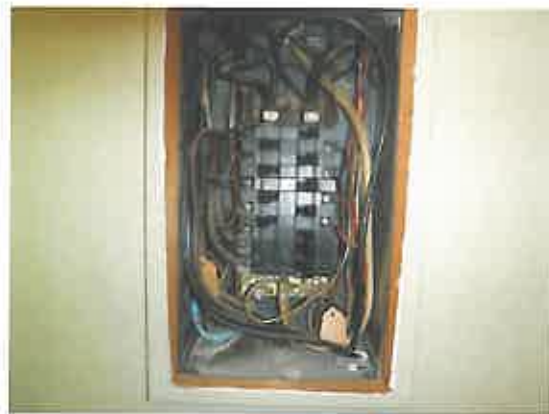
View of the interior of the electrical subpanel

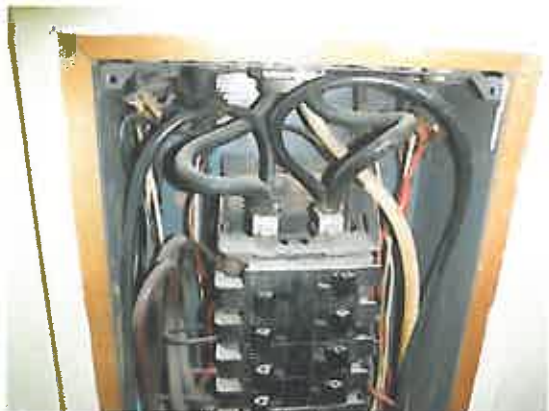
View of improperly installed wiring in the subpanel

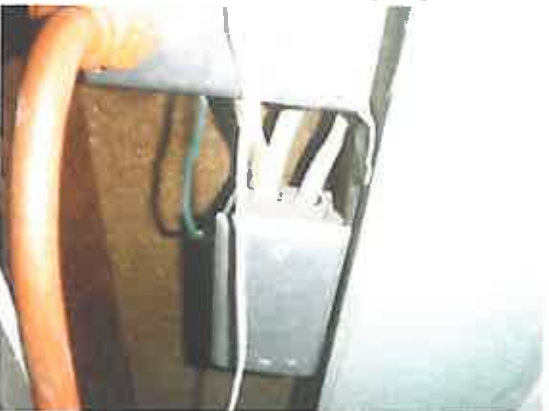
View of unprotected wiring entering a box in the garage

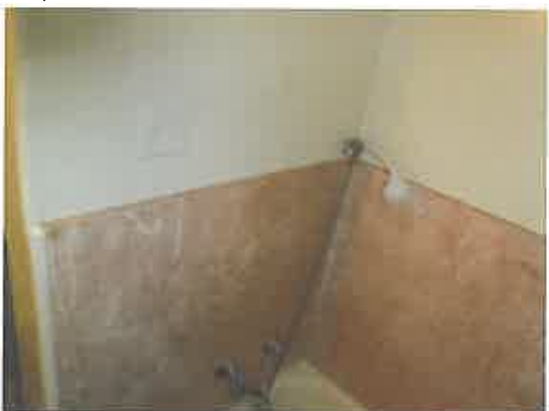
L. Spliced wires are exposed & not installed into junction boxes located in the attic over the kitchen & living room & in the crawlspace under the kitchen & the hall. Non water proof switches are installed within the boundaries of the right bathroom bath tub-contact hazard.

View of improper switches installed at the right bathroom tub area

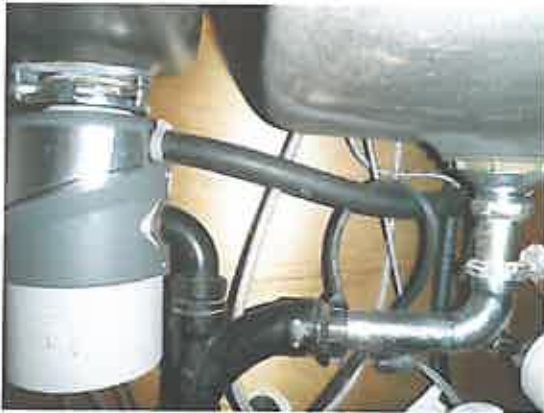
f. Dishwasher drain line has an improper slope going from the air gap to the disposer which can trap water. Dishwasher is loose in the cabinet. Dishwasher is very noisy & well beyond its life expectancy.

View of the dishwasher drain hose with an improper slope

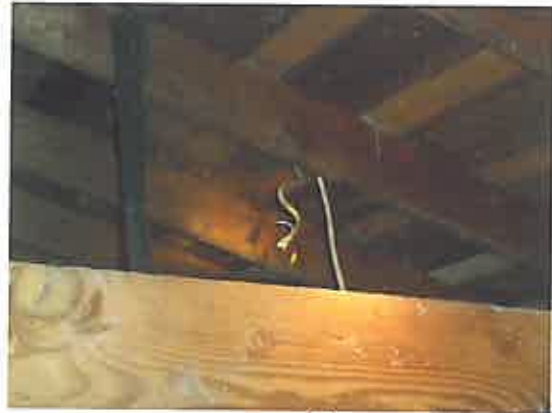
View of loose, unprotected & exposed wiring in the attic over the living room area

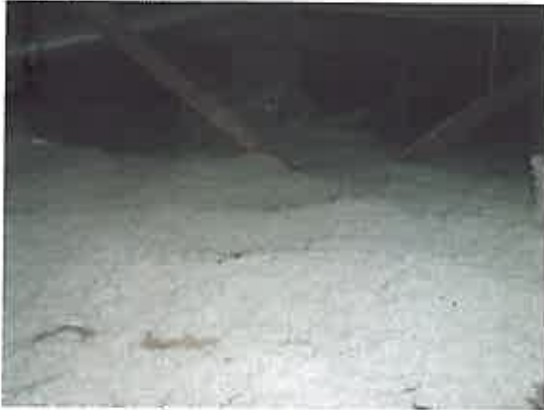
Sample view of upgraded attic insulation restricting access & visibility

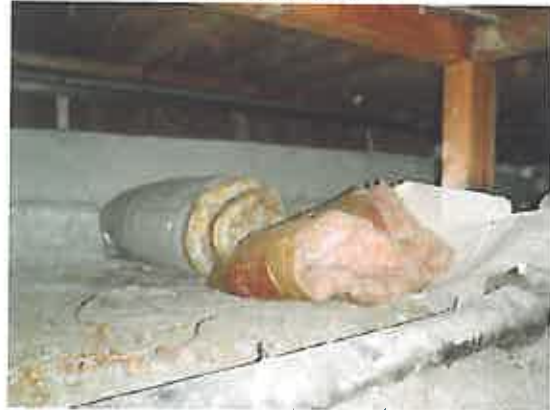
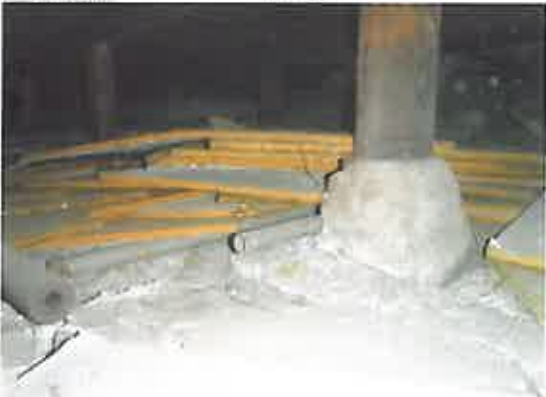
Sample view of debris in the crawlspace

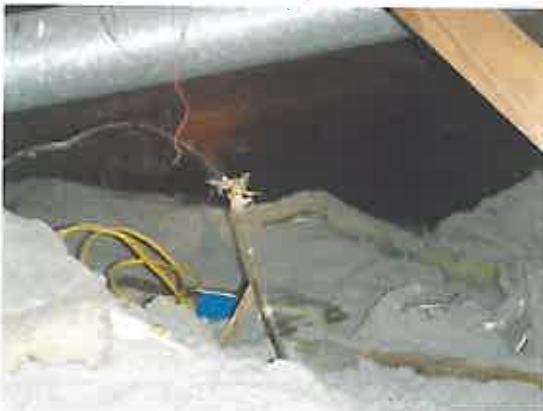
View of improperly spliced & exposed wiring in the attic over the kitchen

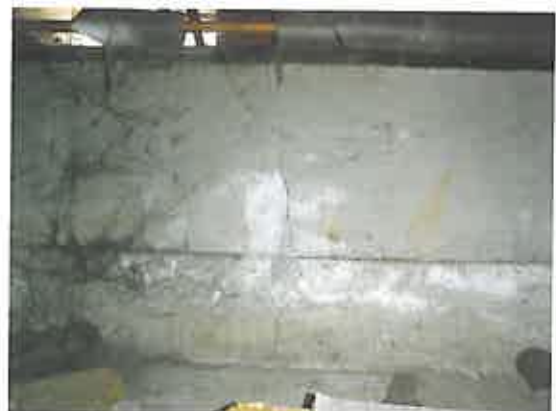
B. Various vertical foundation cracks exist going from the top to the footings. Rear left corner foundation is cracked & beginning to separate. Various cracks show signs of water penetration which can rust & corroded the steel rebar in the foundation. Have the foundation further inspected by a qualified foundation expert.

Sample view of a vertical foundation crack with signs of moisture entering through the crack

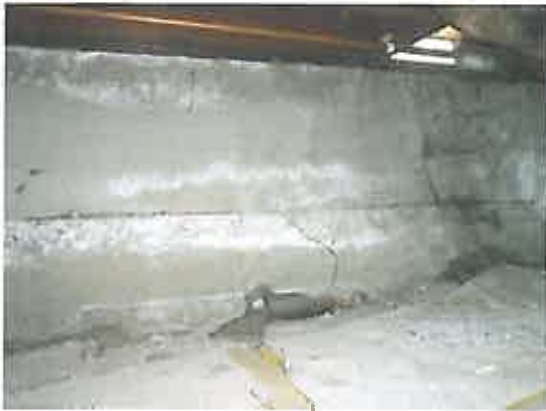
a. Signs of water intrusion into the crawlspace. Soils are currently damp at the rear left corner area & under the left bathroom (NOT from a plumbing leak). Drainage improvements recommended. Recommend extending the downspouts and draining the water a minimum of 10 feet away from the foundation. Recommend regrading the soils to drain the water away from the foundation.

Sample view of efflorescence indicating water intrusion into the crawlspace

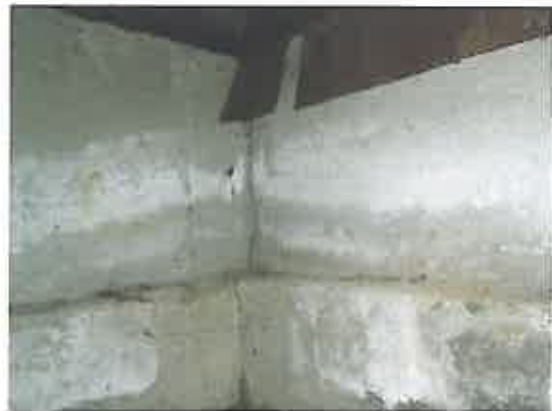
View of the cracked & separated rear left corner of the foundation

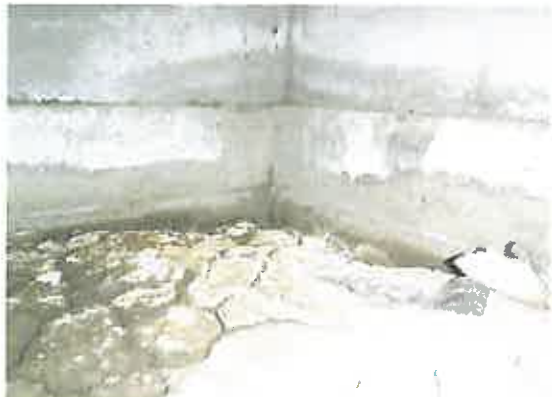
View of damp soils at the rear left corner area in the crawlspace

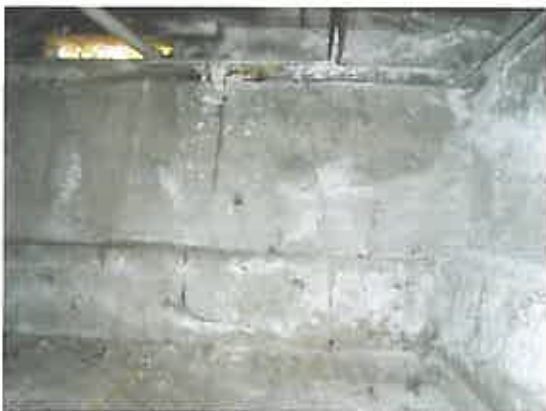
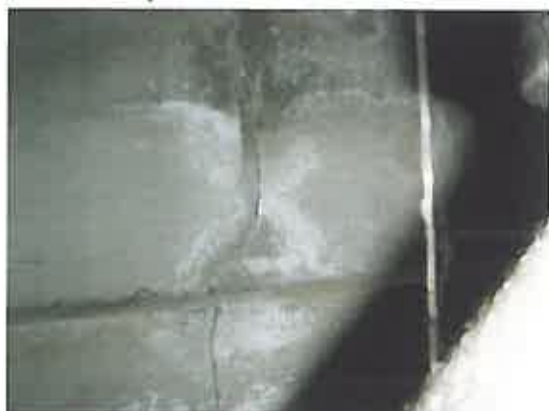
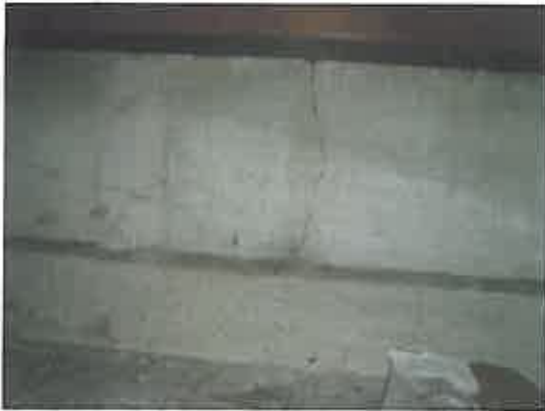
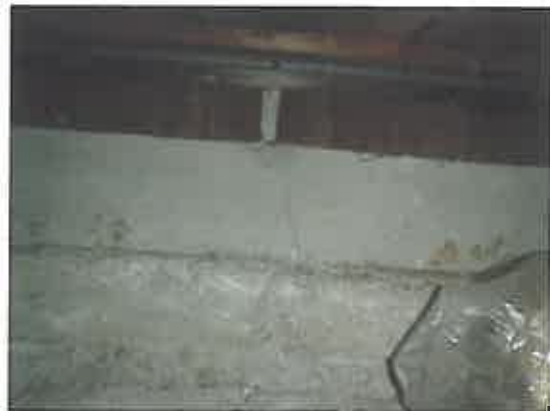
Sample view of a vertical foundation crack

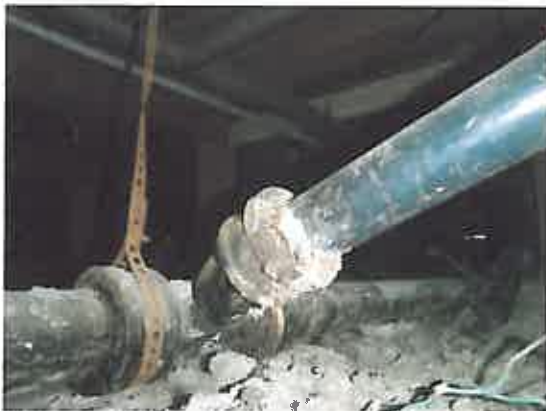
Sample view of corrosion at a cast iron drain line

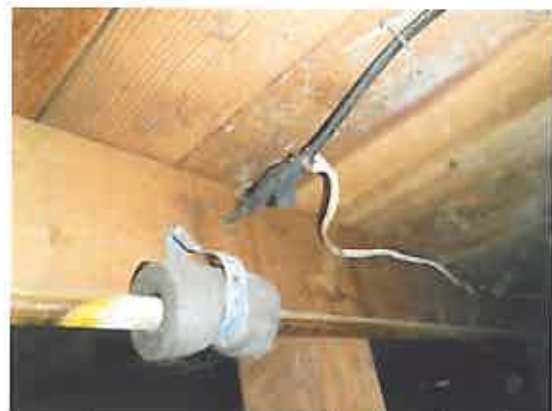
View of improperly spliced & improperly protected wiring under the hall area

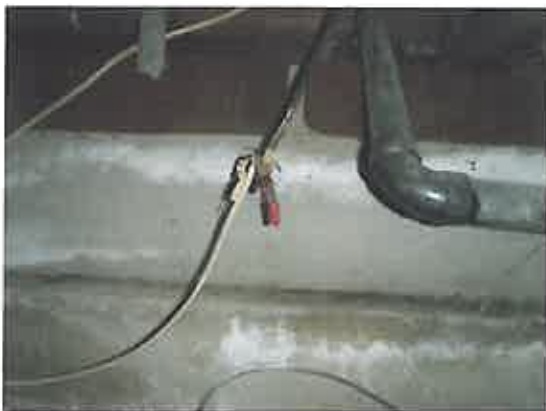
View of improperly spliced & exposed wiring under the kitchen

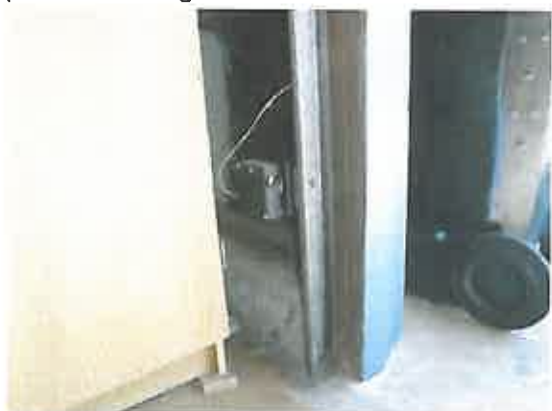
View of a high garage door opener sensor
