| Case No: | 2025-0389 | | Date of visit: | 09/10/2025 | | |
| Site No: | FS0237 | Site Name: | Gorsten | | | |
| Business No: | FB0119 | Business Name: | Mowi Scotland Ltd | | | |

# Fish Health Inspectorate visit report

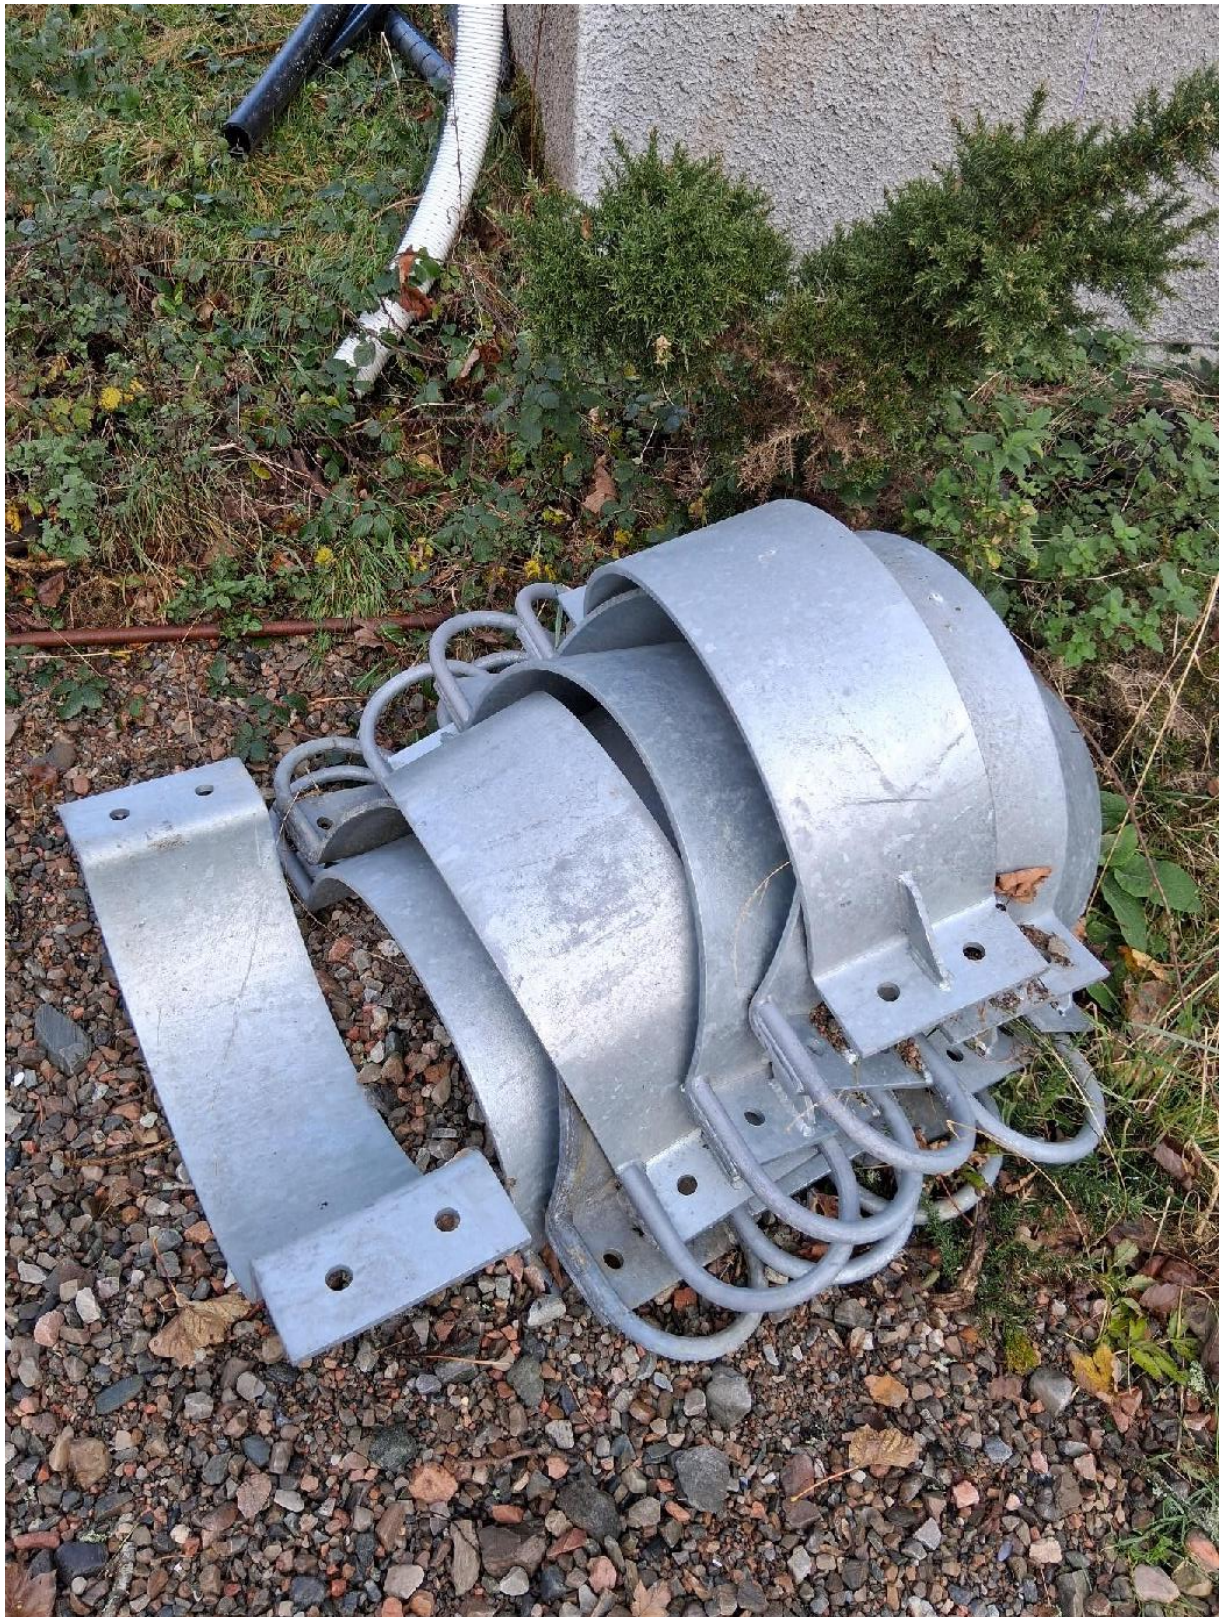
Photo 1: Clamps used to attach tidal barrier floatation tube to mooring chain. One of these clamps broke during the storm.

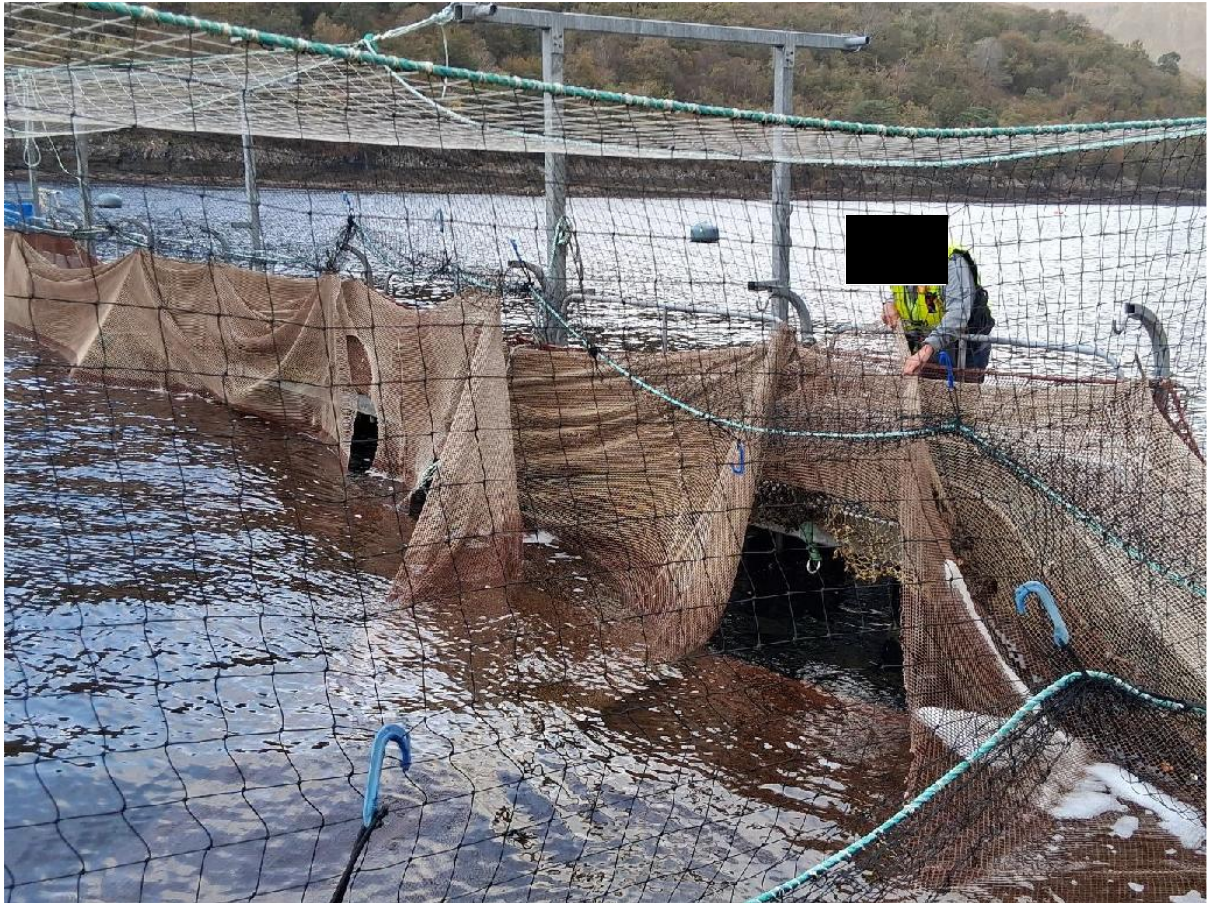
Four holes found in total on the north side of the net closest to the tidal barrier. Two of these bigger holes are rectangular and approximately 4-5 meters wide and between 1-5 meters below the water line. Two of the smaller holes were about 2 metres wide at about 4 metres from the bottom of the net. Net is 12m deep. Damage reported at 8am on Saturday. According to site staff, mobile phone signal was reportedly OK at the site on Saturday morning. Mobile signal in other areas of the west coast of Scotland may have been poor or absent

Photo 2: Holes in the net of cage 2. A member of site staff stands next to one of the larger holes

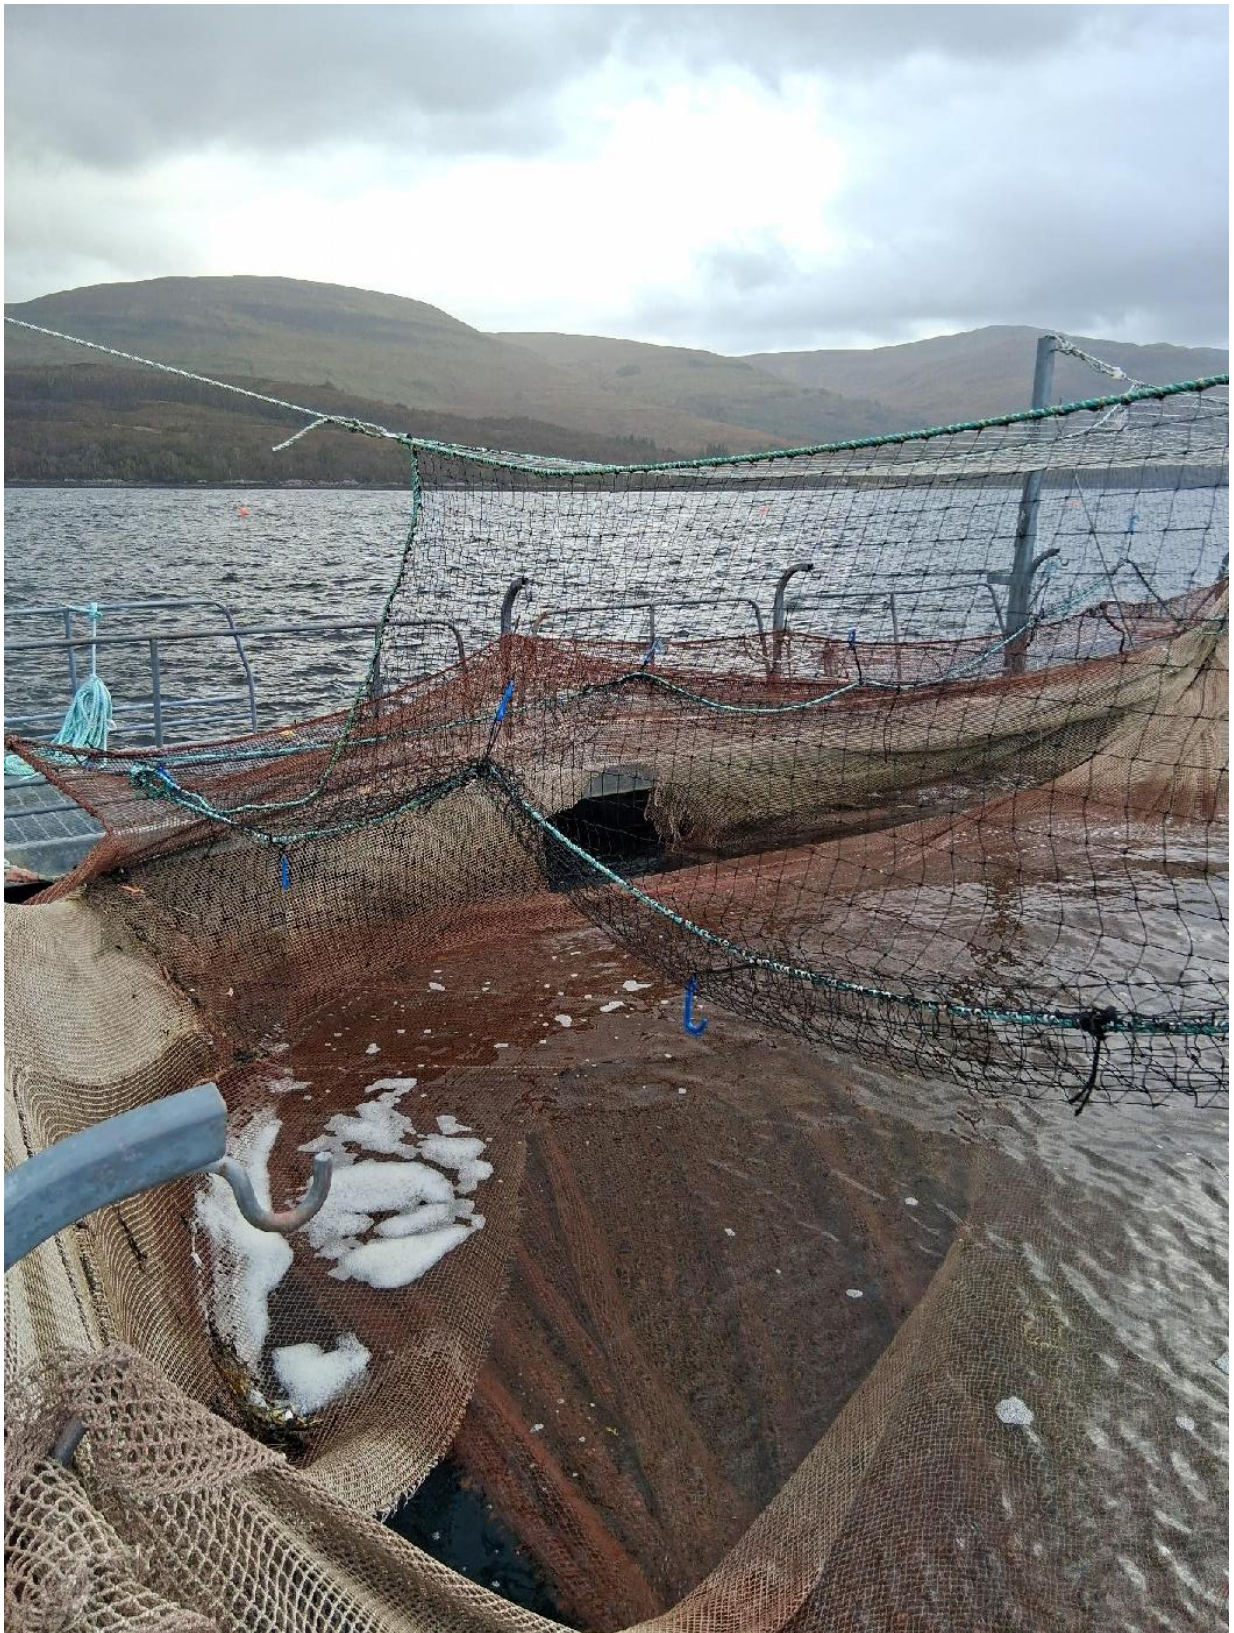
Photo 3: Holes in cage 2. The hole in the centre of the photo is one of the smaller holes.

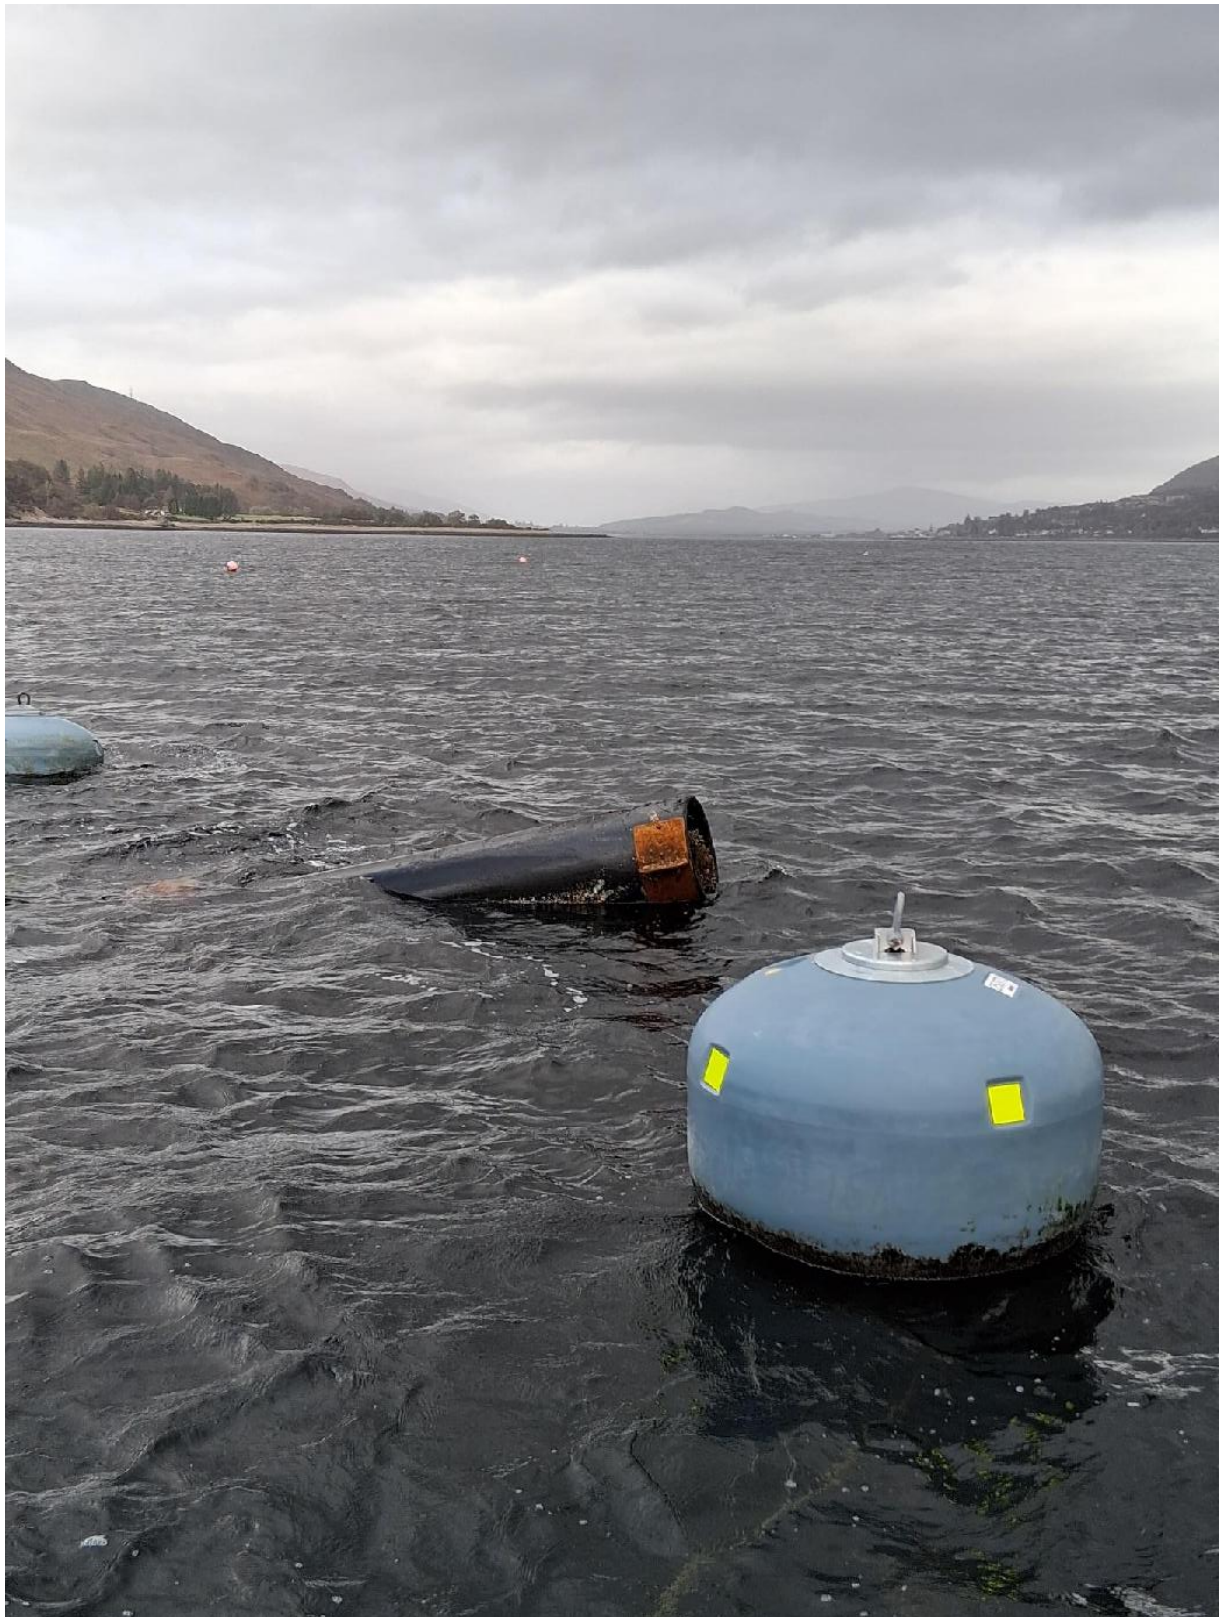
Photo 4: Most eastern end of the tidal barrier floatation tube, partially sunken with a metal fixing (which was used to secure the floatation tube to the cage group using chains).

It is recommended that in accordance with A Code of Good Practice for Scottish Finfish Aquaculture (CoGP) (Chapter 4, section 4.16) procedures should be developed and implemented to ensure the tidal barrier attached to the facilities and its mooring components are inspected in accordance with a documented standard operating procedure and a documented inspection plan which is based on risk assessment.

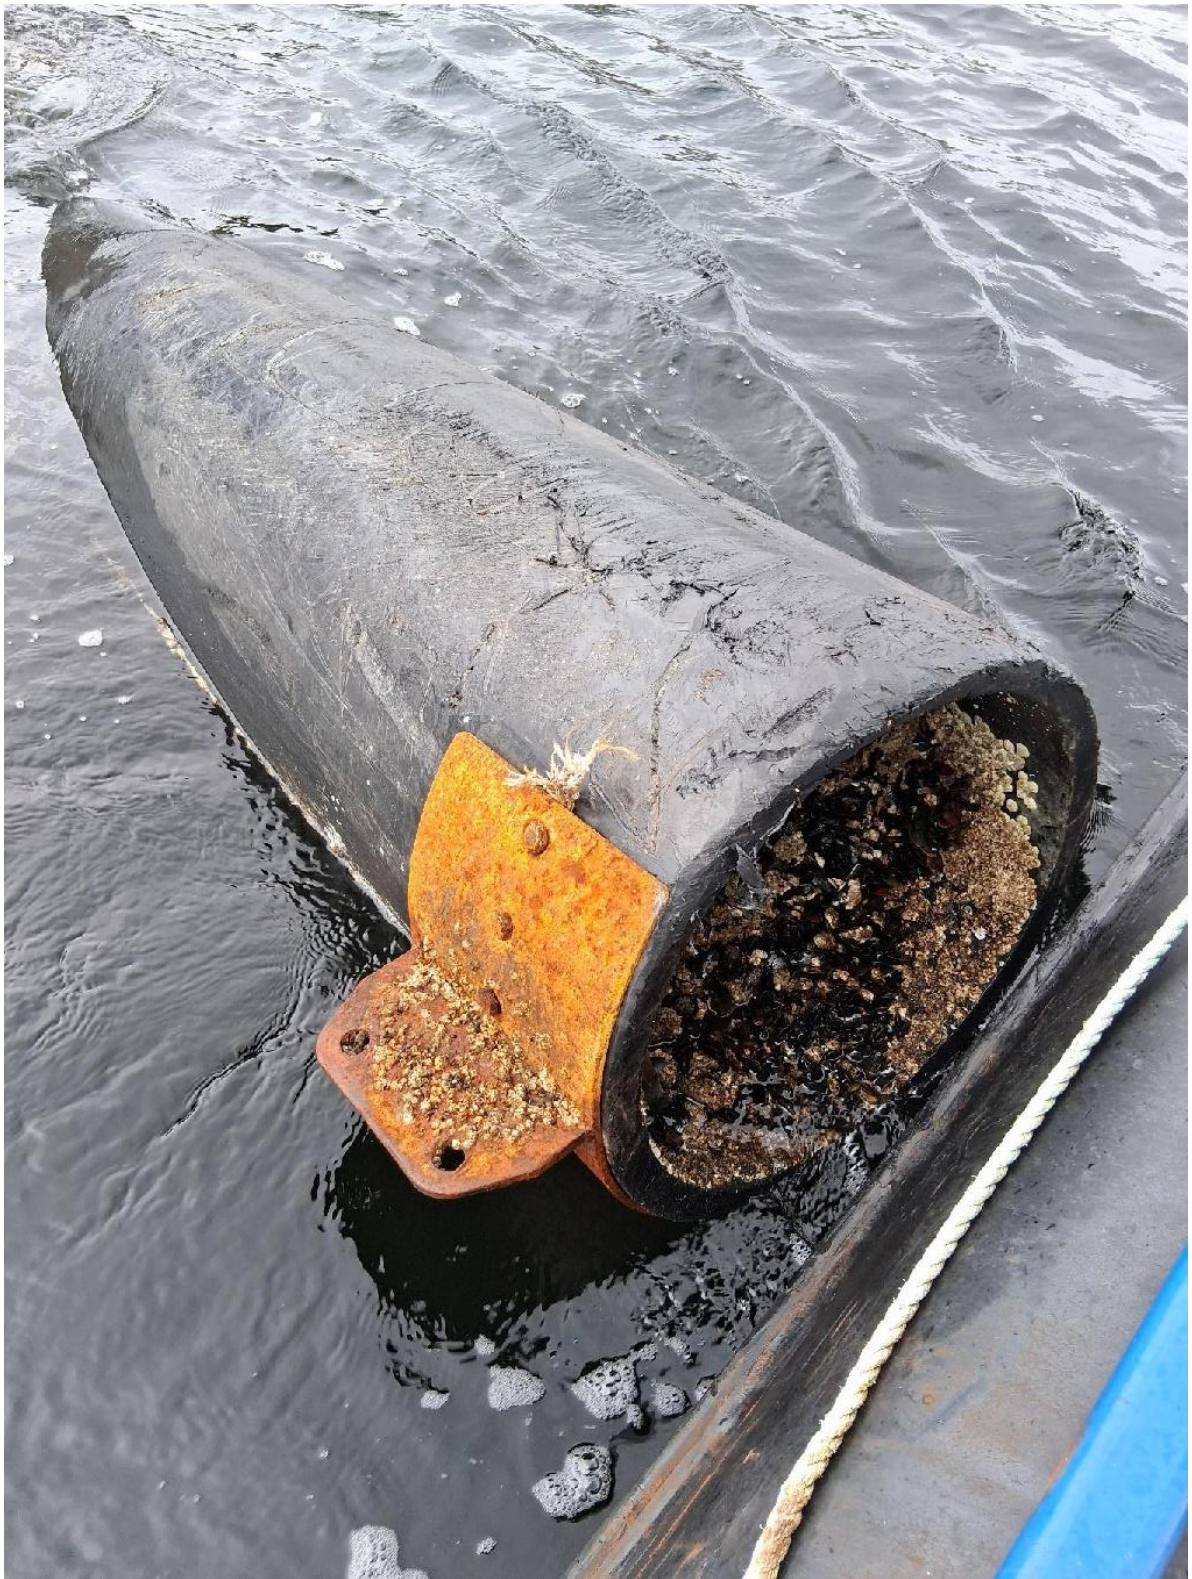
Photo 5: Close up of the eastern end of the floatation tube with metal fixing.
