**Medway Planning & Economic Development Board
Meeting**

Construction Observation Report

Project Name:	Choate Trail
Location:	Copper Drive (off Highland Street) Medway, MA
Report Number:	9
Inspection Date:	3/8/2022
Inspection Time:	3:00 pm

CONSTRUCTION INSPECTION REPORT

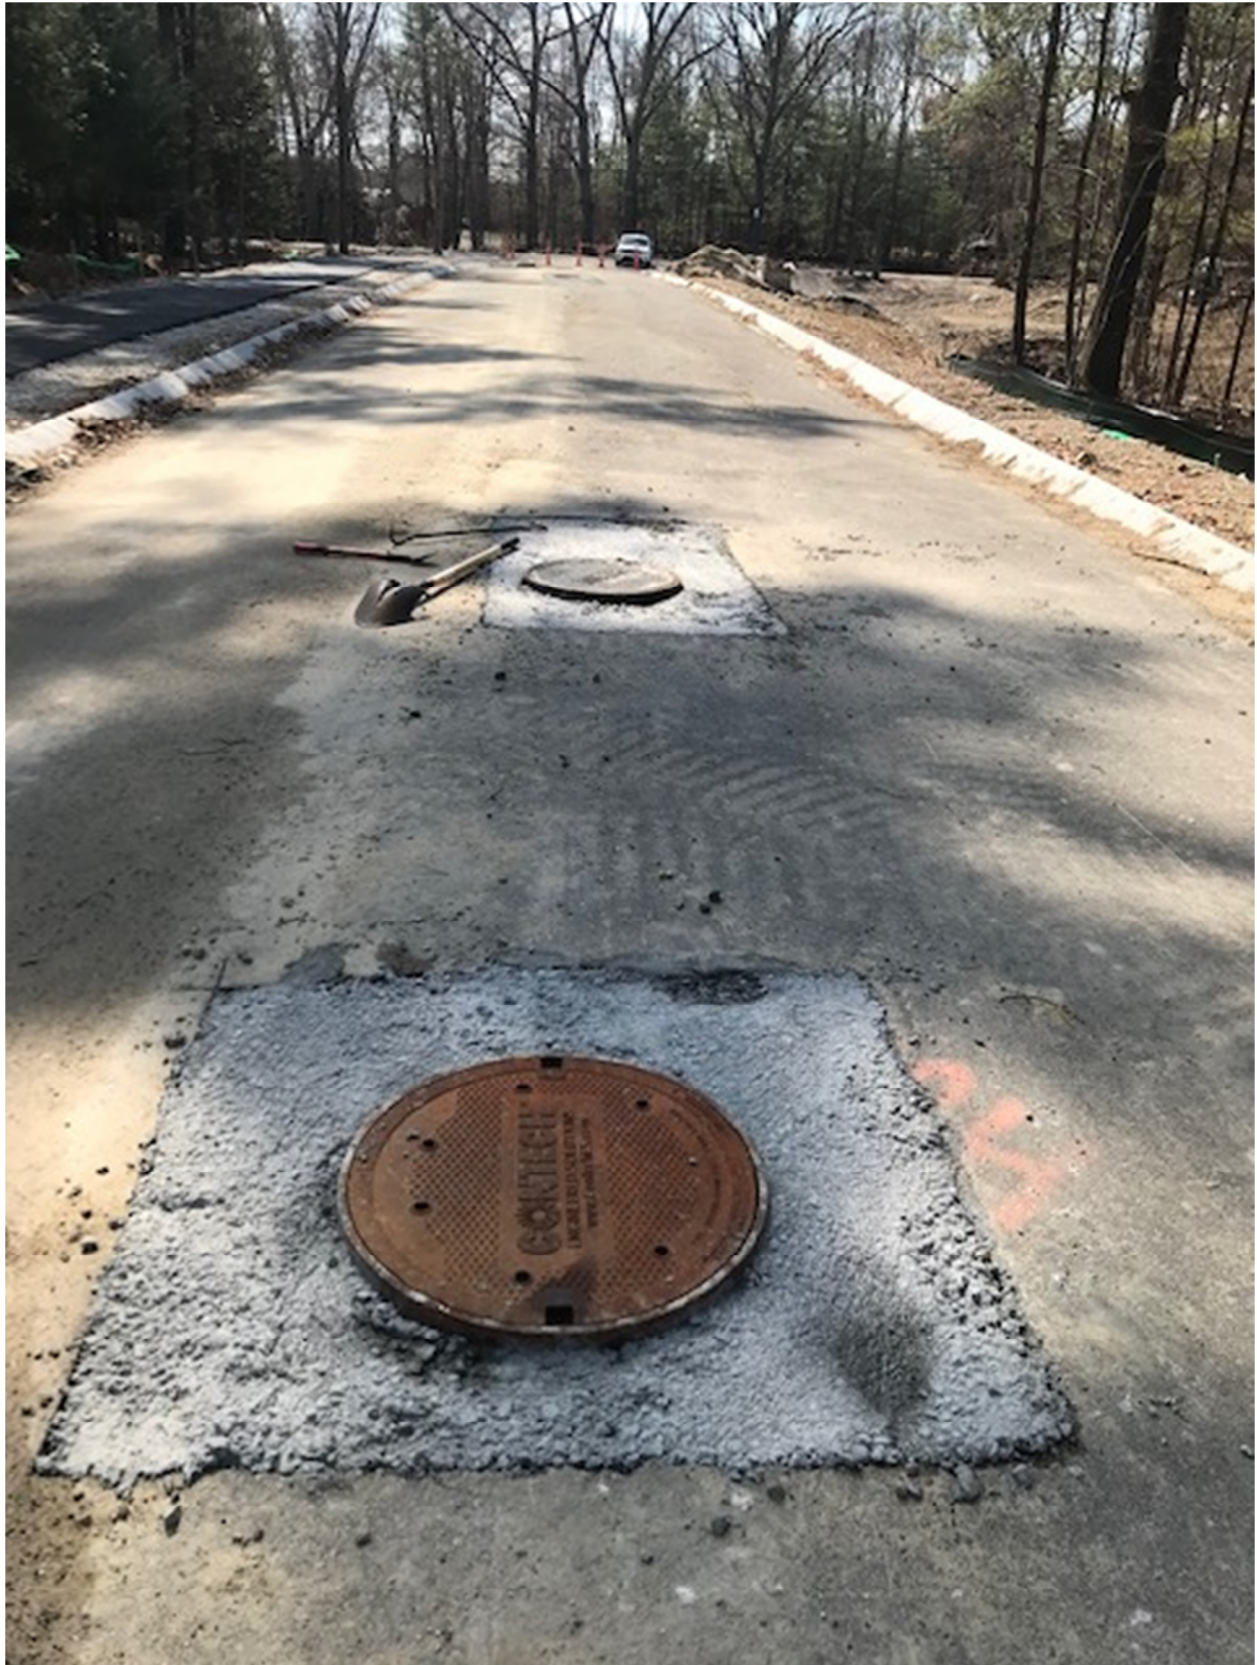
Typical Structure Adjustment to Grade
