Historic Building Condition Assessment Report of the PAUL SMITH'S ELECTRIC, LIGHT & POWER & RAILROAD CO. BUILDING

3 Main Street
Saranac Lake, NY

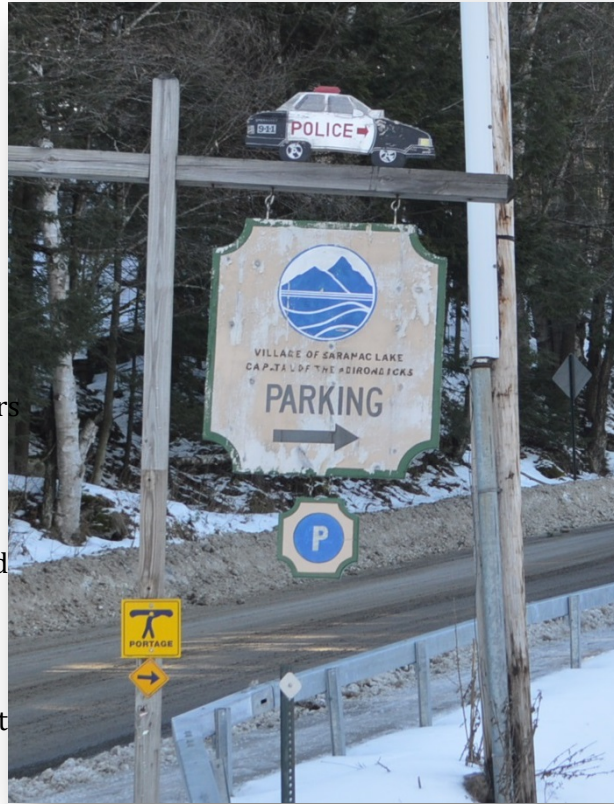
IV. Paul Smith's Power Co. Building Condition Assessment

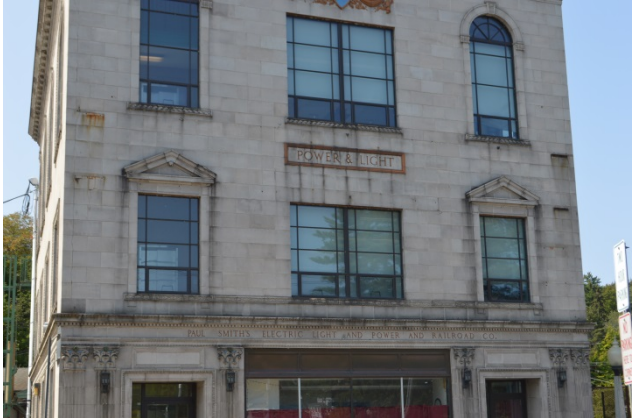
East elevation showing rust staining from iron fasteners

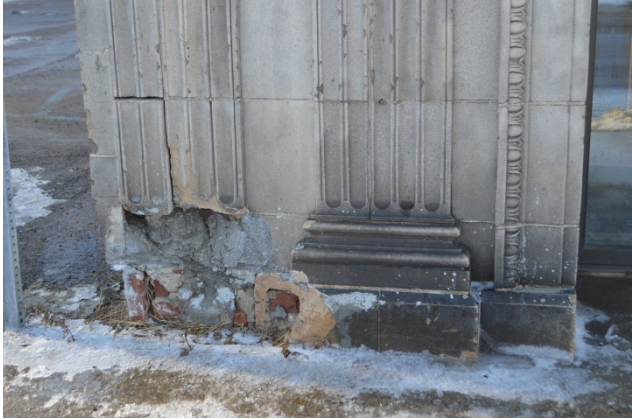
Impact damage of terra cotta base at SE corner

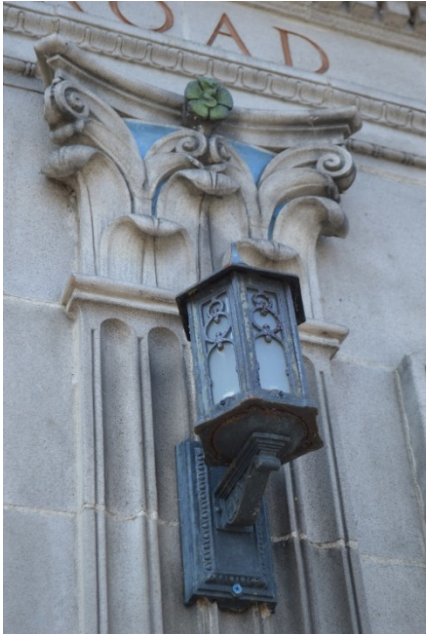
Original cast iron light fixture.

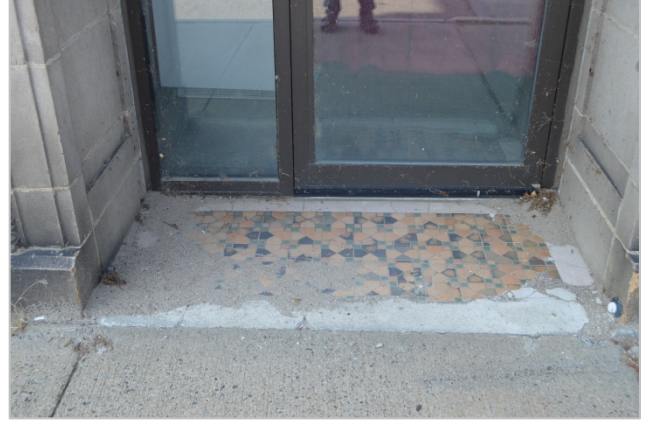
Damaged original glazed tile & marble entry floor

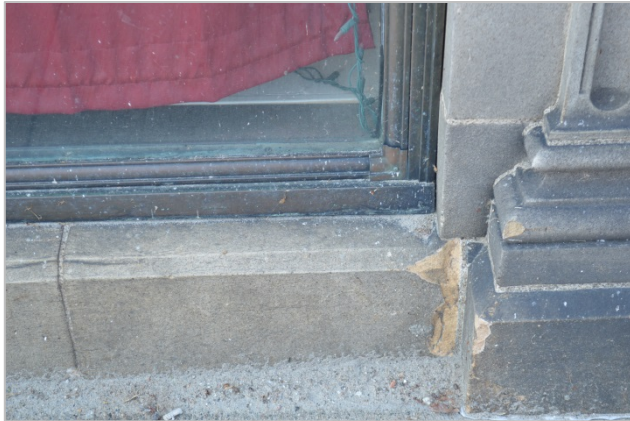
Evidence of freeze-thaw damage along Main St. sidewalk

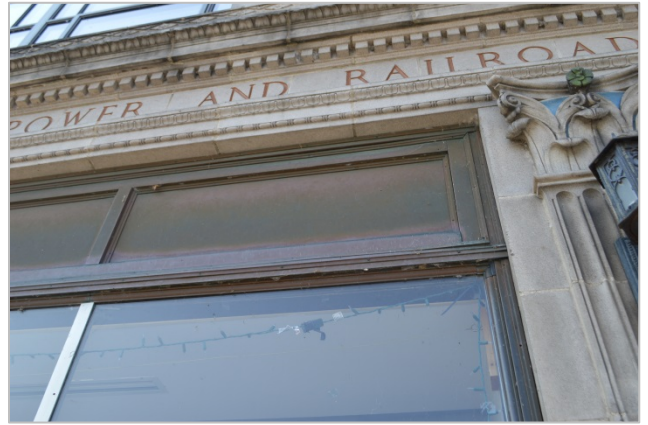
Original storefront & transom window—missing glazing

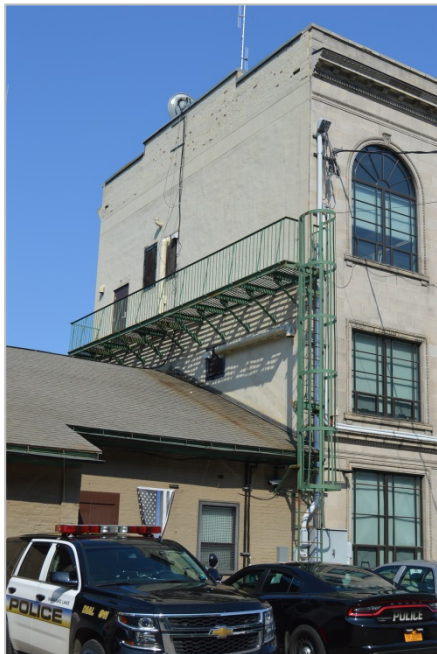
View show infilled windows on West wall.

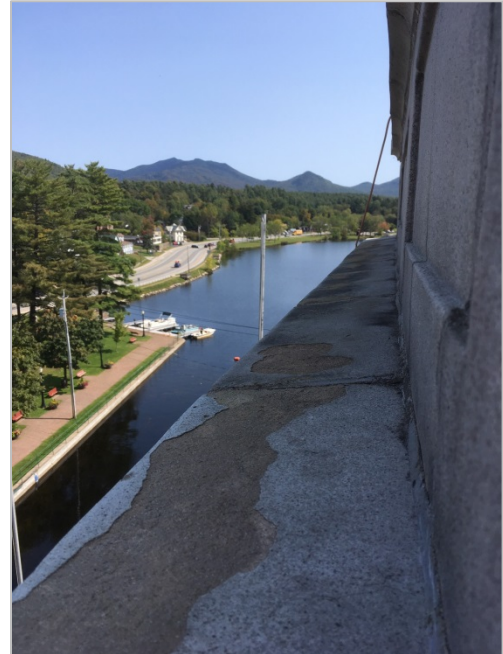
Typical terra cotta glaze damage on horiz. ledge.

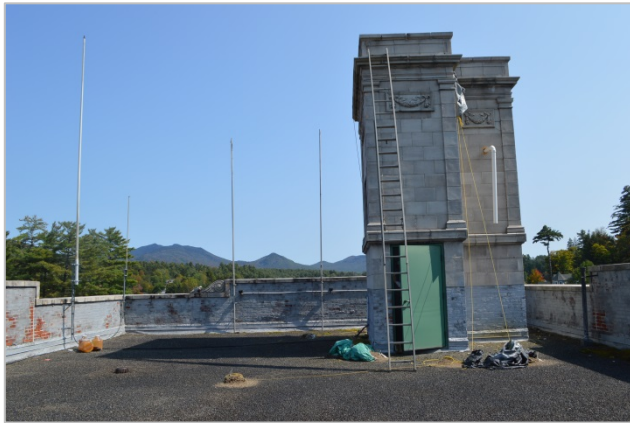
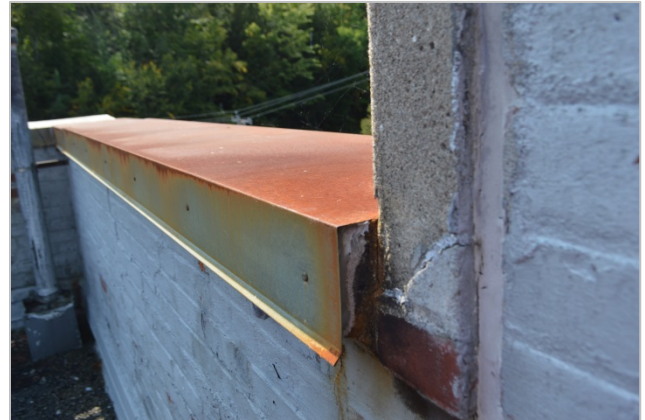
View of roof, headhouse and parapets. Note modern additions. Rusted sheet metal cap at west parapet wall.

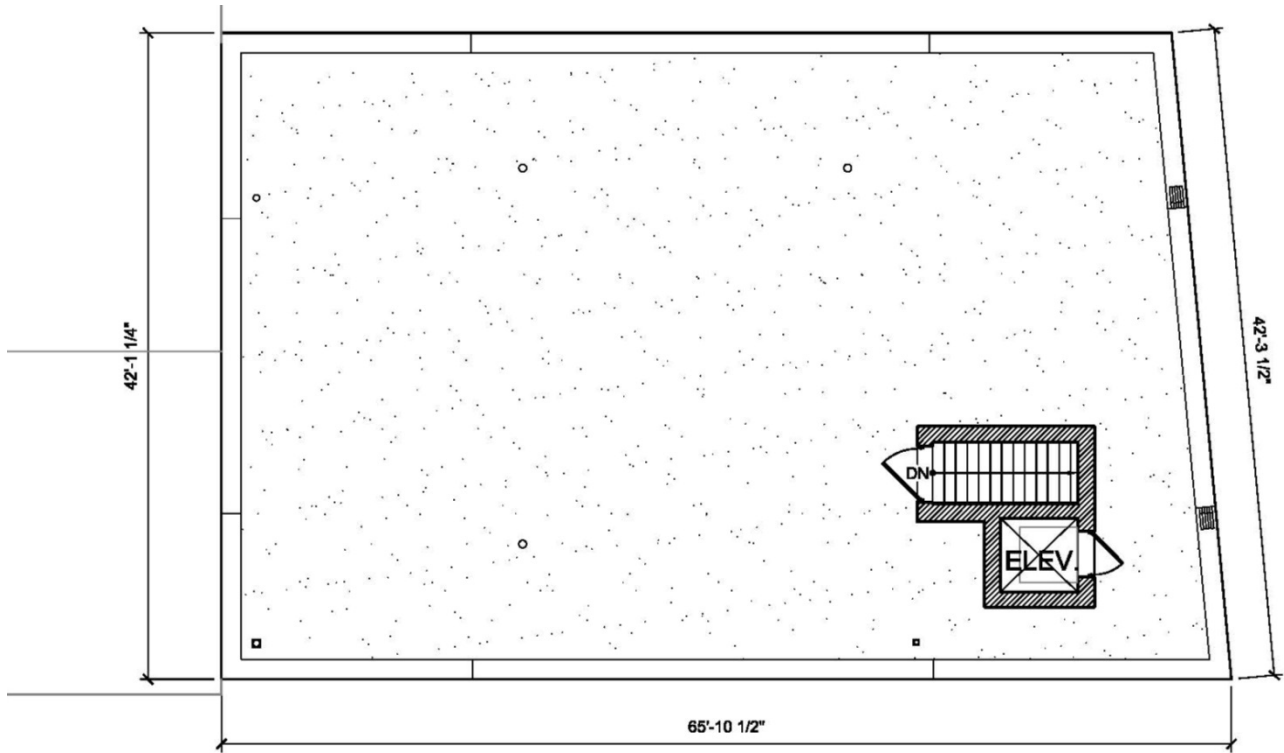
EXISTING ROOF FLOOR PLAN

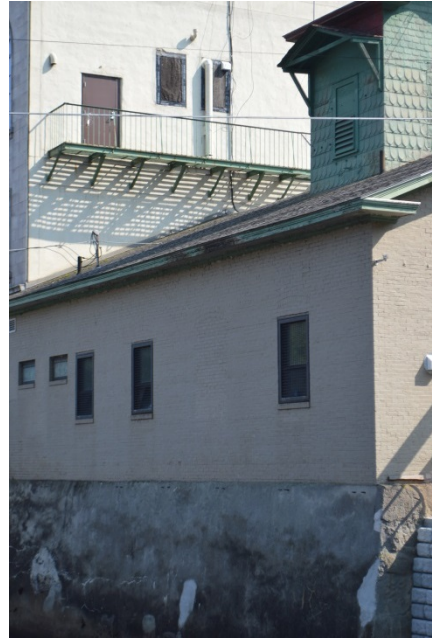
North roof eave exhibiting paint failure

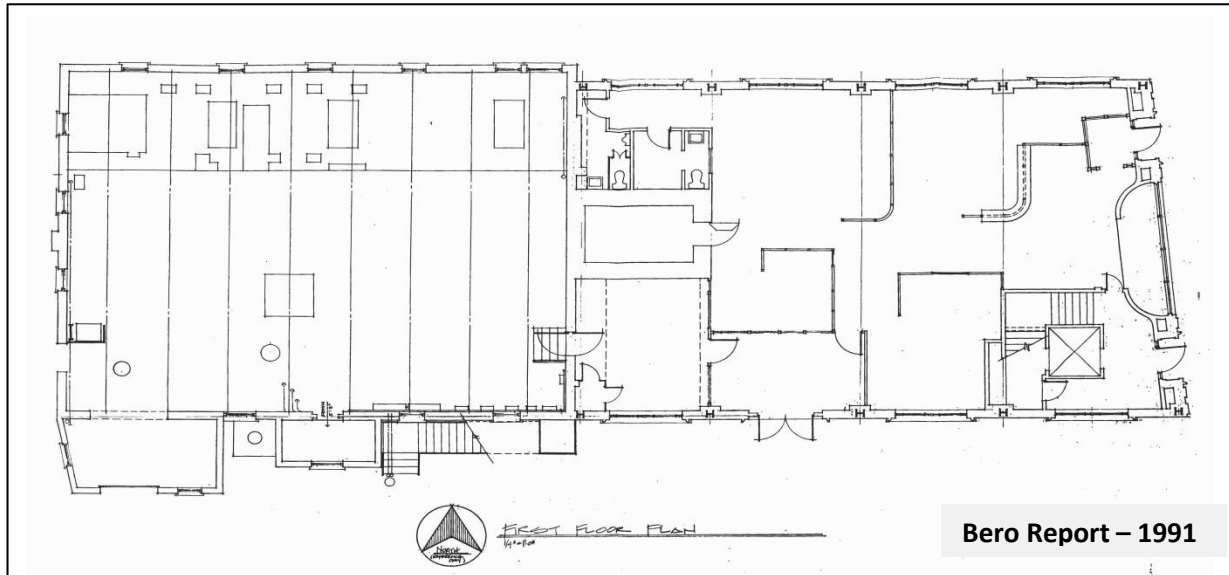
Power House First Floor (PH-1):

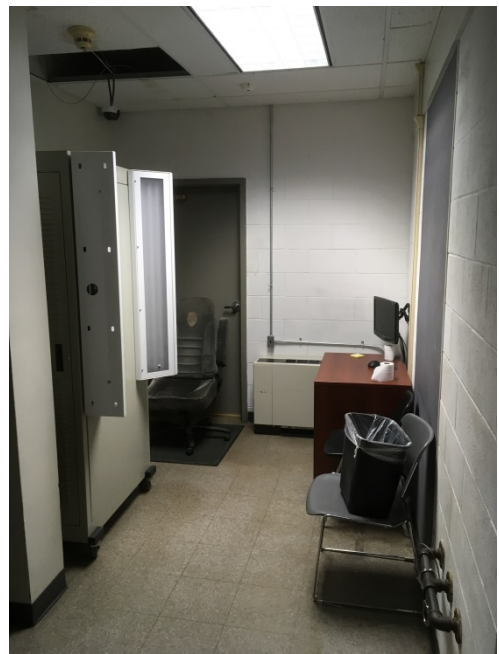
Interrogation/Photo Room

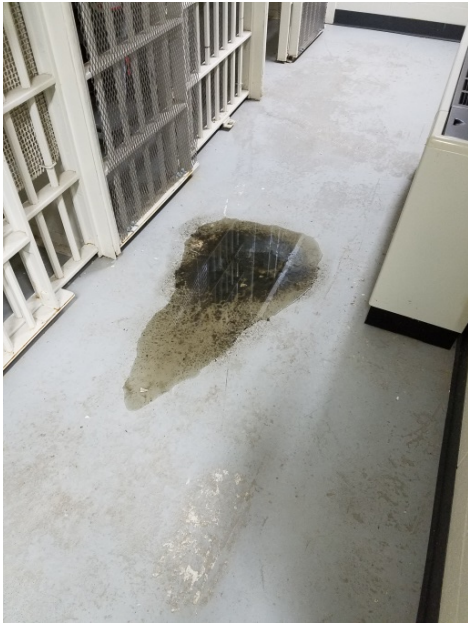
Jail Cell area – sewer backflow

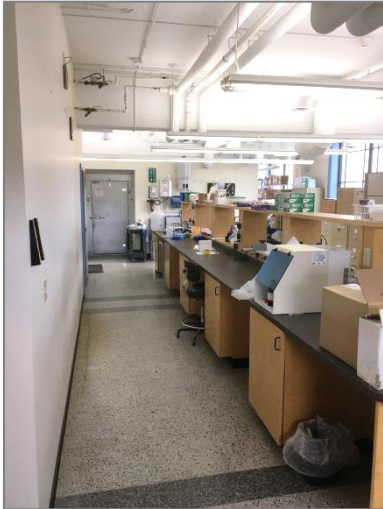
First floor–Terrazzo flooring with Borders interrupted by new partitions.

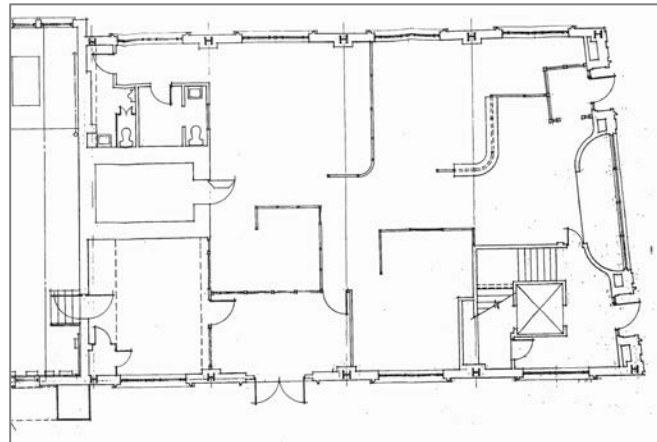
- the floor patterns and the ceiling beam layout, rather than at odds with these original designs. The original character of this floor included a large open space with full view of the tall windows throughout. Introduction of modern partition walls negatively impact this original design intent. Space partitioning should be accomplished by means of low walls that do not obscure full view across the space. An original or early floor plan indicates that modular partitions were used for division of space and functions and provides an example for future layouts.

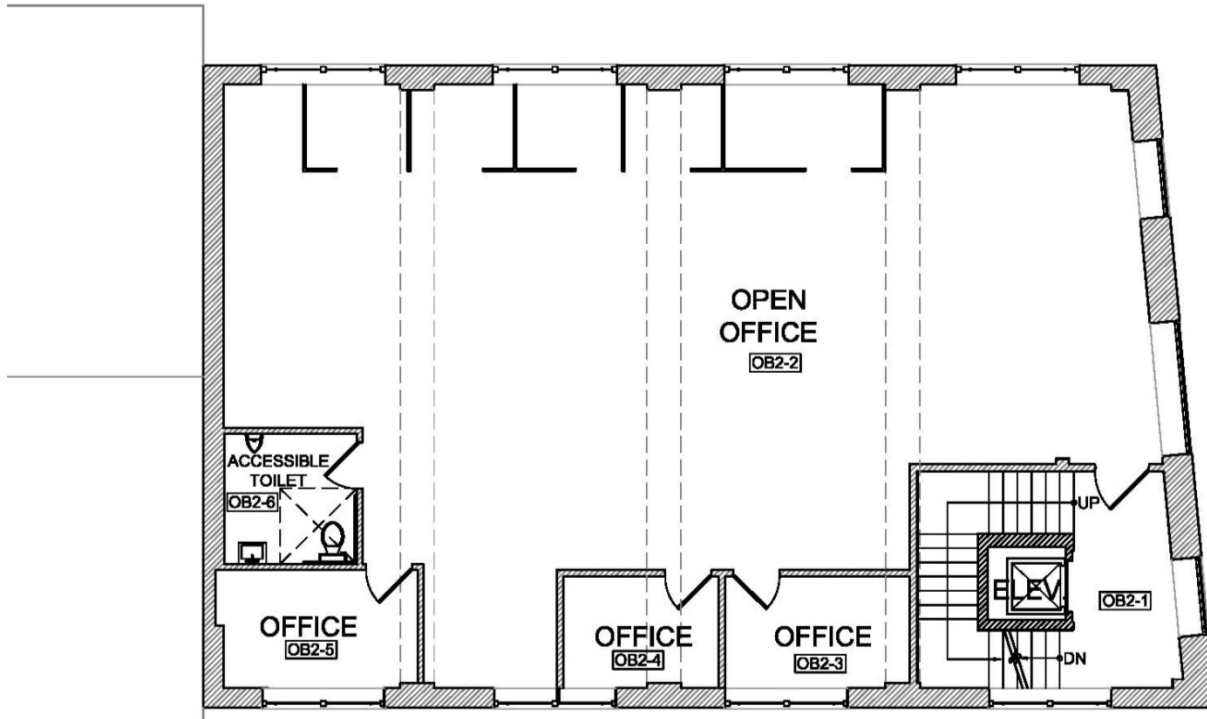
EXISTING SECOND FLOOR PLAN
 SCALE: 1/8" = 1'-0"
 0' 1' 2' 4' 8'

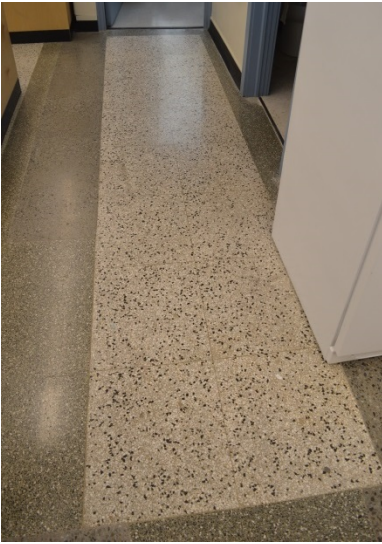
2nd floor – Terrazzo floor patterning

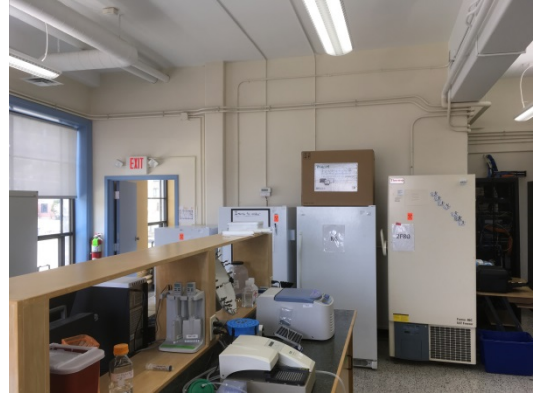
2nd Floor - View of southeast corner of open office.

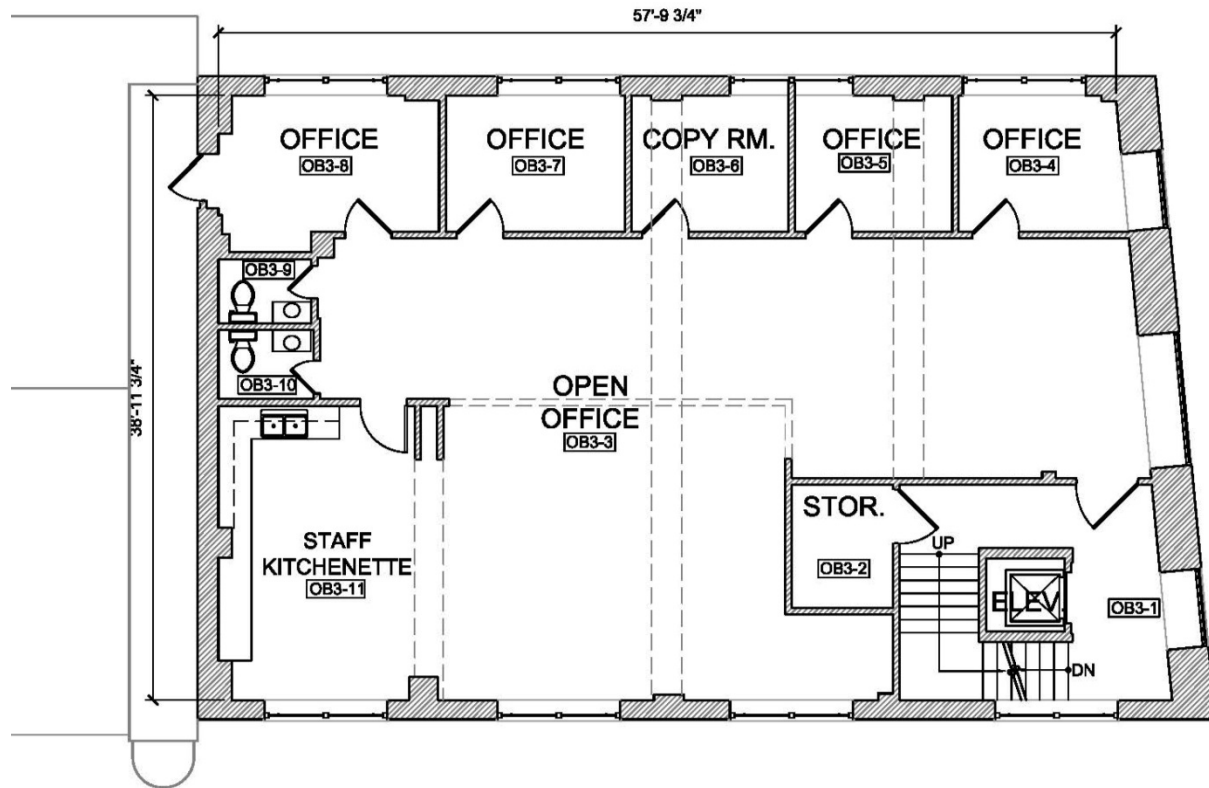
EXISTING THIRD FLOOR PLAN
 SCALE: 1/8" = 1'-0"

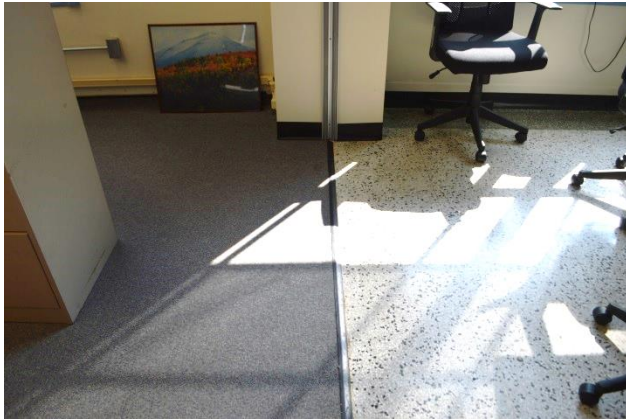
3rd floor - Area of floor showing terrazzo & carpeting

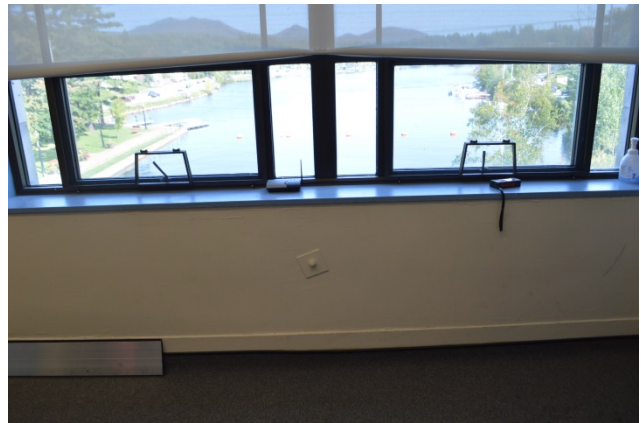
3rd floor - Detail view of modern replacement window.

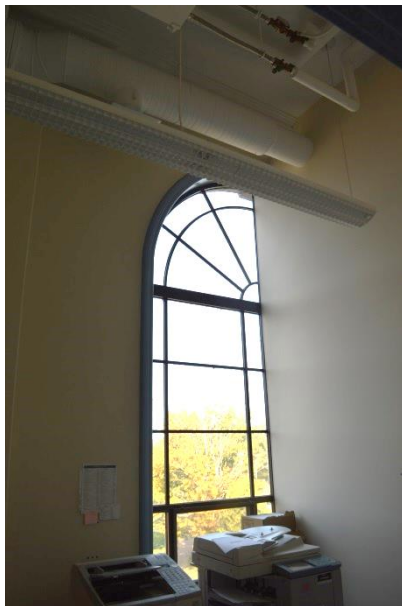
3rd floor - View of bisected window

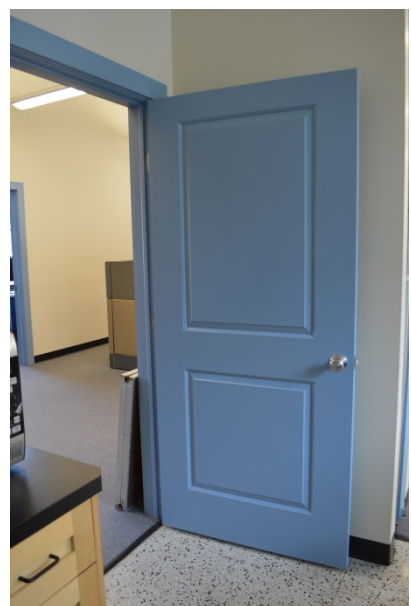
3rd floor - View of typical modern door.

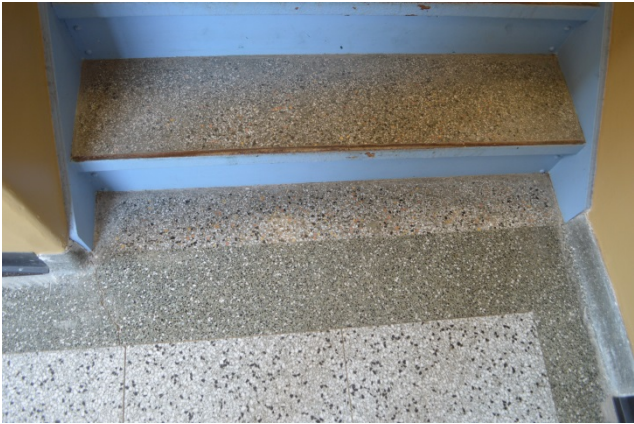
2nd floor –View of three terrazzo colors & stair structure

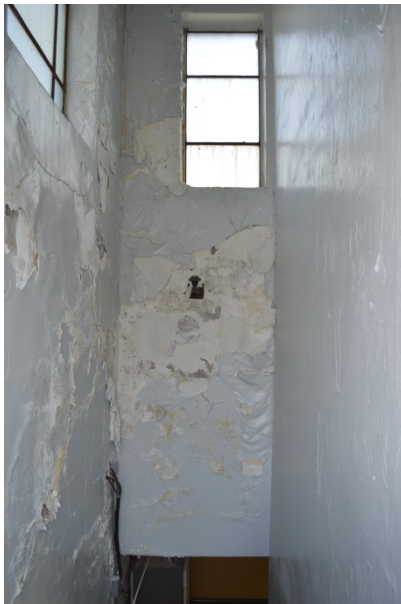
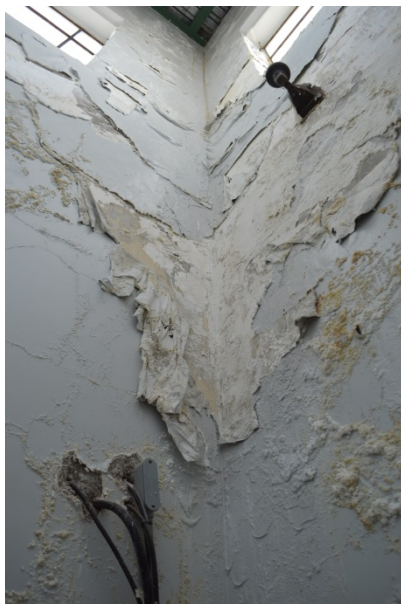
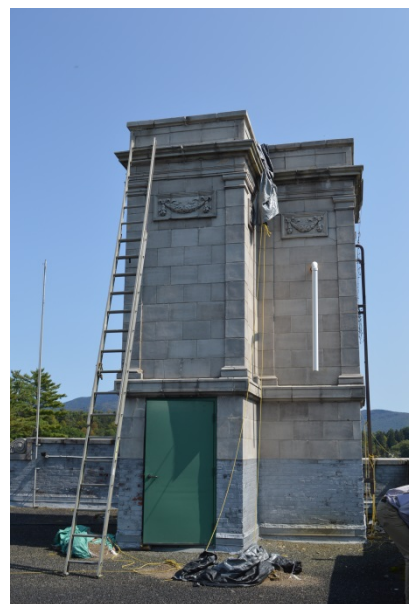
View of wall condition of headhouse Extensive water infiltration causing damage. Headhouse door from roof.

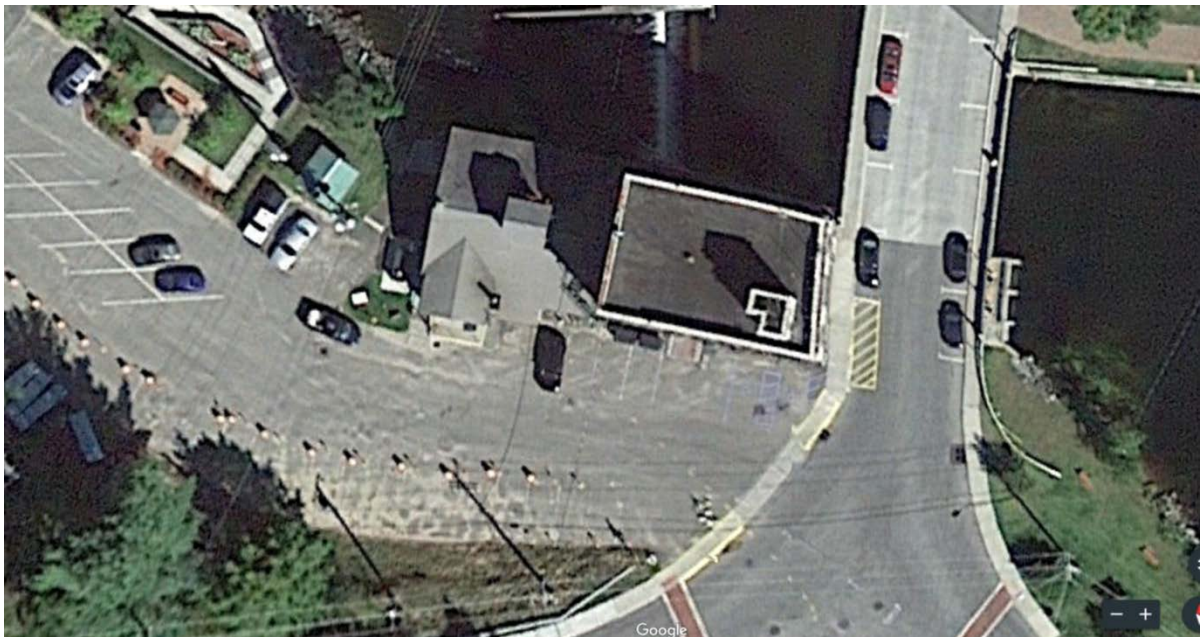
General Office Building Interior:

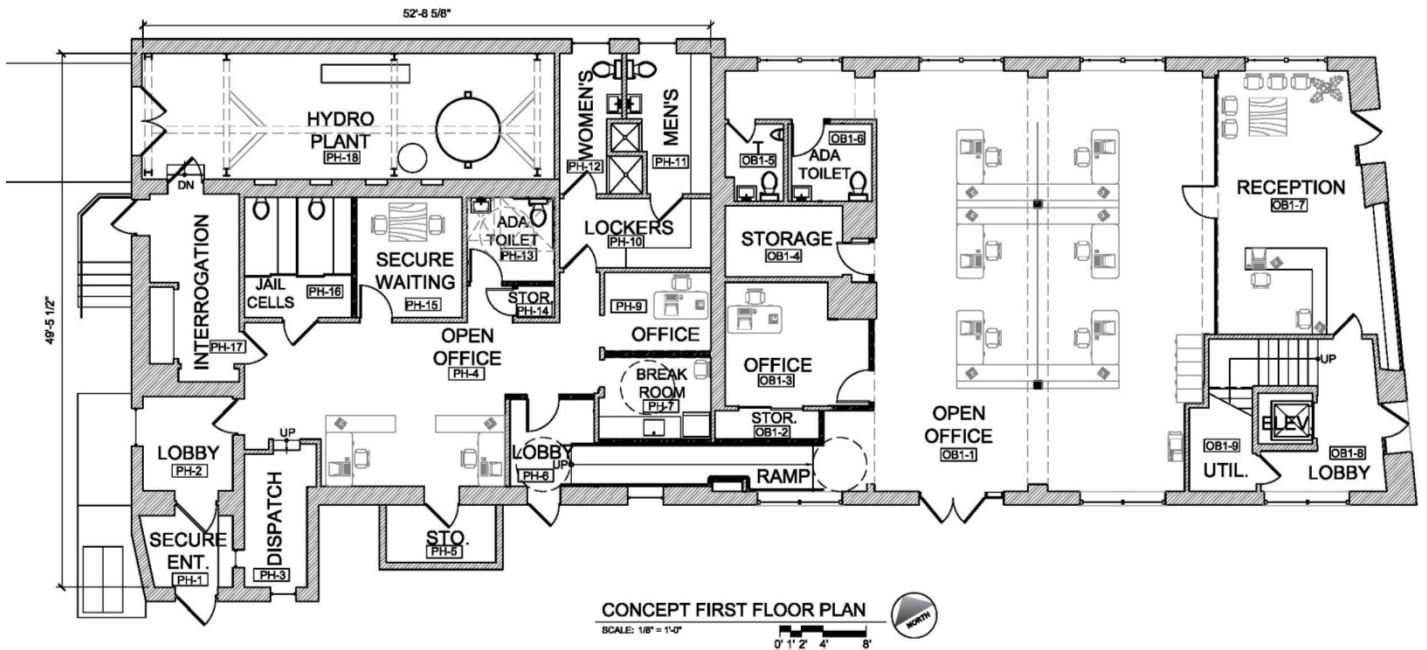
Second Floor Interior:
