Historic Building Condition Assessment Report of the **SARANAC LAKE FIRE STATION**

100 Broadway
Saranac Lake, NY

December 12, 2022

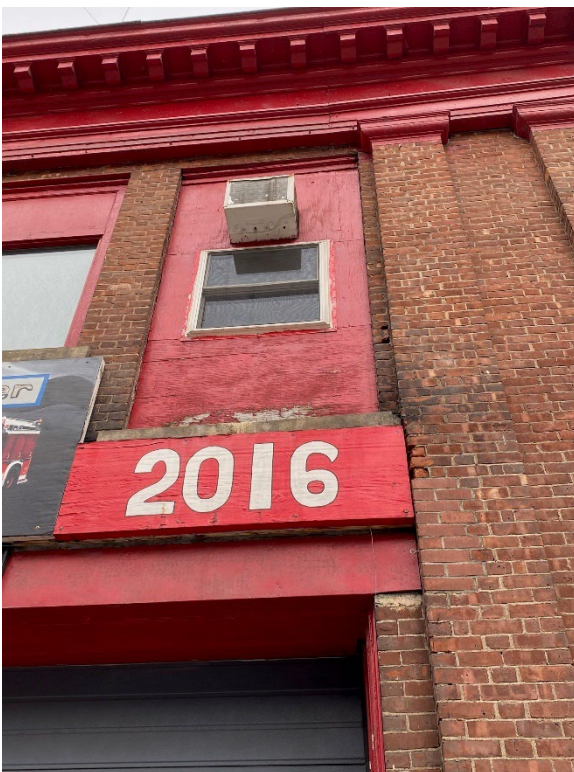
Second floor door & window openings infilled with painted plywood, replacement units & a/c

3. New wood or aluminum-clad windows and doors replicating the original multi-paned windows, doors and transoms should be installed on the front (west) and side (south) elevation replacing the inappropriate plywood, a/c units and smaller replacement windows. The full original framed openings should be reinstated. While the sash can be painted red, the trim should all be repainted a cream color to match the limestone trim of the building. This would include the metal cornice, the pilaster capitals, the narrow 3-lite windows between the brick pilasters and the new storefront assembly in the garage door opening.

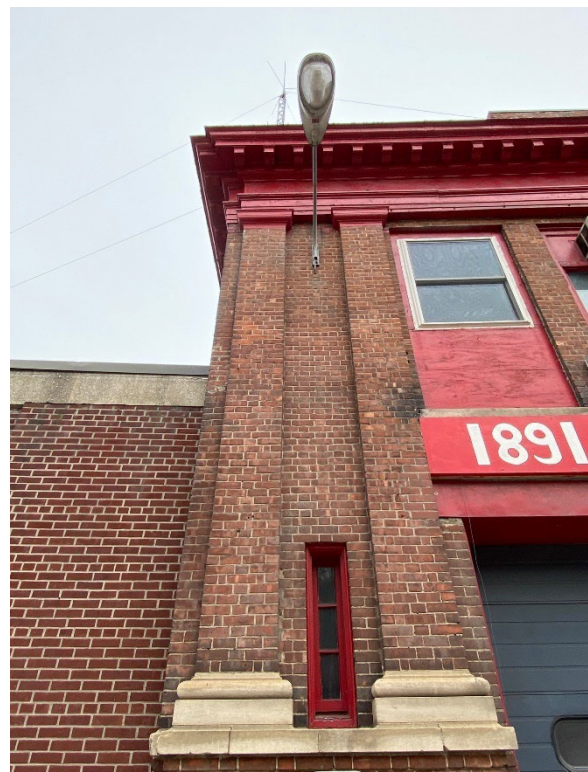
Pressed metal entablature/cornice painted red. Note stone pilaster capitals also painted red.

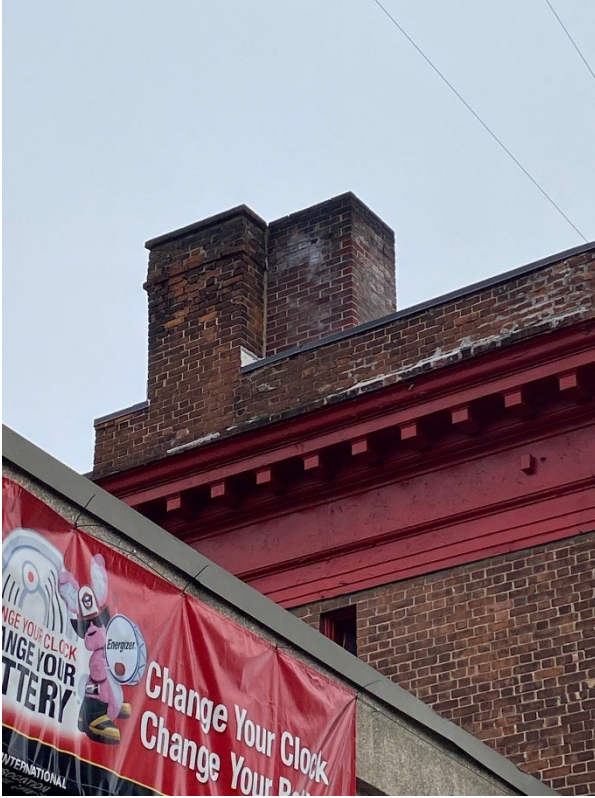
Metal entablature returned on north elevation. Note brick parapet & orig. chimney with new boiler chimney added next to it.

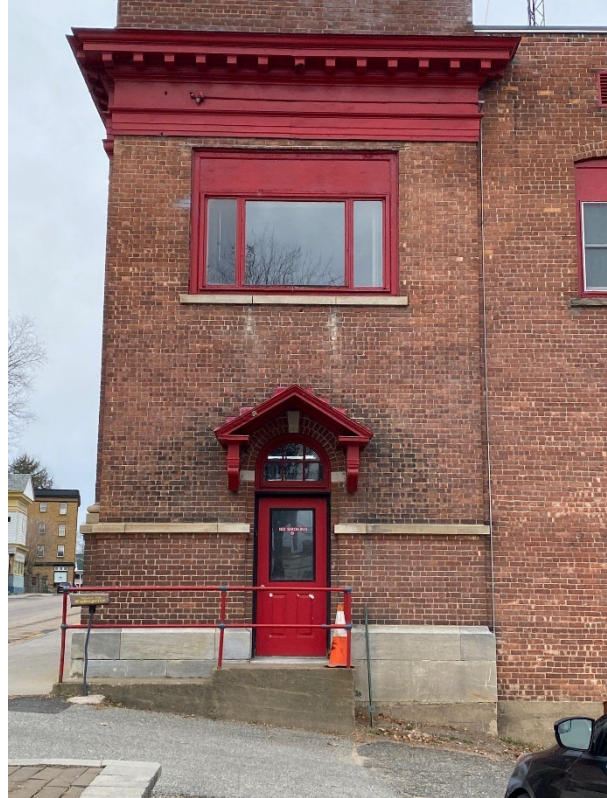
Original side entry with replacement door and framed down and altered 2nd floor window.

4. Replace the metal entry door on the side elevation with a solid wood paneled door replicating the original appearance of the side door. Retention of the transom and gabled canopy above is important.

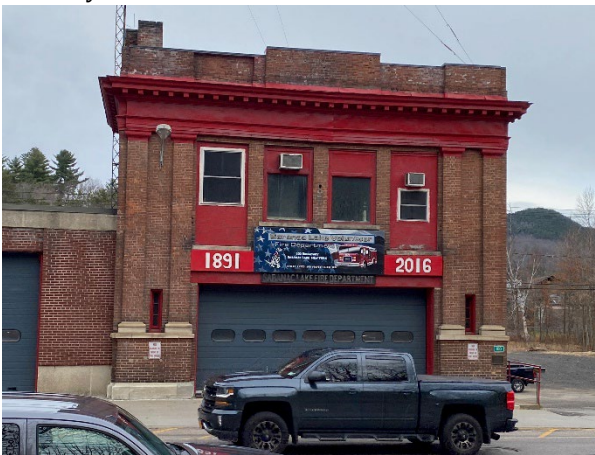
Front elevation with altered 2nd floor window/door openings and missing balcony.

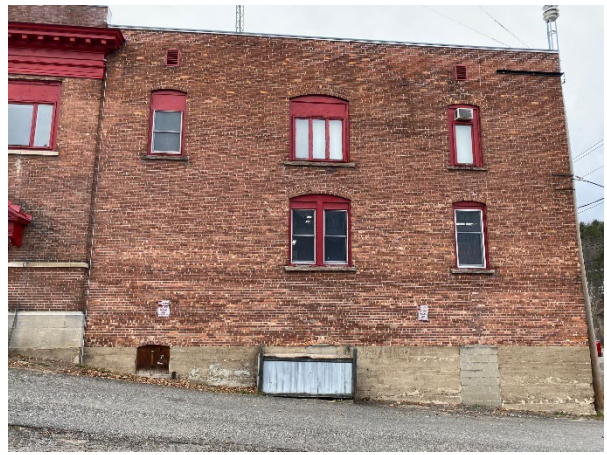
South elevation with altered window openings.

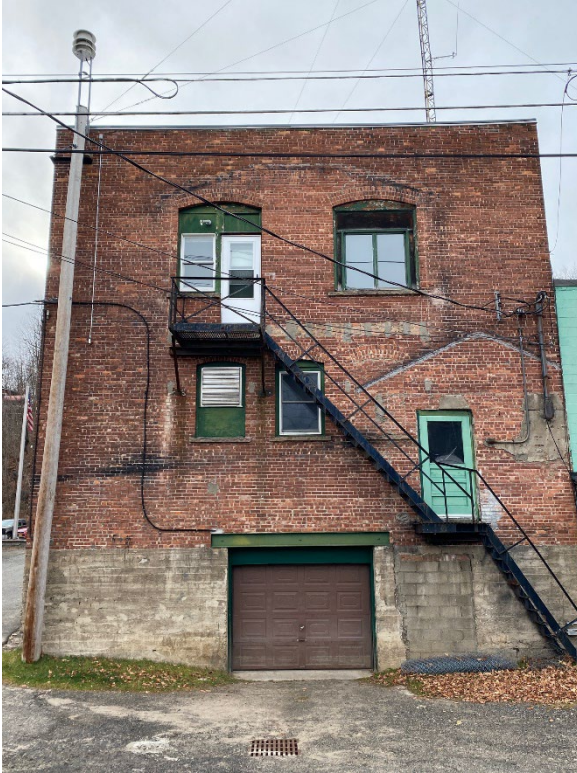
Rear east elevation with ghost lines of former 2nd floor bay window and gabled roof of NE addition.

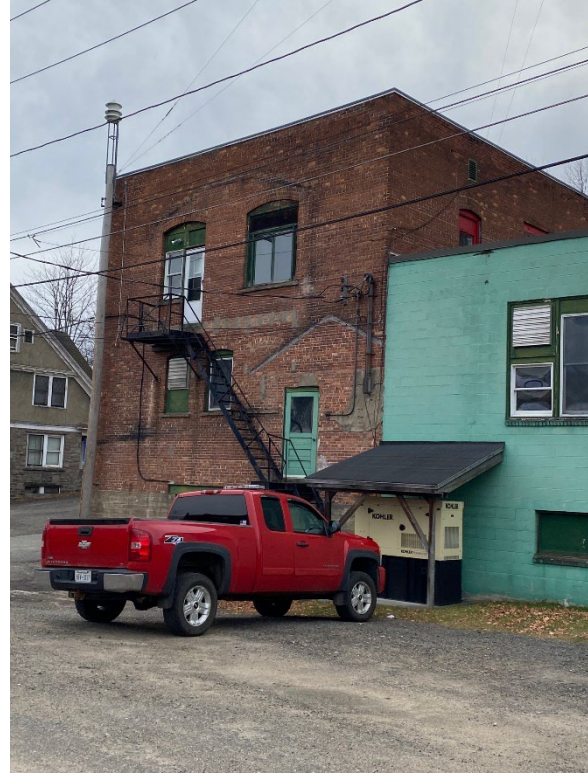
View of north elevation showing altered window openings and c.1960s CMU addition.

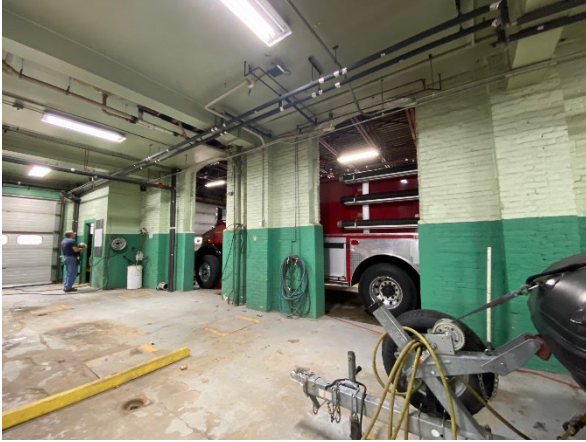
North wall where orig. window openings have been opened to created doorways to new addition.

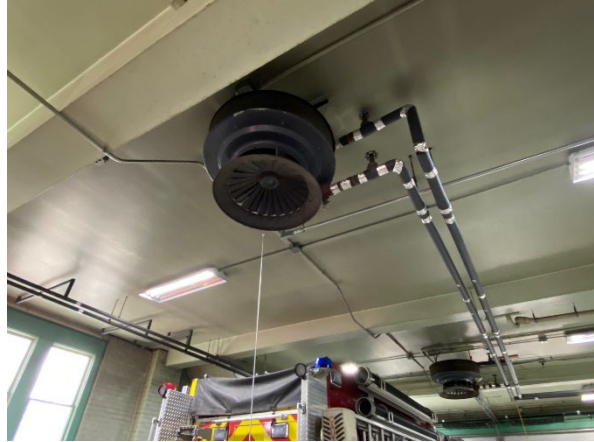
Note exposed electric, piping and equipment attached to ceiling.

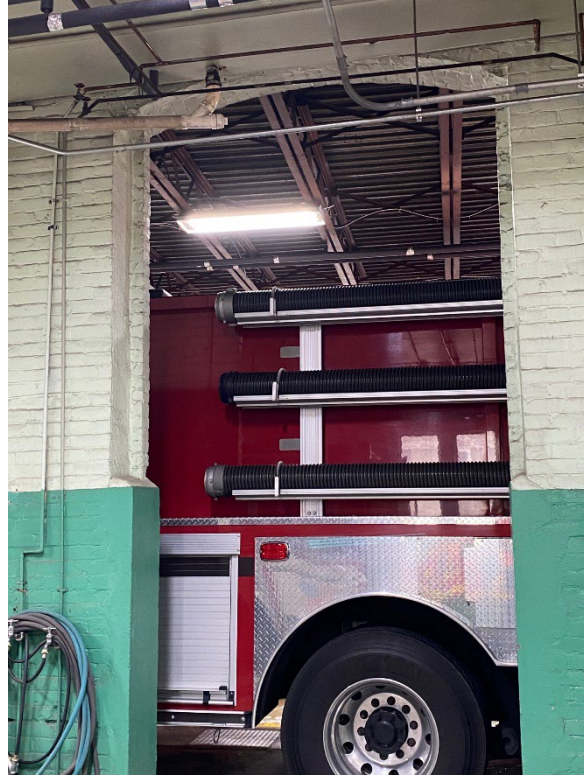
Orig. window opening on north wall which were enlarged to create doorway to 1960s addition.

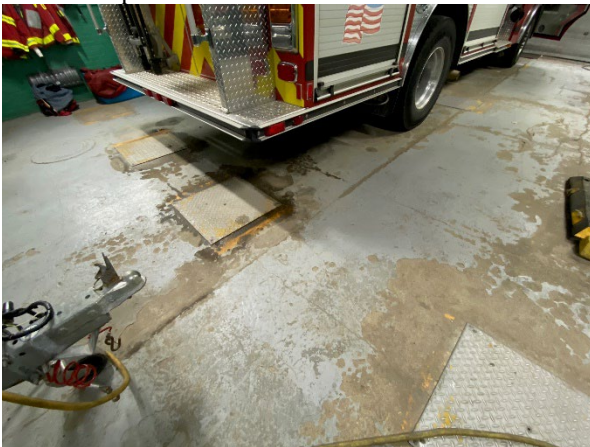
Detail view of patched concrete floor of garage bay.

1. Remove and replace existing damaged areas of poured concrete flooring. This would be an opportunity to consider the use of radiant floor heating in a new poured concrete floor system (on metal decking). A polished concrete floor, or epoxy coating is possibly the most durable for public function spaces. Modern vinyl flooring (LVT, tile, sheet) should be avoided in this historic space, as it is dates to the current era only, is not a sustainable materials and is not a timeless material choice.

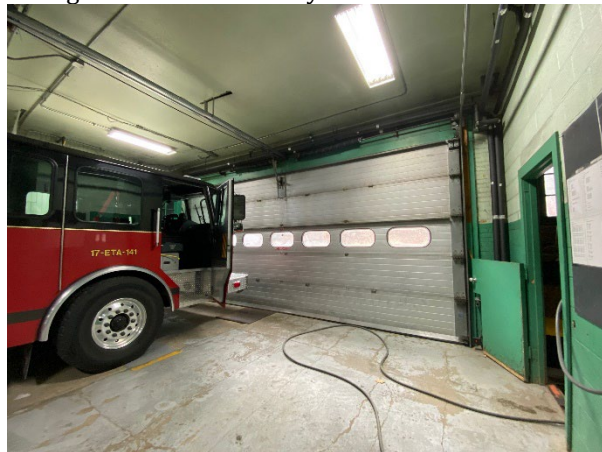
Detail view of modern overhead door on front wall.

1. Replace overhead garage door with wood and glass storefront assembly replicating the original hinged door appearance. One leaf of this assembly can actually be configured to serve as a new ADA compliant entry door on closer and with automatic opener if side entry is found to be non-compliant or not ideal programmatically.

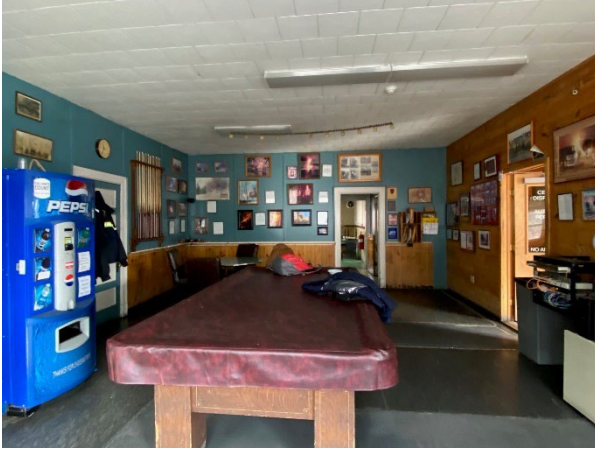
2nd floor Day Room with modern (mid 20th c) wall, ceiling & floor finishes.

1. Careful and selective removals of layers of wall finishes, flooring surfaces and dropped or applied ceiling tiles with fluorescent light should be conducted to reveal the original finishes assumed to be plaster at walls and ceilings and wood flooring. This will allow for a more accurate assessment of the repair/refinishing needs. It is probable that an asbestos abatement effort will be needed during this removal phase and it is recommended that samples be taken and tested early on to determine the full scope of removals work necessary.

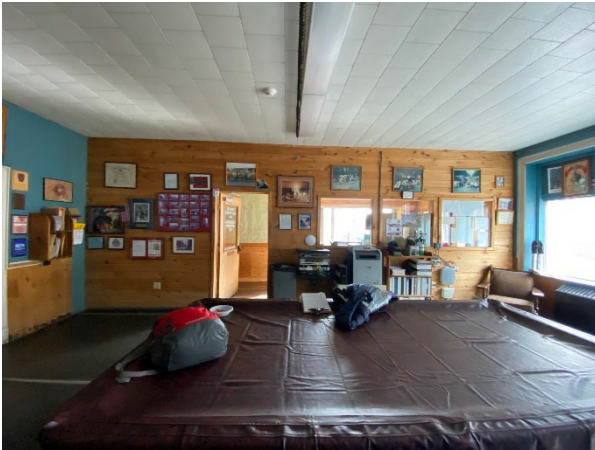
Modern south partition wall of Day Room constructed of knotty pine boards & fixed windows – out of character of orig. finishes.

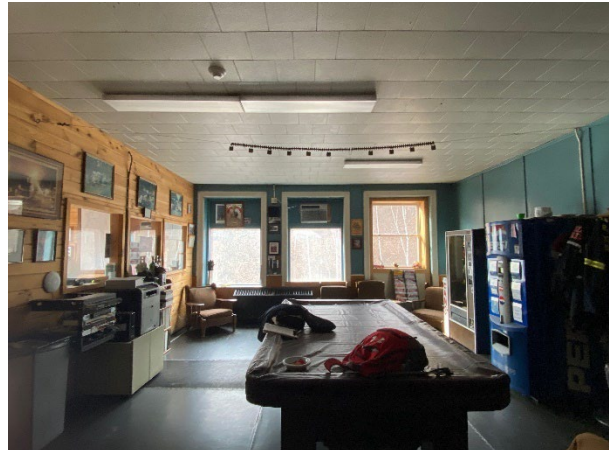
View to west (front) wall in Day Room where orig. windows and doors to former balcony have been infilled & replaced.

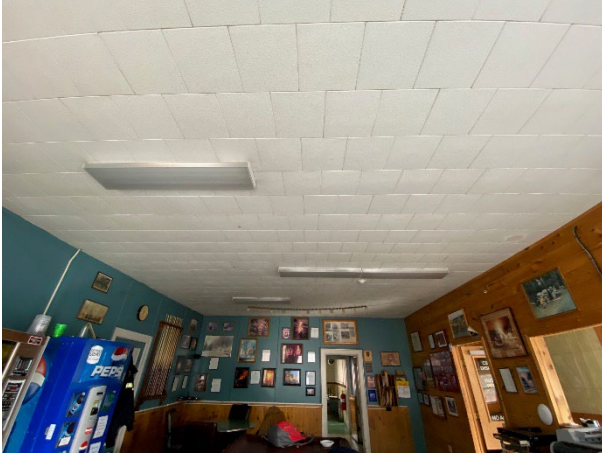
Interlocking acoustical ceiling tiles within Day Room with surface mounted fluorescent lighting.

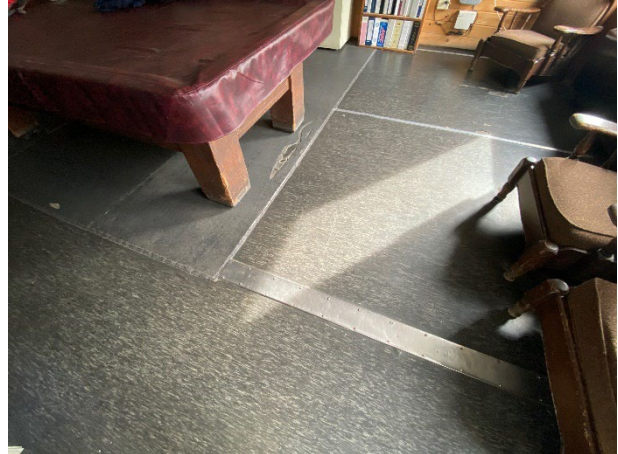
Linoleum sheet flooring pieced together with stainless steel threshold strips. Likely over orig. wood flooring.

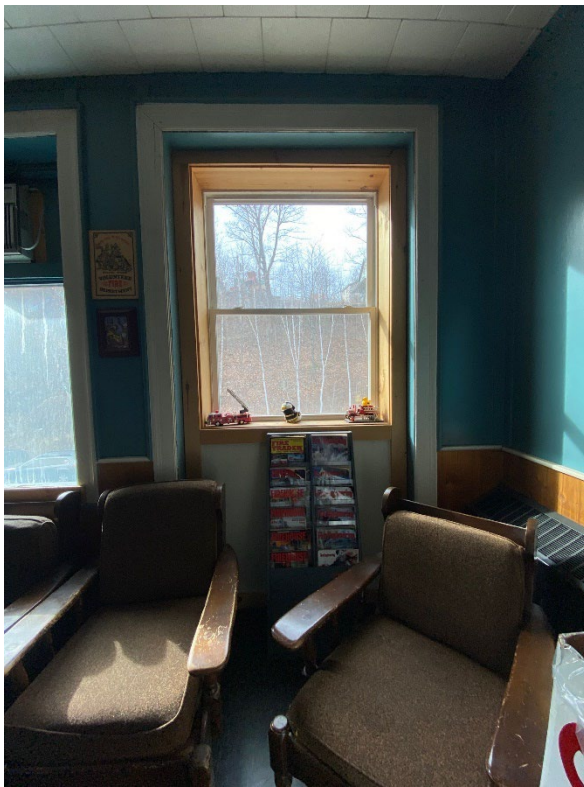
Detail view of orig. doorway opening to front balcony, now infilled with a small window unit.

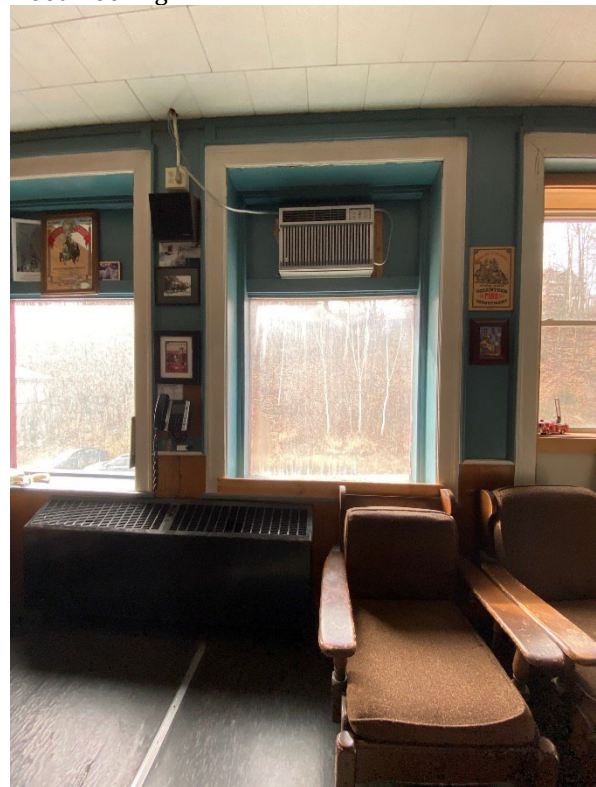
View of centered windows on front wall of Day Room with plywood infills and fixed window units replacing orig. double hung sash.

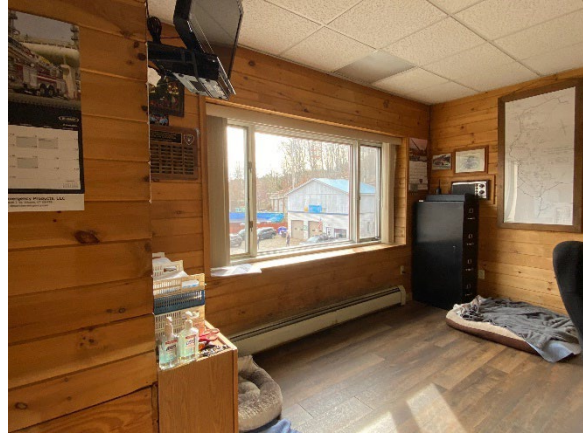
Large original window opening infilled & framed down with smaller plate glass and casement windows.

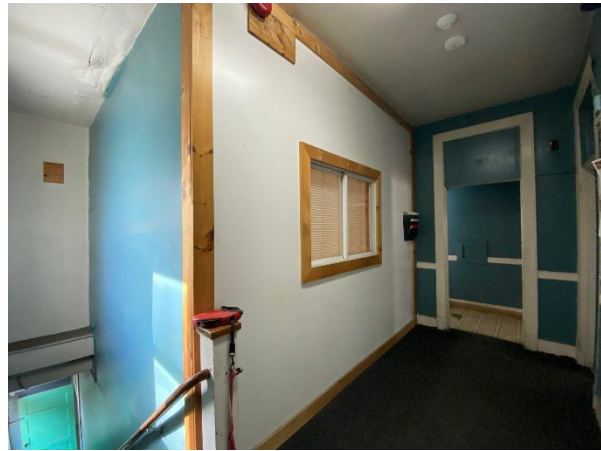
Modern finishes on west wall of stair hall – out of character with orig. finishes.

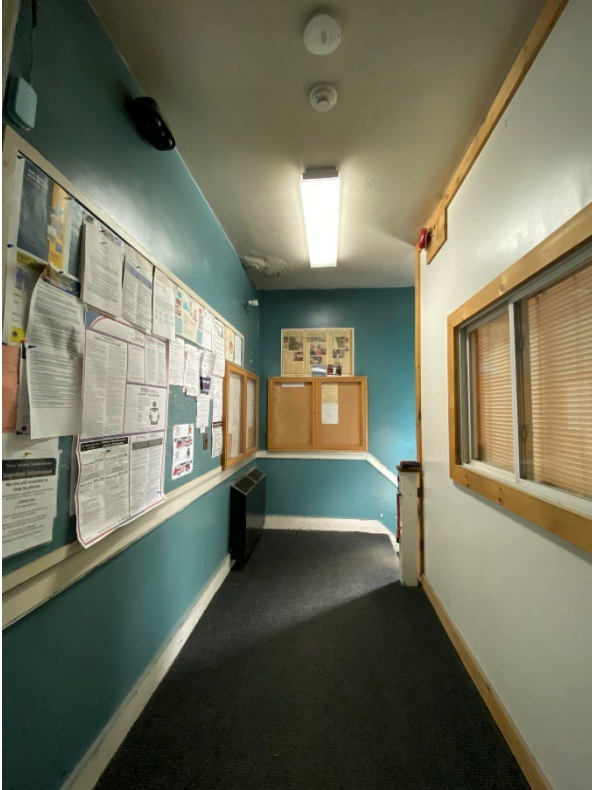
Stair hall has wall-to-wall commercial carpeting but orig. wood baseboard intact on 3 of 4 walls.

7. The stair hall is one of the most intact spaces with little alteration. The plaster finishes need some level of repair/refinishing and the flooring is covered with wall-to-wall high-traffic commercial carpeting. It would be recommended that the plaster finishes be retained and repaired, and that perhaps beaded board wainscot be added to protect the lower sections of the walls given the level of public wear and tear in this space. This wainscot could be continued down the stringer walls of the staircase and into the side entry vestibule.

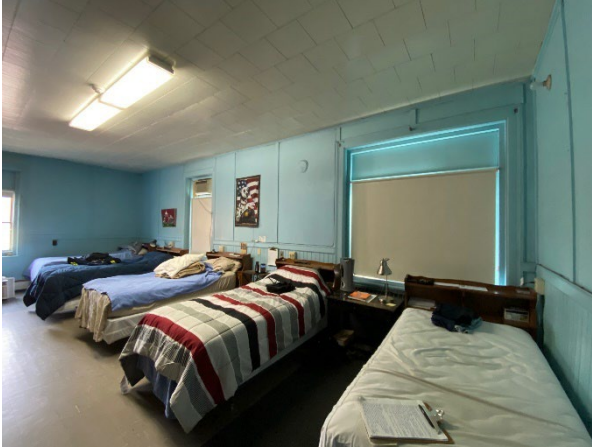
South and east walls of Bunk Room show how original window openings have been retained but have modern replacement units.

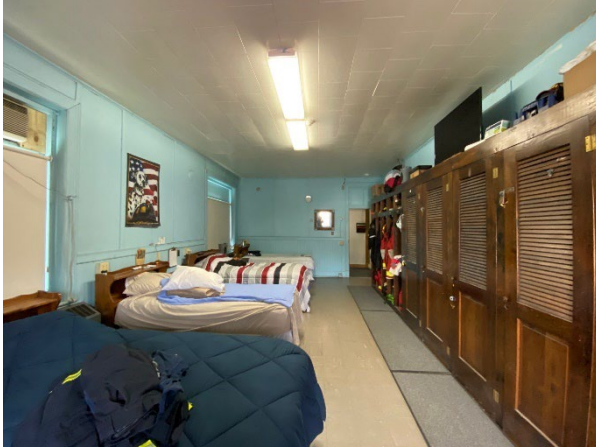
Historic wall, ceiling and floor finishes covered with layers of vinyl tile, acoustical tile and Masonite sheet paneling.

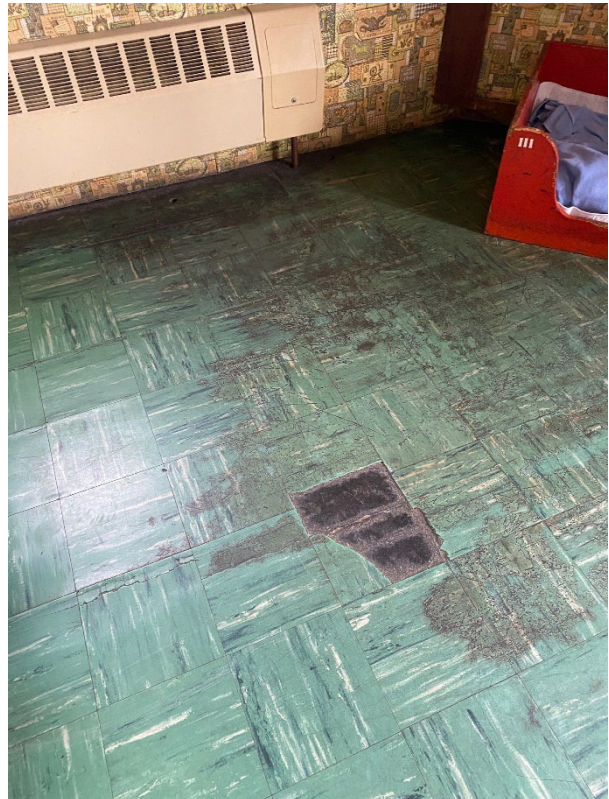
Vinyl composition tile (VCT) on floor is in poor condition in many locations. 9" square VCT typically contained asbestos & is considered a HAZMAT.

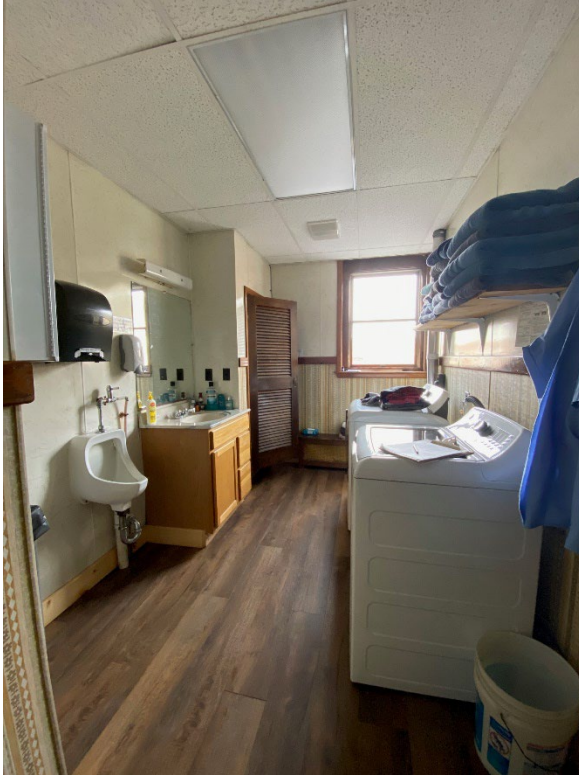
Bathroom/shower/laundry facilities on 2nd floor positioned along north wall. Window is framed down from original openings size.

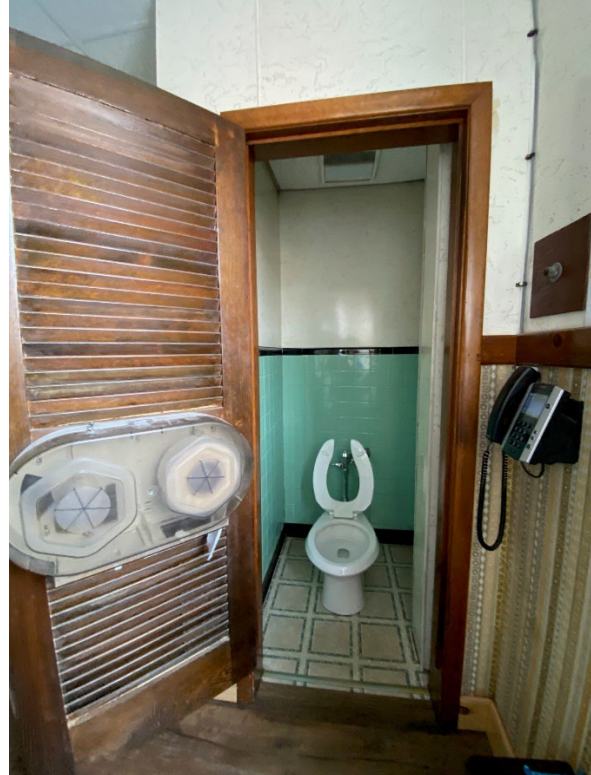
Mid/late 20th century fixtures and finishes are showing age and wear.

4. The existing bathroom is seriously outdated and in poor condition with exposed plumbing, surface mounted electrical wiring and dryer exhaust pipe, dropped ceilings and with low quality plumbing fixtures. If a new building with second floor spaces is constructed, this space which is located along the north wall and is central at the second floor level opposite the stair hall, would be ideal to use as a connection vestibule, or elevator lobby to provide ADA accessibility to these second floor spaces from a new elevator in the new building. Typically, it is advised when linking a new building with a historic one that an existing masonry opening such as a window be used to make the connection, rather than penetrating through a solid wall where no opening exists. It is also recommended that a space that has been the most compromised or having lost the greatest architectural integrity already be targeted for a new use or extensive alterations. Alternatively, this space could be fully renovated to create ADA compliant toilet rooms for public use, given the presence of plumbing/waste utilities to this location already. In either case, the many layers of mid/late 20th /early 21st century finishes should be stripped away to reveal the first/original wall, ceiling and floor surfaces.

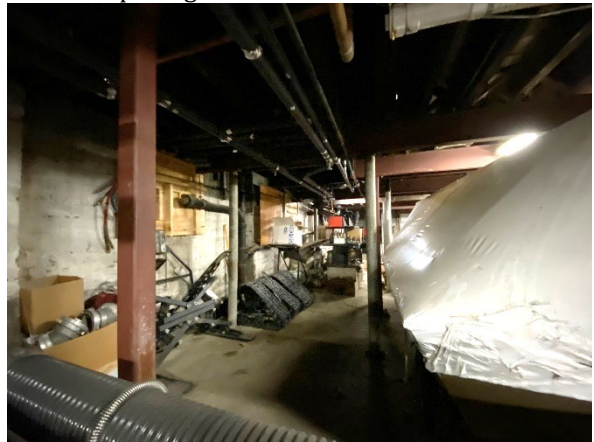
View of parge-d foundation wall on north side of basement with former window openings to crawl space of 1960s addition infilled with plywood.

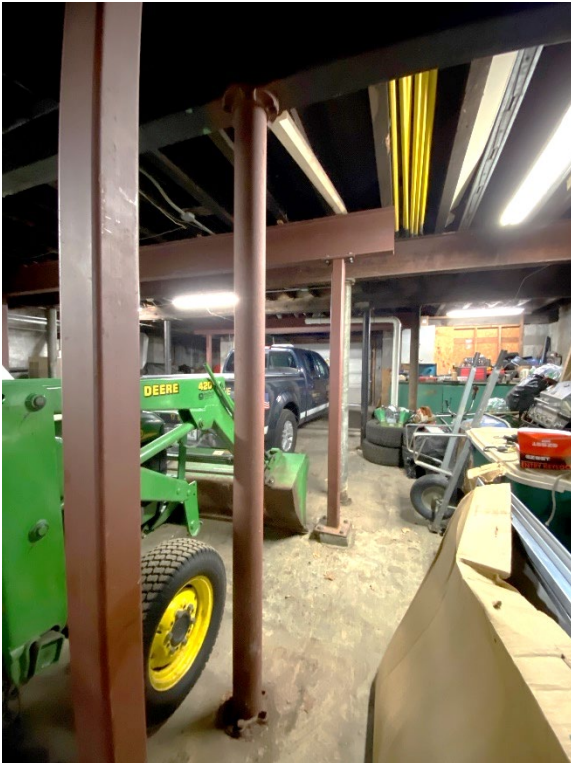
View of row of metal columns in random positions to support added steel beams for first floor framing.
