Feasibility Study for

Village of Saranac Lake Emergency Services Facility

Saranac Lake, NY

October 11, 2023

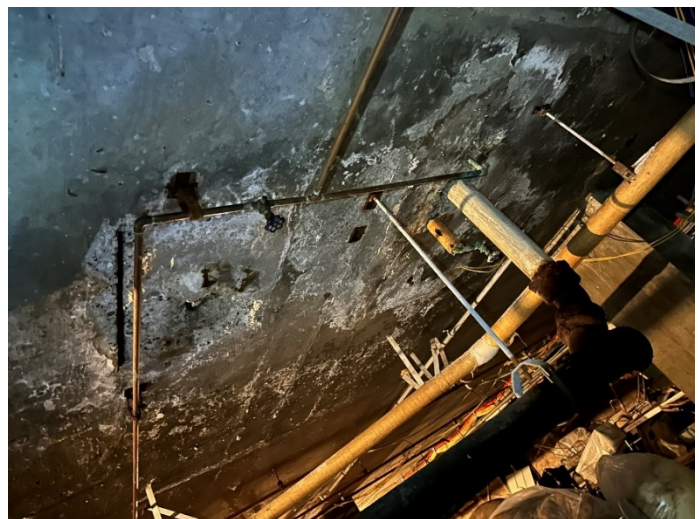
1. Minor concrete deterioration was noted on the underside of the existing 1st floor level elevated slab on the west side of the existing mechanical room. Deterioration noted in the field include spalling, delamination, and cracking. Wendel recommends that the existing elevated slab is locally repaired; remove and replace concrete material as required.

Figure 1 Concrete Slab Spalling Damage

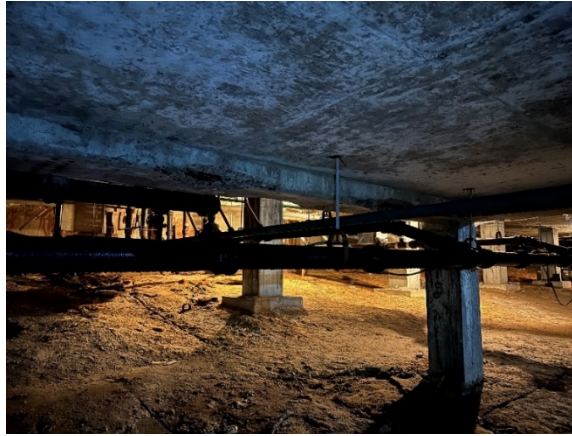
2. Minor concrete deterioration was noted on the underside of the existing 1st floor level at an existing concrete beam located in the south-central region of the original building, near the stair transition located in the main hallway. Deterioration noted in the field include spalling, delamination, and rebar corrosion. Wendel recommends that the existing beam is locally repaired; remove and replace concrete material as required.

Figure 2 Concrete Beam Spalling Damage

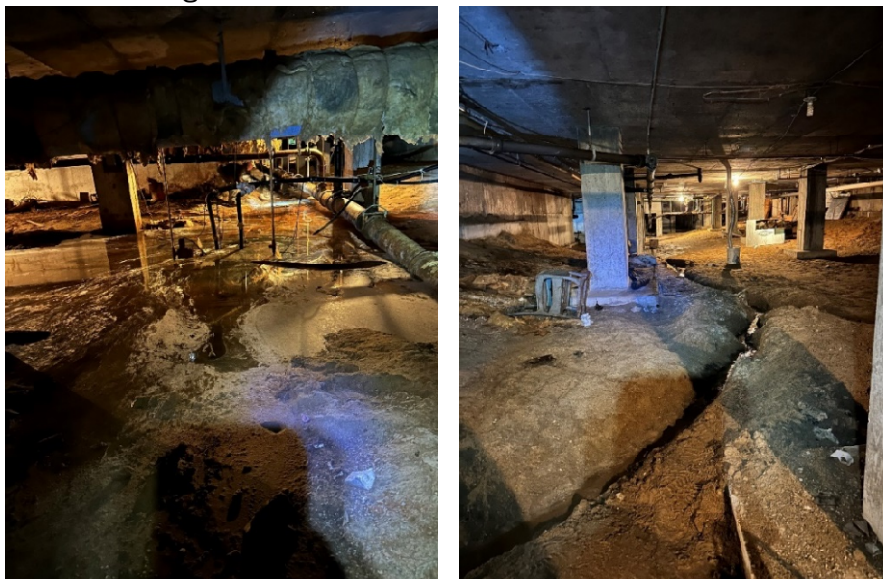
3. Water infiltration was noted in the crawl space on the west side (minor), south side (moderate), and east side (severe). Water is actively flowing from the west side to the east side of the existing crawl space, with erosion of the sub-base material. A large pool of standing water is currently located in the north-east corner of the existing crawl space. Further investigation is required to determine the source of the water, but leaking pipes were noted in the field on the south-west corner. An existing sump pump appears to be in the north-east corner but is currently not functioning. Structurally, this standing water is a concern to the long-term stability of the existing foundations. Wendel recommends further investigation and installation of a sub-drainage system tying into a new sump-pump; in the meantime, we recommend the existing sump-pump is repaired and actively running to eliminate the standing water.

Figure 3 & Figure 4 Water Infiltration in Crawl Space

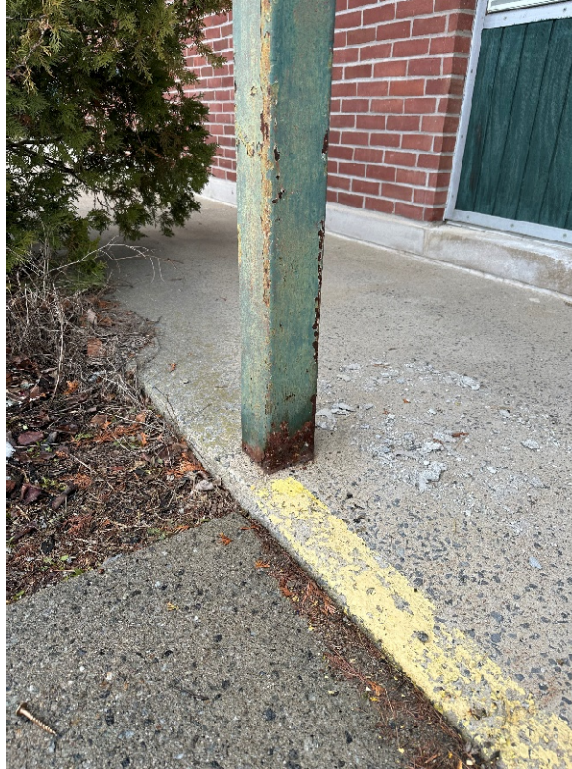
4. Minor steel deterioration was noted on the exterior columns on the south entrance of the building. Deterioration noted in the field includes coating failure and steel corrosion at the base of the column due to chloride exposure. Wendel recommends that the existing steel columns exposed to the elements are blast cleaned and coated with a high-performance coating system.

Figure 5 Steel Column Corrosion

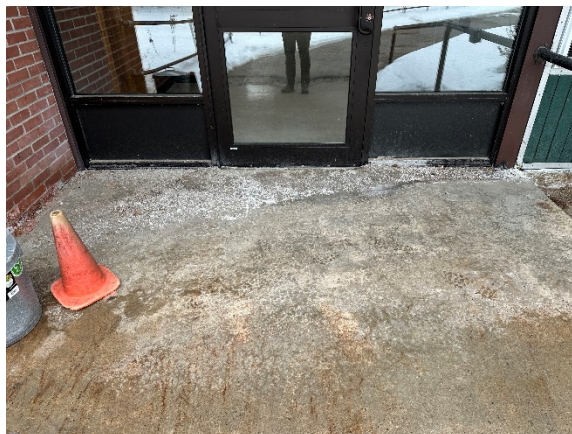
5. Minor concrete deterioration was noted on the exposed concrete surfaces at all entrance slabs due to chloride exposure. Deterioration noted in the field includes spalling, delamination, and cracking. Wendel recommends the existing slabs are removed and replaced in their entirety.

Figure 6 South Entrance Concrete Damage

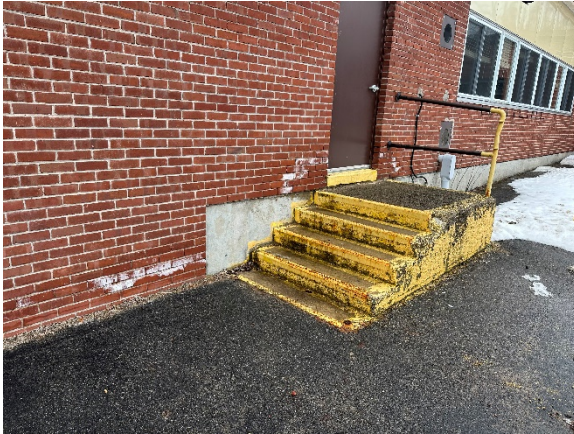
Figure 7 North Entrance Concrete Damage

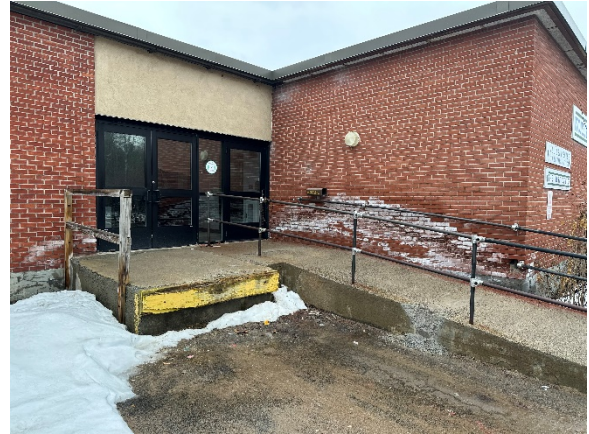
Figure 8 East Entrance (1993 Addition) Concrete Damage
