The Village of
Saranac Lake
New York

Emergency Services
Facilities Assessment
(ESFA)

September 24, 2012

Historic Building Condition Assessment Report of the **SARANAC LAKE FIRE STATION**

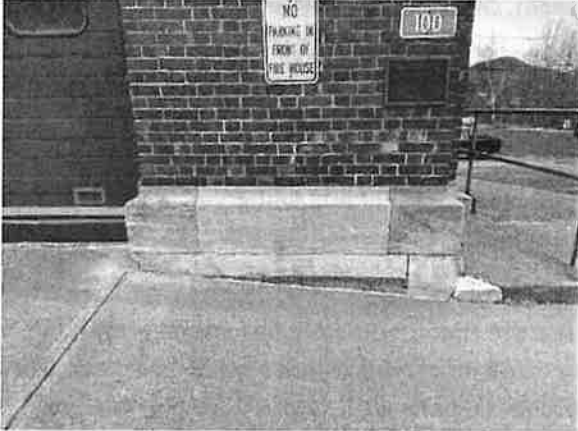
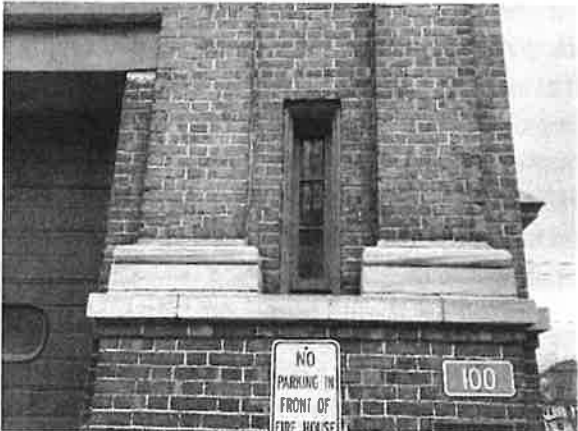
Cut & dressed marble foundation.

Dressed & carved limestone trim.

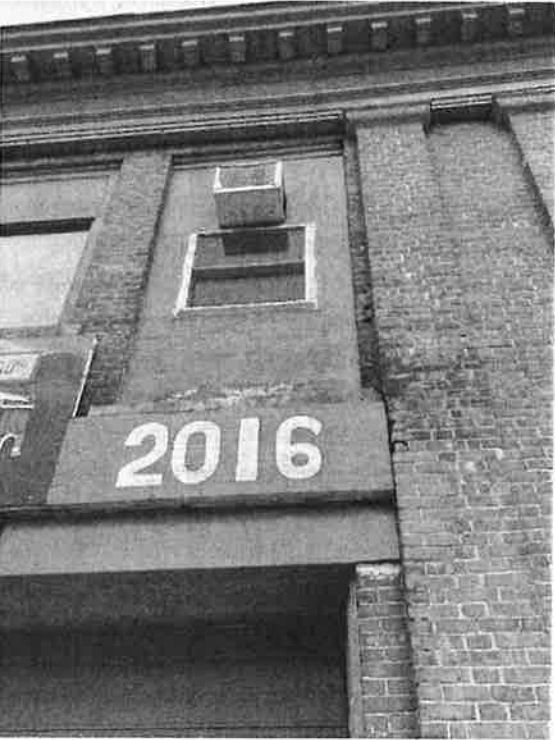
Second floor door & window openings inlaid with painted plywood, replacement units & a/c

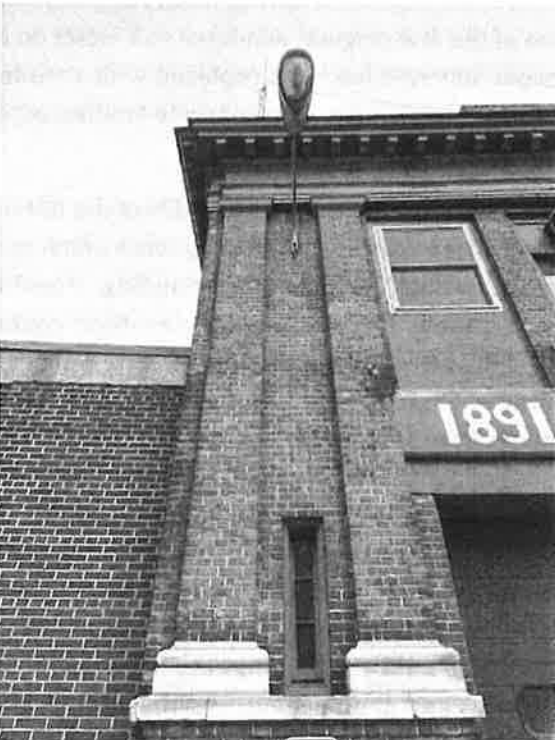
Pressed metal entablature/cornice painted red. Note stone pilaster capitals also painted red.

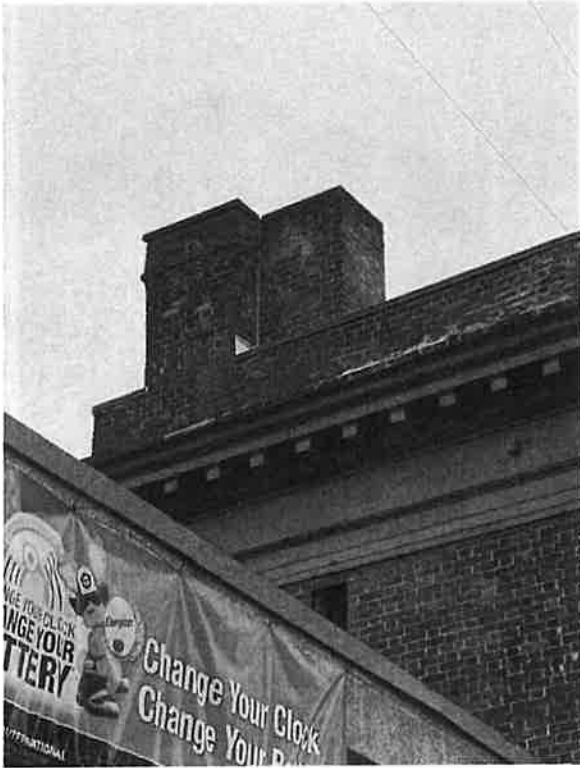
Metal entablature returned on north elevation. Note brick parapet & orig. chimney with new boiler chimney added next to it.

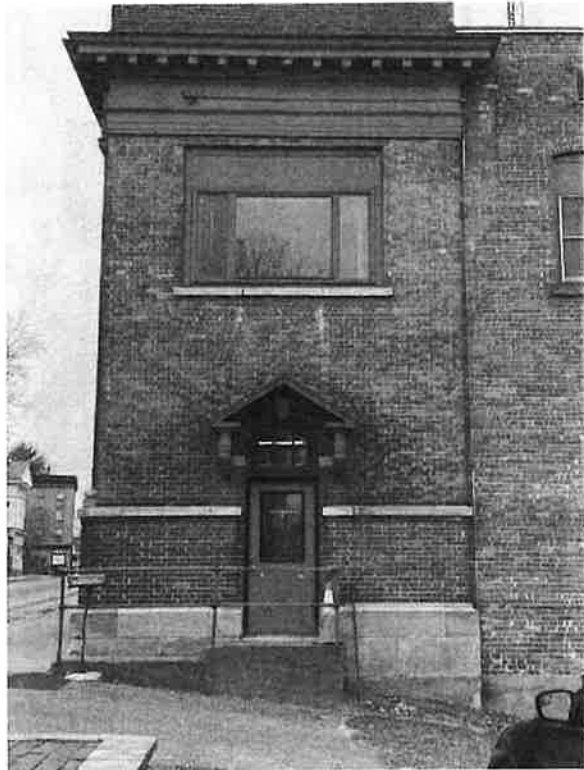
Original side entry with replacement door and framed down and altered 2nd floor window.

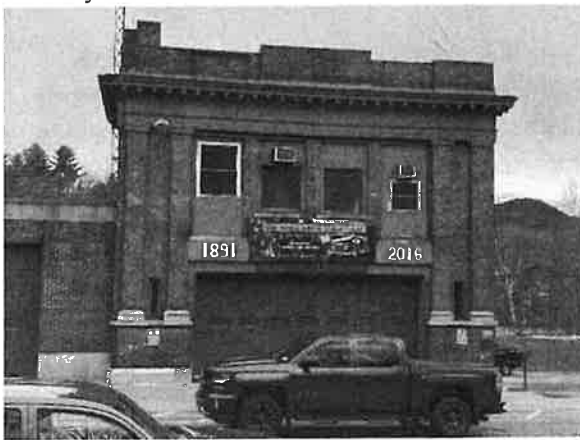
Front elevation with altered 2nd floor window/door openings and missing balcony.

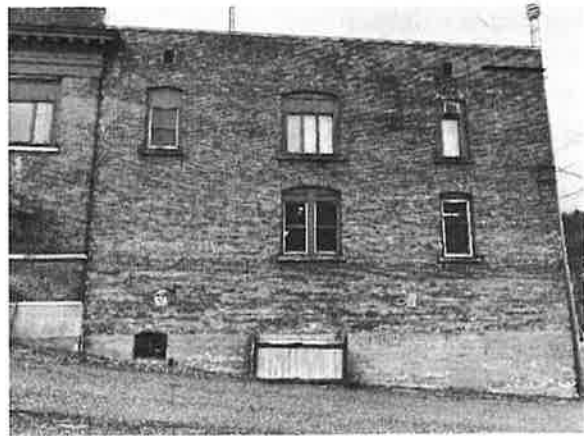
South elevation with altered window openings.

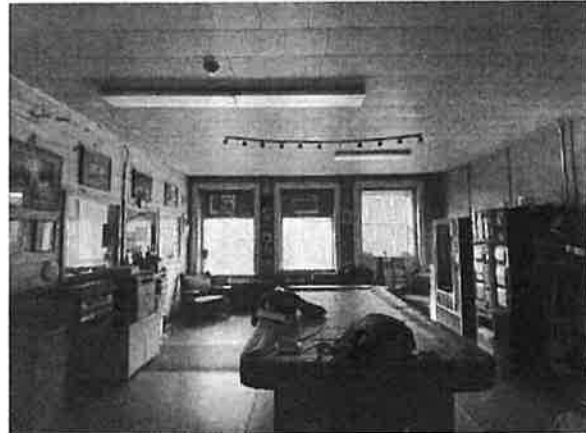
View to west (front) wall in Day Room where orig. windows and doors to former balcony have been infilled & replaced.

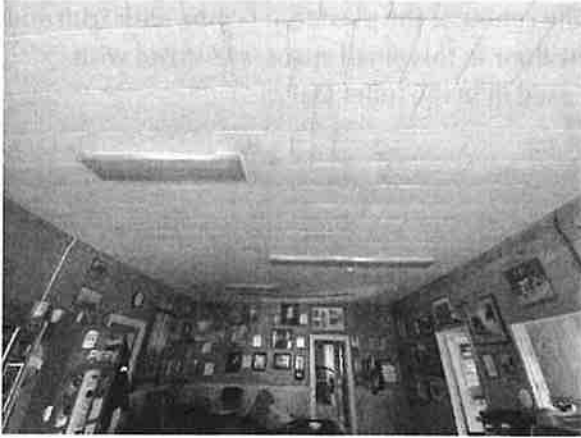
Interlocking acoustical ceiling tiles within Day Room with surface mounted fluorescent lighting.

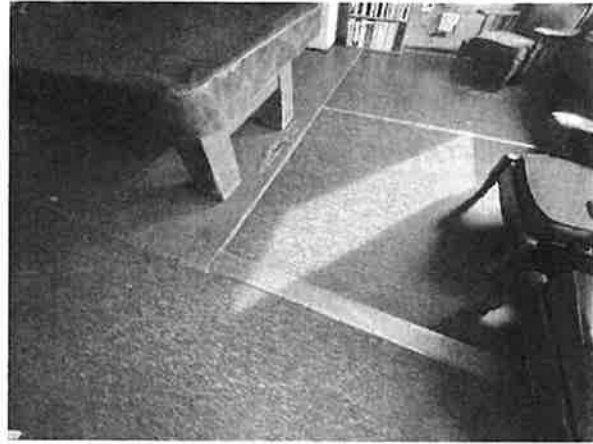
Linoleum sheet flooring pieced together with stainless steel threshold strips. Likely over orig. wood flooring.

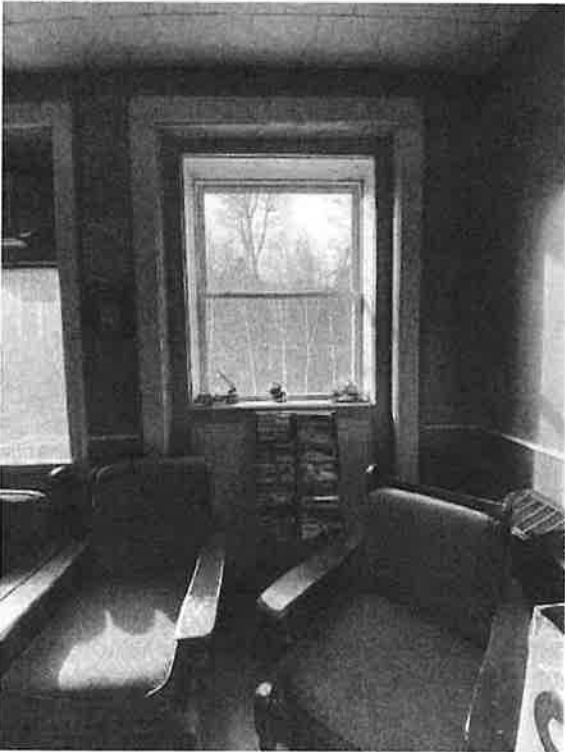
Detail view of orig. doorway opening to front balcony, now infilled with a small window unit.

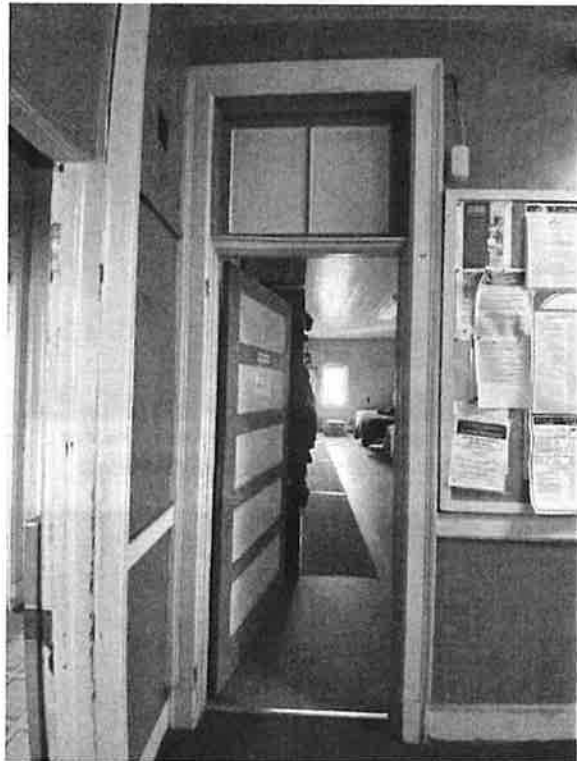
Doorway to bunk room retains original trim surround, transom (glass painted) and paneled door.

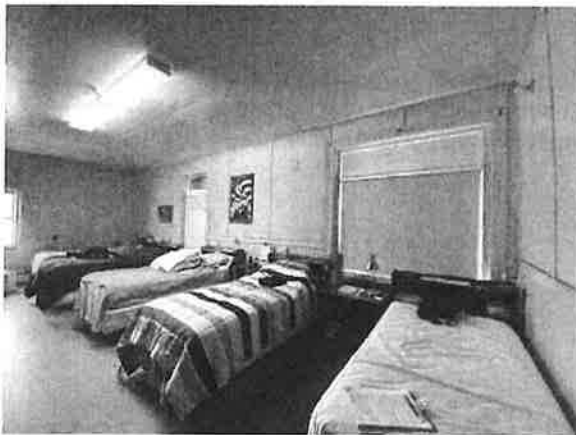
South and east walls of Bunk Room show how original window openings have been retained but have modern replacement units.

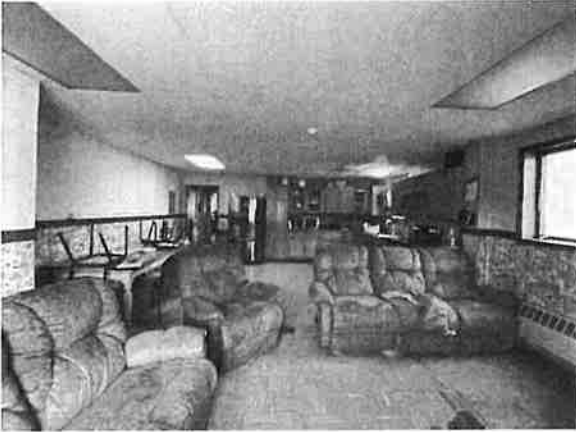
2nd floor Kitchen/Lounge space with mid 20th c. wall, ceiling and floor finishes. Cabinetry is 21st century and in good condition.

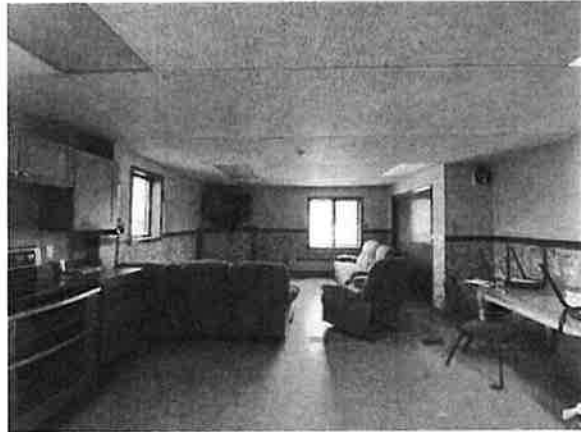
Kitchen finishes, aside of cabinetry dates to the 1960s renovations after neighboring fire.

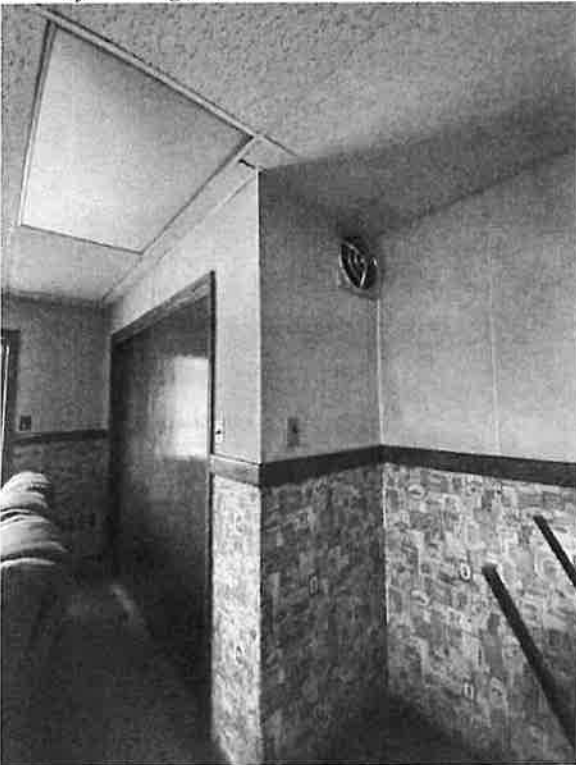
Closet built into SE corner of Kitchen is modern with hollow core sliding doors. Masonite paneling covered with wallpaper.

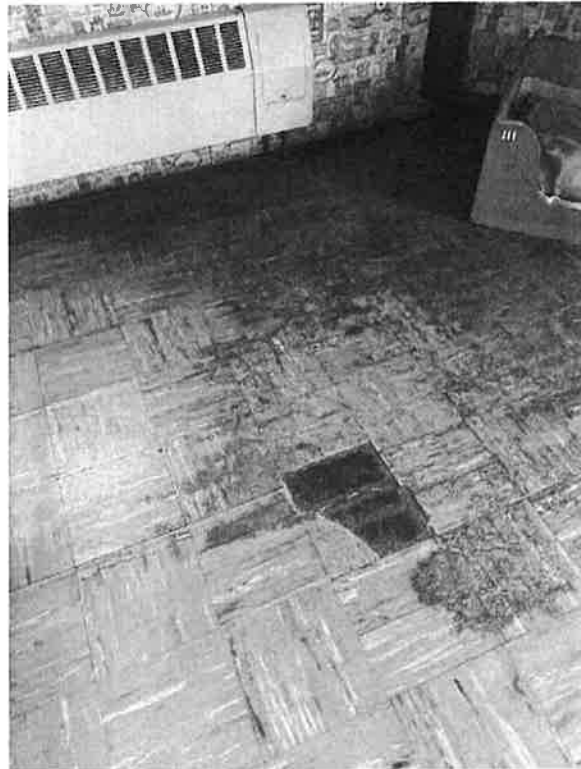
Vinyl composition tile (VCT) on floor is in poor condition in many locations. 9" square VCT typically contained asbestos & is considered a HAZMAT.

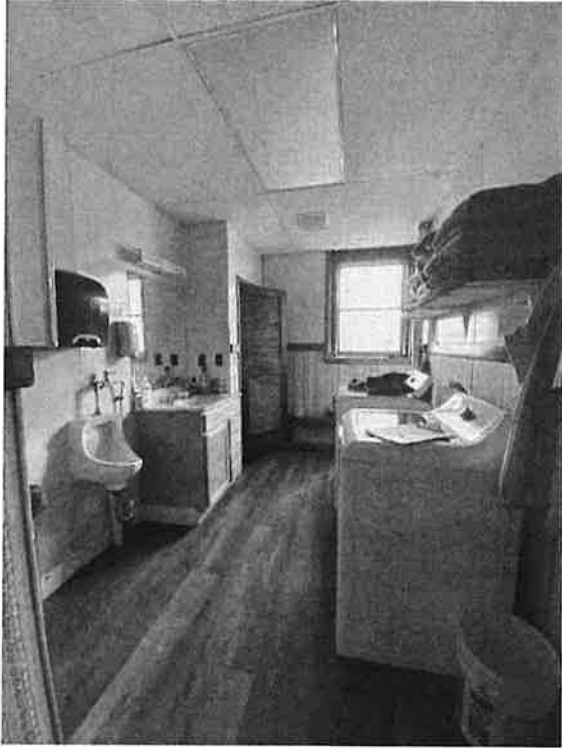
Bathroom/shower/laundry facilities on 2nd floor positioned along north wall. Window is framed down from original openings size.

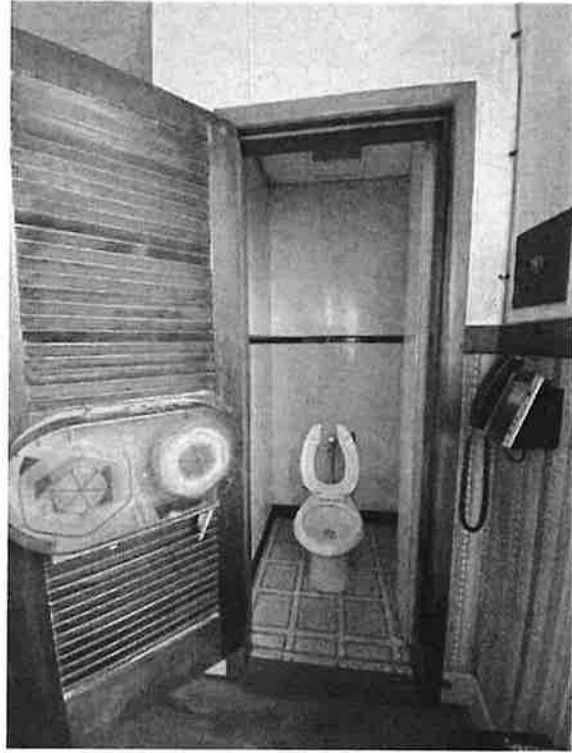
Mid/late 20th century fixtures and finishes are showing age and wear.

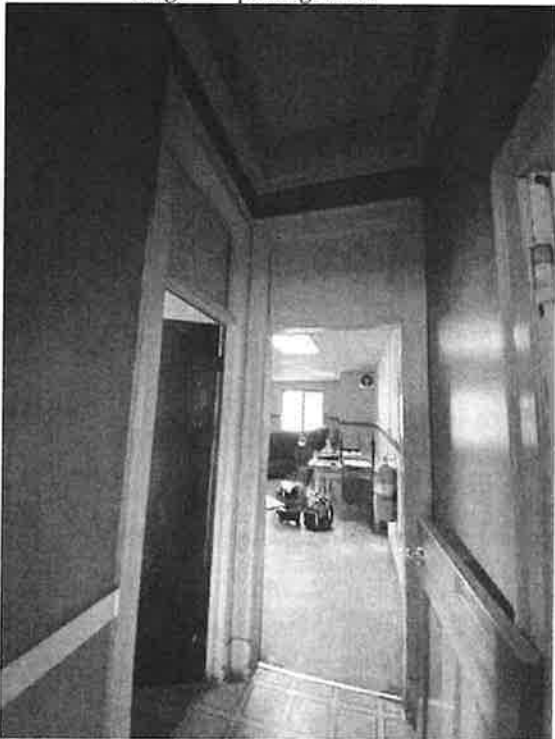
Central 2nd floor short hallway retains original trim elements at doorways.

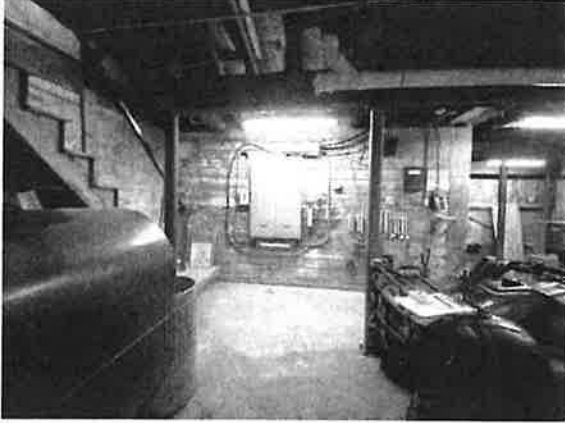
Shiplap board partition wall at bottom of stairs in SW corner – former coal bin. Note new elect. panel.

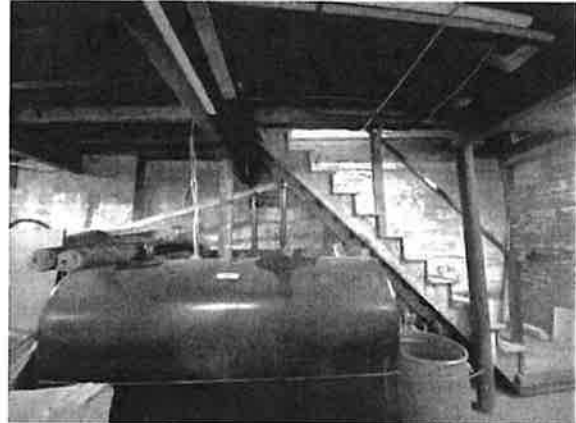
Looking south at staircase along parged foundation wall. Note oil tanks with filler pipes through former window opening.

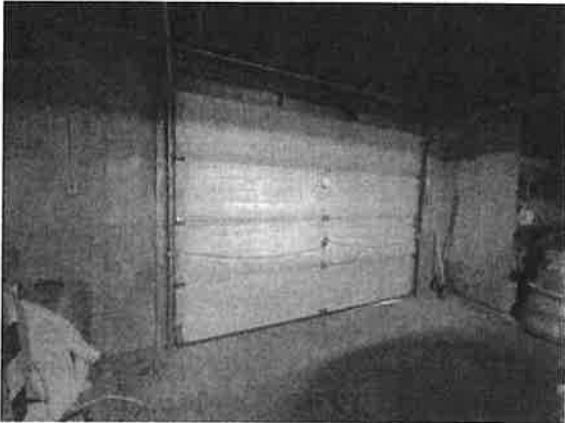
Modern overhead garage door on rear (east) wall.

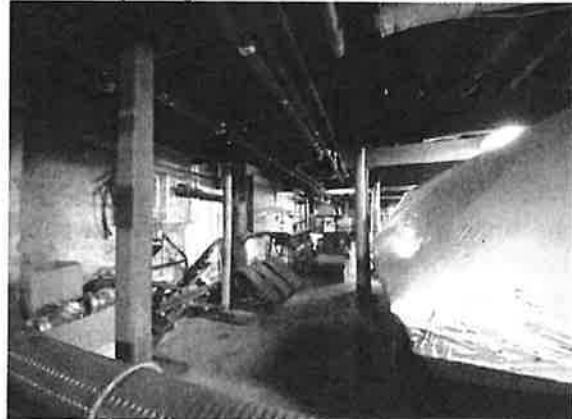
View of parged foundation wall on north side of basement with former window openings to crawl space of 1960s addition infilled with plywood.

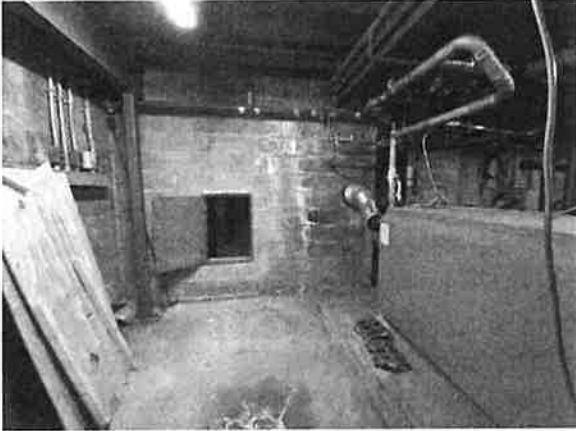
View of wall of hose tower with access door. Note new boiler exhausts into new chimney built within hose tower.
